PHASE II ENVIRONMENTAL ASSESSMENT
OF THE
SAMOVAR
ABANDONED MINE SITE

**PHASE II ENVIRONMENTAL ASSESSMENT
of the
SAMOVAR MINE SITE**

Environmental Services
Public Works and Government Services Canada

February 1997

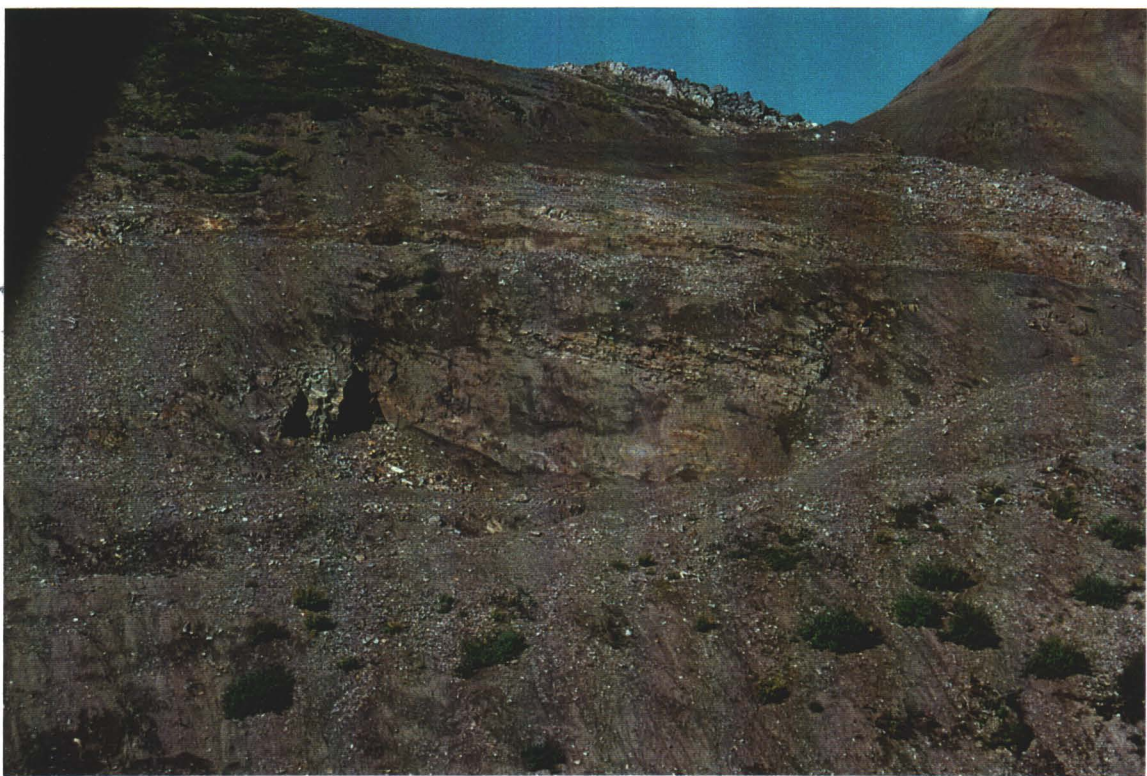
Photo 2. Excavation in upper trench area.

Physical disturbance is limited to access roads constructed to the mine site and small open cuts on the mountainside (Photos 1 - 4). A waste rock pad has been constructed

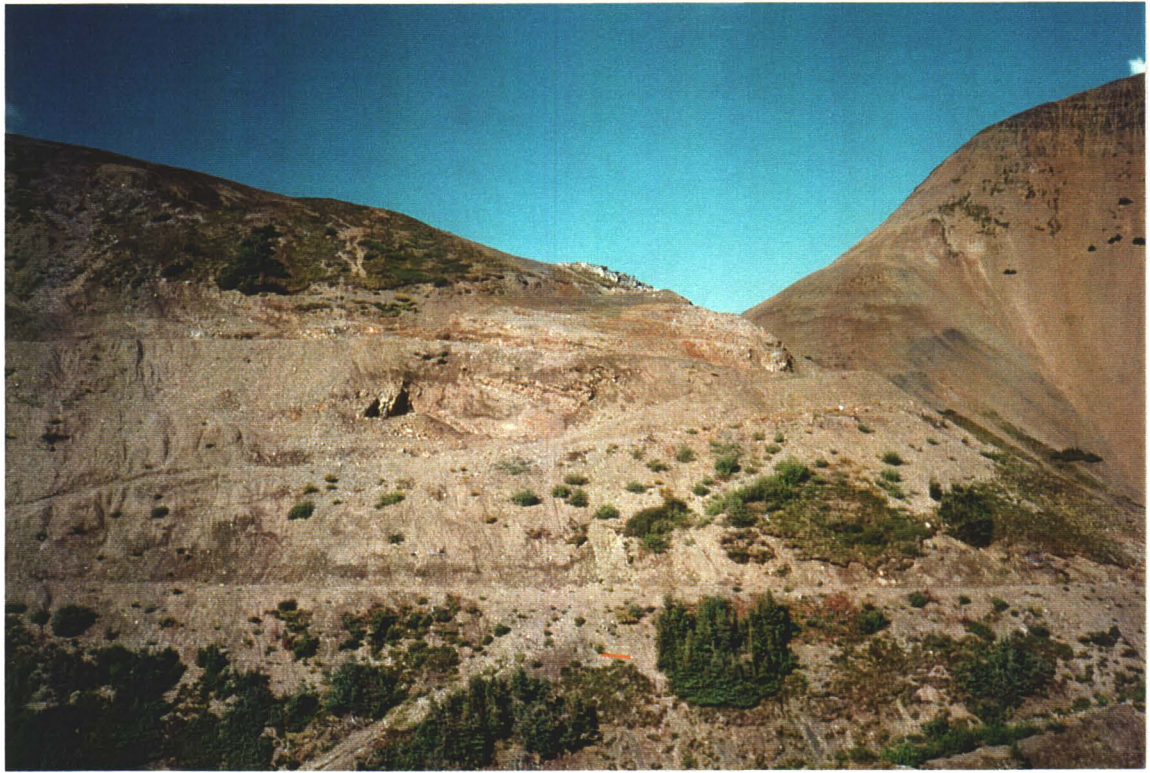
Photo 3. Upper level trenching; excavation face visible near centre of photo.

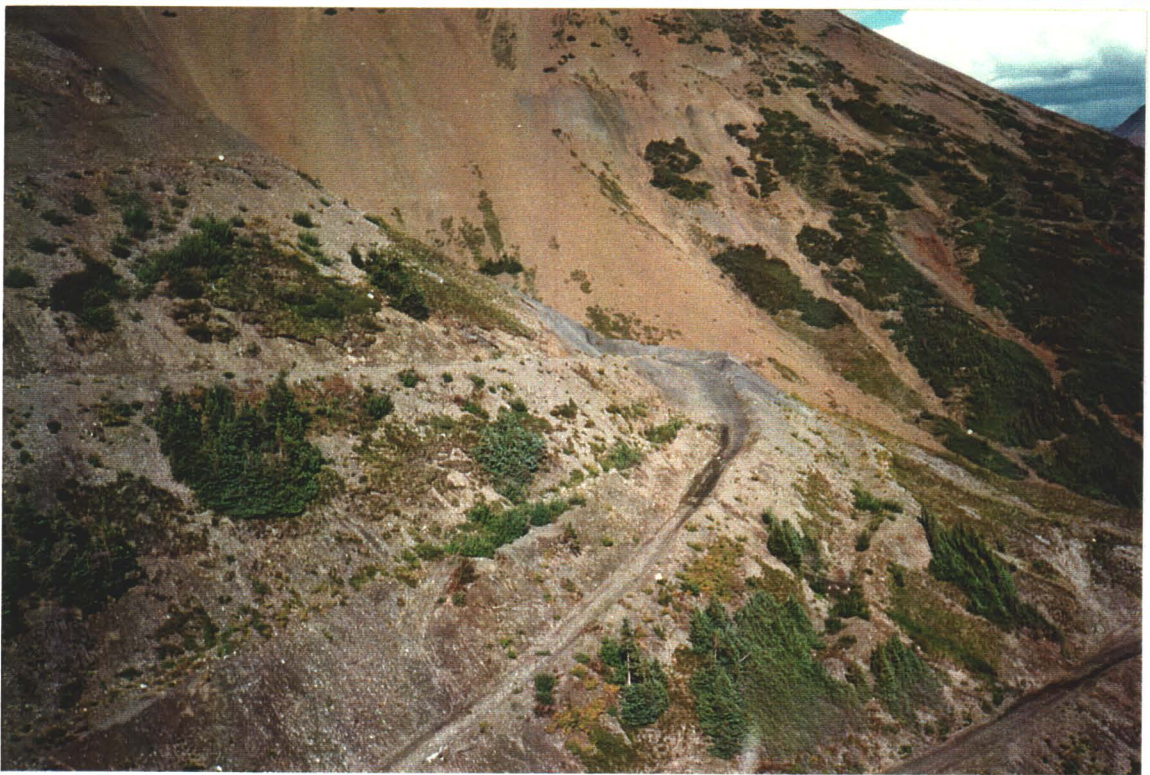
Local runoff and snowmelt from the north and east slopes of the Samovar property drains southeast toward an unnamed stream at the base of the mountain. The stream is about 175 metres east of the main workings, and curves southwestward to pass the mine site again at a distance of 500 metres. Hydrological/water quality records are not available for streams in the Samovar area. One waste rock seep was observed about 150 m southeast and downhill of the main workings.

Photo 4. Access road to upper level trenches; seep visible as wet patch on the road near the centre of the photo.

Recommendation 2. Additional water quality sampling is recommended to monitor effects of possible acid generation from waste or underlying host rock. Samples should be collected at SAMOV-WQ-002 and SAMOV-WQ-003 to monitor background water quality and inputs from the mine site respectively. Samples should be analyzed for dissolved metals, pH, conductivity, and sulphate, and the results compared to the CCME criteria for Freshwater Aquatic Life. The monitoring program extend for at least 5 years and provide water quality data for spring freshet, middle summer and late fall runoff conditions.

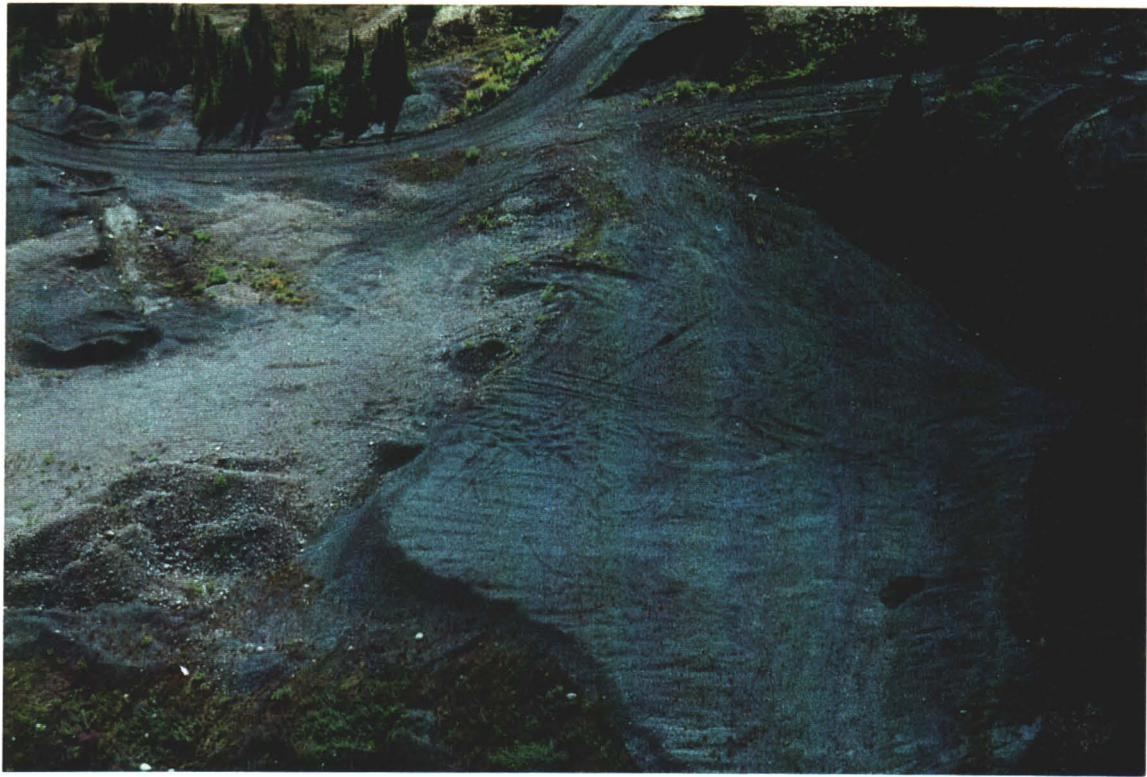
adjacent to the mine access road at the base of the slope (Photo 5).

Photo 5. Waste rock pad constructed near mine access road at base of slope.

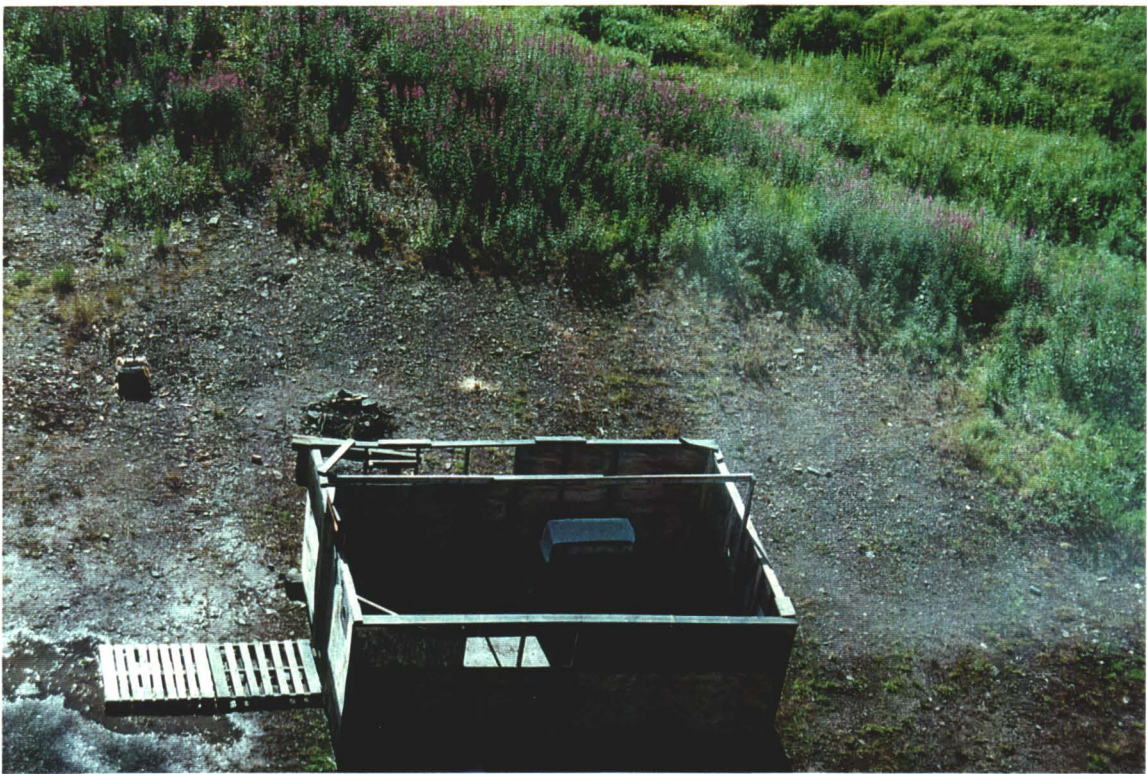
A small cabin is the only significant structure at the Samovar site. Details of construction features and interior contents are summarized in Table 5.1.

Photo 6. Cabin on mine access road.

Recommendation 1. To address aesthetic concerns, the cabin should be burned and solid waste materials should be consolidated, crushed, and buried. The preferred burial location is at the cabin location. Waste rock cover material is available at that site, and the materials will be isolated from the stream running to the east and south of the mine site.

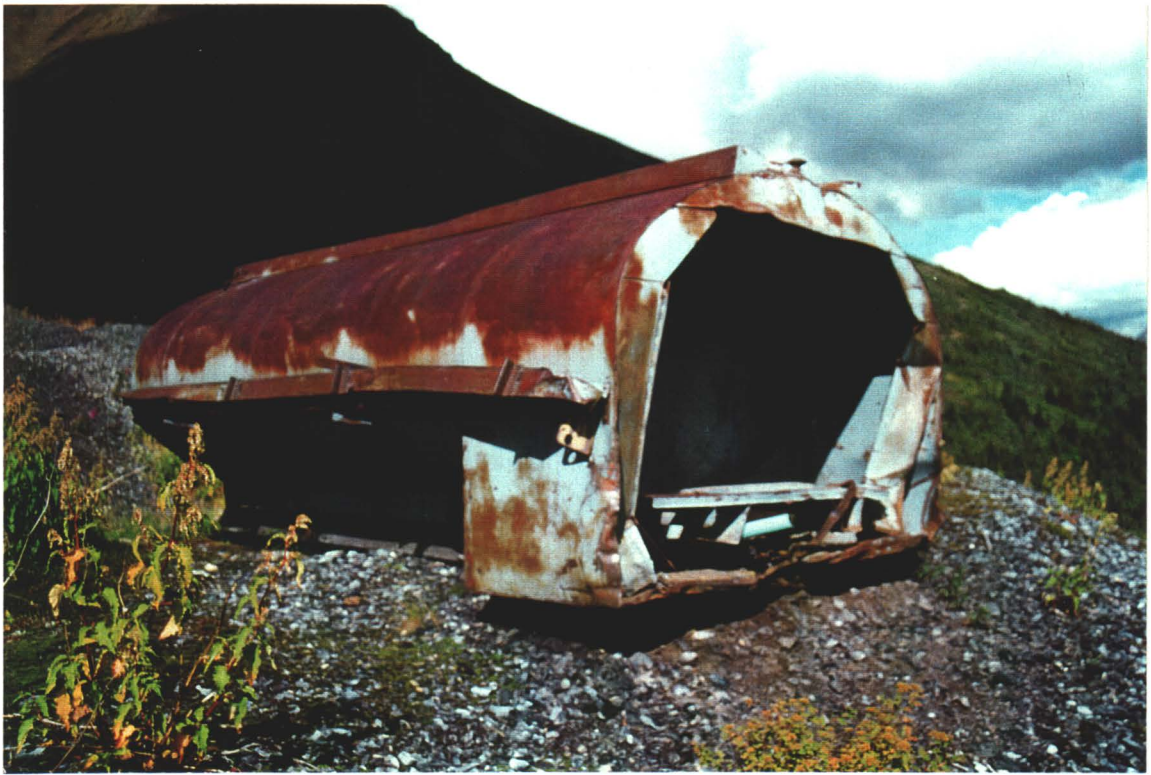
Photo 7. Bowser-style truck tank on mine access road at base of slope.
