**PHASE II ENVIRONMENTAL ASSESSMENT
OF THE
SILVER CITY
ABANDONED MINE SITE**

**Action on Waste Program
Indian and Northern Affairs Canada**

**Environmental Services
Public Works and Government Services Canada**

March 1997

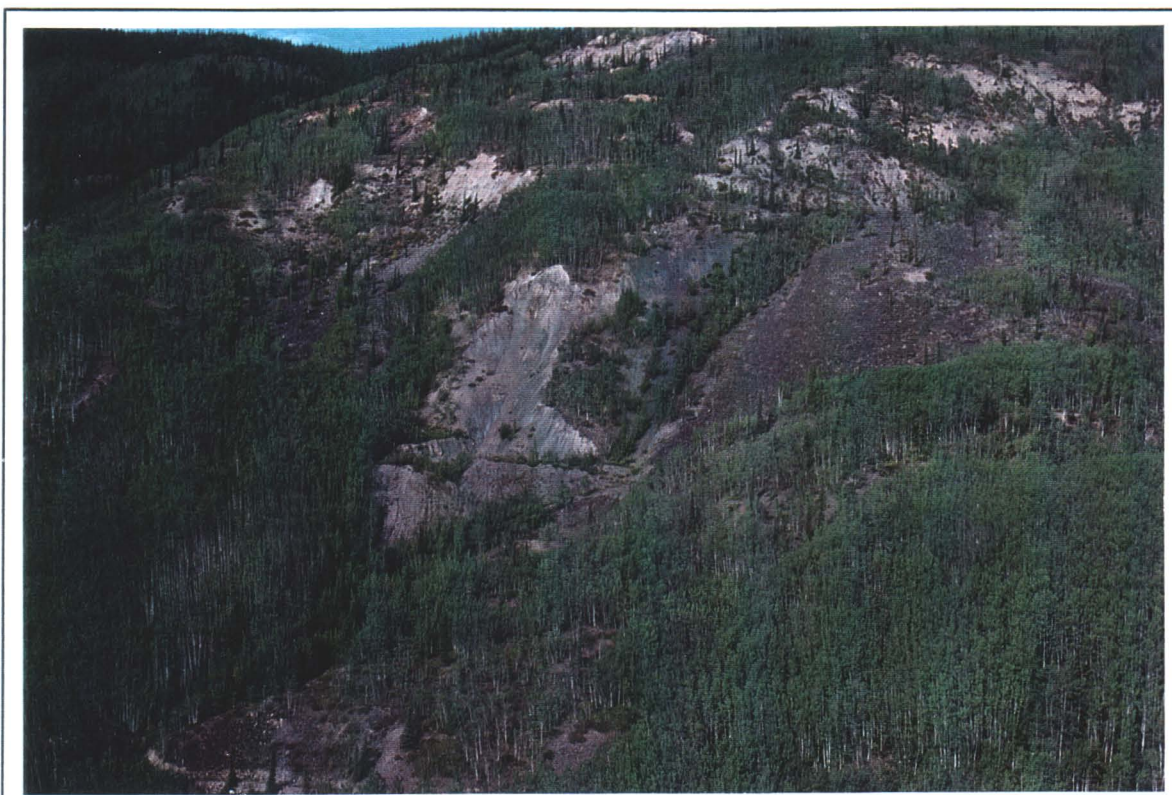
Photo # 1 - Overview of Silver City Mine from Air

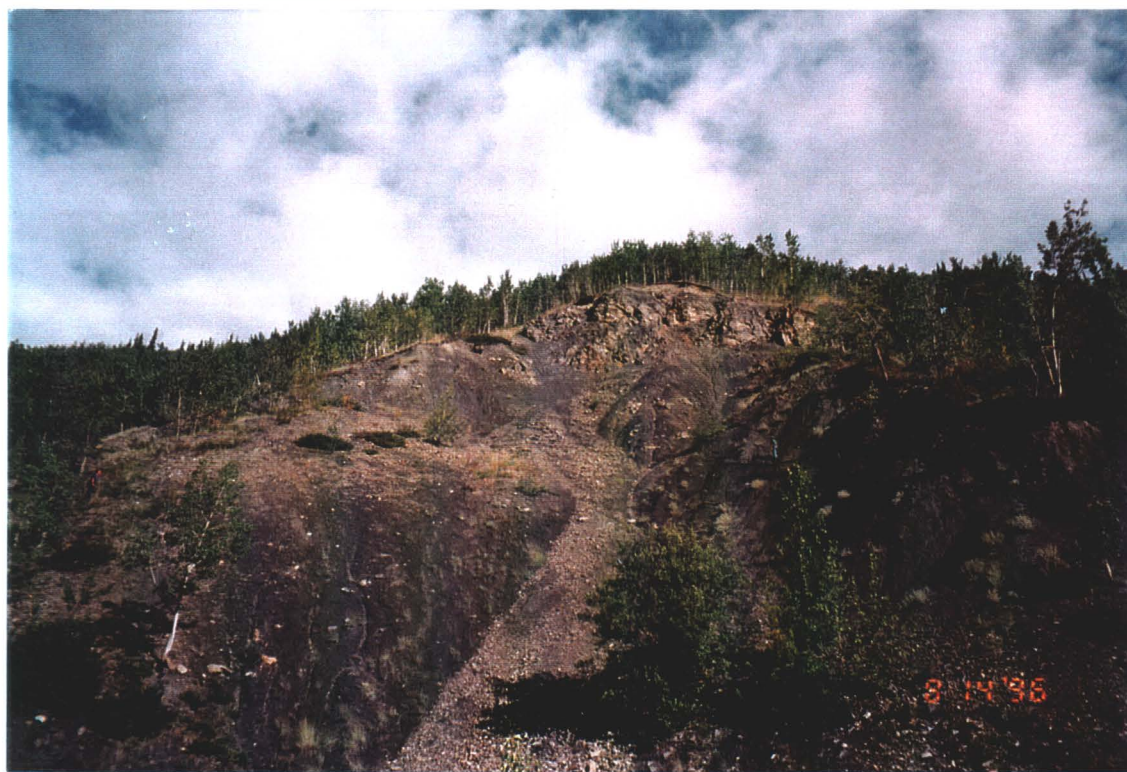
Although three adits were reported to have been completed on site, none were found during the site investigation. It was surmised that the adits have been covered

over or engulfed by the landslide.

Photo # 2 - Main Excavation Location with probable Rock Chute

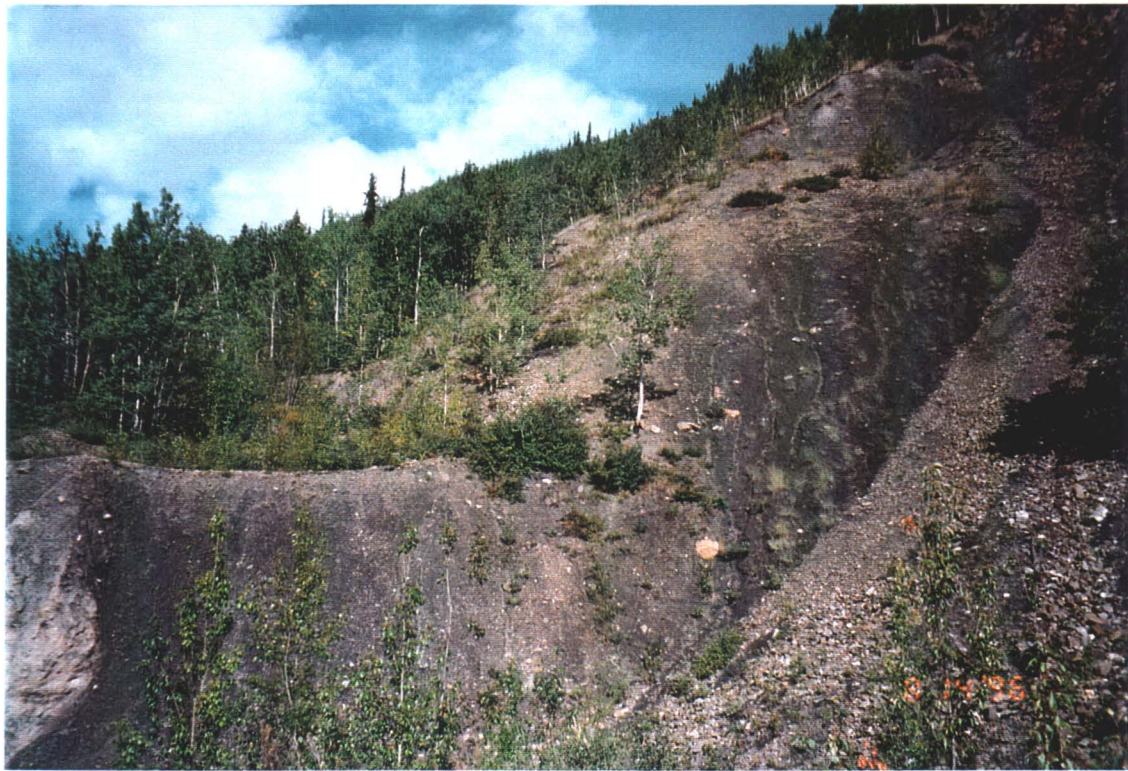
Several waste rock piles of similar composition were deposited at the base of the slope containing the landslide. The piles are composed primarily of limestone and shale, with minor barren quartz and calcite clasts. The shale often had surficial iron oxide staining. No evidence of sulfide oxidation was seen on the pile surface and no sulphides were identified in the waste.

Photo # 3 - North End of Waste Rock Ridge

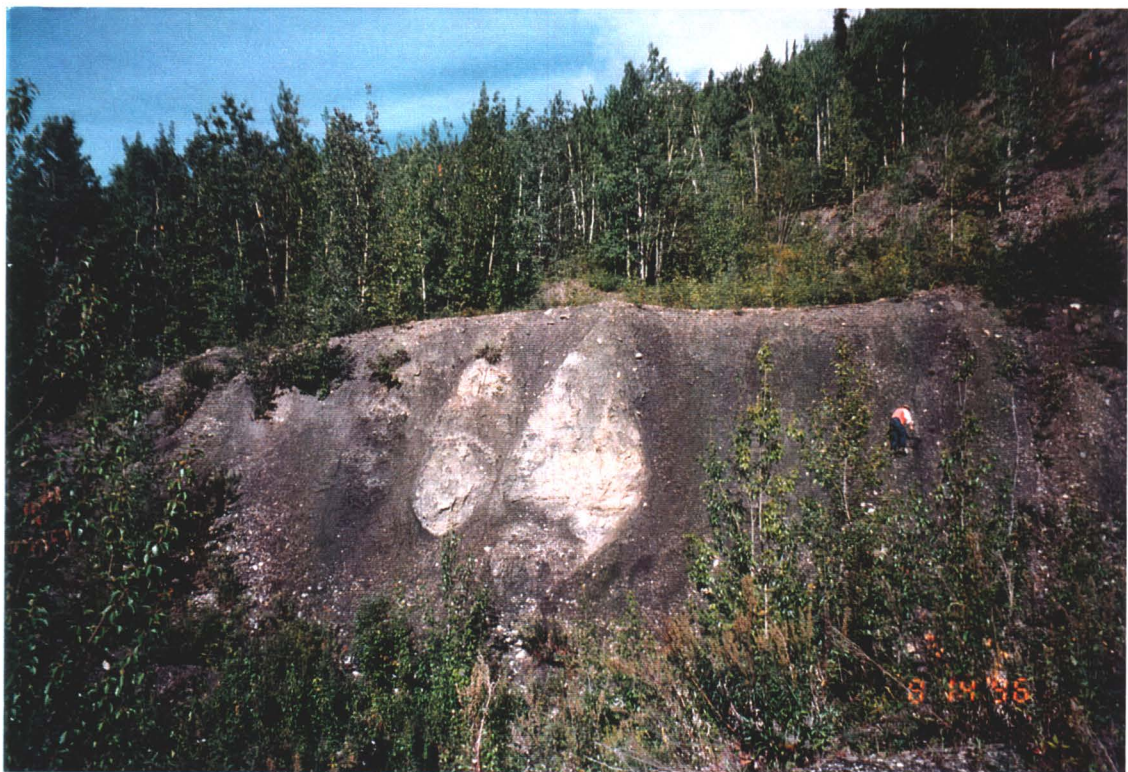
One sample pit was dug in the largest waste pile at the foot of the slide area, and one rock sample was collected for analysis by Acid Base Accounting (ABA) and determination of metals by Inductively Coupled Plasma - Atomic Emission Spectrophotometry (ICP-AES).

Results of solids analysis are listed in Appendix B and summarized in Table 3. The material in the piles was alkaline and had moderate conductivity (690 $\mu\text{S}/\text{cm}$). The total sulphur concentration was low (0.17%) and the material contains abundant neutralizing potential. The NP/AP value for the sample was 14, indicating that the material has a low potential for generating acid.

Sample ID	Sample Location and Description	Discussion of Results
SCWR/P1/1	Pit was dug at the top of main waste rock pile. Material is dark grey and contains abundant clasts of shale.	Material has pH=8.1 and is not potentially acid generating (NP/AP=14); high Zn, moderate As, Cu.

Metal concentrations were low in the waste, which contained 222 mg/L zinc, 64 mg/L arsenic, and 94 mg/L of copper. Other metals were present in lower concentrations.

Photo # 4 - Waste Rock Ridge (SCWR/P1/1)

The waste rock at Silver City is not potentially acidic and contains low metal concentrations. The environmental risks associated with this material are, therefore, low.

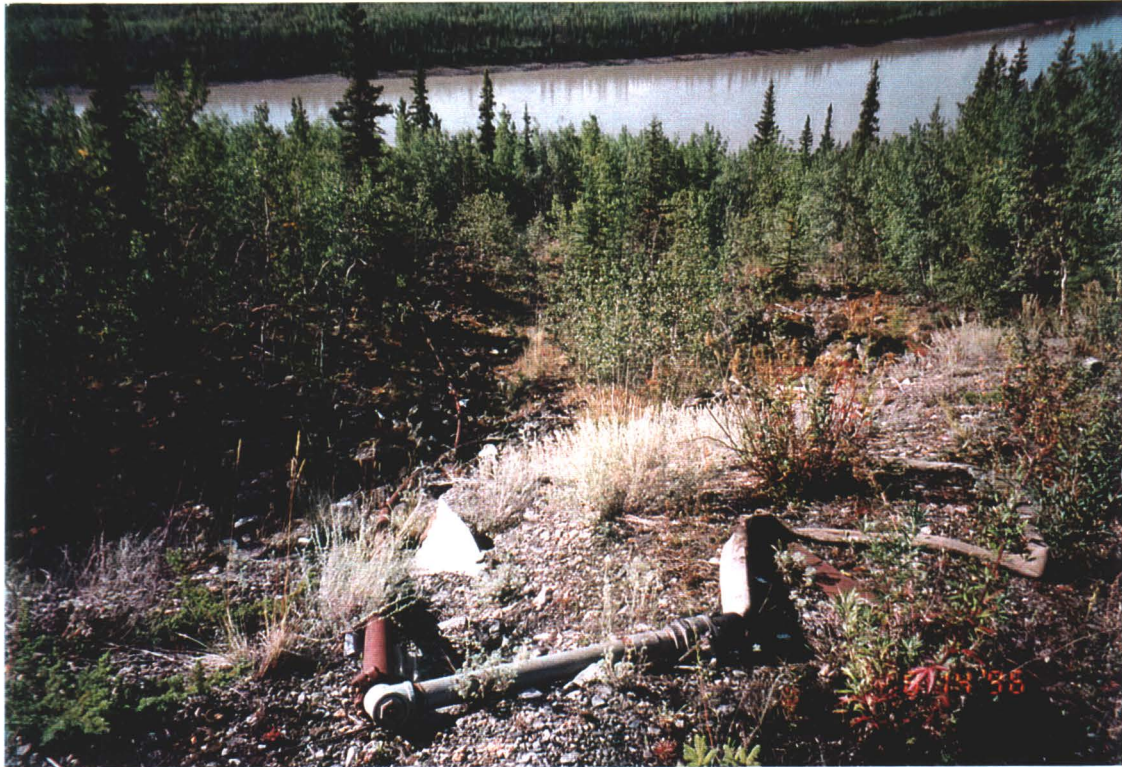
Waste Material	Number/ Volume	Location	Comments
Water supply pipe and associated metal debris	1	Extending from base of east scree slope approximately 500m down slope.	Pipe diameter= 75mm, Scraps of corrugated steel nearby
Collapsed trailer unit (burned) and metal debris	< 100m ³	At base of slope near river, among heavy vegetative growth	Location of minor dumpsite from operation

Photo # 5 - Top End of Steel Pipe Leading down Mountainside

Using applicable federal and territorial criteria as well as northern mine reclamation guidelines, the recommendation is that no additional work be conducted on this site. Due to the small volume of debris remaining on site and encroaching vegetative cover, mobilizing equipment to remove or dispose of the debris is not economically feasible. No further test work is recommended on the waste rock.

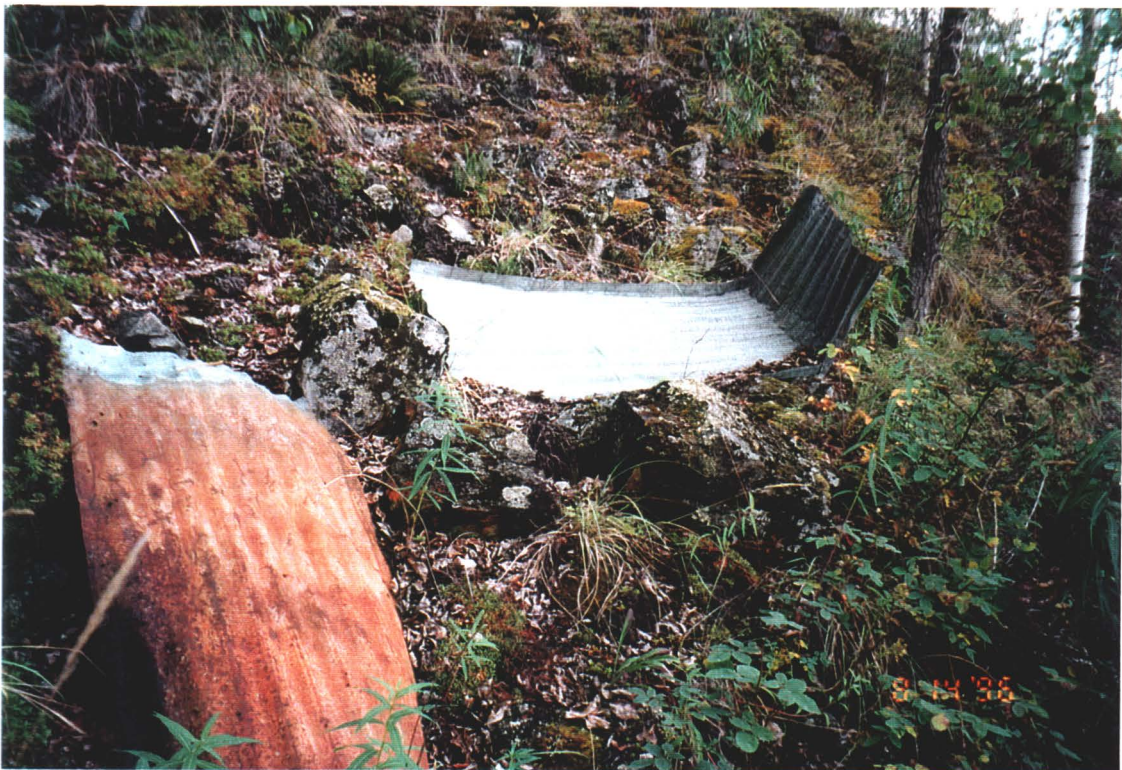
Metal debris remaining on site is limited to two locations, either near the water supply pipe or near the burned trailer unit. The overall volume of debris is low and is well covered by vegetative growth.

Photo # 6 - Assorted Metal Debris near Scree Slope

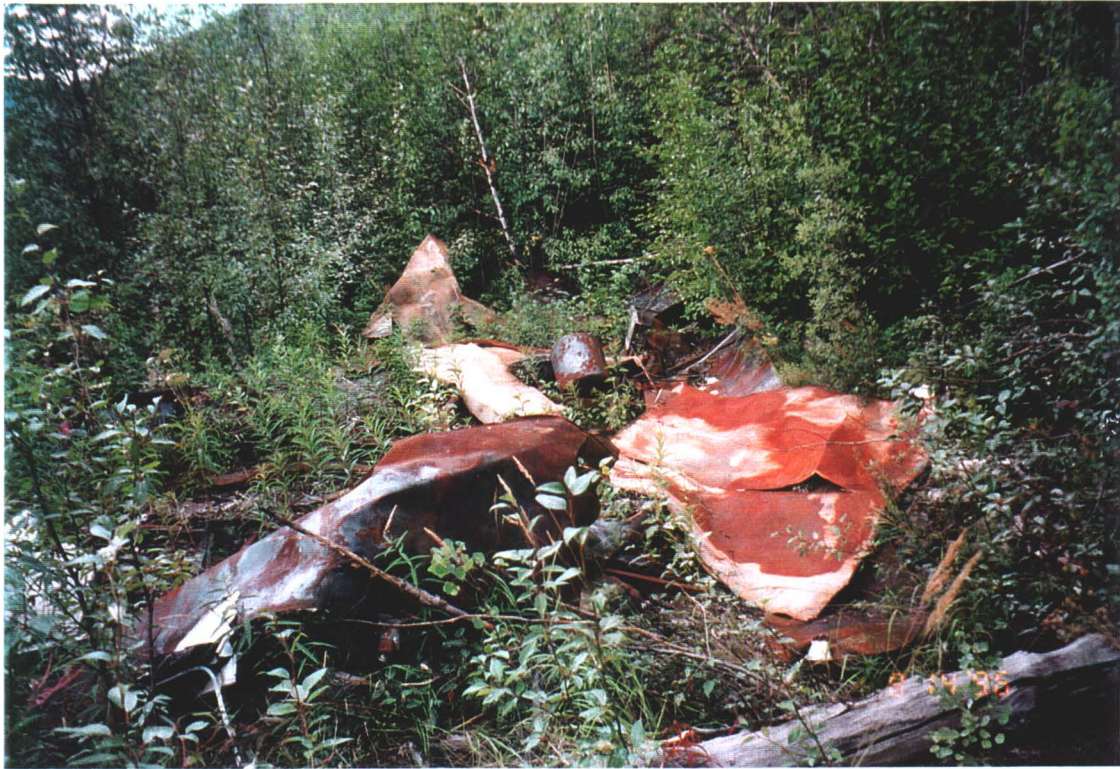
Photo # 7 - Metal Debris Dump near River

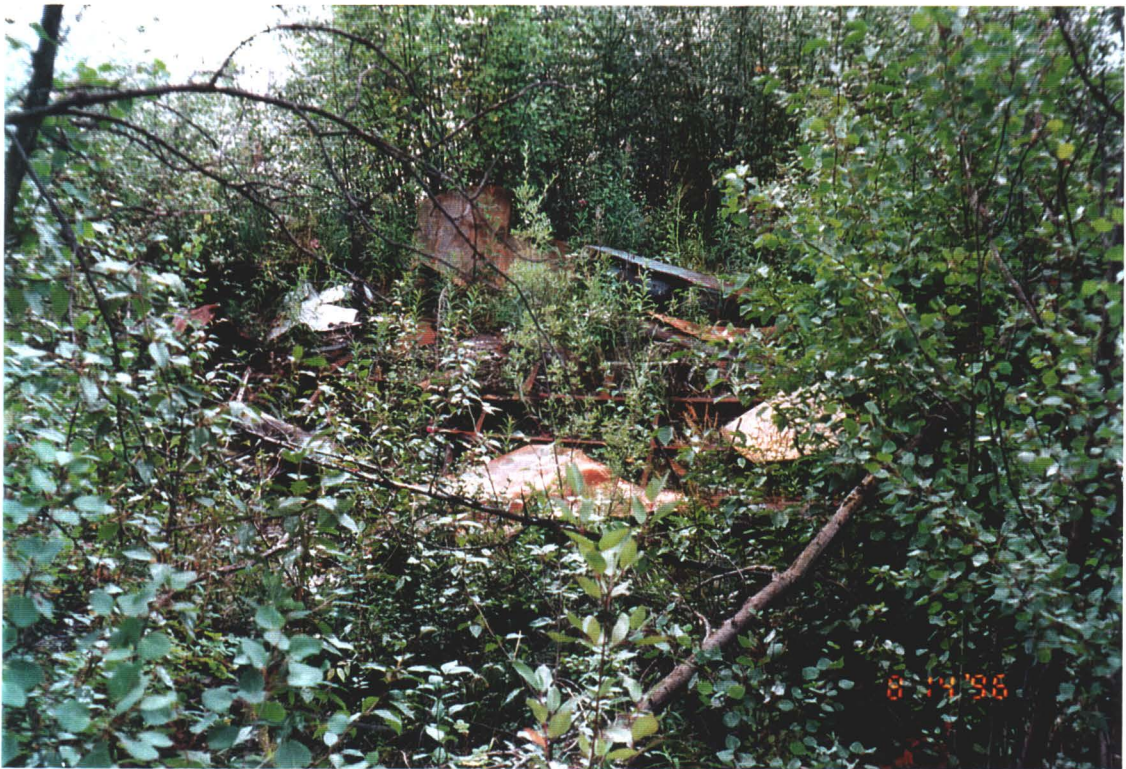
The results of the investigation concluded that environmental risks from the Silver City mine site are low. An assessment of the acid rock drainage potential shows that the risk to the environment due to the presence of waste rock is currently insignificant. Minor aesthetic concerns arise from a steel water supply pipe running down most of the mountainside towards the river, assorted metal debris nearby and a small metal dumpsite at the base of the hillside where a collapsed and burnt trailer has been left.

Photo # 8 - Remains of Collapsed Office Trailer near Metal Dumpsite
