**PHASE II ENVIRONMENTAL ASSESSMENT
OF THE
SOURDOUGH (COAL CREEK)
ABANDONED MINE SITE**

**Action on Waste Program
Indian and Northern Affairs Canada**

**Environmental Services
Public Works and Government Services Canada**

March 1997

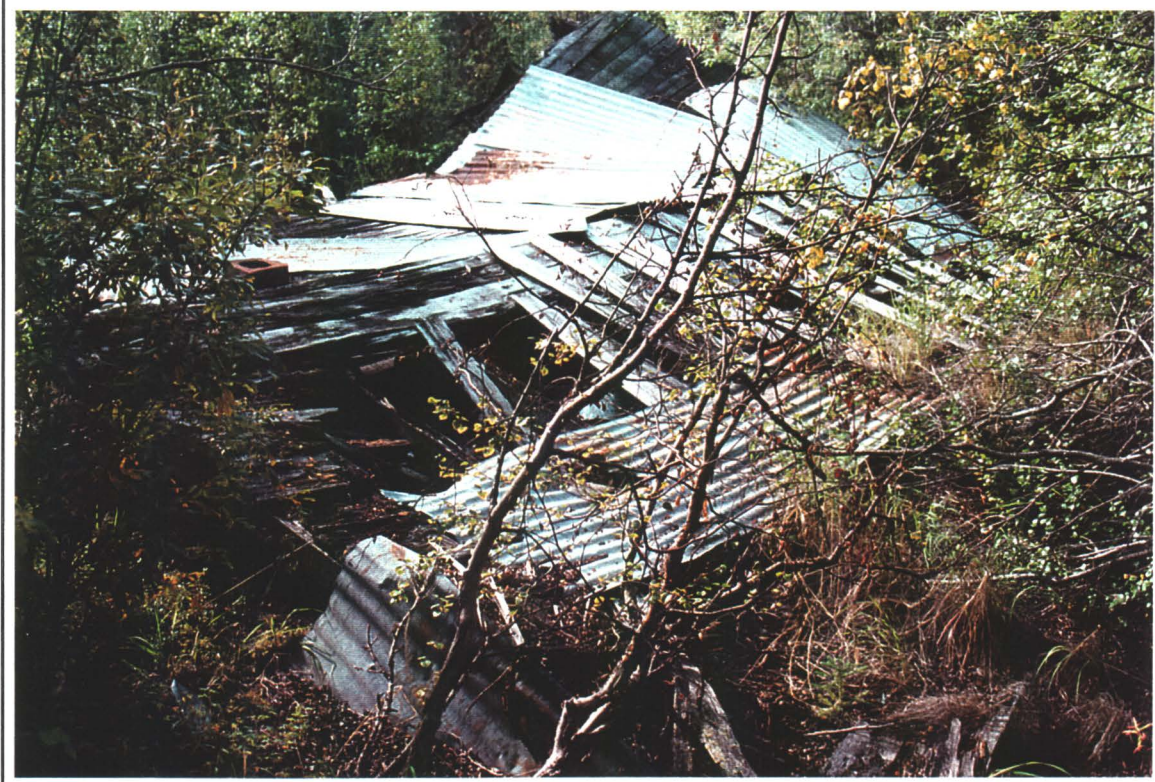
Photo # 8 - Maintenance Building (Collapsed)

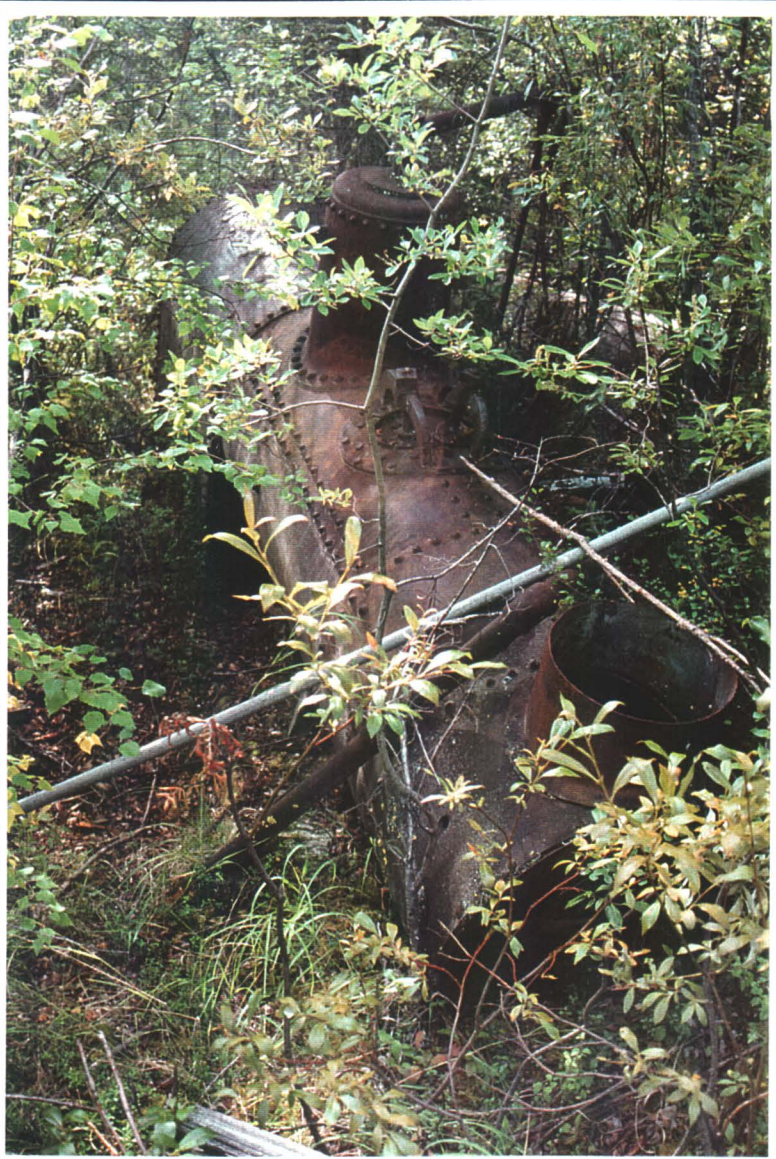
Photo # 9 - Boiler Unit near Maintenance Building

Waste Material	Number/ Volume	Location	Comments
Riveted boiler units	2	1) 5m X 1m at maint. bldg, 2) 9m X 2m along railway r.o.w.	Empty, rendered unusable
Rail ore cars	6	Along end of railway r.o.w.	Primarily wood, most undercarriages removed
Rail pump car	1	10m east of bunkhouse	Fair condition, possible heritage value
Collected wood debris	<75 m ³	West of Powerhouse	Three piles of wood from collapsed buildings
Misc. wood debris	<20 m ³	Scattered around site and around old buildings	Non-preserved, burnable
Misc. metal debris	<10 m ³	Scattered around site and near cookhouse & log residence	Non-burnable and rusted
Cement bags	<6 m ³	Approx. 20m NW of Powerhouse	Decaying bags piled together

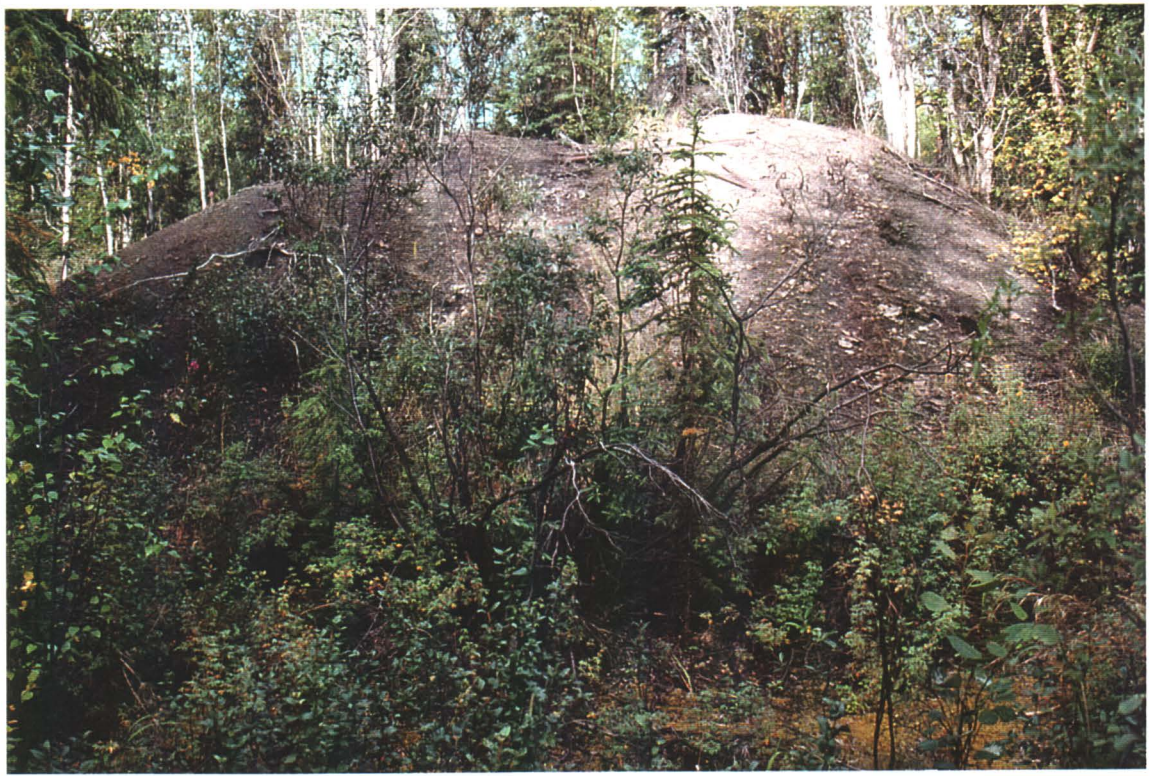
Photo # 10 - Coal Waste Pile (SD-WR-P1-1)

Three waste rock piles and one coal stockpile were found on the site. Other waste and ore piles may be present and hidden in the thick bush covering the area. The coal was composed of sand to cobble sized particles. The waste was composed primarily of shale with rare pieces of coal. The total amount of waste and ore on site is approximately 4039 tonnes (4452 tons).

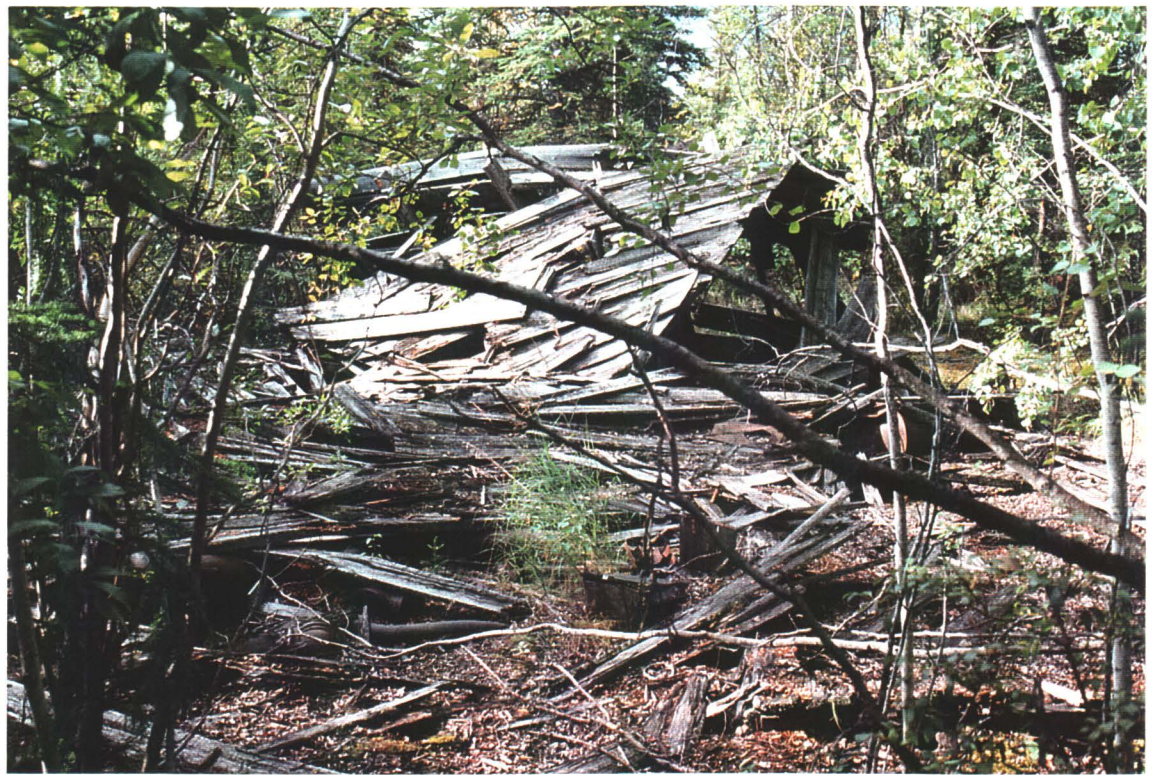
5) Warehouse	12m X 7m	Southwest of Maint. Bldg. at terminus of right-of-way (r.o.w.) for railcars	Collapsed, metal clad roof
6) Powerhouse	Approx. 10m X 35m	Approx. 50m east of landing area	Extremely poor shape, badly degraded concrete, several foundations surround facility, two sump structures surround north and east sides

Photo # 13 - Warehouse Building (Collapsed)

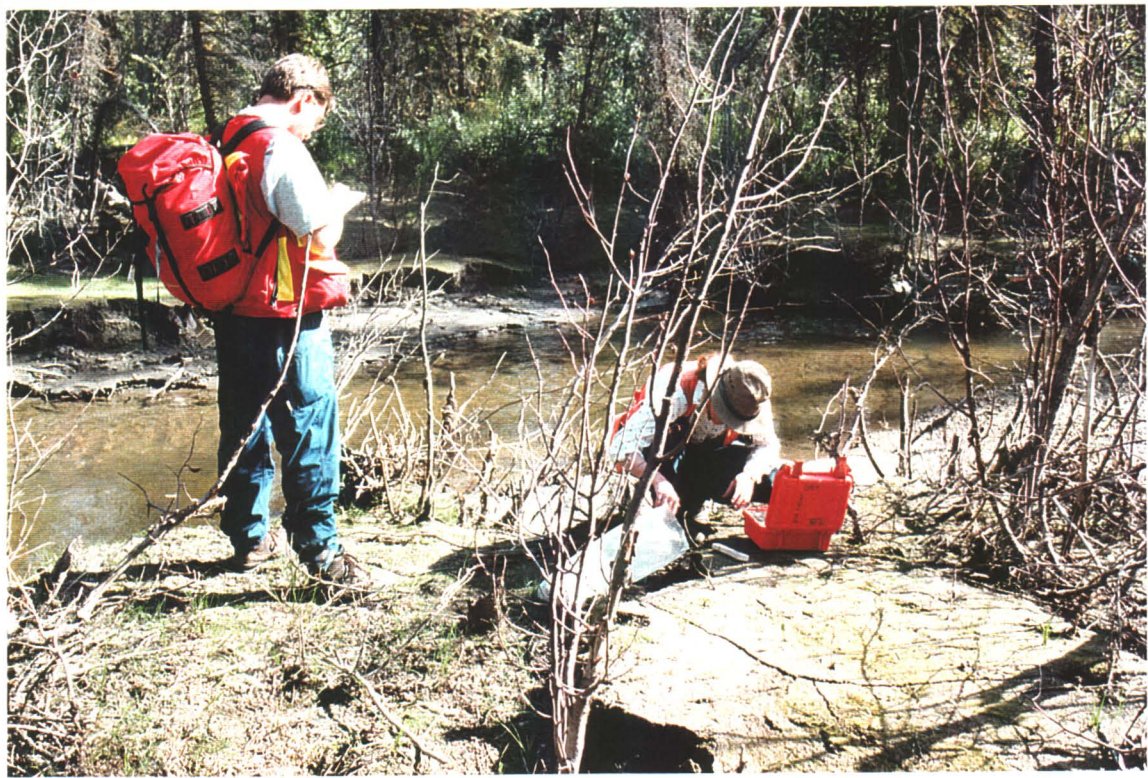
Photo # 14 - Downstream Water Quality Sample (SD-WQ-STR1-1)

Two water samples were taken in the tributary to Coal Creek, one upstream of the mine site and one downstream. Table 4 identifies the significant findings of the sampling program conducted to determine the potential impact of the site to surface water bodies. The upstream background sample was taken to represent the background condition to which the downstream sample results will be compared. Field measurements of pH and conductivity were taken. Complete analytical results are provided in Appendix B.
