PHASE II ENVIRONMENTAL ASSESSMENT
OF THE
SOUTH GAMBLER
ABANDONED MINE SITE

**PHASE II
ENVIRONMENTAL ASSESSMENT
OF THE
SOUTH GAMBLER MINE SITE**

**Environmental Services
Public Works and Government Services Canada**

March, 1997

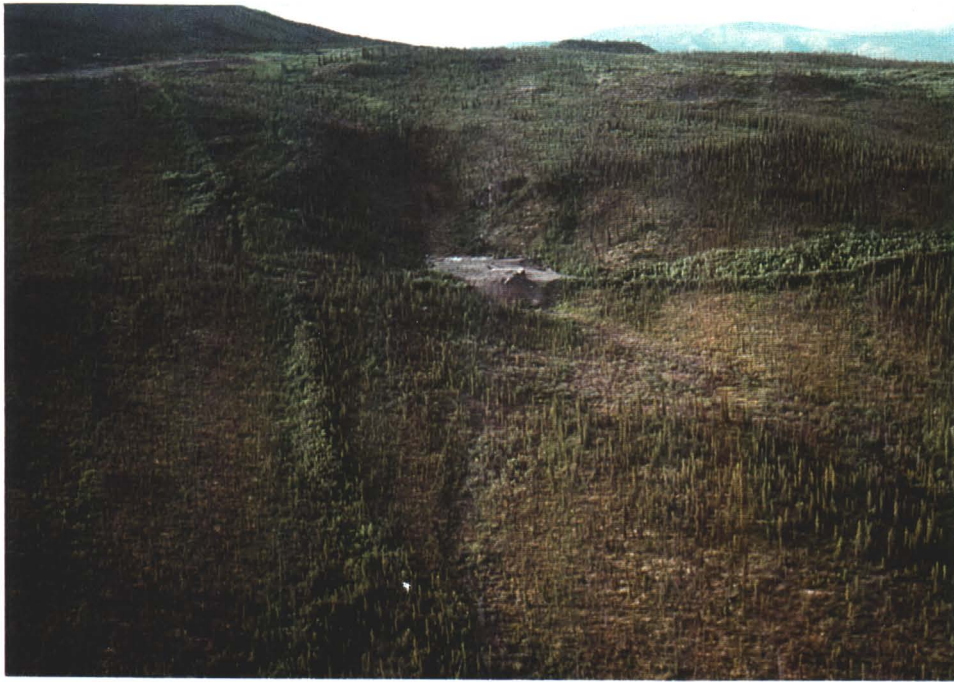
Photo 1. Aerial view of site looking south with old Wernecke mine site at upper left.

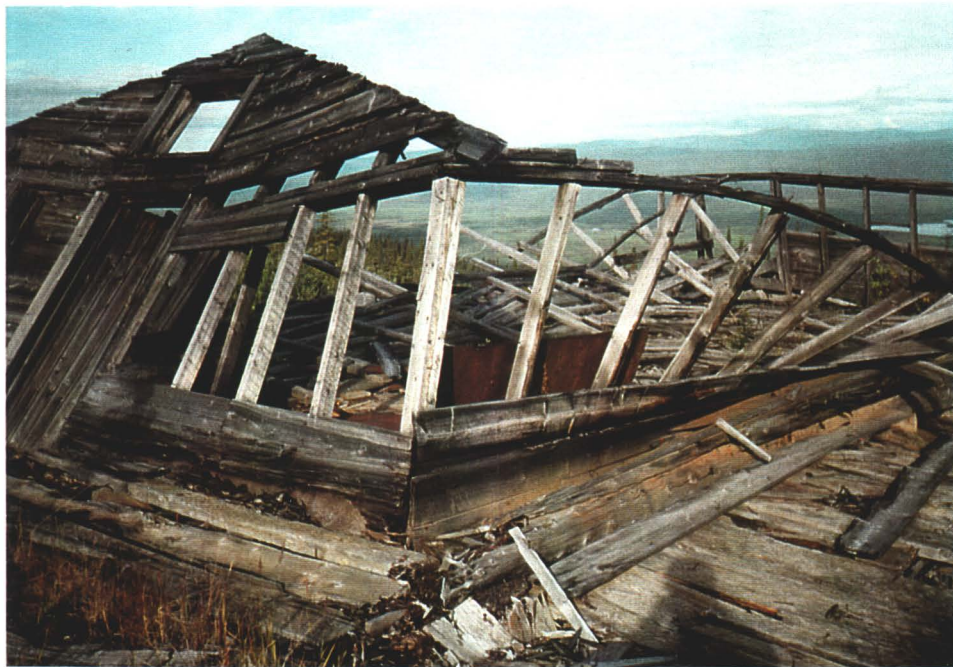
Photo 2. Delapidated wood frame structure at mine site.

ASSESSMENT COMPONENT	RISK	RECOMMENDATION
1. Building, Infrastructure, Equipment		
Wooden remnants of powerhouse	Health & Safety / Aesthetic	Demolish & burn on site.
Wooden remnants of mechanics workshop	Health & Safety / Aesthetic	Demolish & burn on site.
Wood waste scattered by site	Health & Safety / Aesthetic	Burn on site.

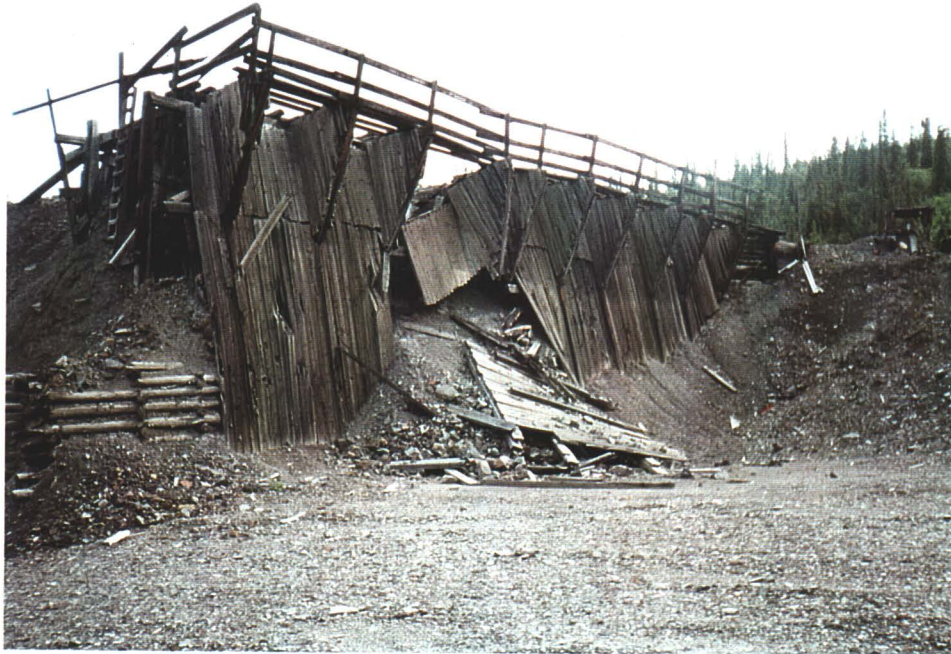
Buildings remaining on site include a former powerhouse, a mechanic's workshop (both of which are derelict), a log cabin located 80 m north of adit (in fair condition) and an elaborate (deteriorating) wooden loadout facility (See Photos 2 - 8). Infrastructure identified on site includes the mine adit drainage system which channels water from the adit beneath the waste rock pile and discharges 70 m to the northeast (See Photos 9 & 10).

Photo 3. Deteriorated condition of load out facility necessitates expedient demolition.

It is recommended that all the loadout structure be demolished, wood waste burned on site, and any metal waste buried on site for health and safety reasons. All other debris on-site, including empty 205 L barrels, an ore car, and miscellaneous metal debris, should be buried along with any non burnable material from the loadout structure.

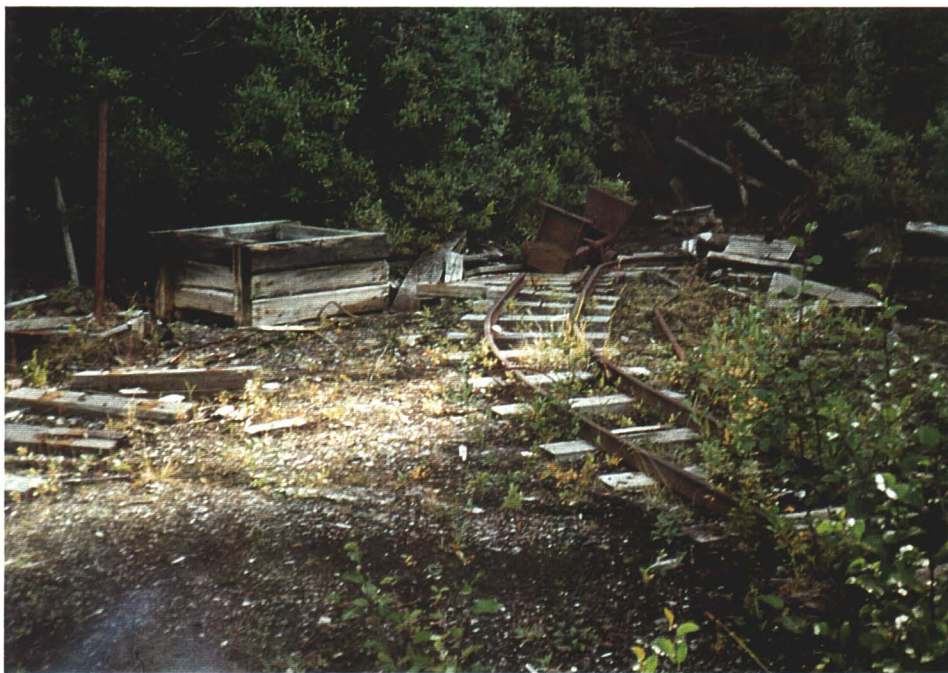
Photo 4. Trestle leading towards covered adit entrance. Note ore cars (rear) & French drain (left).

It is recommended that the mine opening be secured from human and animal access for health and safety reasons. The adit should be covered with a galvanized metal mesh to prevent access while allowing water flow through the adit to continue. Should the mine need to be reopened, access to workings is achievable by removal of the mesh.

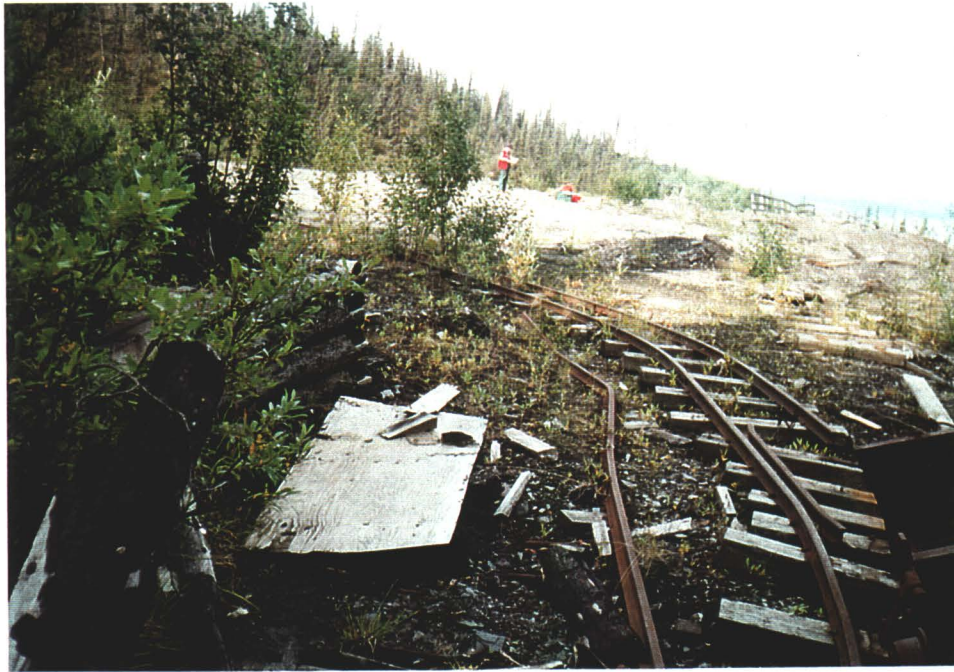
A large amount of wood waste was found scattered throughout the site including timbers supporting rails on trestles running out from the adit (See Photo 5). Equipment found on site includes one ore car, one car body, three empty 205 L barrels, assorted metal mining debris near to the entrance of the adit including rail and pipe, and wood waste dumped over the bank of the waste rock pile. Buildings, infrastructure and equipment identified on site are summarized in Table 1 below.

Photo 5. View from adit entrance looking south.

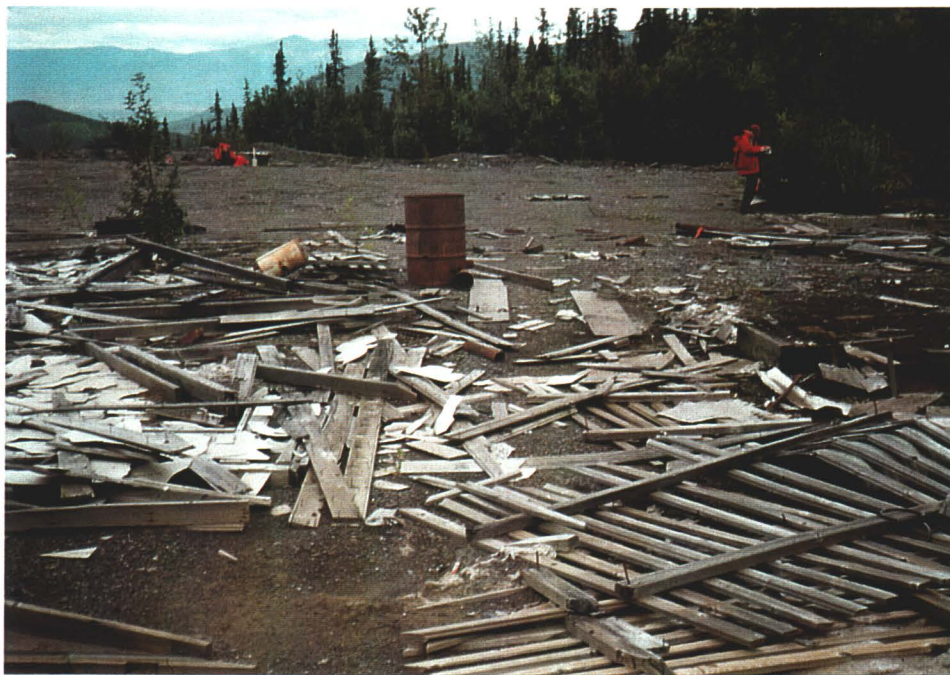
Photo 6. Residue of waste material from building collapse common to site.

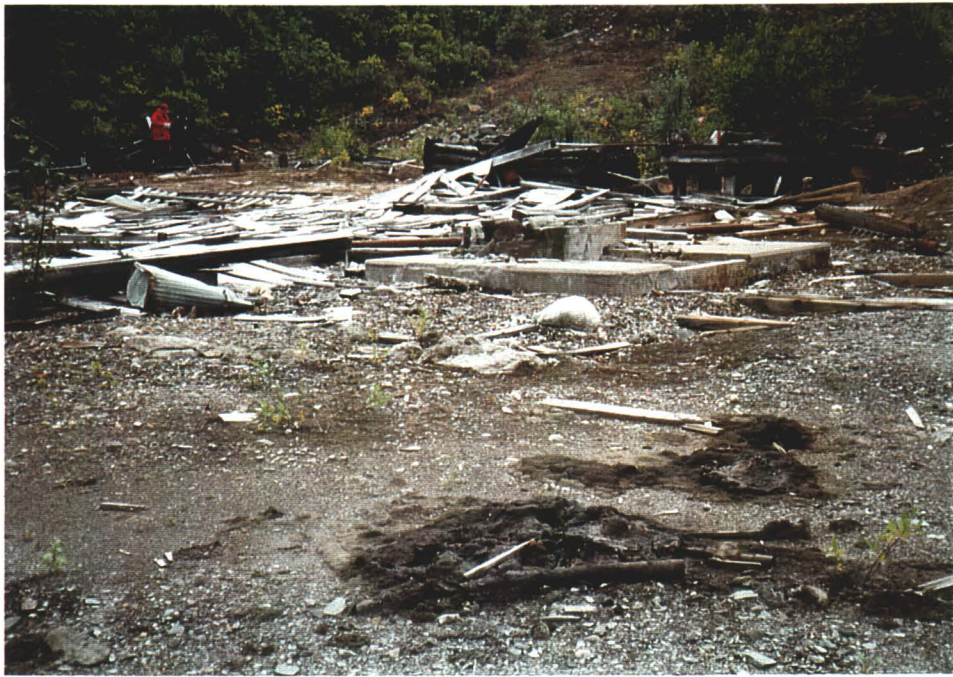
Approximately 3 m² of hydrocarbon-stained soil was observed on the South Gambler abandoned mine site.

Photo 7. Heavy oil / grease stains at south side of mine site in suspected shop area.

3. Hazardous Materials		
Approx. 3 m ² of heavy grease & oily stained soil	Environmental Concern	Spread, scarify, mix and fertilize on site
4. Water Quality		
Mine Seepage/Site Drainage	Moderate Env. Risk	Construct diversion ditch
Receiving Waters	Minor Env. Risk	Monitor 1/4'ly every 5 years

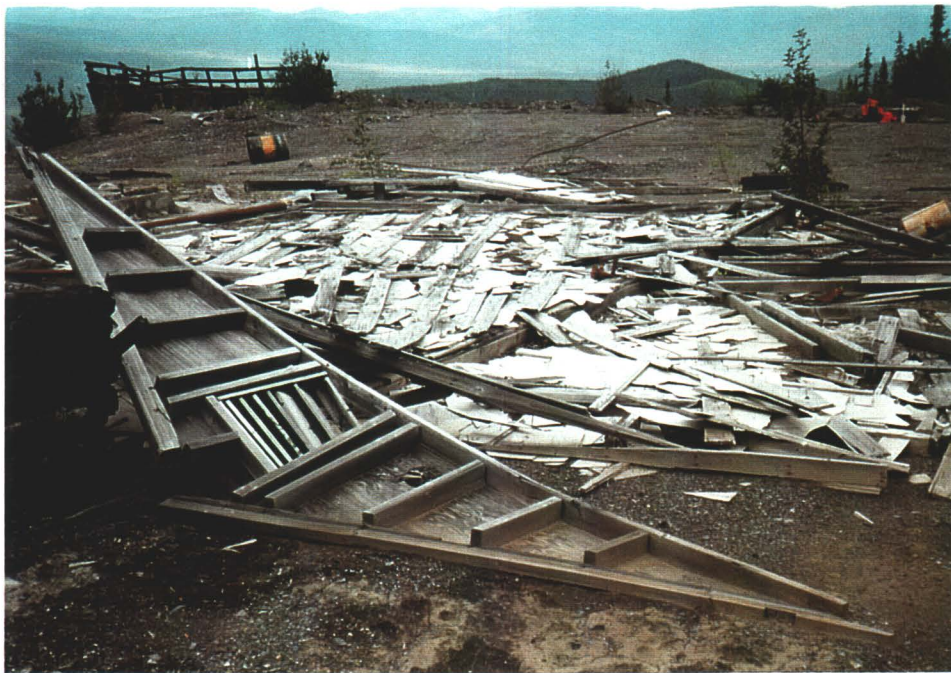
Photo 8. Further instances of building waste material with empty barrels and load out (rear).

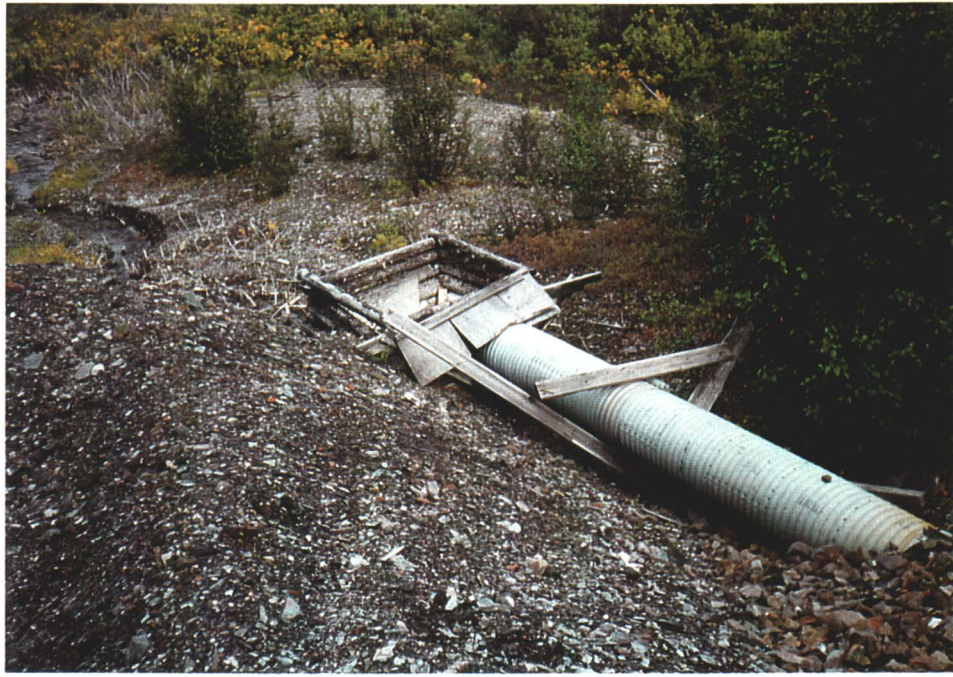
The adit discharge water is currently flowing through a buried drain at the edge of the waste rock pile. Buried waterways are undesirable, since they may cave or otherwise plug up and cause uncontrolled surface runoff.

Photo 9. Furthest extension of French drain downslope 85 m from adit entrance.

It is recommended that the groundwater flow out of the adit be redirected such that it no longer flows beneath the waste rock pile. This requires the construction of approximately 100 m of lined diversion ditch.

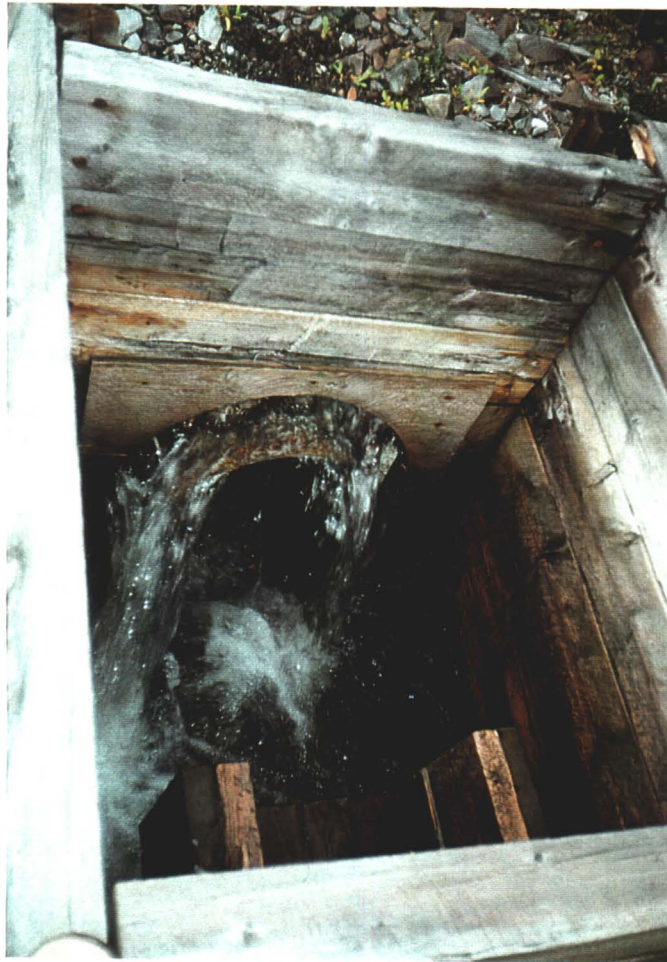
Photo 10. French drain entry adjacent to adit opening.

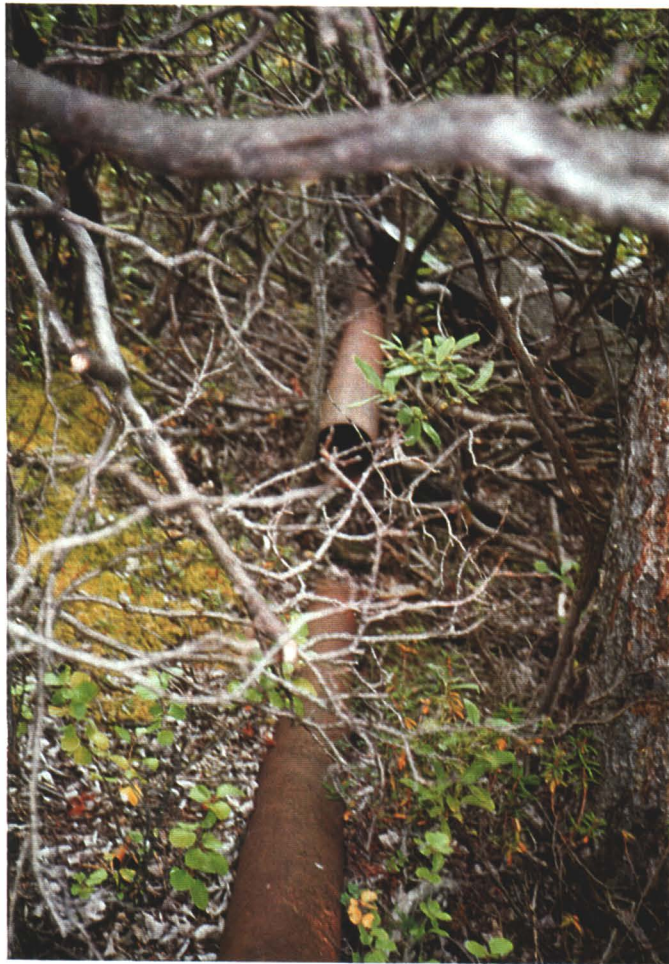
Photo 11. Pipe providing services to adjacent cabin.

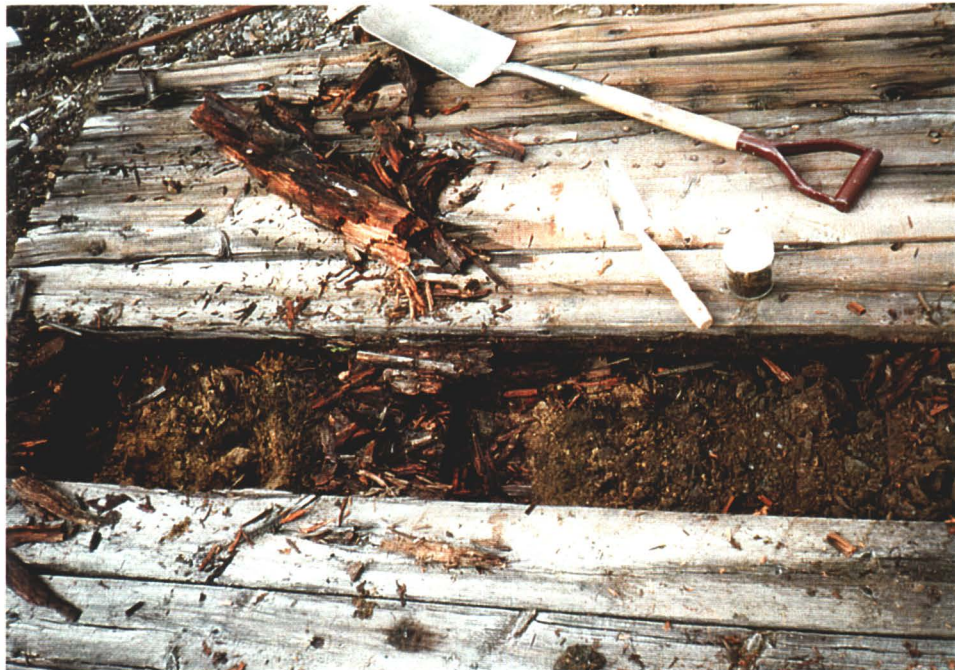
Photo 12. Site of SG-SL-201 taken beneath floorboards of suspected generator shack.

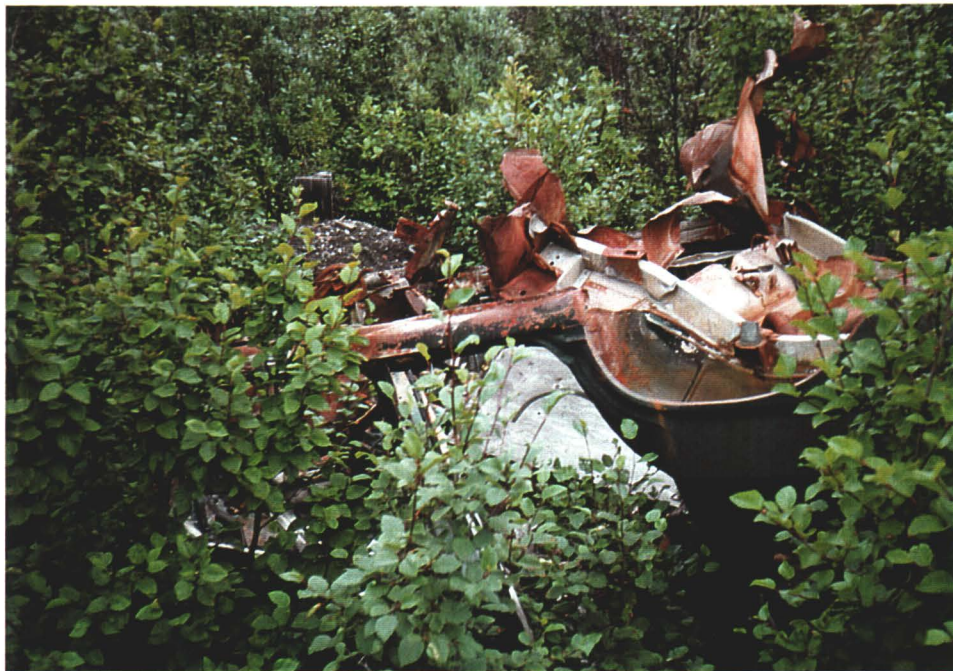
Photo 13 Vehicle wreckage located at eastern portion of site.

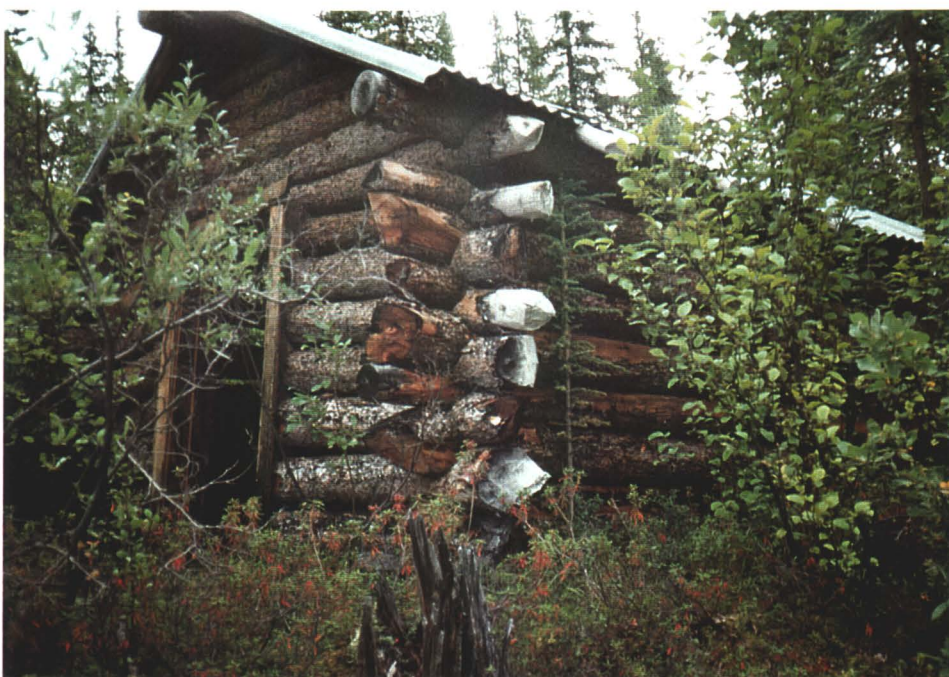
Photo.14 Rough hewn log cabin in fair condition could be used as emergency shelter.

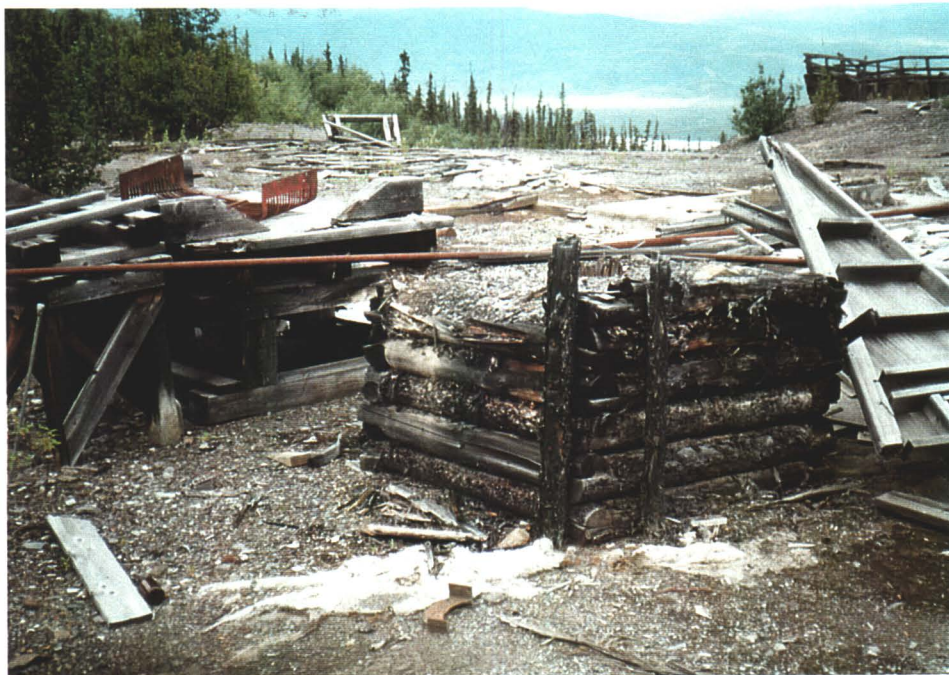
Photo 15. Damaged cribbing used to support power poles.

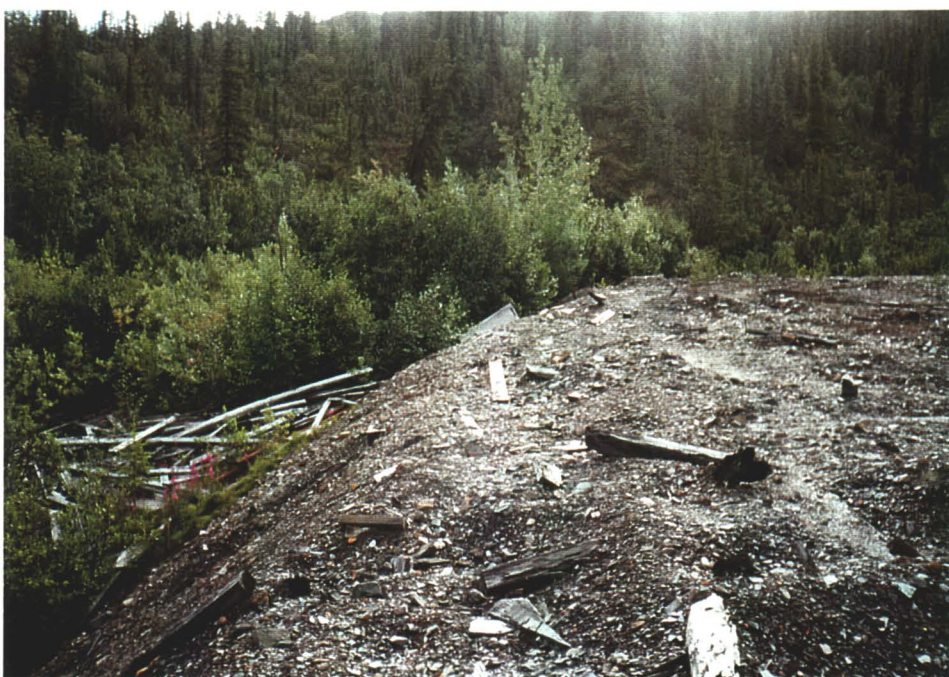
Photo 16. Miscellaneous wood waste downslope from waste rock storage area.

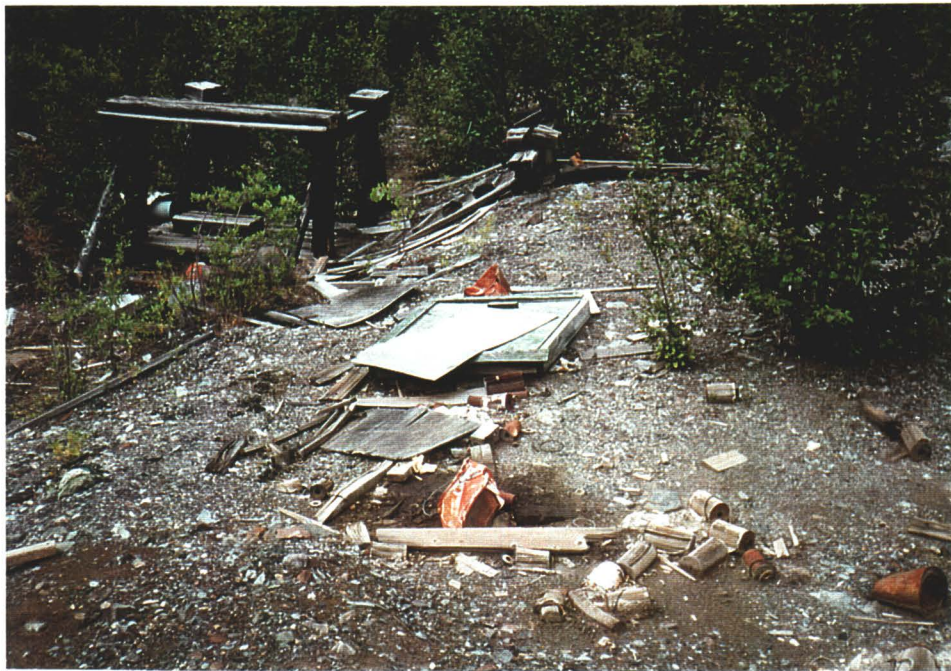
Photo 17. Further instances of heavy oil/grease staining on site.

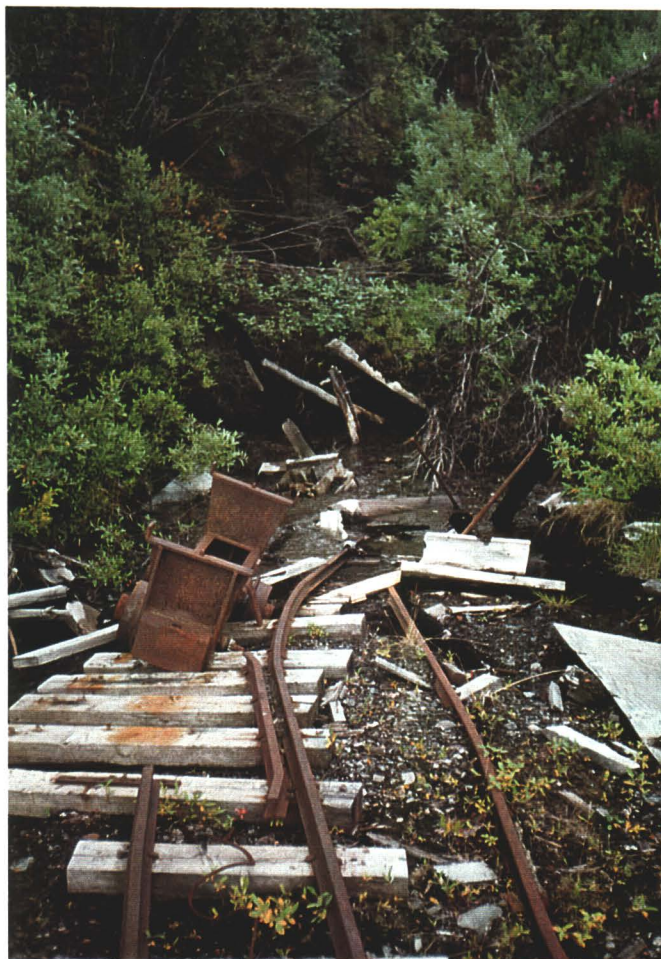
Photo 18. Detail of trestle and covered over entrance to adit.

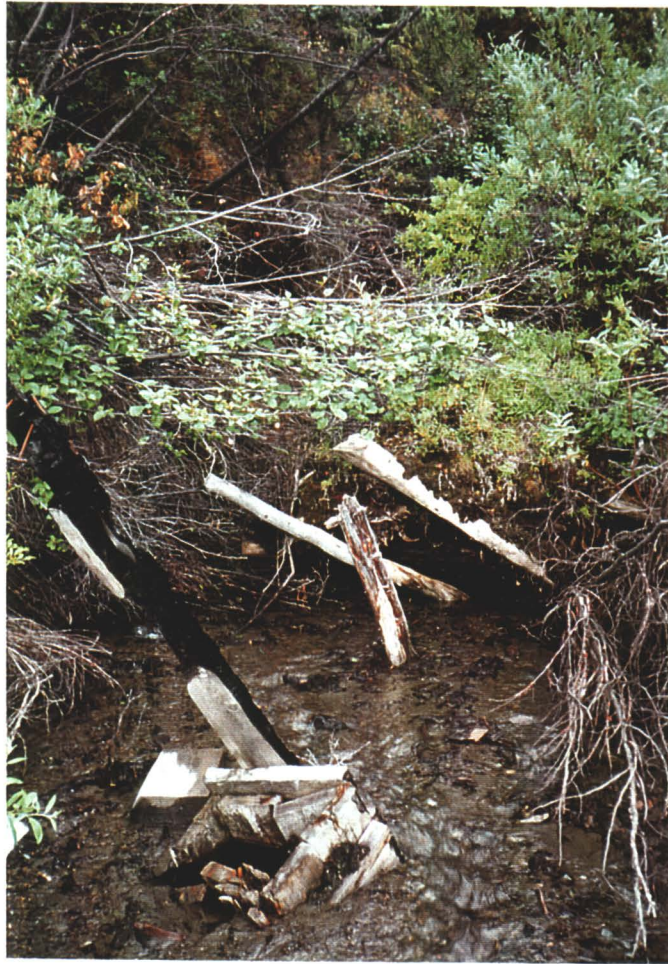
At the time of site inspection, approximately 600-800 liters/minute of water was observed flowing out one of the adits into a vertical shaft beside the adit. Upslope of the site, a poorly defined gully was observed to channel snowmelt and water from seasonal subsurface thawing across the site past the waste rock dump and continuing downslope into a gully below the site. Some vegetation stress in this gully, both above and below the site, was evident due to sediment accumulation.

Photo 19. Adit seepage draining to French drain.

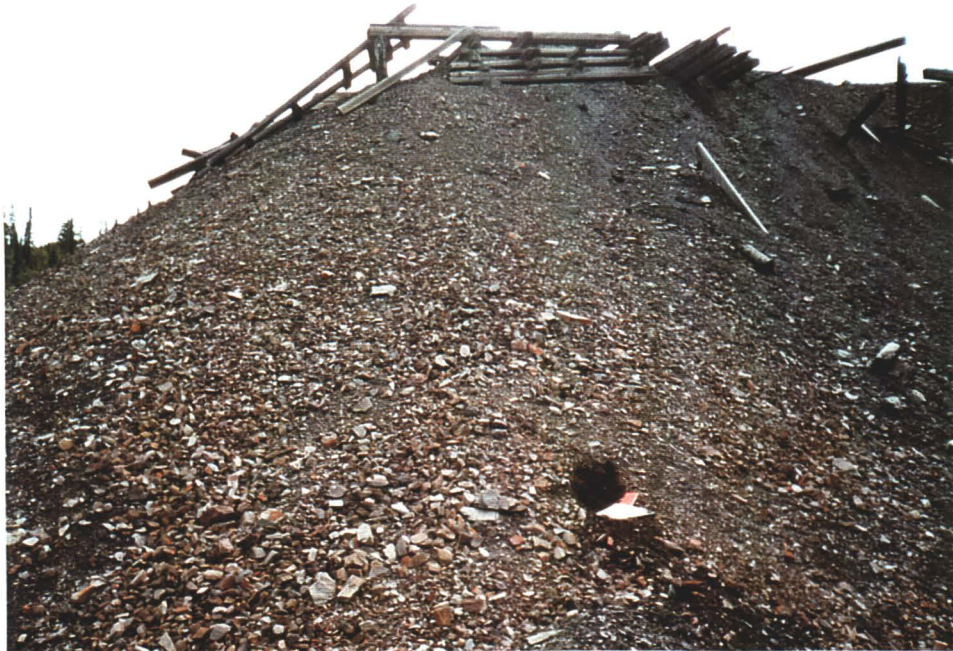
Samples SGWR/P301 and SGWR/P305 were collected from waste rock that exhibited iron carbonate staining on the surface. P301 was collected from the crest of the waste rock pile, where the material was predominantly sand / silt size, and P305 was collected from the toe of the pile, where the average size of the material was larger.

Photo 20. Test pit SG-WR-P305 looking east and located on northwest side of waste rock pile.

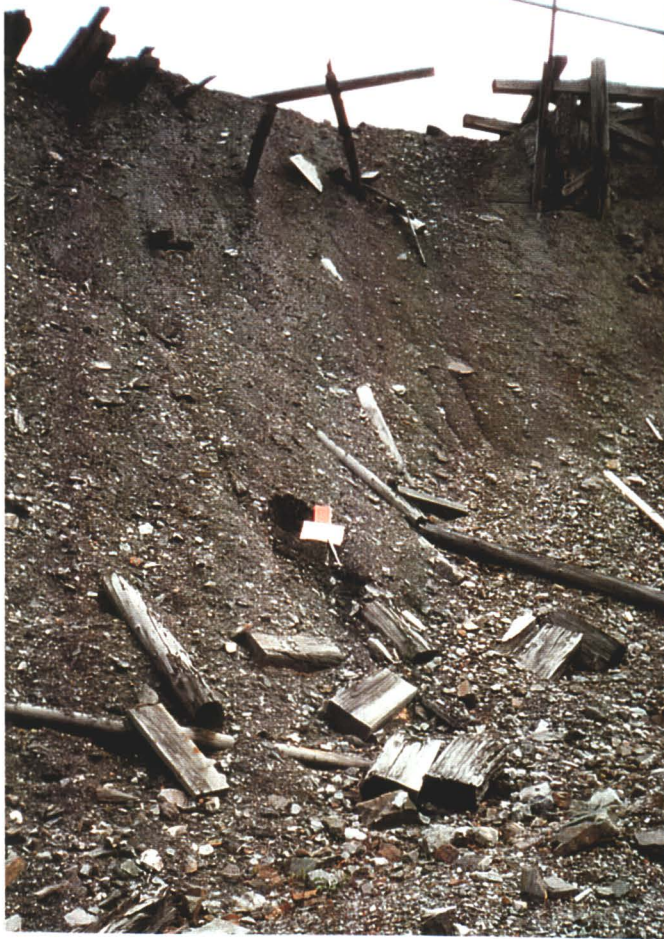
Sample SGWR/P304 was collected from an area of mineralized graphite schist that exhibited whitish secondary mineralization on the surface. Sample SGWR/P303 was collected from the chlorite schist rich portion of the dump. Sample SGWR/P302/1 was collected from the mixed waste rock material on the south side of the pile. Sample SGWR/P302/2 was collected from the iron carbonate stained soil beneath the waste rock. The test pit logs are summarized in Table 1.

Photo 21. Test pit SG-WR-P304 located on northwest side of waste rock pile.

SGWR/P304	Sample collected from mineralized graphitic schist on the northwest edge of the rock pile. The surface had a whitish precipitate. The sand and gravel size material was collected over a thickness of 30 cm. 1% of the material was cobble size up to 8 cm. The field paste pH was 7.5 and the conductivity >1990 μ S/cm.
SGWR/P305	Sample collected at the toe of the rock pile northwest corner in material similar to P301. The sample was collected over a thickness of 35 cm in moist dark grey/brown sand and gravel size material. The field paste pH was 8.1 and the conductivity 40 μ S/cm.

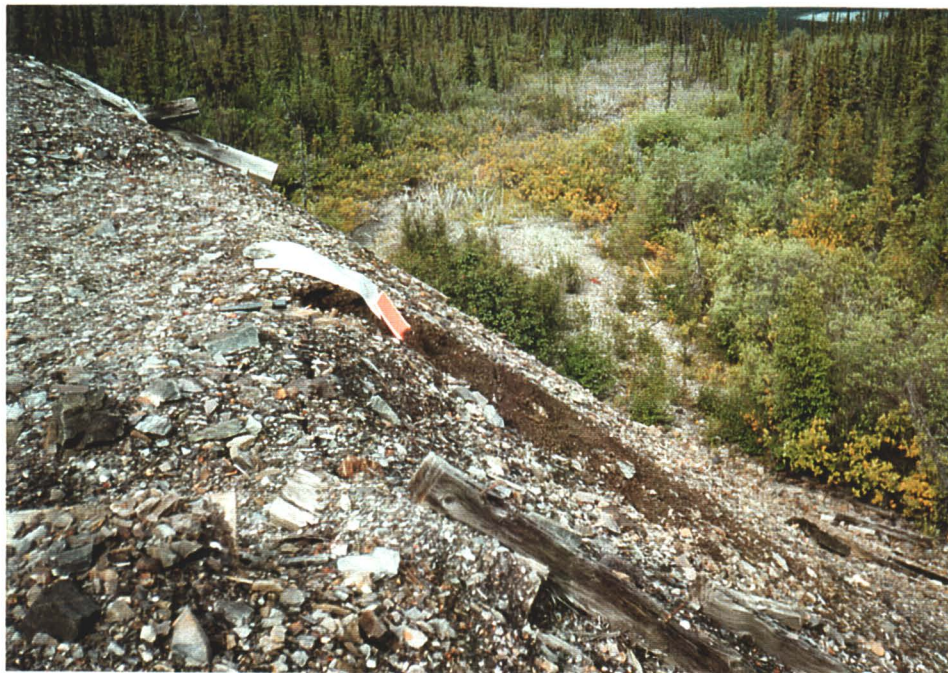
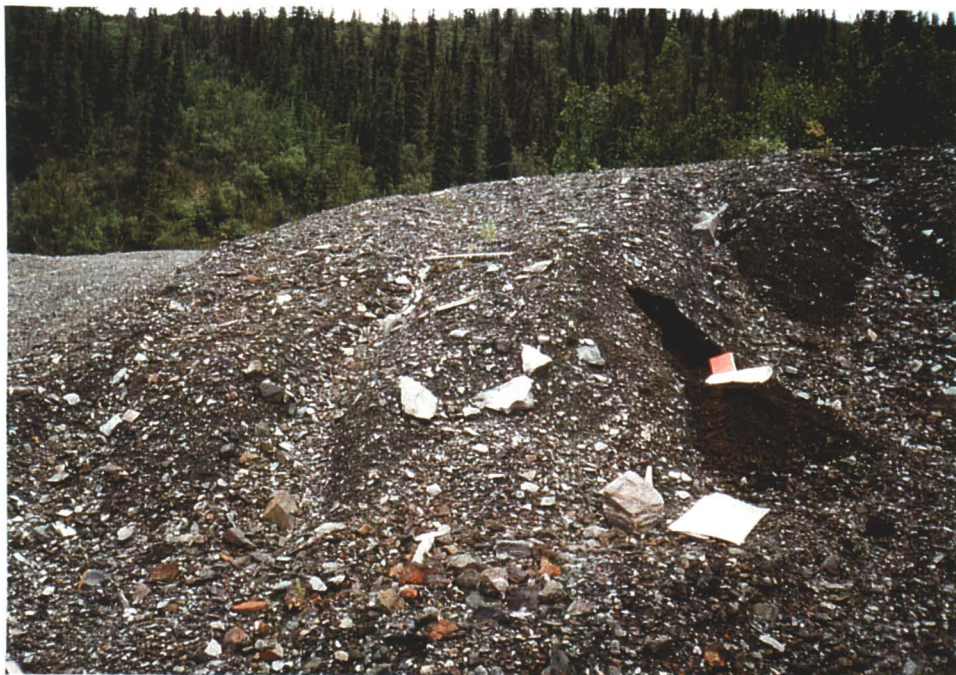
Photo 22. Test pit SG-WR-P301 looking northwest and located on north side of waste rock pile.

Photo 23. Test pit SG-WR-P301 looking northwest and located on north side of waste rock pile.

Sample ID	Sample Location and Description
SGWR/P301	Sample collected at the crest of the rock pile's northern edge in material that exhibited iron carbonate staining on the surface. Sample was collected over a thickness of 20 cm in dark grey/brown silt, sand and gravel size material that included chlorite schist and pyroxenite with minor galena and sphalerite. Field paste pH was 8.0 and conductivity 110 μ S/cm.
SGWR/P302/1	Sample collected from mixed waste rock material at southern edge of the rock pile over a thickness of 30 cm. Material consisted of graphite schist with <1% of the surface exhibiting staining. Field paste pH was 7.9 and conductivity 280 μ S/cm.
SGWR/P302/2	Sample collected over a thickness of 20 cm in sand and silt sized brown soil below P302/1. Field paste pH was 8.3 and conductivity 310 μ S/cm.
SGWR/P303	Sample collected in chlorite schist and greenstone below the load out facility. The sample was collected over a thickness of 40 cm in grey/green in coloured sand and gravel size material. The field paste pH was 8.0 and conductivity 60 μ S/cm.

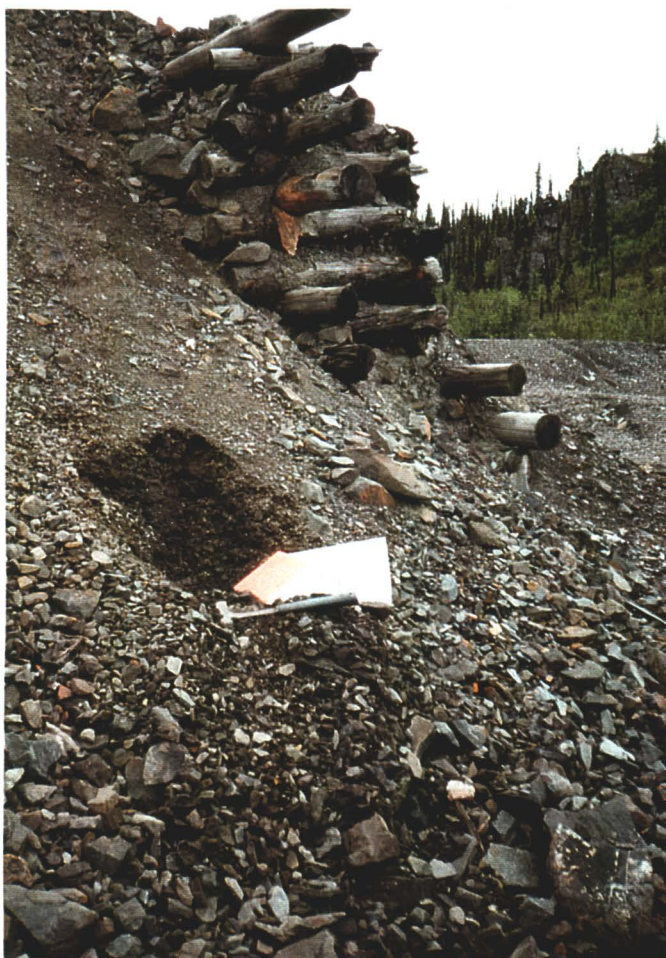
Sample P303, representing the chlorite rich waste rock, has an NP:AP ratio of 9.4. Sample P302/2, representing the soil underlying the dump and sample P305, from the coarser iron carbonate stained waste rock, have NP:AP ratios of 15.4 and 6.6. Total sulphur concentrations in the three samples ranged from 0.4% to 0.6%. These materials have low acid generating potential. Sample P301, from the finer iron carbonate stained waste rock, also has low acid generating potential. It has a NP:AP ratio of 3.0, a total sulphur concentration of 1.22%, with 17% as sulphate, and it has a net NP of 65 kg CaCO_3 .

Photo 24. Test pit SG-WR-P303 looking south southeast & located at toe of load out facility.
