**PHASE II ENVIRONMENTAL ASSESSMENT
OF THE
STORMY
ABANDONED MINE SITE**

**Action on Waste Program
Indian and Northern Affairs Canada**

**Environmental Services
Public Works and Government Services Canada**

March 1997

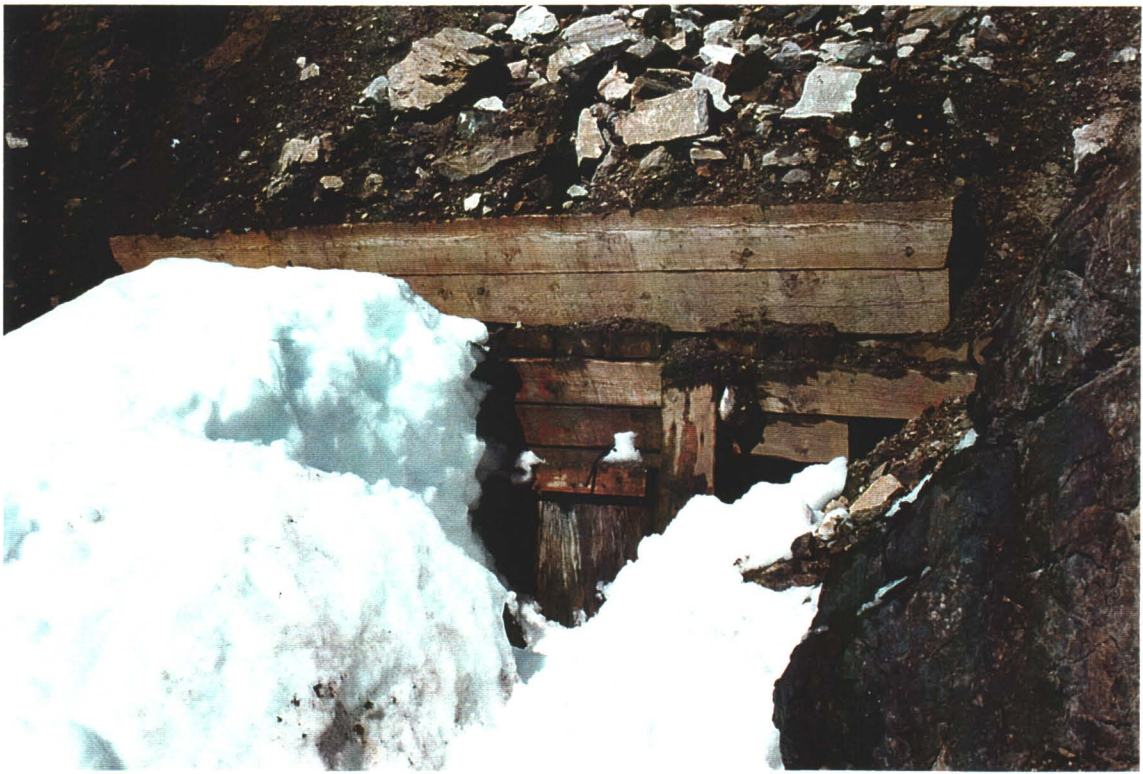
Photo# 6: Adit Seal

The phase I investigation of the Stormy abandoned mine site revealed that there exists an adit sealed by wood, four building structures, rock core, several empty barrels, miscellaneous solid debris, and a small quantity of waste rock.

It is recommended that the mine adit be secured from human and animal access for health and safety reasons. The adit should be covered with surrounding rock and soil using available equipment. Timbers should be removed and buried along with other site debris. Should the mine need to be reopened, access to workings is achievable with heavy equipment.

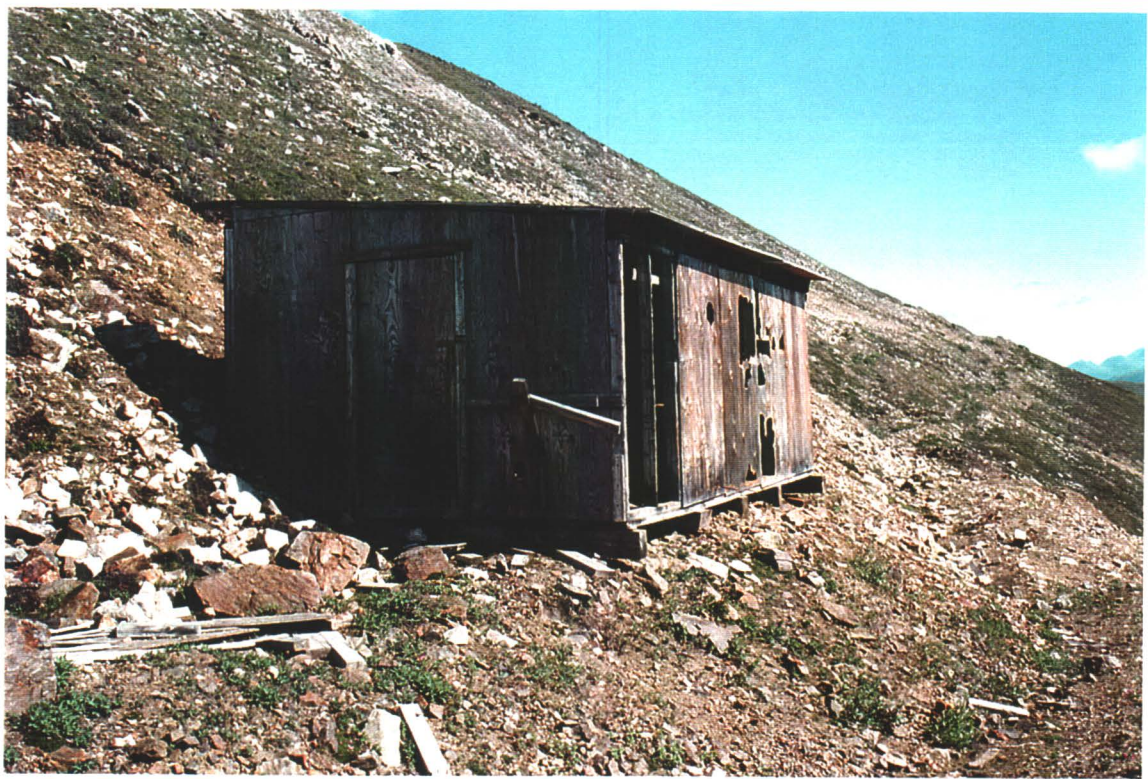
Photo# 8: Building at Upper Site

Four building structures are on site and present a safety hazard to the public if left unmaintained. Some buildings contain waste debris and are easily accessed.

It is recommended that all buildings be demolished and buried on site. Waste material that is non-hazardous combustible may be burned on site.

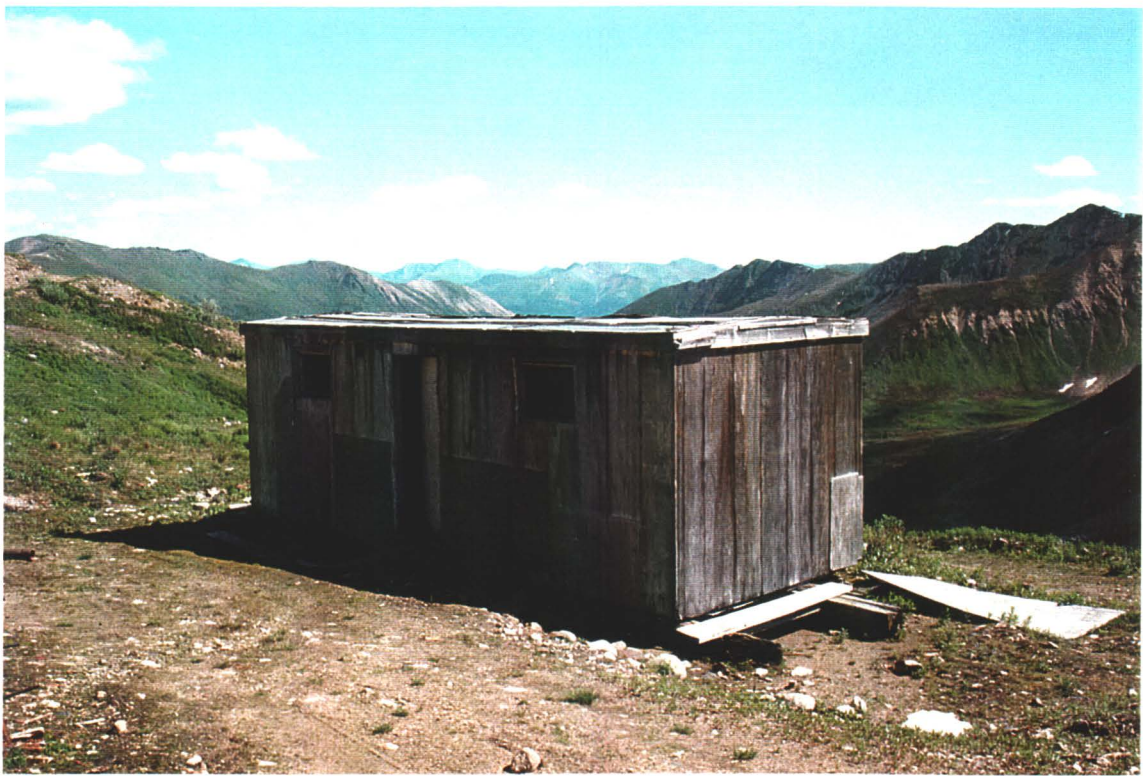
Photo# 10: Kitchen and Mess Building

Very little hazardous material was detected on site. One old and dry battery was located in the mess building. No soil staining was observed.

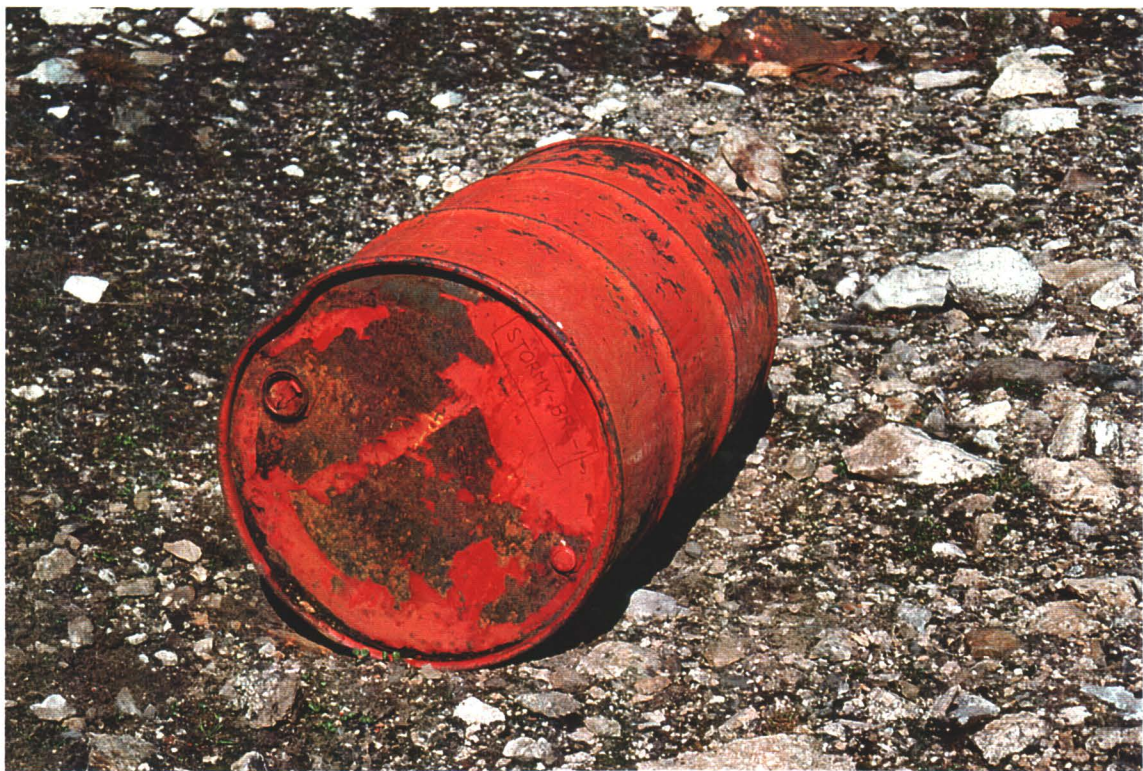
Photo# 20: Barrel Sample Sto-brl-1

A minor environmental risk exists as a result the abandonment of petroleum hydrocarbons on site. One barrel, in poor condition, contains approximately 200 litres of a liquid organic waste. Based on laboratory analysis, the disposal of liquid waste may be locally incinerated.

Waste petroleum hydrocarbons on site should be immediately removed from the site and disposed appropriately. It is recommended that barrel contents be incinerated. This may be done using a portable incinerator by air transporting the barrels to a central disposal location. If cleanup of this is conducted along with a regional cleanup, the barrel contents may be incinerated at a temporary barrel incineration facility established for the purpose of incinerating waste hydrocarbons at several mine sites in the area.
