**PHASE II ENVIRONMENTAL ASSESSMENT  
OF THE  
STUMP  
ABANDONED MINE SITE**

**Action on Waste Program  
Indian and Northern Affairs Canada**

**Environmental Services  
Public Works and Government Services Canada**

**March 1997**

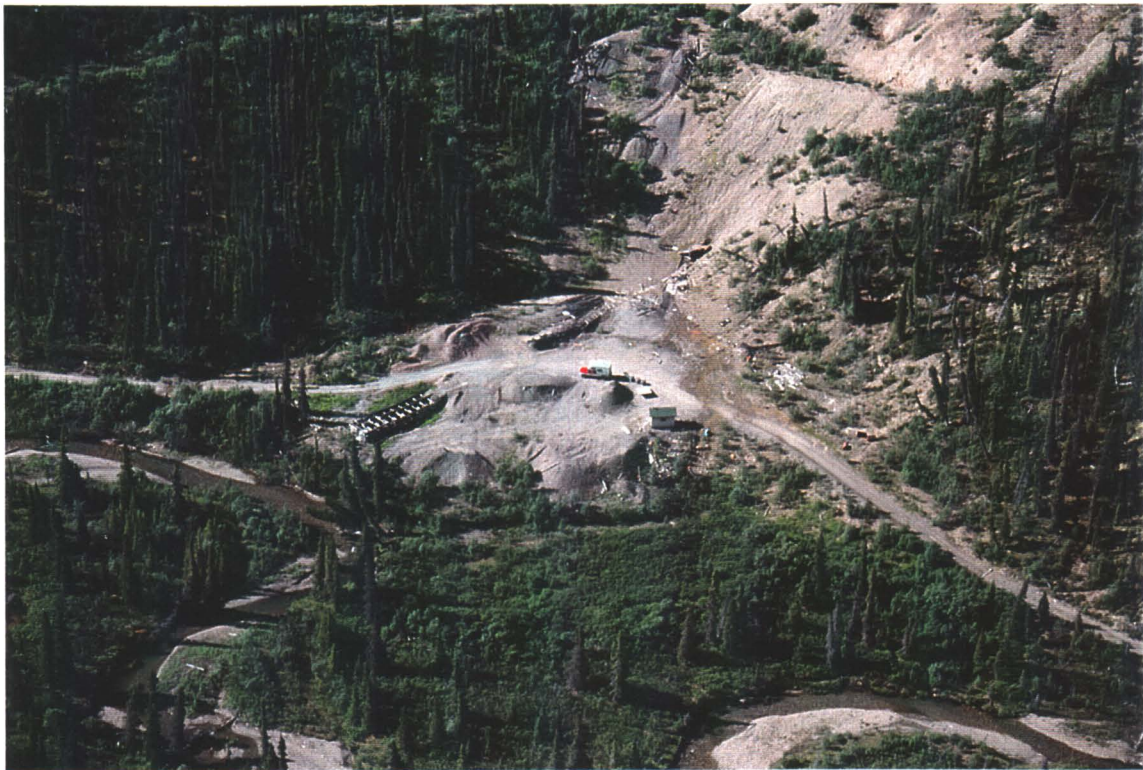
The lower of the two adits is located at the level of the road. Only a thin layer of waste (<5 tonnes) is spread outside this adit. Two small waste piles have been deposited by end-dumping from a trestle outside of the upper adit, located approximately 20 metre up the hill. Material in these piles is matrix supported and composed of dark gray to green-brown clayey sand with few pebbles and cobbles. Spotty iron oxide staining was observed where individual sulphide grains have weathered.

**Photo # 3 - Lower Site, Staging Area, Waste Rock**

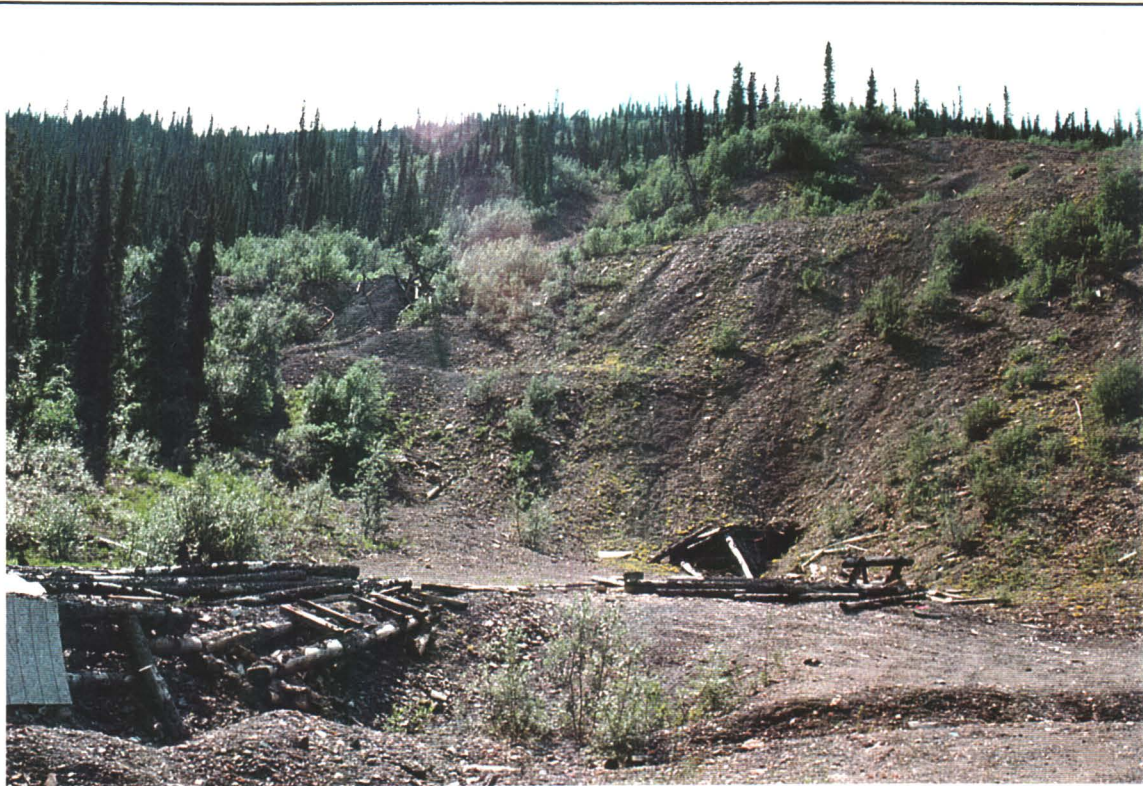
| Adit | Location | Drift Length | Condition |
|---|---|---|---|
| Lower Adit | lower staging area, 1151 m elev. | 67 metres | unstable condition - loose rock above opening, timber structure rotting, 2x6 cladding partially blocking entrance |

The rails and trestles in front of the lower adit are physically unstable and pose a health and safety hazard to humans visiting the site. Several large timbers used for loading and transporting ore are left perched are a safety hazard.

**Photo # 4 - Load-out Ramp and Lower Adit**

It is recommended that the rails and trestles, shed, and load out ramp be demolished and buried on site for health and safety reasons. This can be accomplished using locally available resources and labour and can be buried on-site together with other site debris. Burial can occur by covering waste material with surrounding rock and soil on a clearing adjacent to a rock slope.

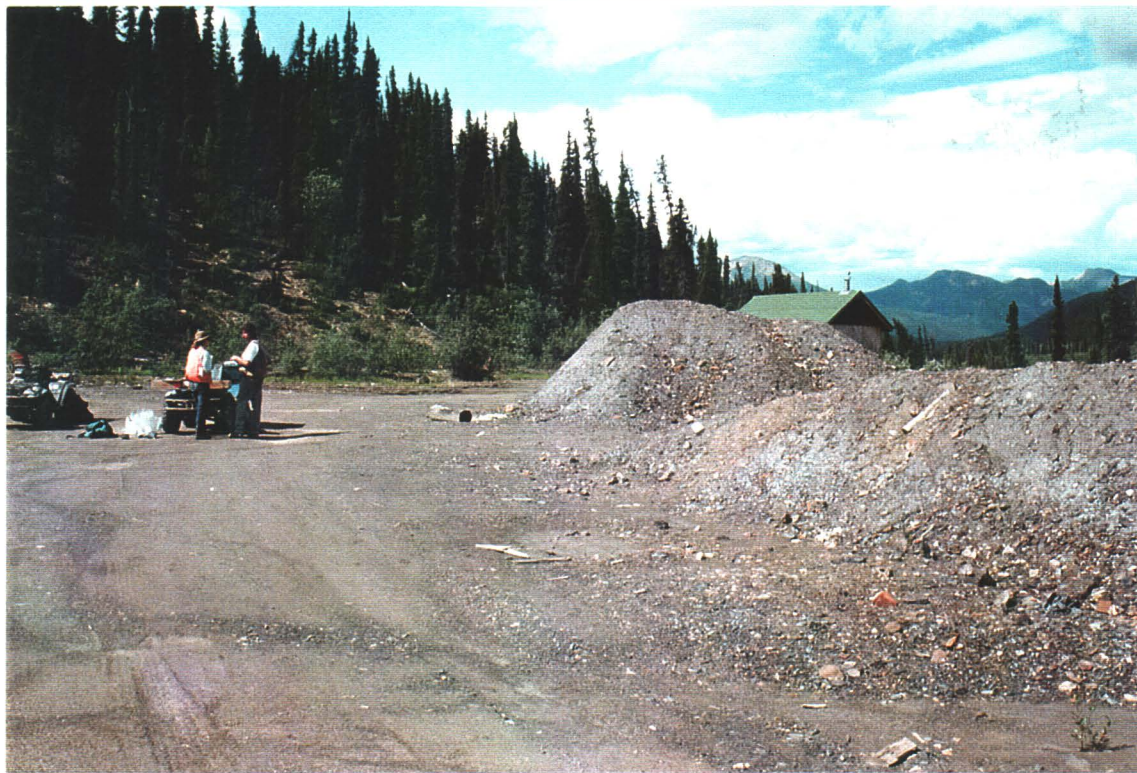
**Photo # 5 - Ore and Waste Rock at North End of Staging Area**

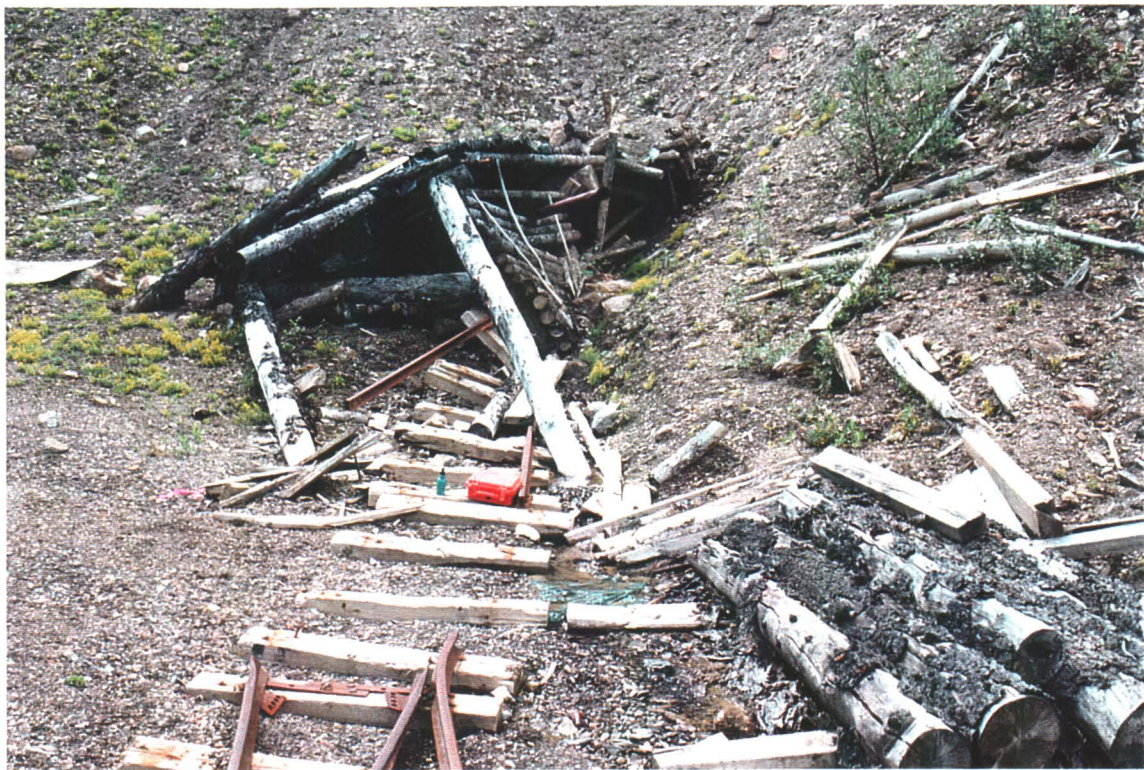
**Photo # 7 - Seepage from Lower Adit**

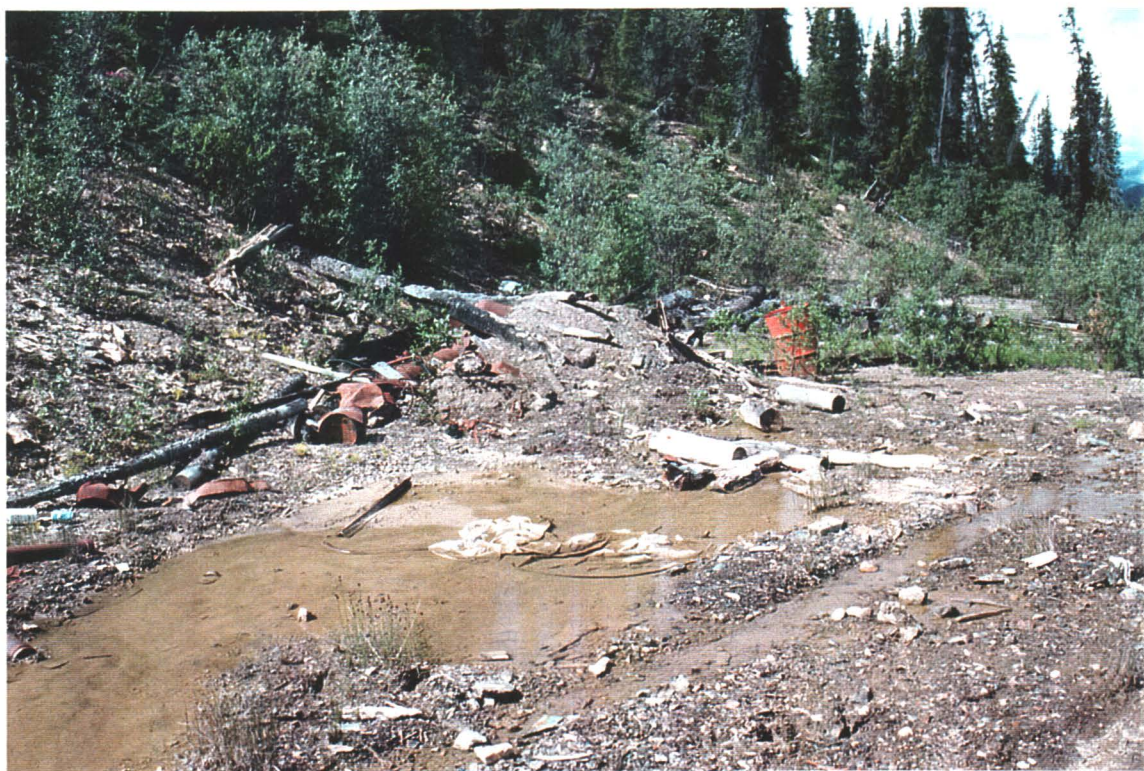
One full 205 litre barrel is present on site north-northwest of the lower adit. Currently, it is not leaking nor is there any evidence of soils staining, however if not properly disposed of immediately, the barrel presents a potential environmental risk.

**Photo # 8 - Lower Adit Seepage, Full 205L Barrel, Site Debris**

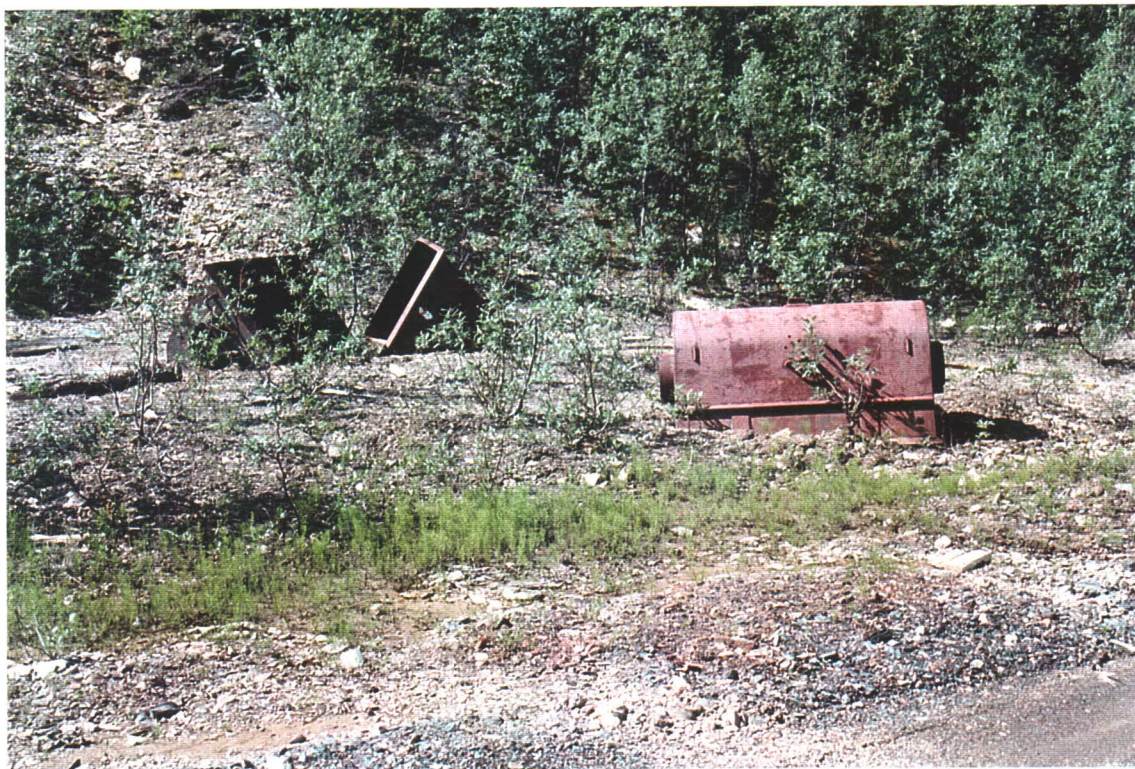
**Photo # 9 - Abandoned Ore Cars**

It is recommended that the miscellaneous site debris be collected and buried on-site for aesthetic reasons.

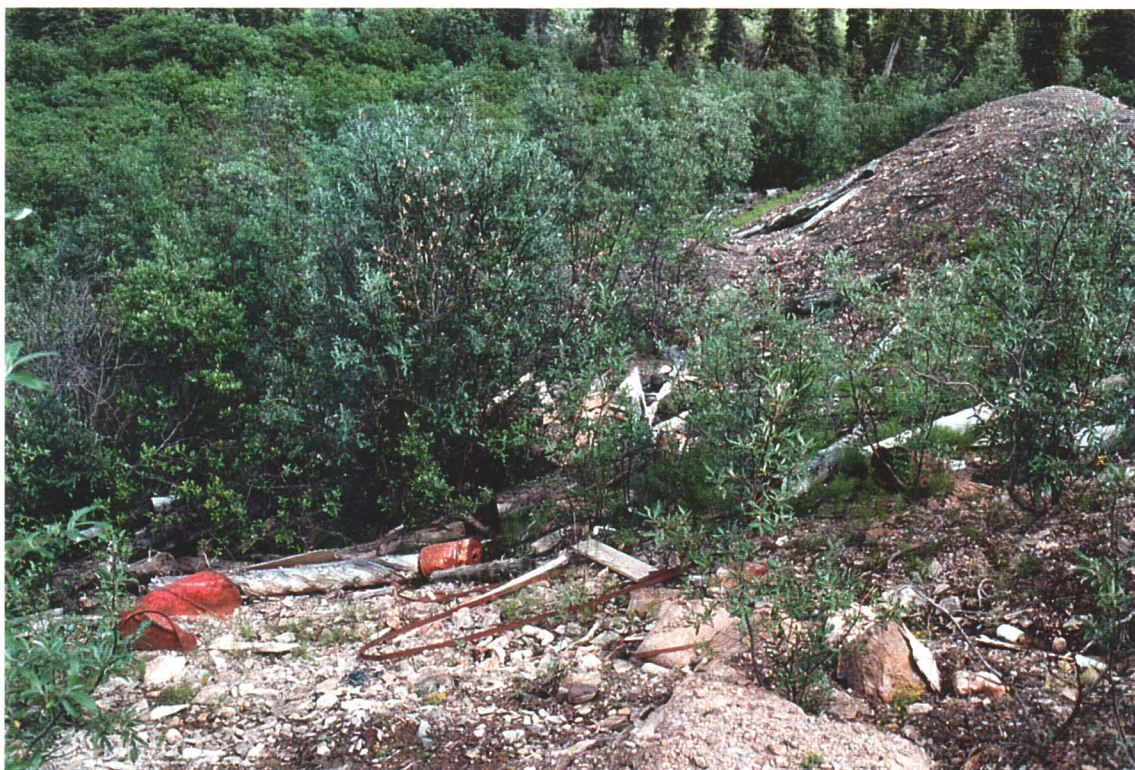
There was a only small quantities of non-hazardous waste material observed in and around the site. A small amount of metal piping and debris is at the lower site west of the adit and south of the main access road. A very small quantity of debris is scattered throughout the site. Several small piles of timbers used for supporting structures and loadout ramps lay near the adits and total < 50 cubic metres of material. One empty barrel was observed approximately 95 due north of the lower adit.

**Photo # 10 - Scattered Site Debris at North End of Staging Area**

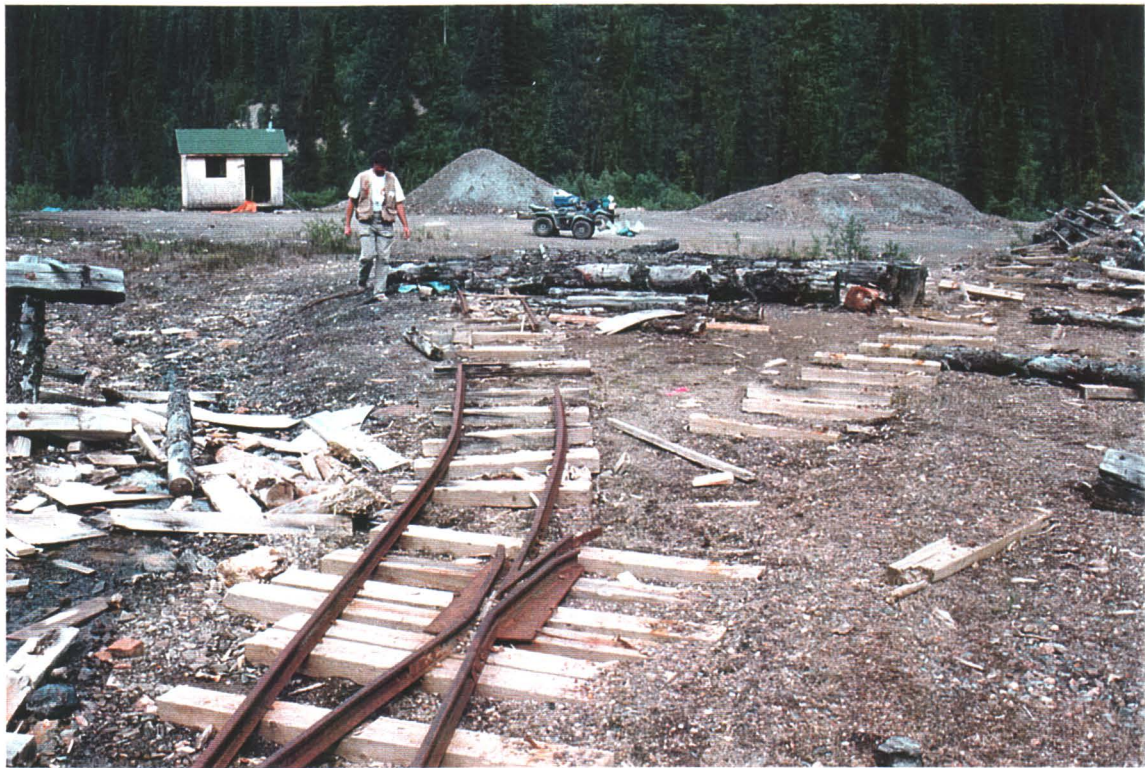
Photo # 11 - Track and Waste Rock

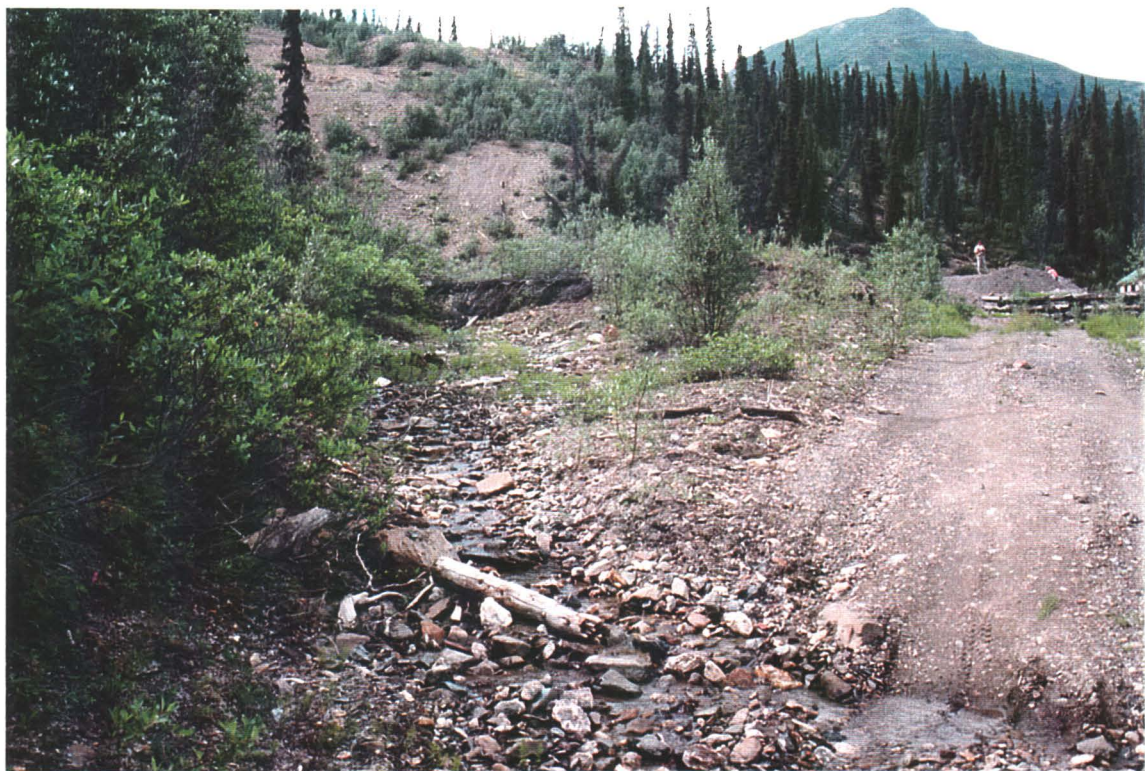
Photo # 12 - Stream on West Side of Site

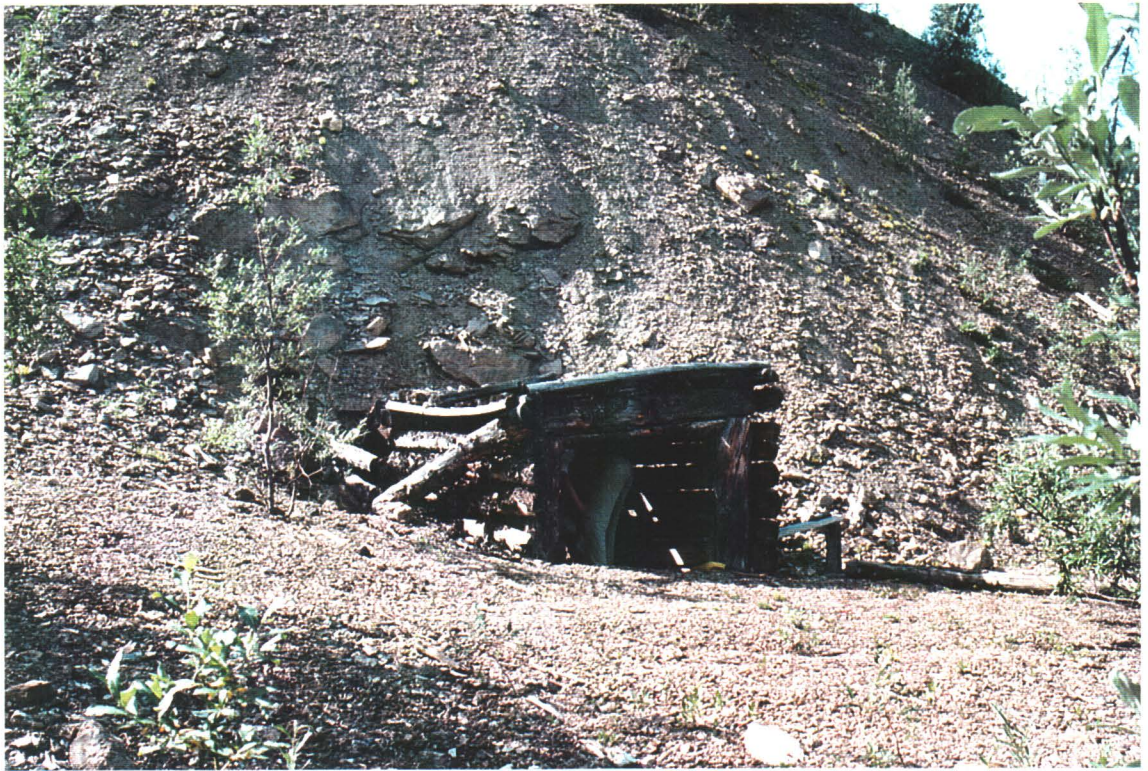
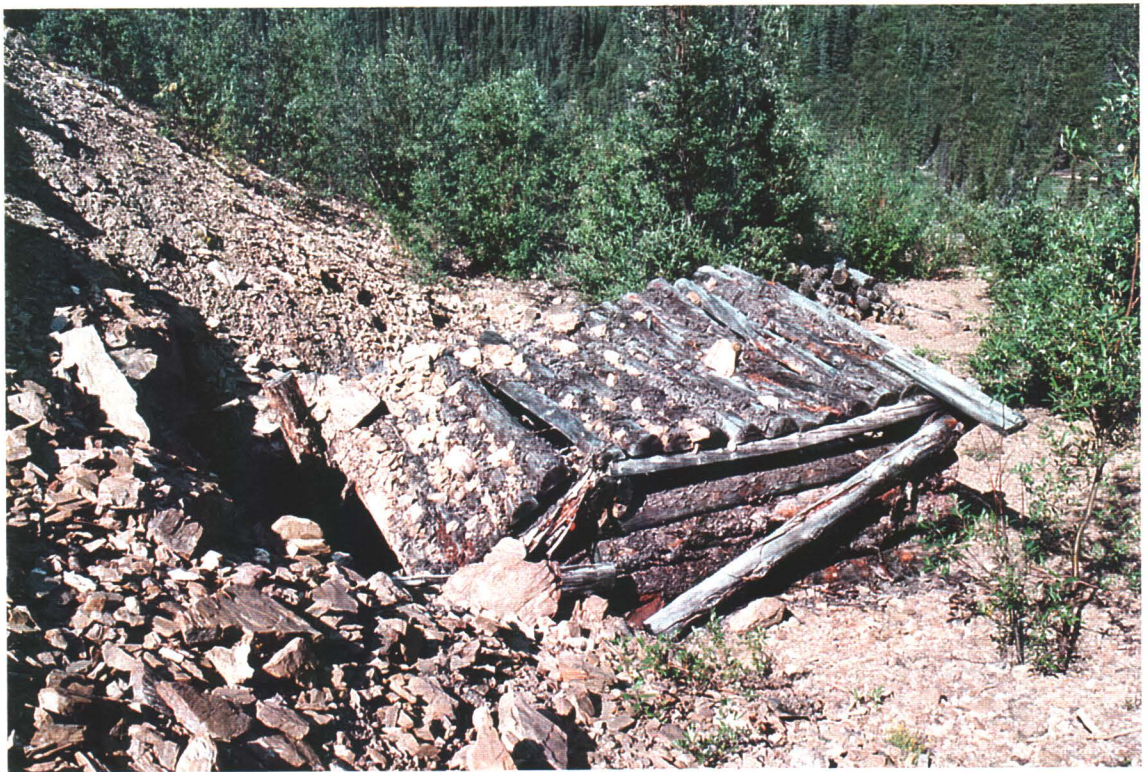
| Adit | Location | Drift Length | Condition |
|---|---|---|---|
| Upper Adit | upper site, 1182 m elev. | Unknown | unstable condition - loose rock above, dilapidated timber support structures, drift partly collapsed at opening |

All the three openings are in unstable condition and are not adequately secured from public and wildlife access. The upper adit is collapsed and remains unstable due both to the rotting supporting structure and surrounding soils and rock. The lower adit remains open and is readily accessible to the public. The unstable supporting structure is collapsed and entrance partly blocked by rotting timbers.

Photo # 13 - Upper Adit

Photo # 14 - Upper Adit

It is recommended that all three mine openings be secured from human and animal access for health and safety reasons. Since site access is good, adits should be covered with surrounding rock and soil using readily available equipment. Timbers should be removed and buried along with other site debris. Should the mine need to be reopened, access to workings is achievable with heavy equipment.

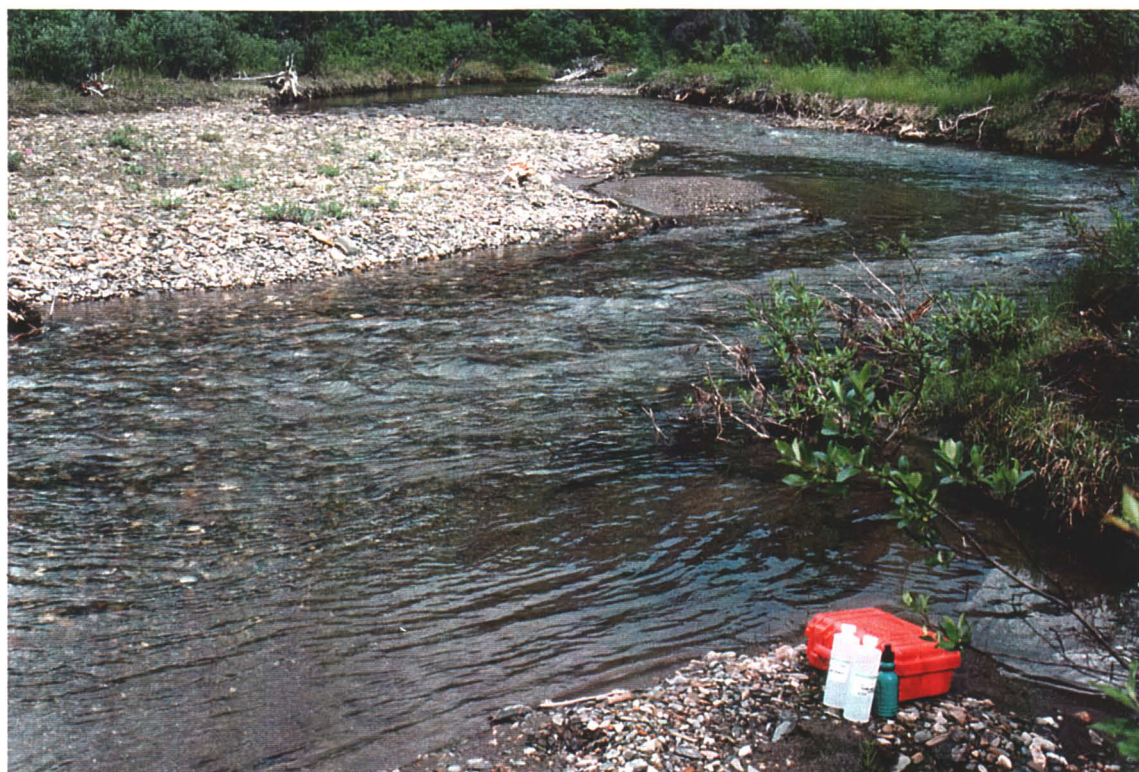
Photo # 15 - Upstream Sampling in the Ketz River

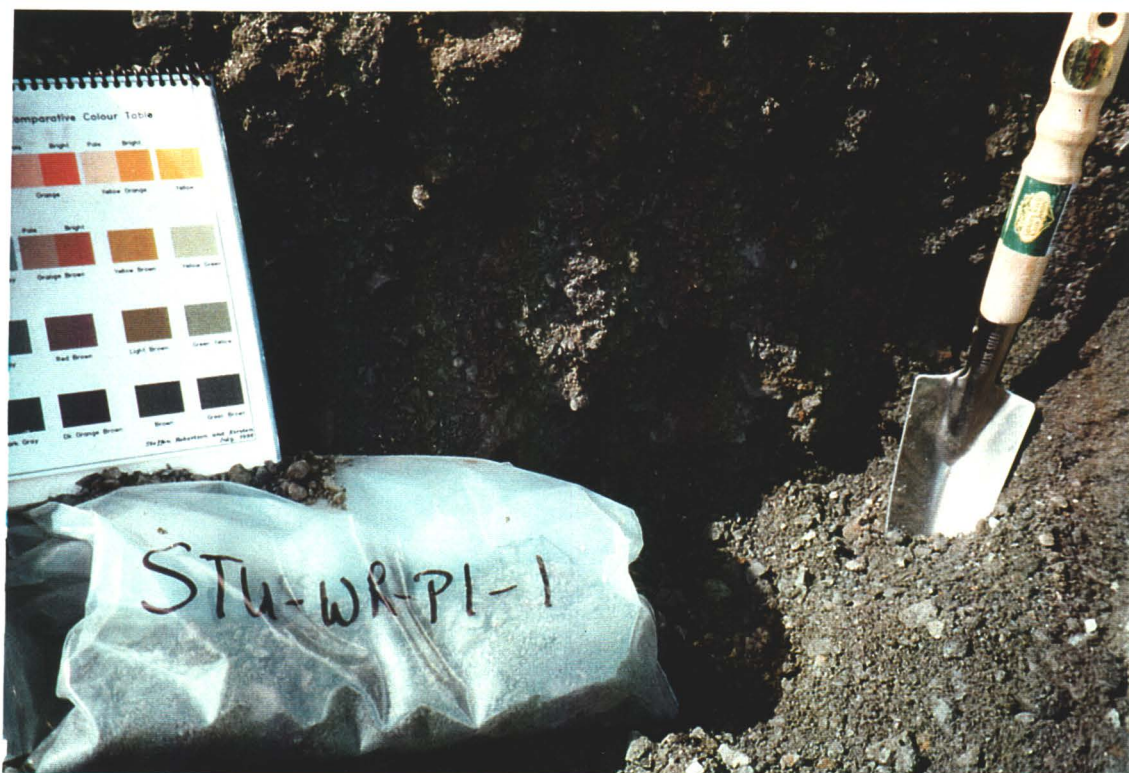
Photo # 16 - Waste Rock Sample, Stu-wr-p1-1

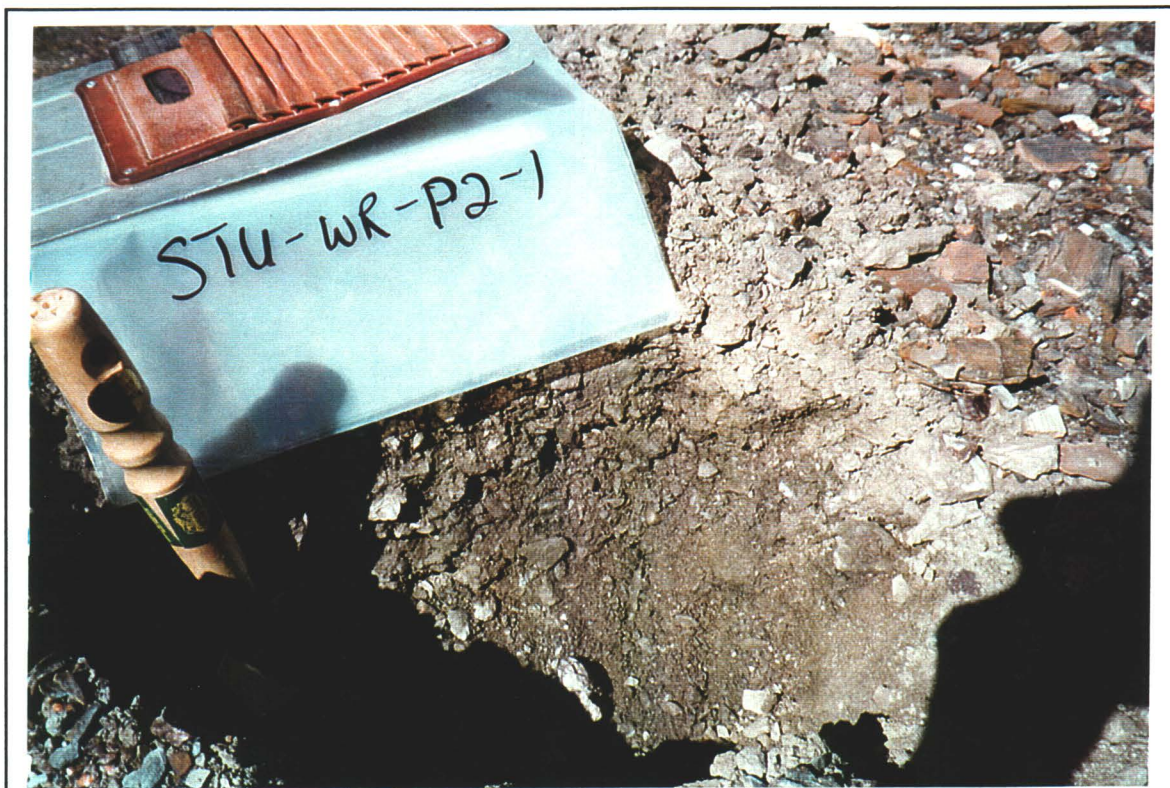
Photo # 17 - Waste Rock Sample, Stu-wr-p2-1
