**PHASE II ENVIRONMENTAL ASSESSMENT  
OF THE  
TINTINA  
ABANDONED MINE SITE**

**Action on Waste Program  
Indian and Northern Affairs Canada**

**Environmental Services  
Public Works and Government Services Canada**

March 1997

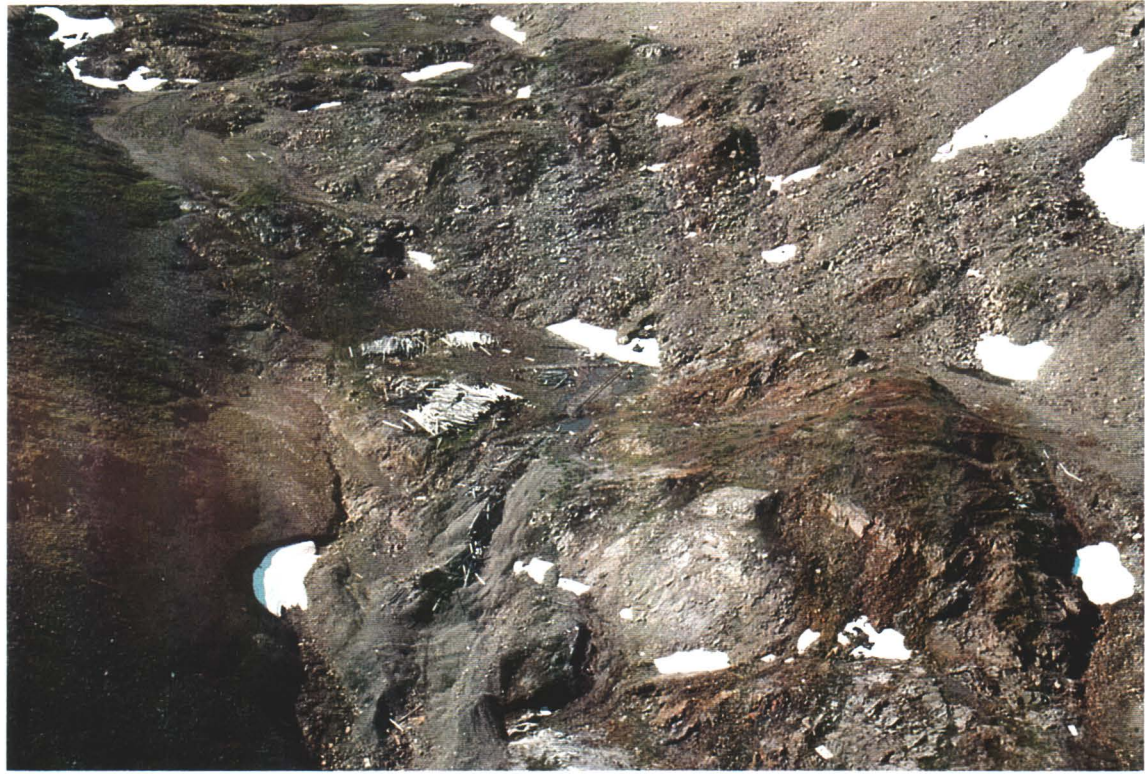
**Photo# 3: Upper Adit and Drainage Coarse**

One adit is present and is located at the exploration site on the north facing slope of an unnamed mountain. The entrance to the adit was partly blocked by snow at the time of the visit. The opening left exposed was not secured. The opening structure is composed of rotting timbers and is in unstable condition.

The adit is in unstable condition, however due to the remote access to the site, the risk to humans is considered low.

It is recommended that the mine opening be left as it is and no further work is required.

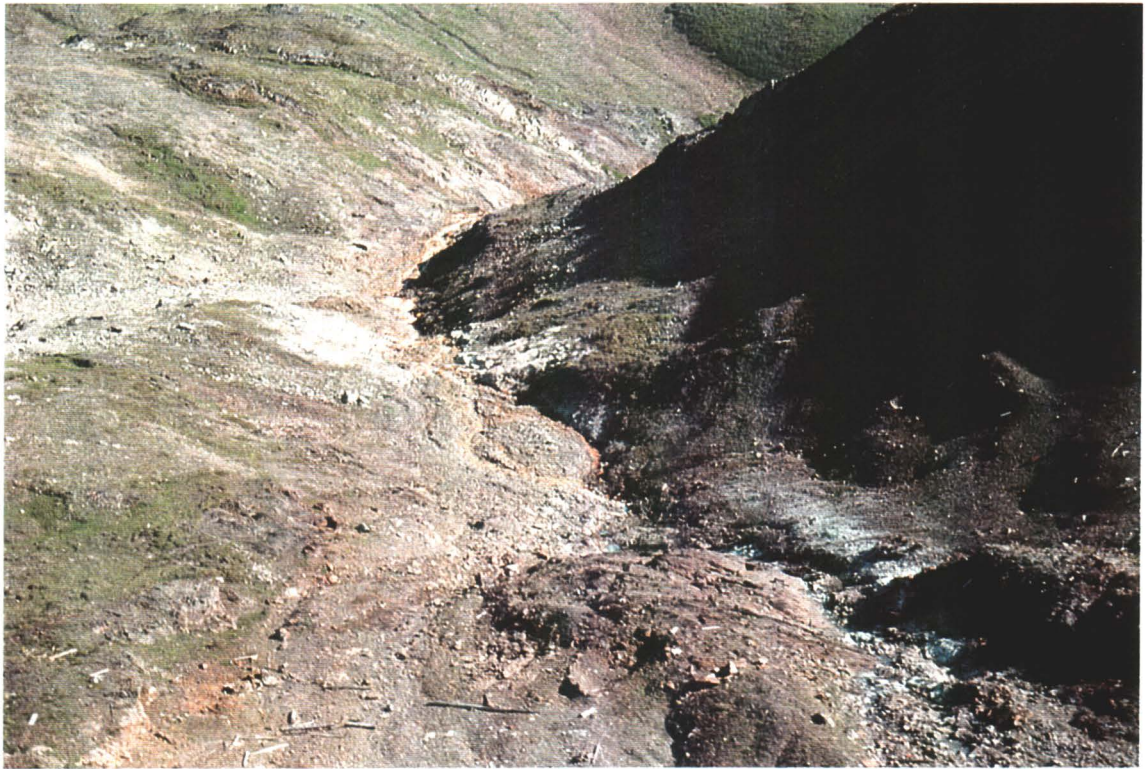
**Photo# 4: Exploration Site Drainage**

Water flowing from the adit (TINTWQ/A1) was good quality with a neutral pH and low conductivity (122  $\mu\text{S}/\text{cm}$ ). Metal concentrations were generally low. The quality of the water deteriorated downstream, however, as a result of seeps entering the stream from the country rock. Approximately 100 metres downstream from the adit entrance, the stream water became cloudy with aluminum hydroxide precipitates and white-gray foam of these precipitates was observed on the east side of the drainage just above the water level. The pH at this location was 5.5 and the conductivity was 460  $\mu\text{S}/\text{cm}$ . Seeps entering the stream from the siltstones to the east appear to be lowering the pH and raising the conductivity. The decrease in pH is causing the precipitation of aluminum hydroxides (probably gibbsite). Limestone waste rock lining the stream on the west buffers the low pH water from siltstones and keeps the pH of the water from decreasing further. At approximately 150 m downstream of the adit, dark orange-brown seeps enter the creek from the platy siltstones. One seep had a pH of 3.5 and a TDS greater than 1990  $\mu\text{S}/\text{cm}$ . Several dark or orange-brown seeps enter the creek from the platy siltstones at this location, abundant precipitation of iron oxides is seen which continues downstream for more than 100 metres.

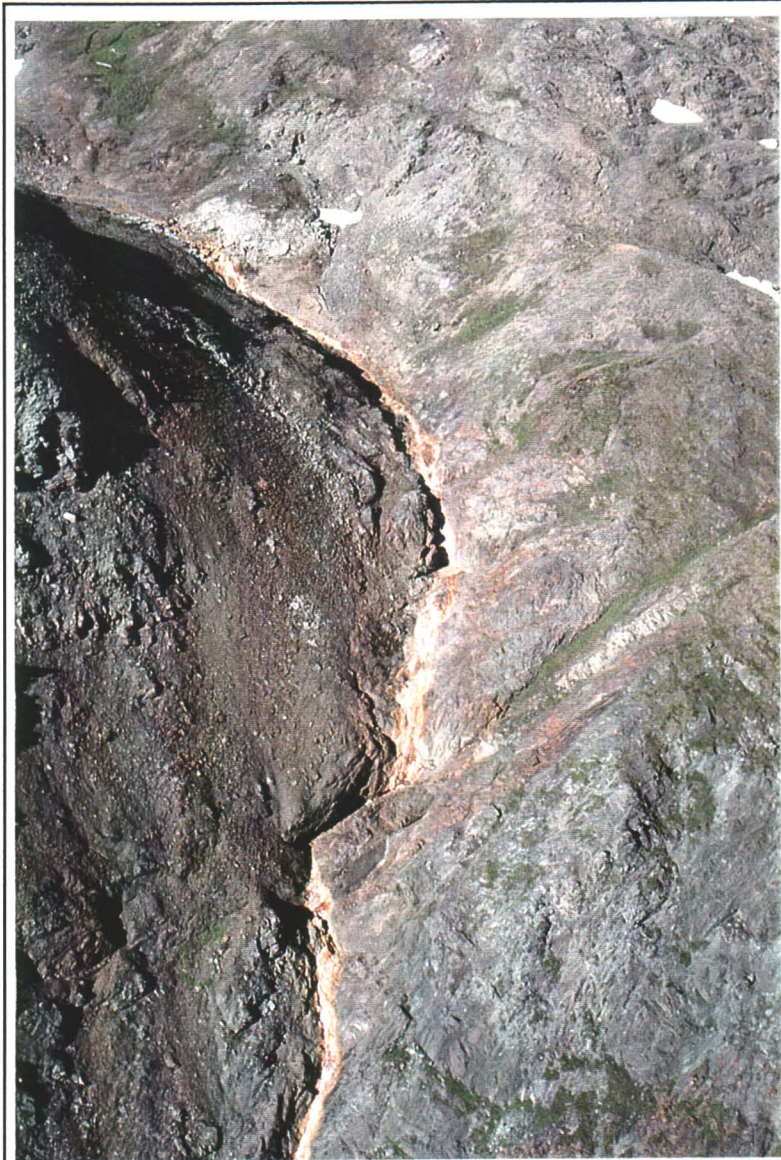
**Photo# 5: Iron Oxidation  
in Exploration Site Drainage**

The adit is located at the head of a small stream that runs down the ridge that comprises the exploration site. Below the adit, the stream is bounded on either side by black, very fine grained siltstone, some of which are coated with red-brown iron oxide staining.

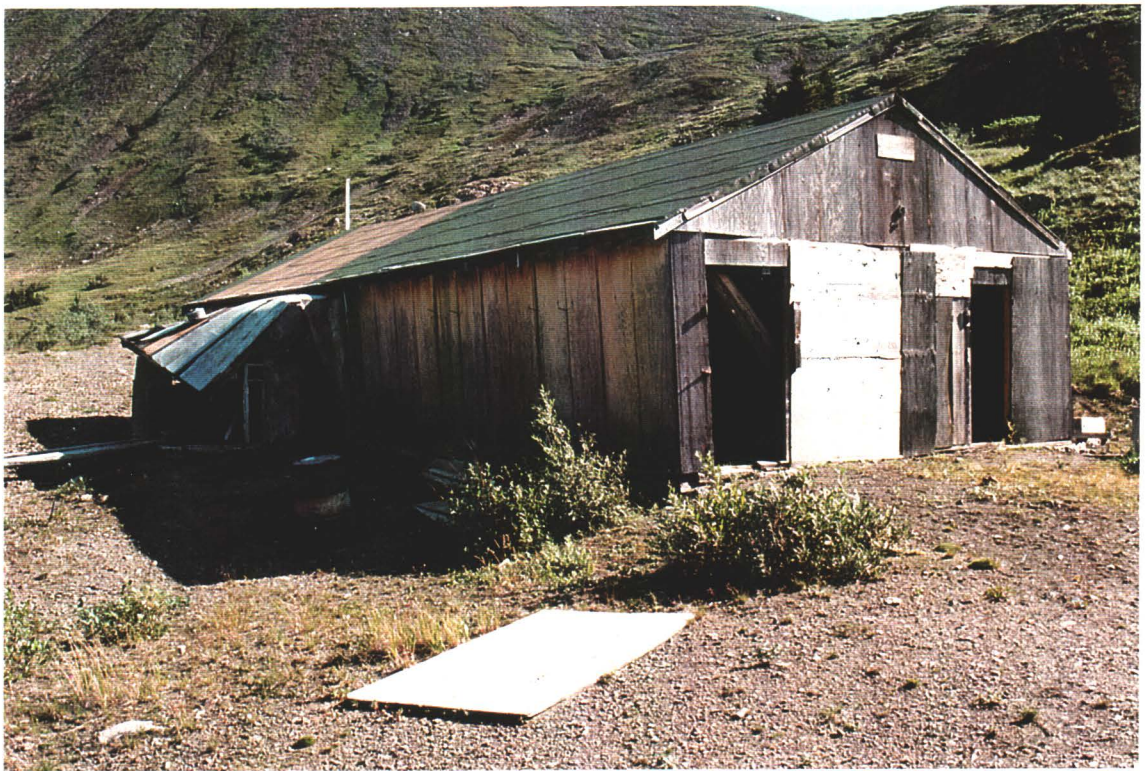
**Photo# 8: Maintenance Shop**

Seven building structures are on site and present a safety hazard to the public if left unmaintained. Most buildings contain waste debris and are easily accessed. A small quantity of domestic hazardous waste, including flammables and combustibles, is stored in the maintenance shop and is a potential health hazard.

It is recommended that all buildings be burned. This is provided that all mining activity has ceased and that the facilities are no longer being used. Waste material that is non-hazardous combustible may be burned on site.

It is recommended the domestic hazardous wastes stored on site be properly packaged, labeled, transported and disposed at an approved hazardous waste disposal facility.

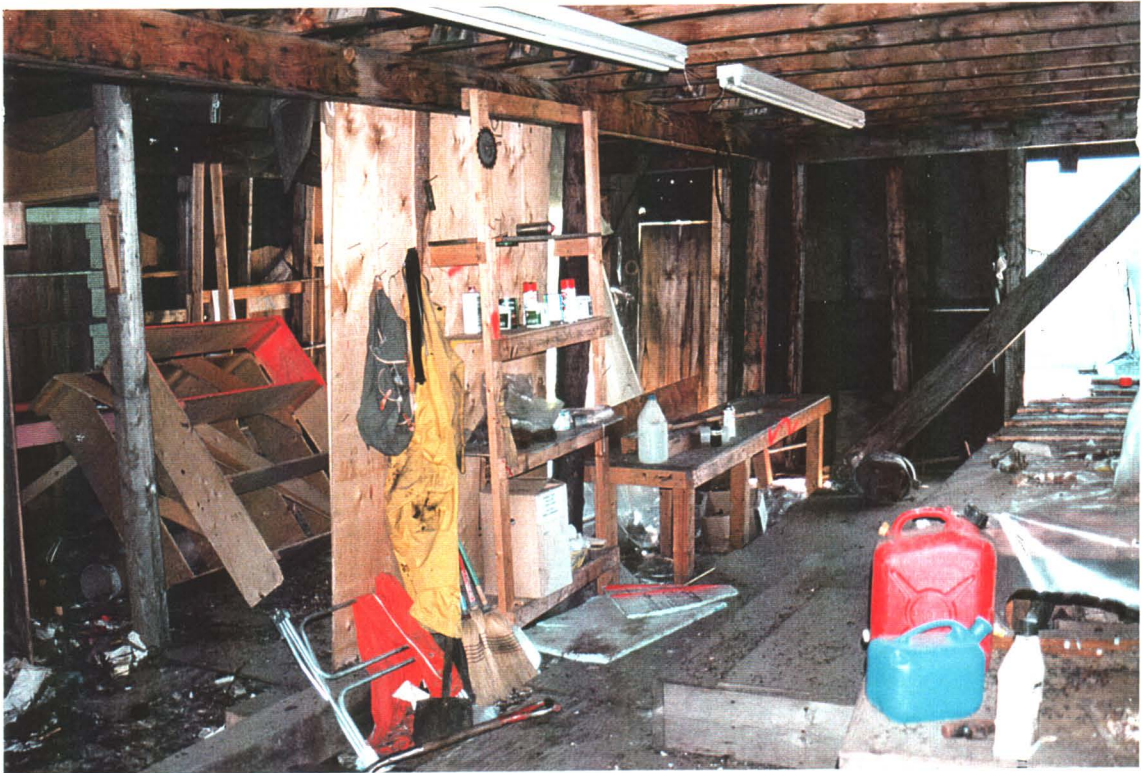
**Photo# 12: Maintenance Shop Interior**

A small quantity of hazardous materials is stored mostly in the maintenance shop and in the kitchen. These substances present a moderate environmental risk to humans and animals visiting the site.

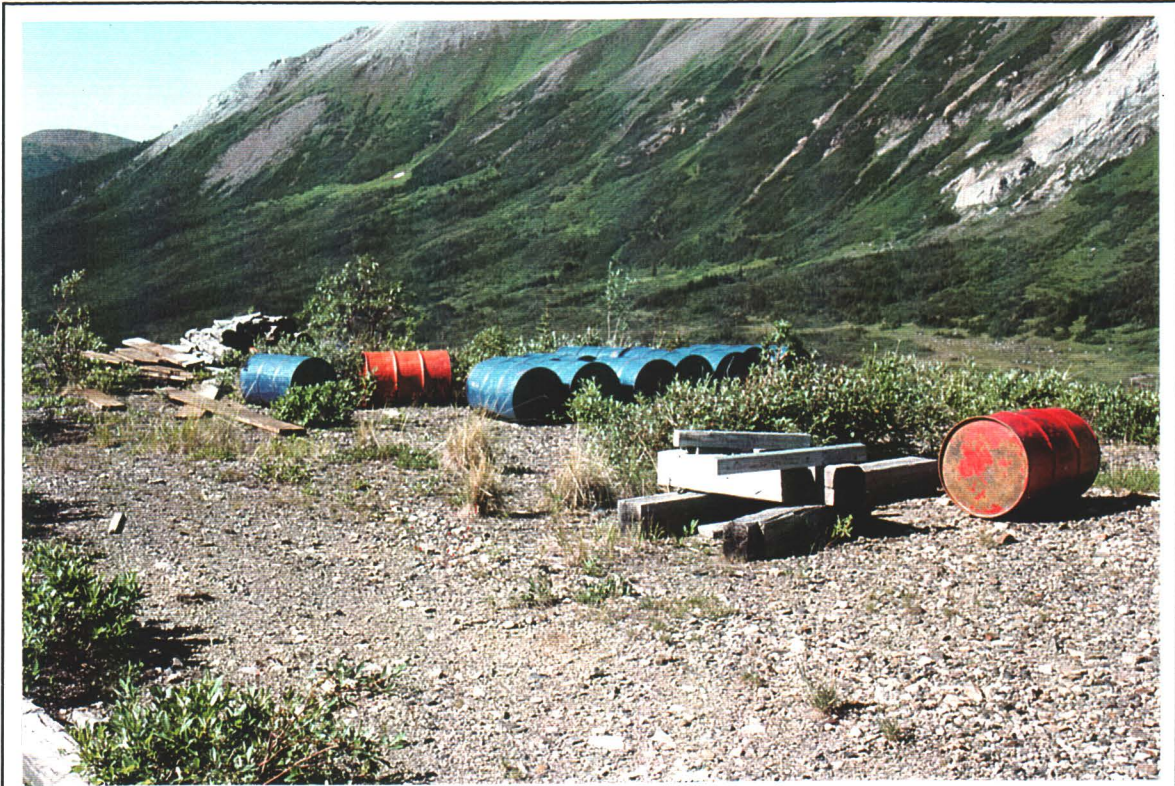
**Photo# 15: Barrels**

The description of hazardous materials observed during the site inspection is listed in Table 3. All hazardous materials were present at the camp site. Very little soil staining was observed. Five representative barrel samples were analyzed for potential incineration and are presented in Table 4. The results indicate that all barrel contents are suitable for incineration.

site and disposed appropriately. It is recommended that barrel contents be incinerated. This may be done using a portable incinerator by air transporting the barrels to a central disposal location. If incineration is conducted along with a regional cleanup, the barrel contents may be incinerated at a temporary barrel incineration facility established for the purpose of incinerating waste hydrocarbons at several mine sites in the area.
