**PHASE II ENVIRONMENTAL ASSESSMENT  
OF THE  
UNION ABANDONED MINE SITE**

**Environmental Services  
Public Works and Government Services Canada**

**March 1997**

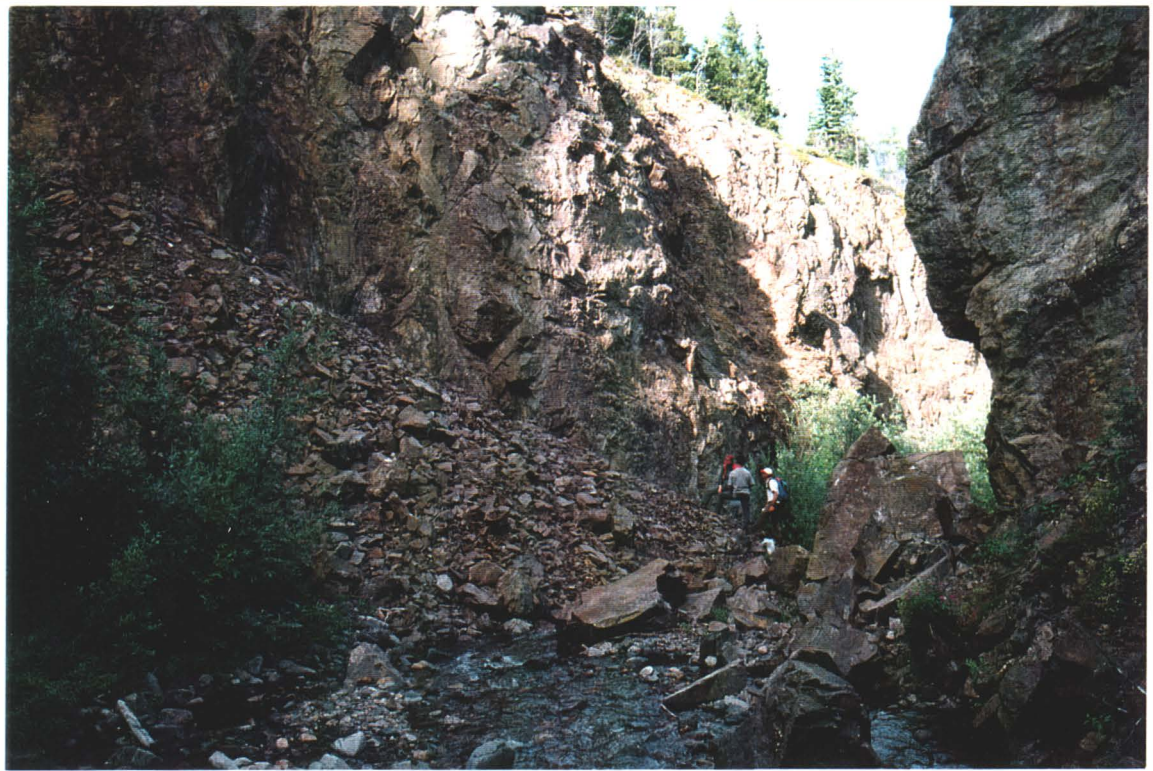
**Photo # 1 - Gorge and Waste Rock, Left Side (West) - Lower Site**

At the lower adits there is approximately 2500 tonnes of waste rock in two piles. Samples were collected from each of these piles (UN/WR/P304 and UN/WR/P305). The rock piles are adjacent to Schnabel Creek in a narrow canyon and the toes of the piles are in the floodplain of the creek. No water was observed flowing through the piles.

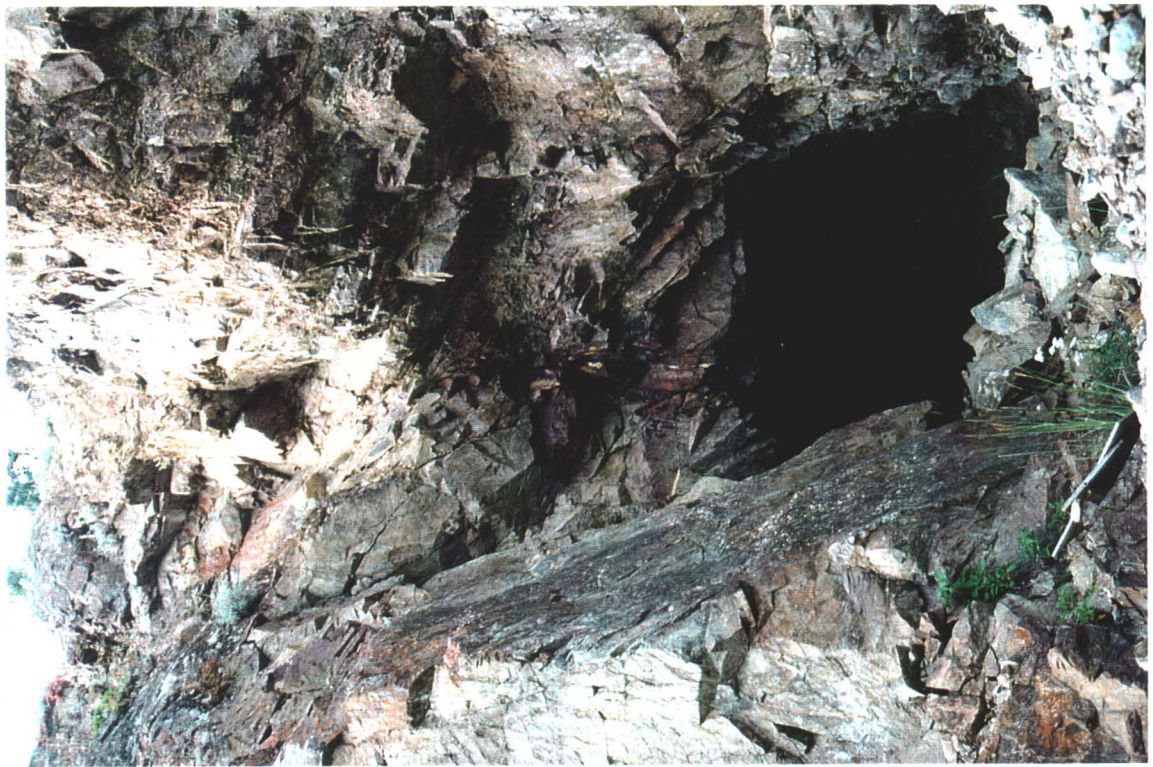
**Photo # 2 - Adit, Right Site (East) - Lower Adits**

Adit	Location	Drift Length	Condition
2 upper adits	west side of Idaho Hill on open hill side	approx. 41 m	both collapsed
3 middle adits	Schnabel Creek canyon on south side of Idaho Hill	unknown	1 collapsed; 2 open
2 lower adits	upper Schnabel Creek canyon on south side of Idaho Hill	unknown	1 collapsed; 1 open

It is recommended that the mine openings be secured from human and animal access for health and safety reasons. The entrances should be blasted shut with explosives to seal the openings with waste rock.

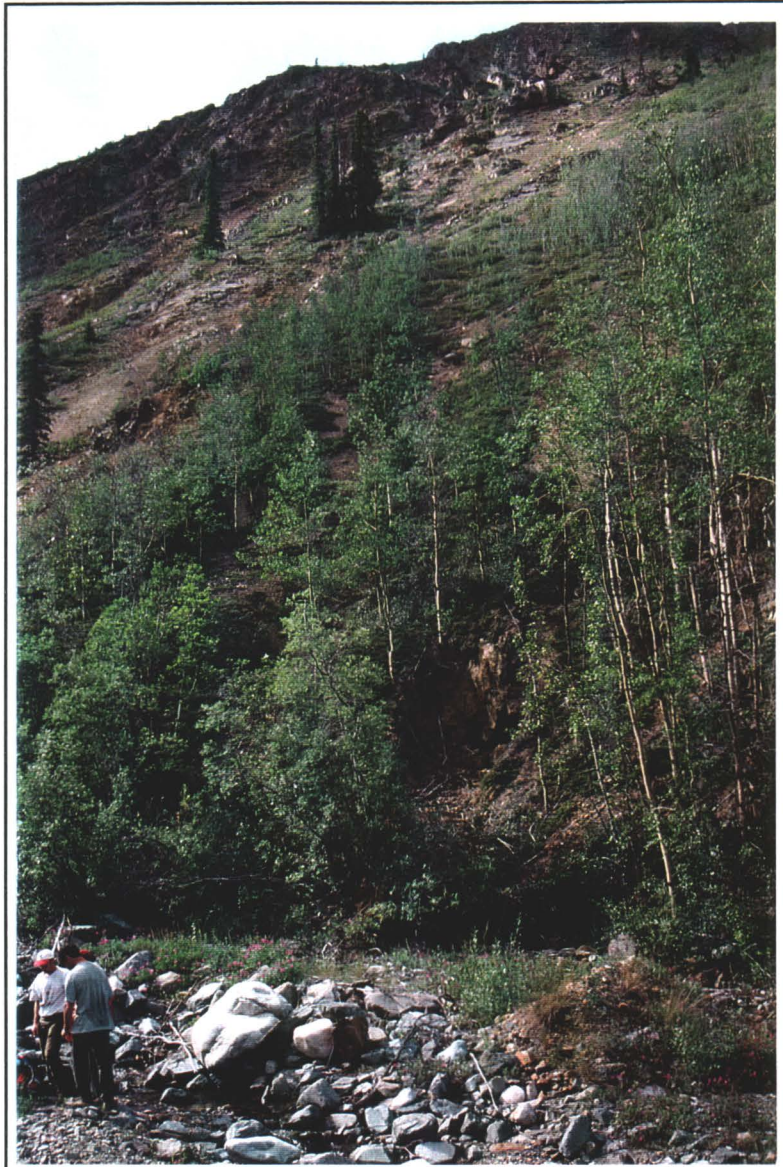
**Photo # 4 - Middle Adits - Most Westerly - Waste Rock**

Small waste rock piles are located adjacent to the adits and open-cuts, as illustrated in Drawing 1. There is approximately 2000 tonnes of waste rock at the middle adits, distributed in seven piles. Samples UN/WR/P301, UN/WR/P302 and UN/WR/P303 were collected from three of the piles. The rock has been deposited within the floodplain of Schnabel Creek. At the time of the site visit no water was observed flowing through the piles but rather was diverted around them.

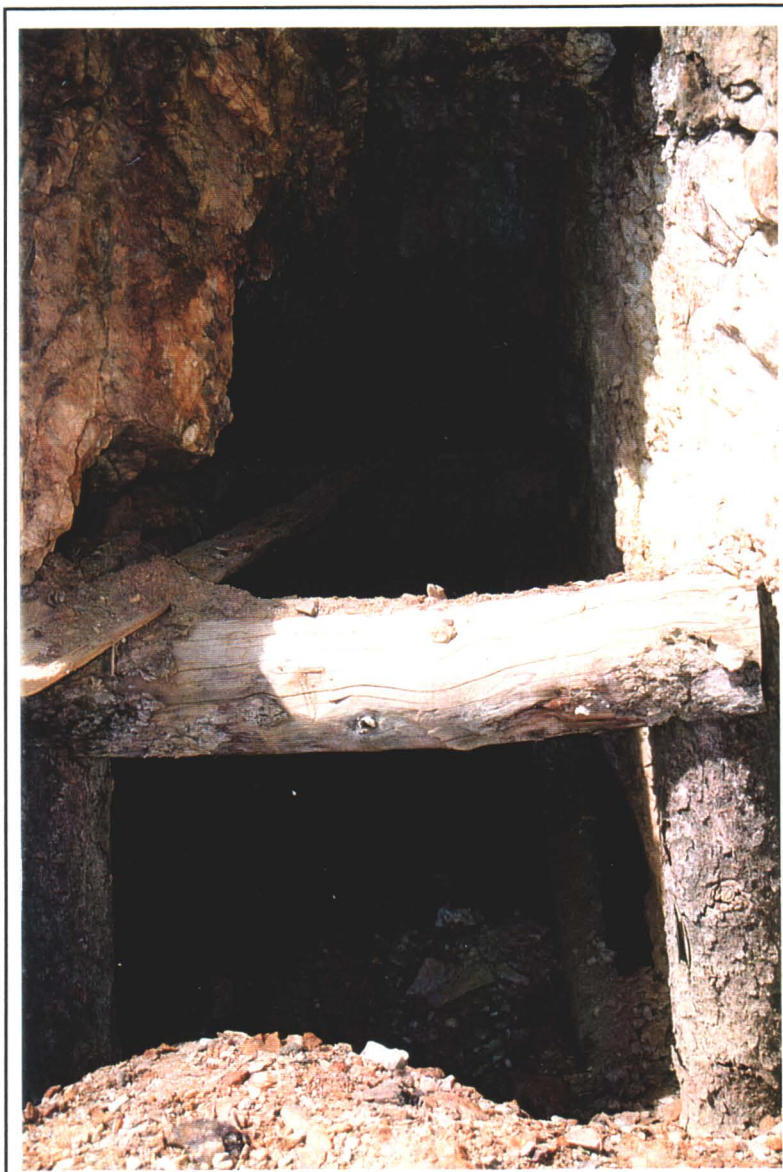
Photo # 5 - Middle Adits - Middle Site - Open Adit

Three of the mine openings are in unstable condition and are not adequately secured from public and wildlife access. The canyon is frequently used by snowmobilers in the winter months and there is ample opportunity for the public to enter the open adits.

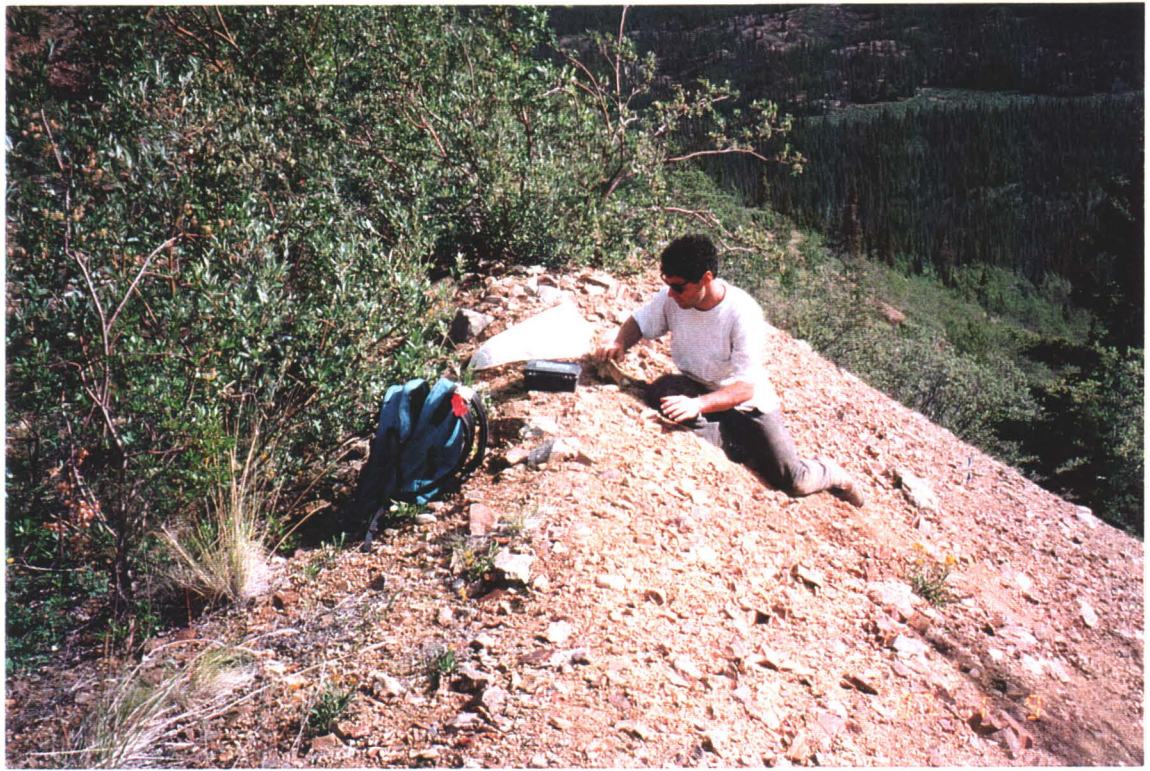
**Photo # 10 - Waste Rock Pile adjacent to Upper Adits**

One sample was collected from the waste rock at the upper adits (UN/WR/P306). The volume of waste rock at the upper adits is estimated to be 650 tonnes. The upper adits are located high on the side of Idaho Hill in a dry/arid environment. No surface water was observed in the vicinity of the workings.

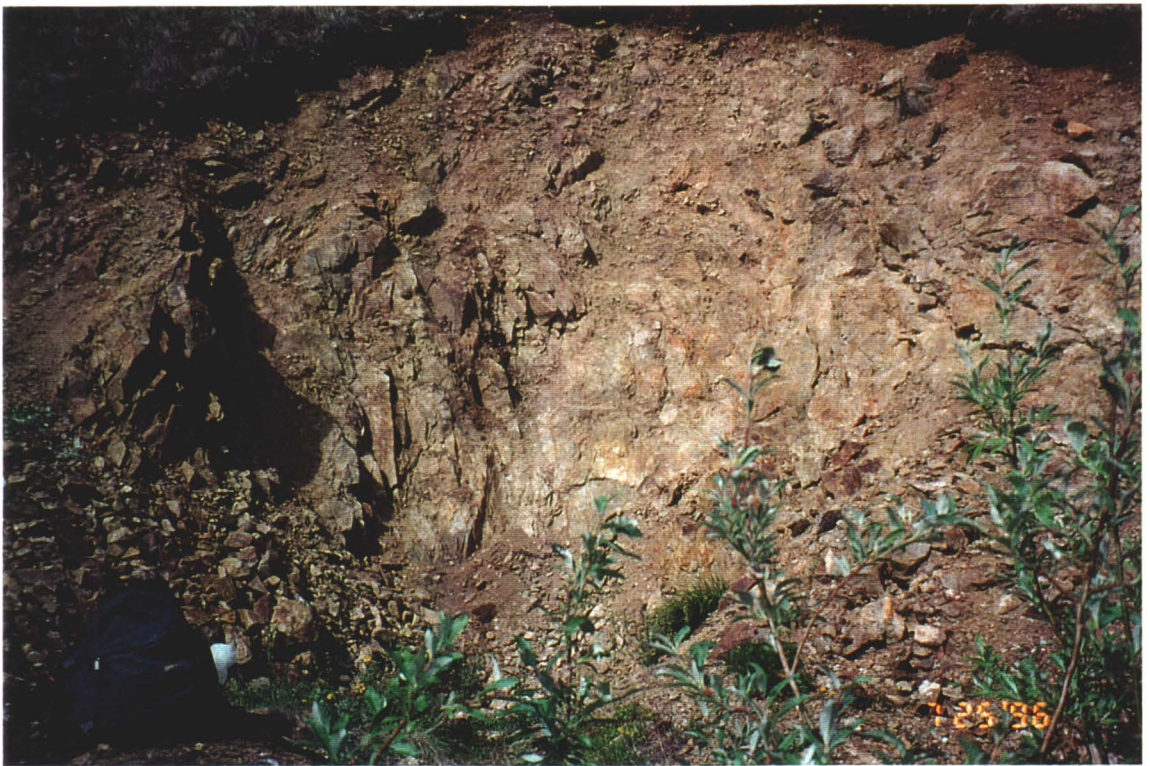
**Photo # 11 - Approximate Area of Closed Upper Adit**

Open cuts and adits are located in three separate areas at Union. The adits at the end of the aerial tramway have been securely buried (upper adits). Of the adits and open cuts in Schnabel Creek canyon (lower adits), one is open and one has been demolished by trenching and is no longer a hazard. Of the middle adits, upstream on Schnabel Creek, one has been demolished by trenching and two are accessible. The open adits at Union do not appear to extend more than 5 m underground. Table 4 shows the results of the mine openings investigation.

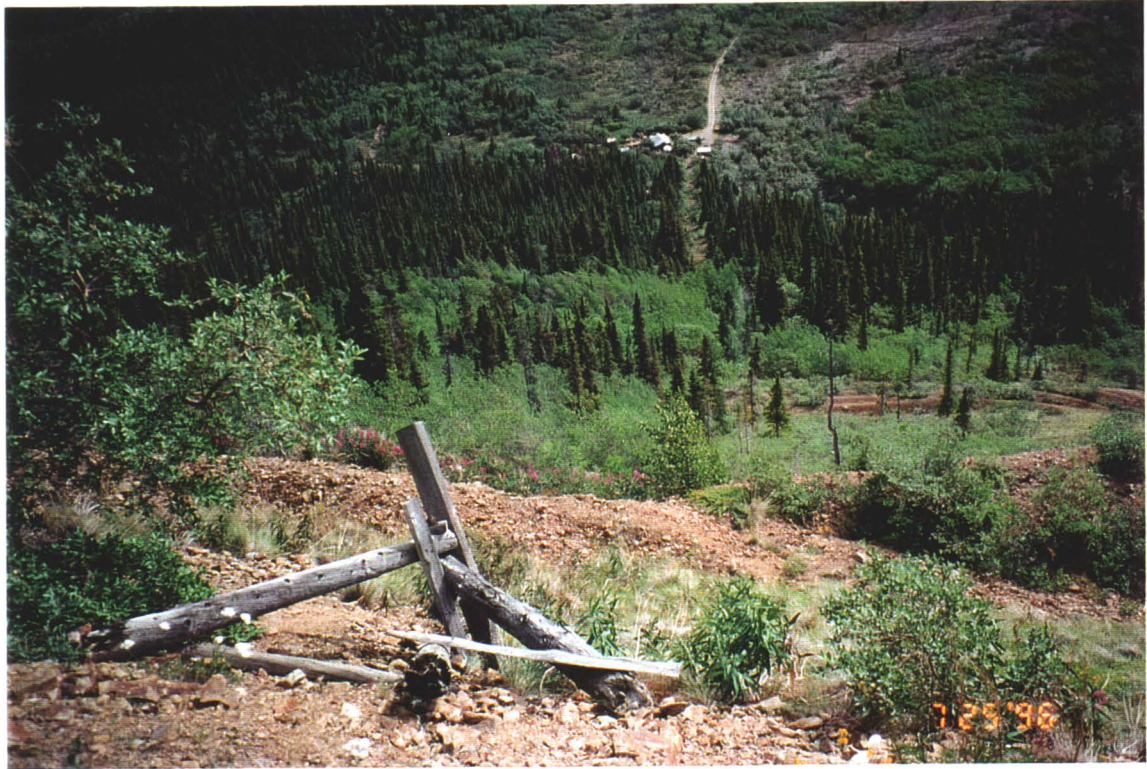
**Photo # 12 - Old Tramway Standard Wood Debris at Upper Adit**

There are no buildings or equipment at the site. The only remaining infrastructure are widely spaced rotted wood timbers remaining from the former tramway up the west face of Idaho Hill that formerly accessed the base camp below. Approximately five standards were noted.

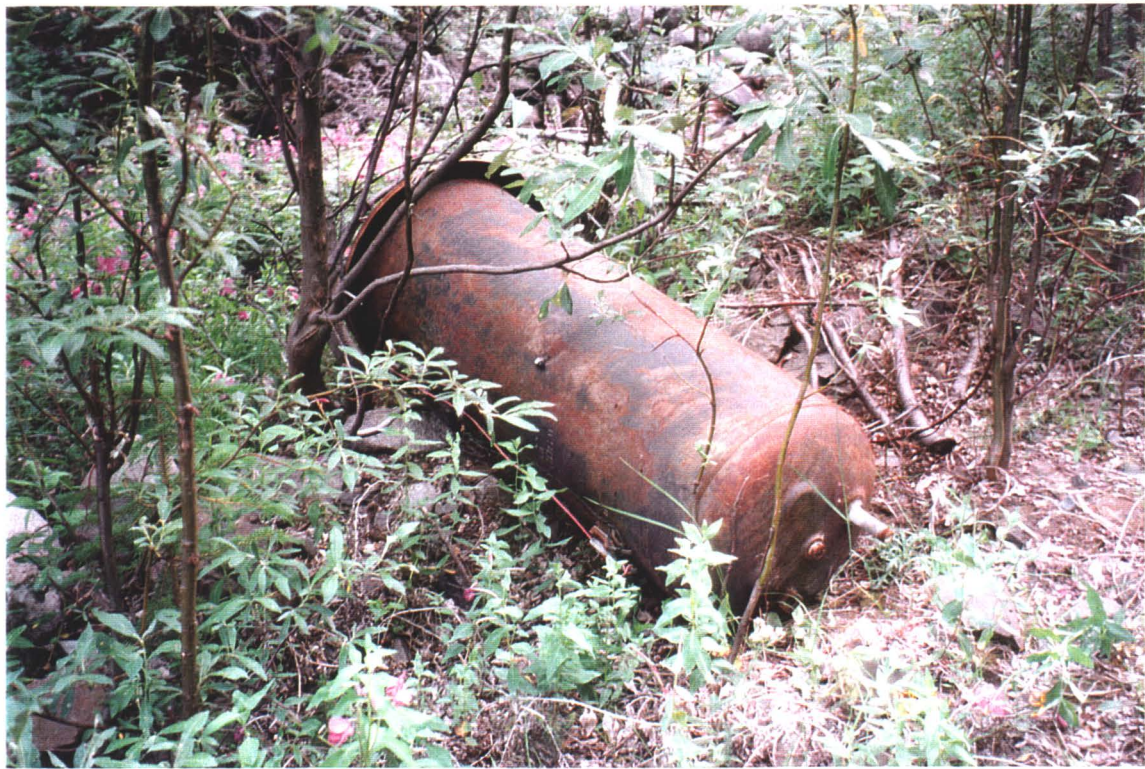
**Photo # 13 - Discarded Metal Debris**

The only non-hazardous waste noted in the area was a discarded 400 L hot water heater near the lower adits.

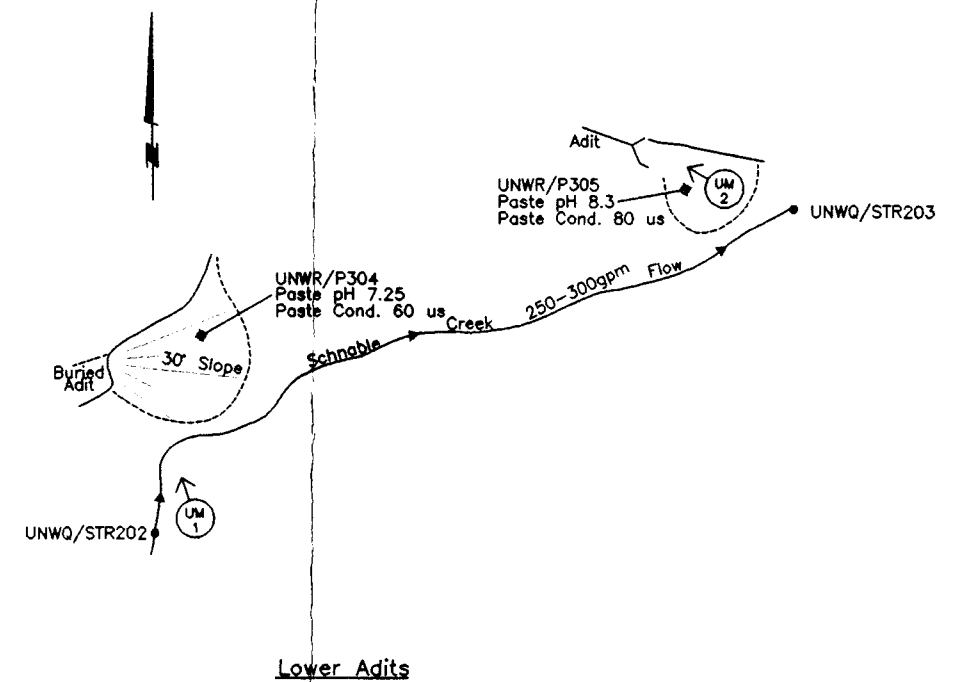
**Note:**  
The Upper Adits Are Located On The North Side Of Idaho Hill And Have Been Securely Sealed. Waste Rock Samples UNWR/P306 Was Collected Here.
