**PHASE II ENVIRONMENTAL ASSESSMENT
OF THE
WHEATON MOUNTAIN
ABANDONED MINE SITE**

**Action on Waste Program
Indian and Northern Affairs Canada**

**Environmental Services
Public Works and Government Services Canada**

March 1997

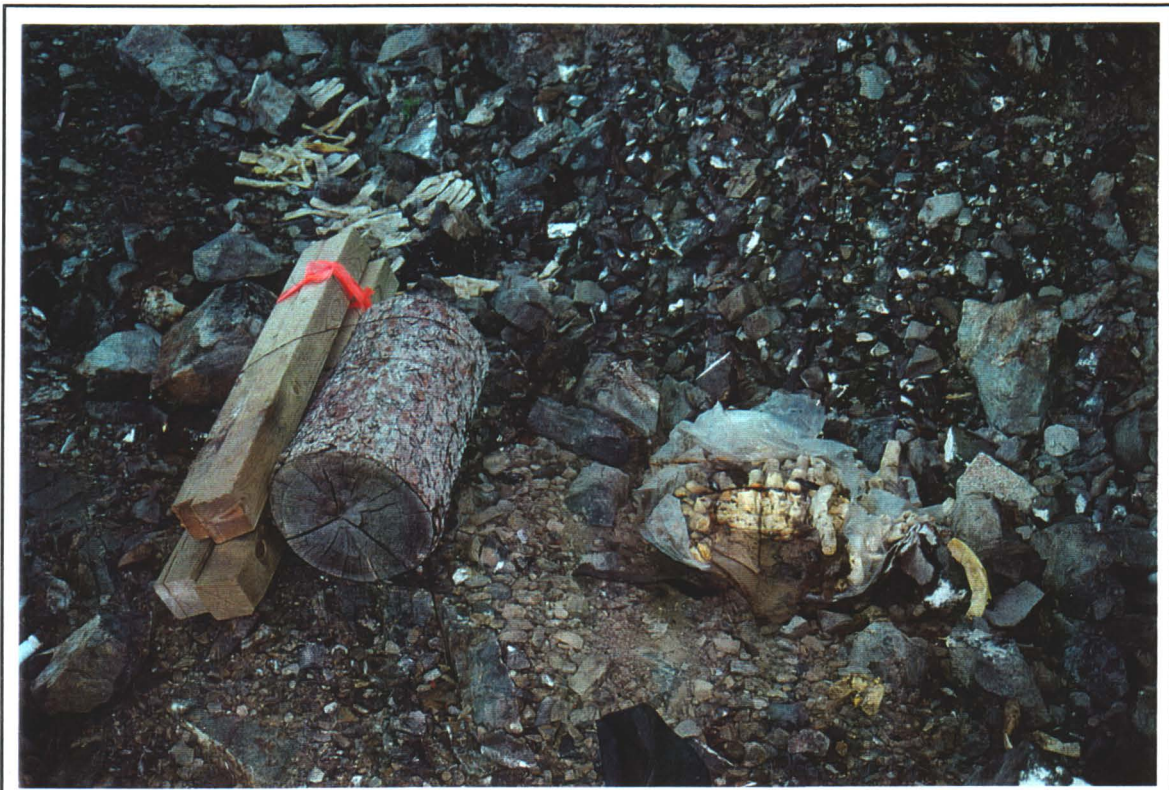
Hazardous materials were limited to an unlocked container of explosives measuring 91.5 cm x 61 cm x 61 cm. A 22 L container of unused oil was also found.

An unlocked container of explosives noted at the site represents a very high risk to human and wildlife safety.

Photo # 3 - Unprotected Explosives

It is strongly recommended that the RCMP be notified of the presence of the abandoned explosive container and asked to dispose of it.

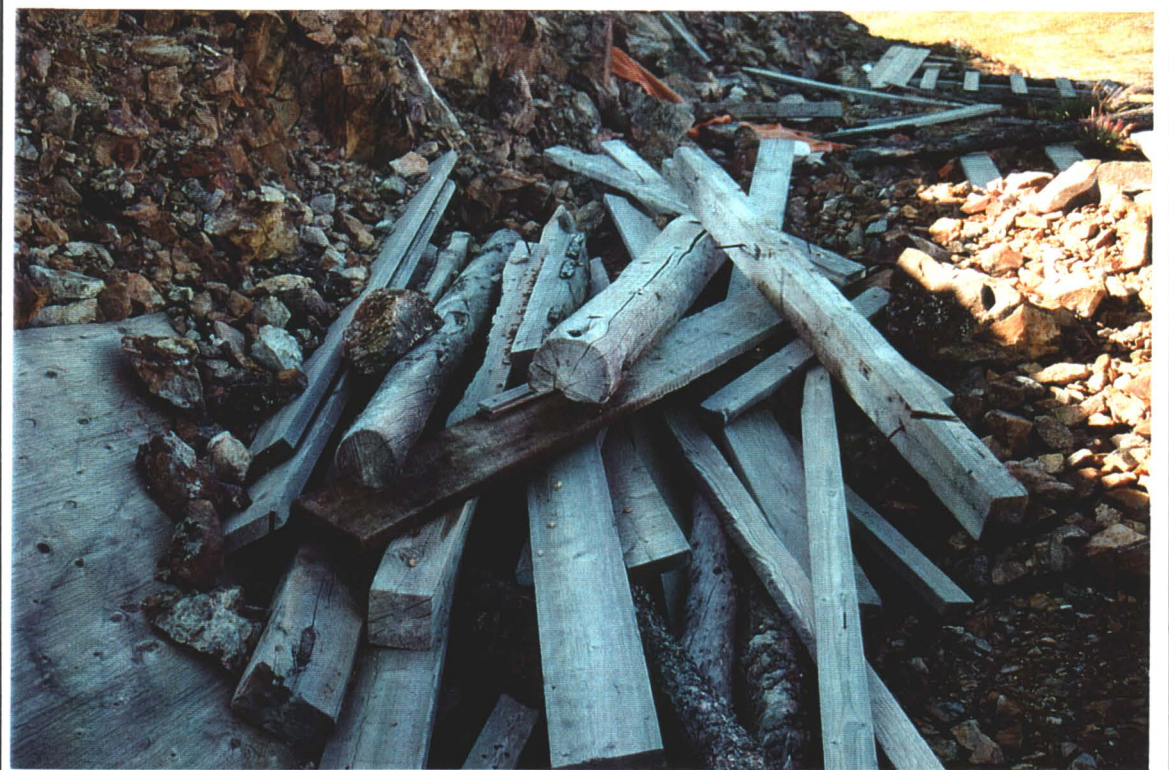
Waste Material	Number/ Volume	Location
empty 205 L barrels	4	adj. to waste rock
timbers	20 m ³	adj. to waste rock
empty core boxes	7	adj. to waste rock

Photo # 4 - Wood Debris

It is recommended that the timbers, empty core boxes, and empty barrels be transported off site and disposed of at a suitable landfill. These activities can be accomplished using locally available resources and labour.

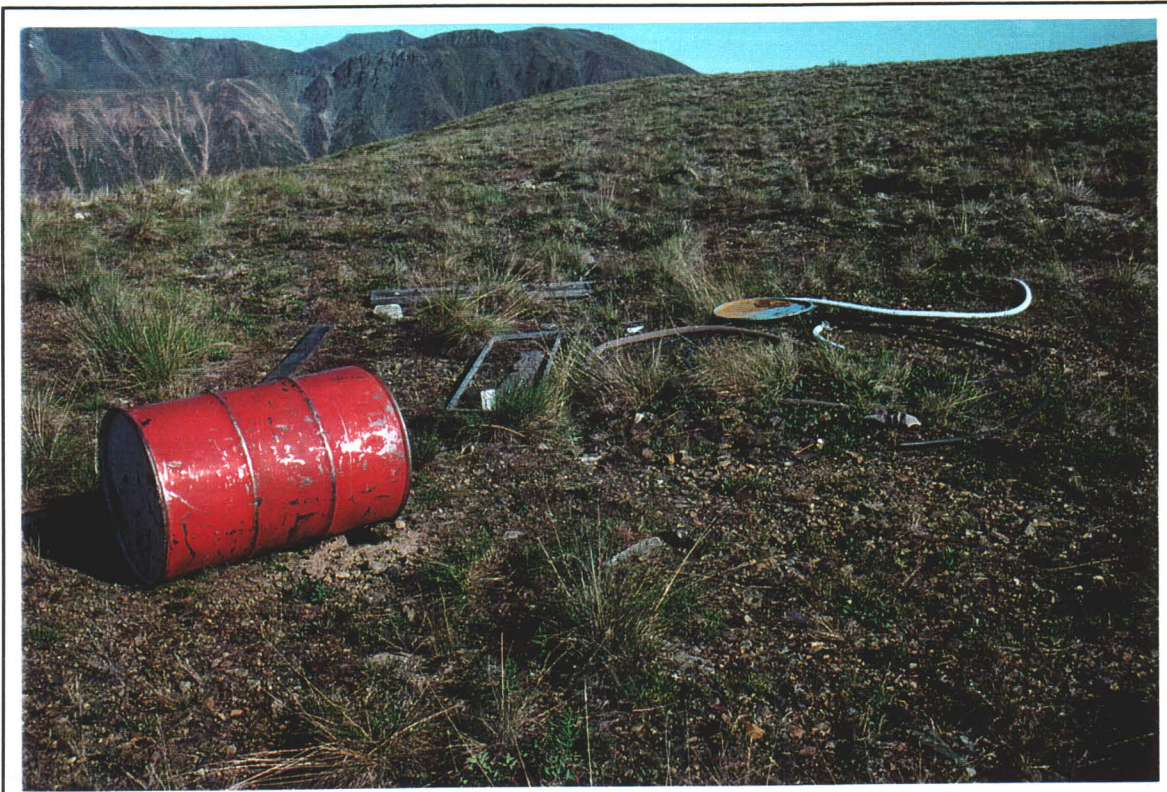
Photo # 5 - Barrel, Cable and Core Sample Box

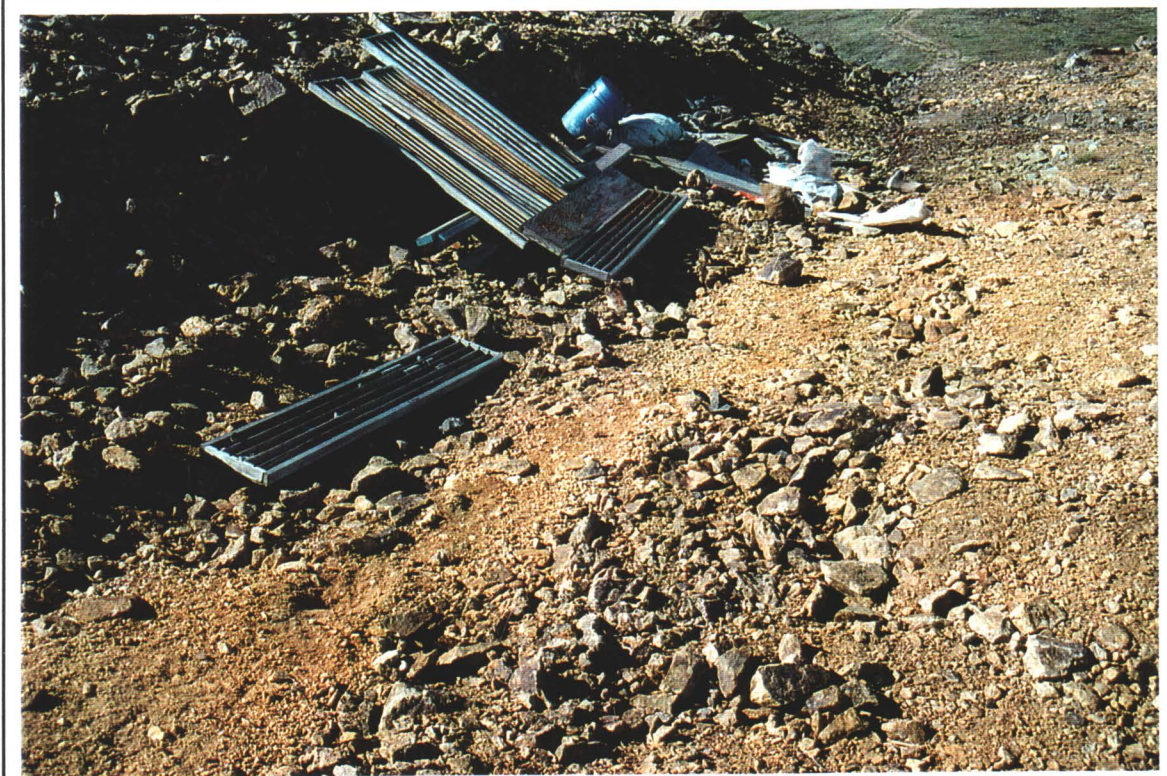
Photo # 6 - Core Sample Boxes and Debris

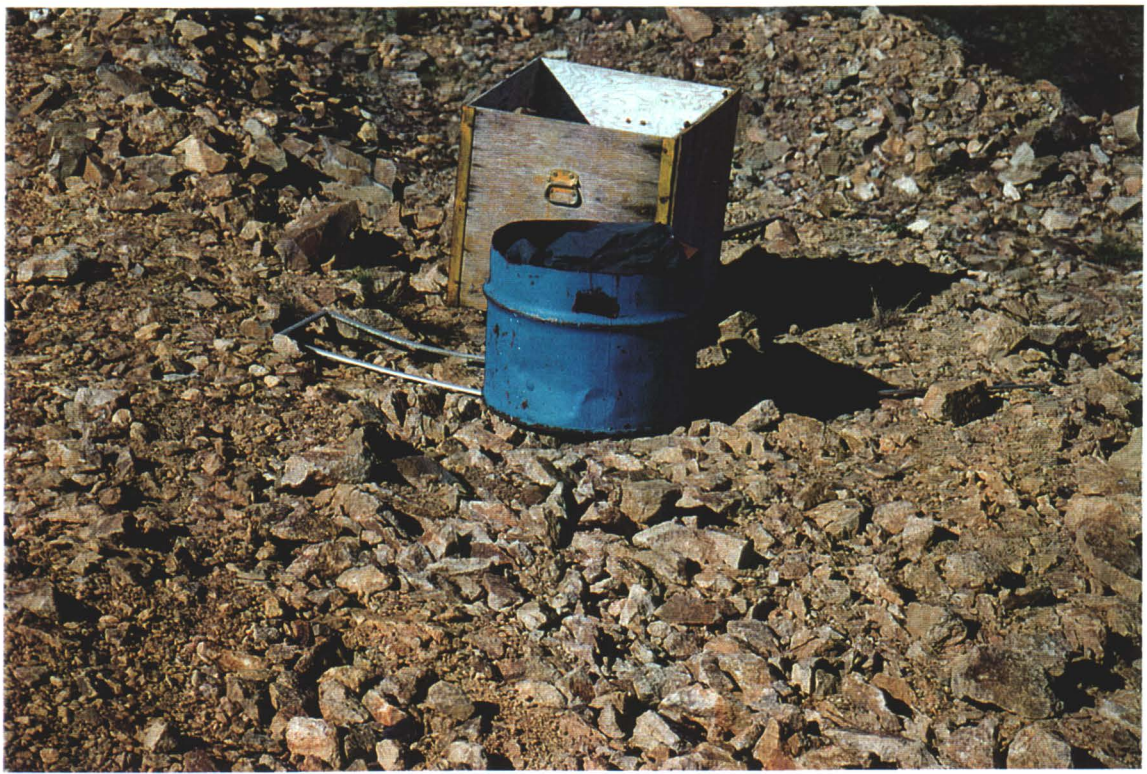
Photo # 7 - Barrel, Box Containing Garbage

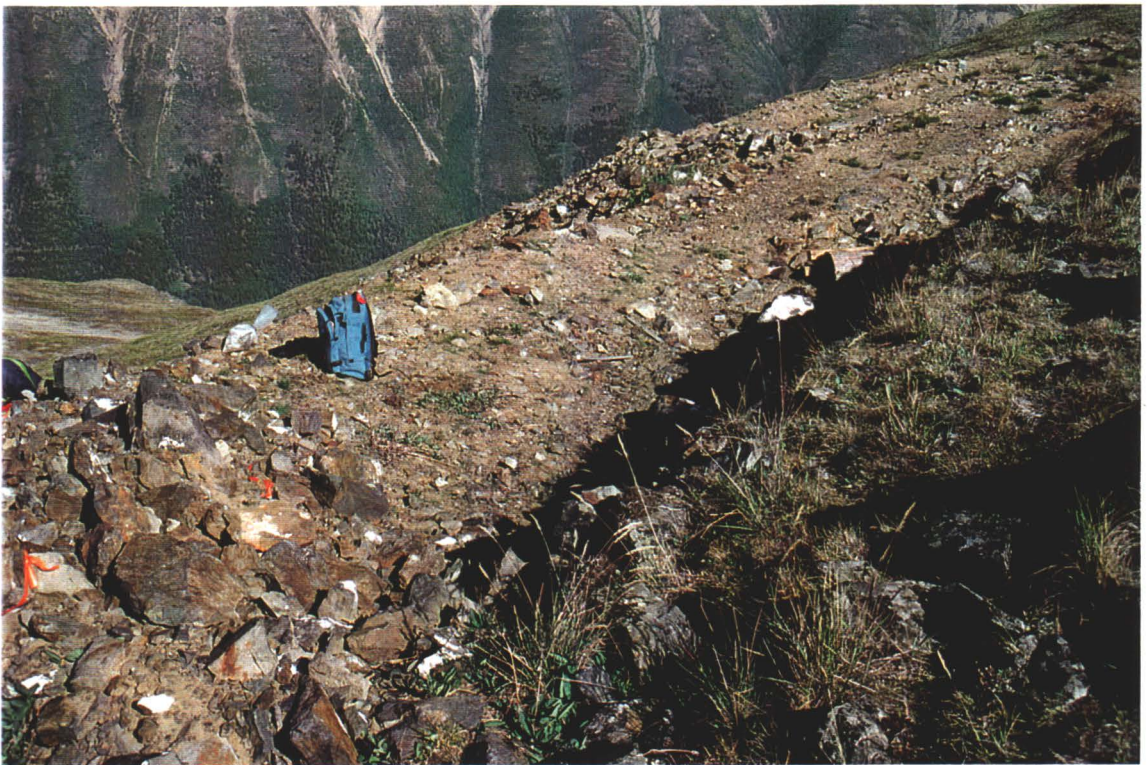
Waste rock at the Wheaton Mountain site is limited to small piles near trenches and pits. Two grab samples were collected from along side of trenches excavated in mineralized, altered granite and submitted for analysis. Sample WM/WR/P201 is representative of 20% of the disturbed rock and sample WM/WR/P203 is representative of the remaining 80%.

Samples WM/WR/P201 and WM/WR/P203 were collected from trenches excavated in the granitic intrusion. The samples had neutral paste pH values of 7.6 to 7.7, respectively. The total sulphur contents were low (0.11% and 0.06%) as were metal concentrations. The NP:AP ratios were 0.95 and 1.80, indicating that the exposed rock has the potential to generate acid. Accounting test results are shown in Table 3.

Photo # 8 - Location of Pit 201
