Yukon Abandoned Mine Assessment

BARITE MOUNTAIN MINE SITE

Waste Management Program
Indian and Northern Affairs Canada

November 1998

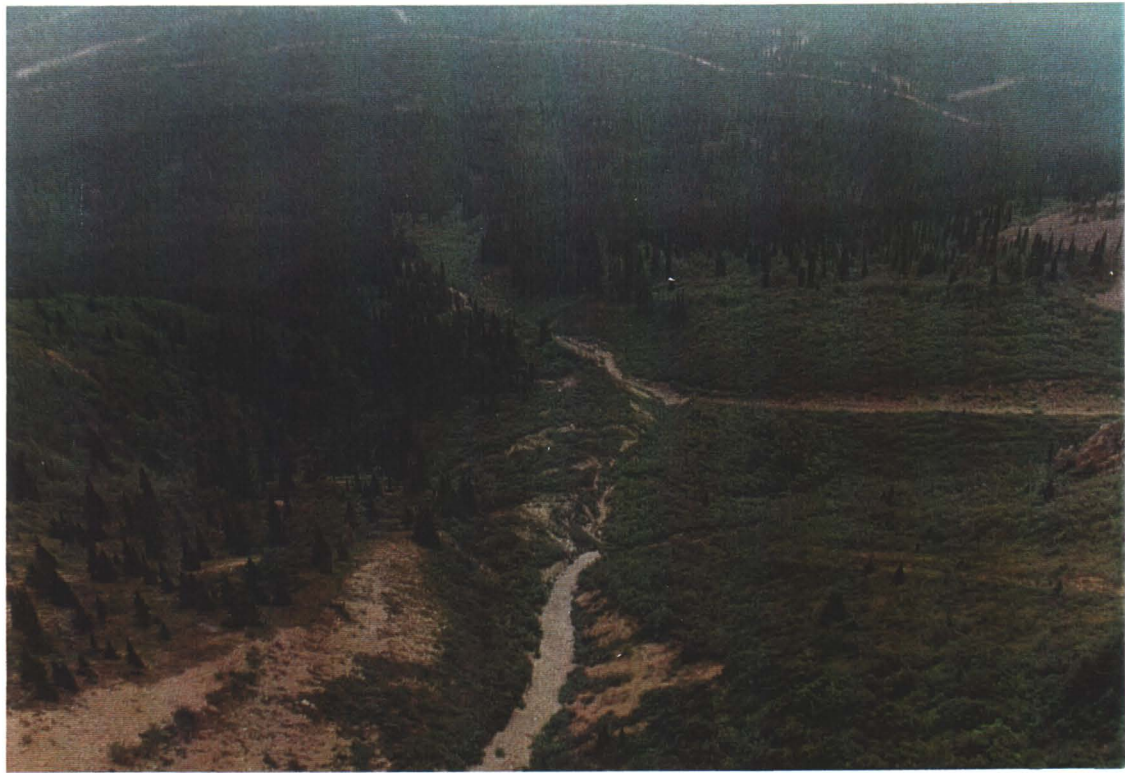
No buildings, infrastructure, or equipment were observed at the Barite Mountain site. A partially-rotted wooden tent platform (perhaps the remains of the mine camp) were located 550 m east of the blast face/quarry area.

Photo 1. Downslope view of tote road (lower centre); former exploration camp believed to have been located in cleared area visible in centre of photo.

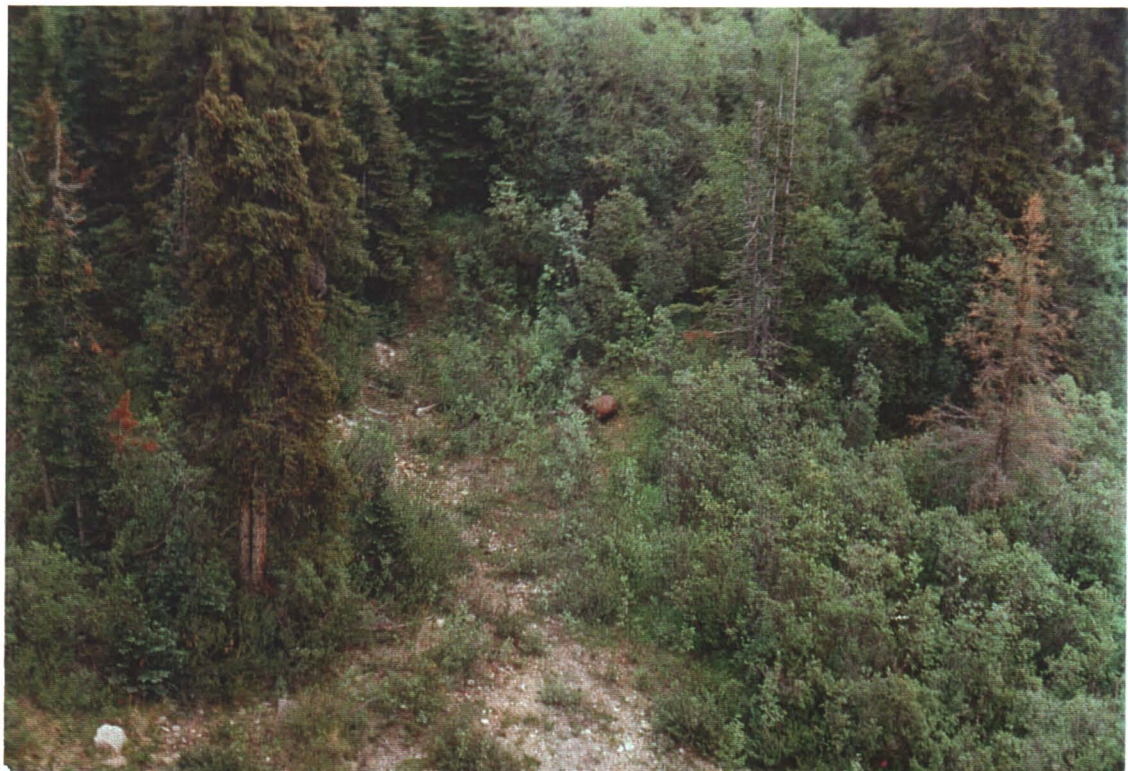
One rusted, ruptured drum was seen near the wooden tent platform. No other non-hazardous wastes were observed at the blast face/quarry area or in the vicinity of the tent platform.

Photo 2. Possible exploration camp area; rusted drum visible at centre of photo.

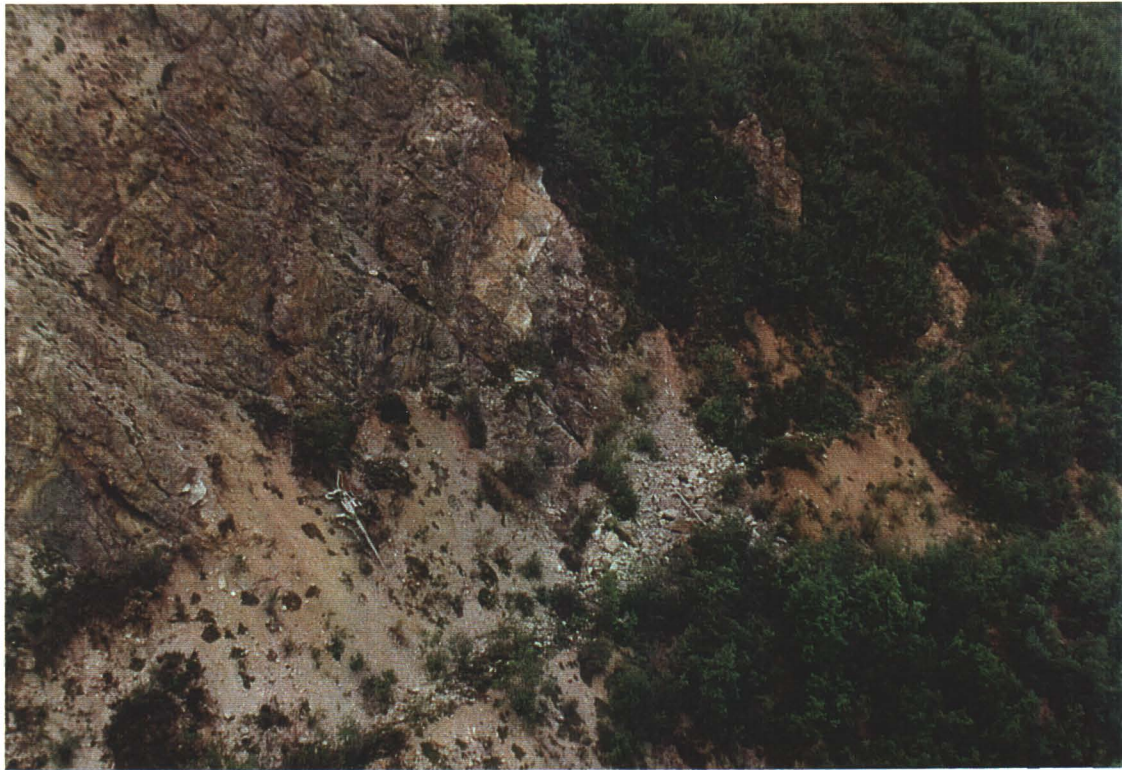
The quarry is a very shallow excavation, while the blast area is essentially a sheer face with minimal overhang. Neither feature poses a substantial risk to human health and safety, although

there is the commonplace safety risk posed by falling rock from upslope cliffs.

Only a very limited amount of mining related disturbance was present at the site. Barite from the test quarry was hauled off site, and waste rock from the test quarry and blast face is essentially indistinguishable from the native talus. Photos MN3 and MN4 show the extent of this disturbance.

Photo 3. Northward view of barite occurrence. Test quarry visible at left centre & blast face visible at upper centre of photo; tote road begins at lower right of photo.

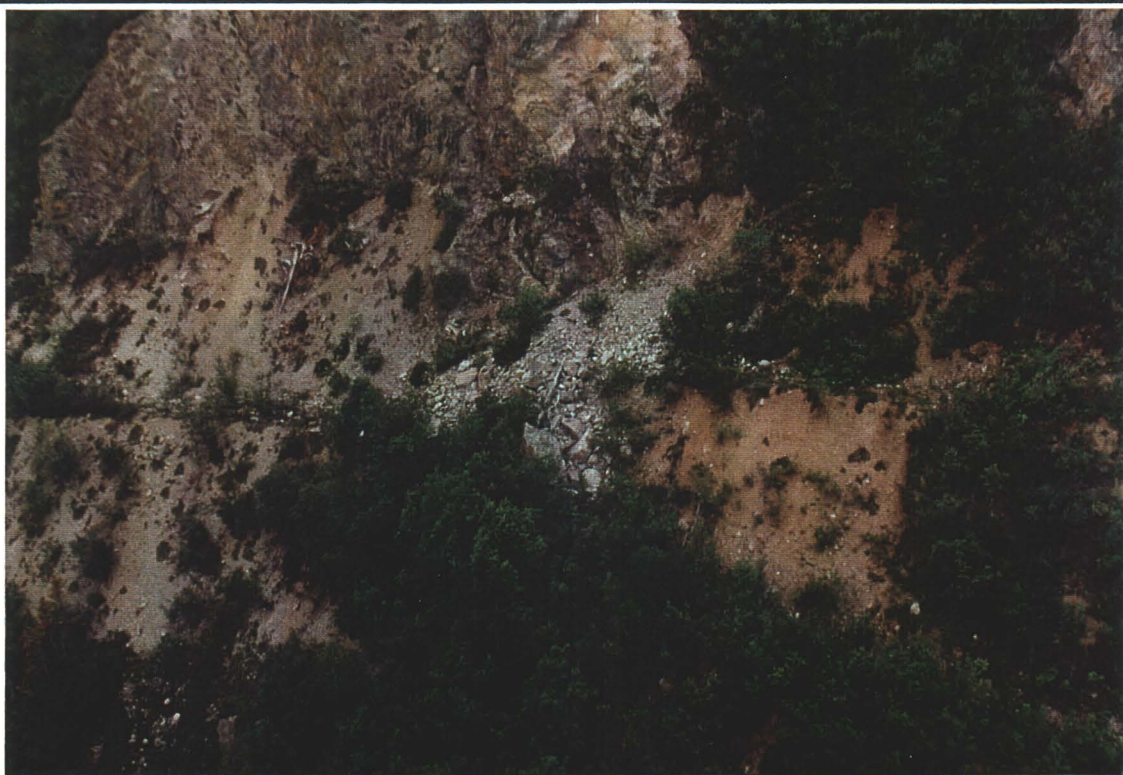
Relatively little waste rock was blasted to access barite at the test quarry. All waste rock fell below the quarry face and is now indistinguishable from natural talus.

Photo 4. Westward view of barite occurrence. Blast face visible at upper centre of photo; talus and waste rock seen at photo centre.
