**Yukon Abandoned Mine Assessment**  
**CORN (BONNET PLUME) MINE SITE**

Waste Management Program  
Indian and Northern Affairs Canada

Environmental Services  
Public Works and Government Services Canada

November 1998

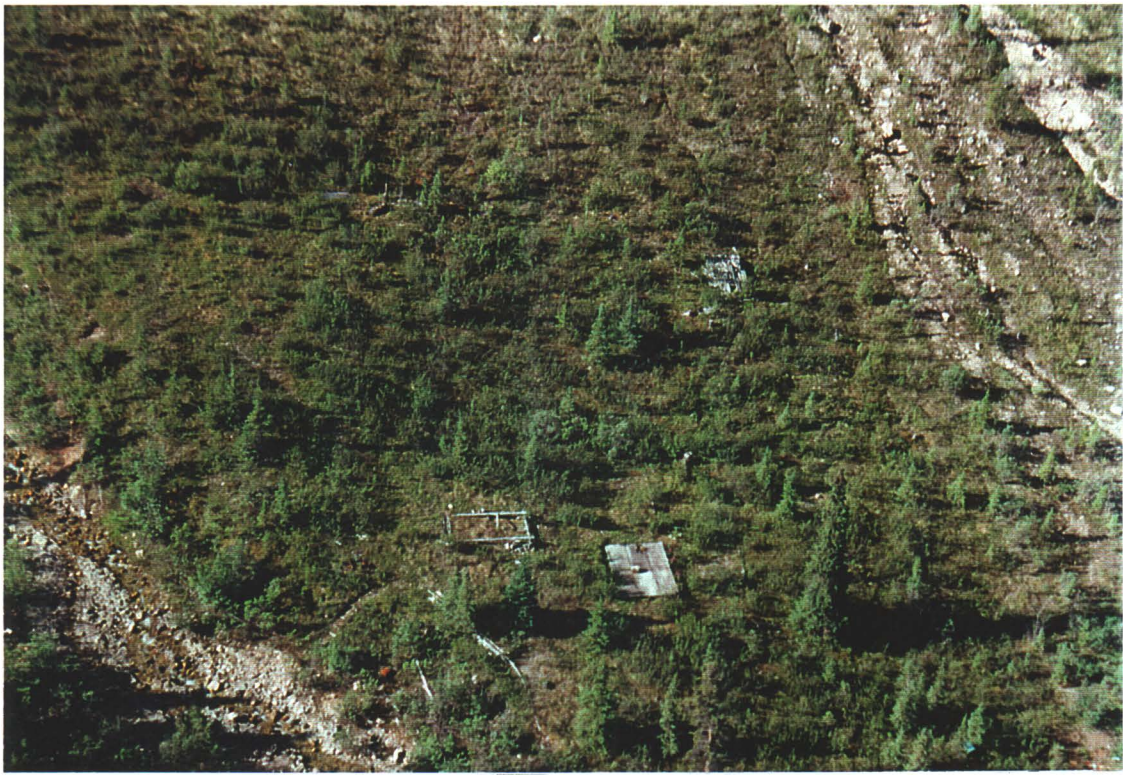
MN 1. Aerial view of former camp and core storage area (unnamed creek - "Spork Creek" - visible at lower left of photo).

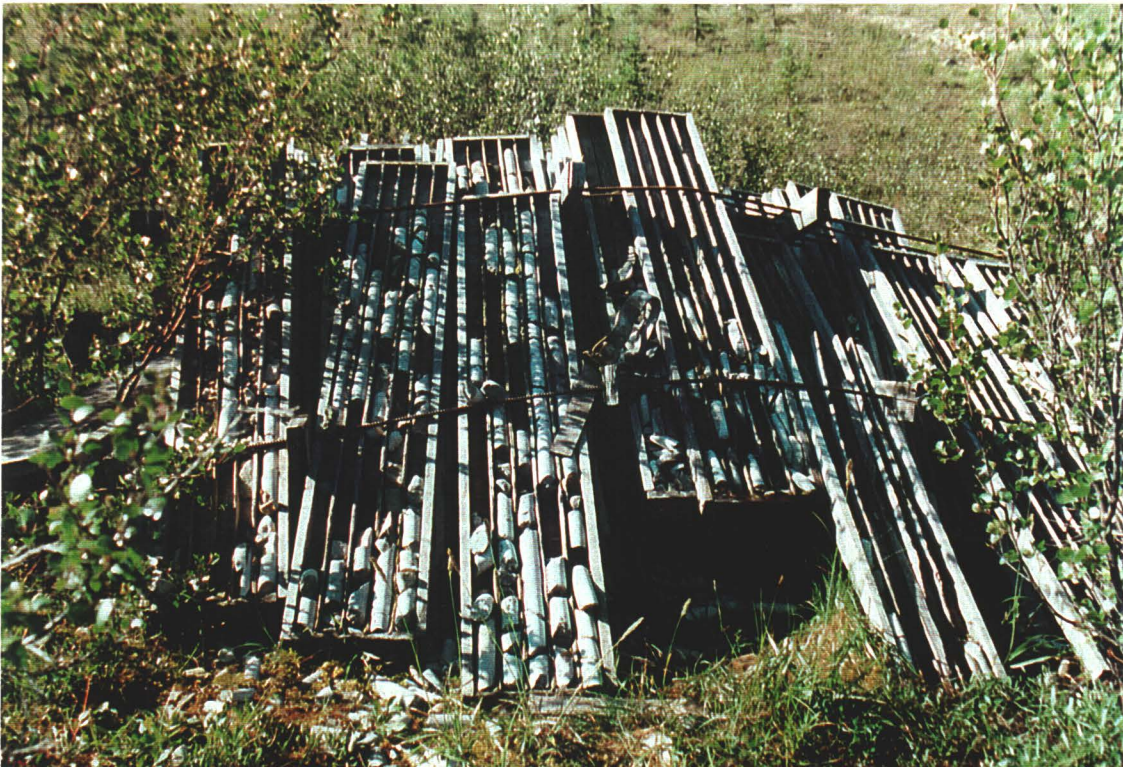
No buildings, infrastructure, or equipment were observed at the Corn site. Several core storage boxes are stacked near the unnamed creek and former camp area. The core box stack is unprotected and has tipped: most core samples have been disturbed (Photo MN 2). A partially-rotted wooden tent platform (Photo MN 4) was found at the former camp and core storage area.

MN 2. Core storage area.

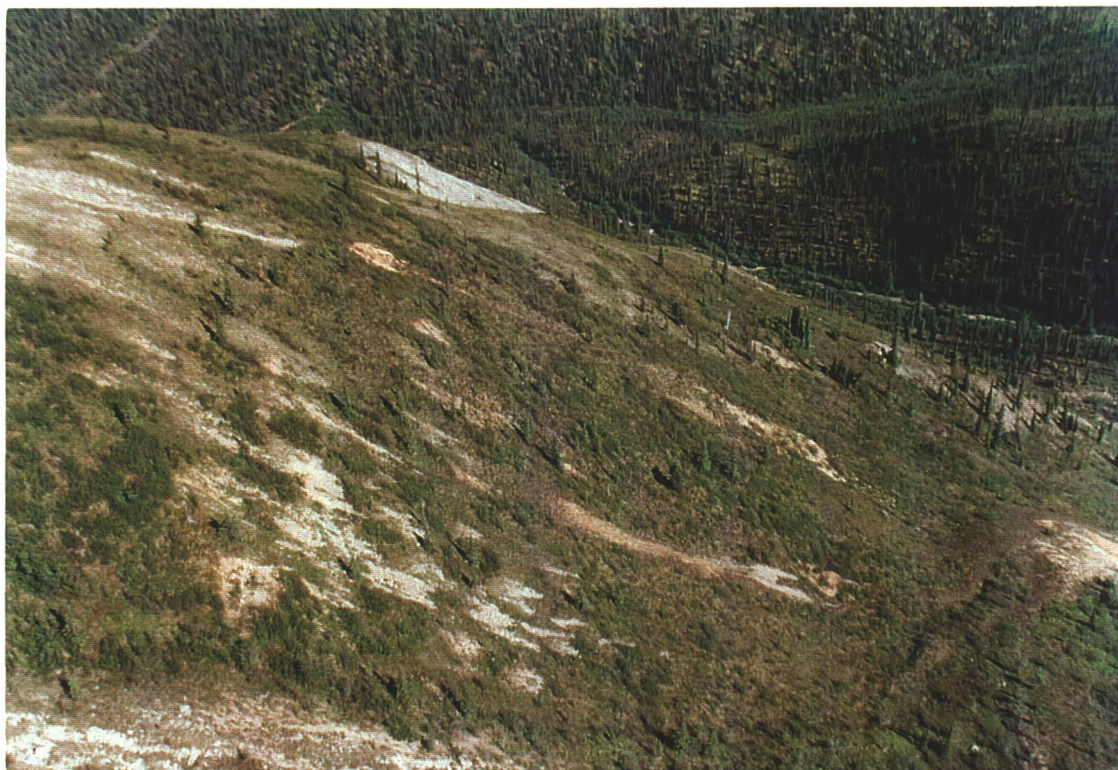
No adits or other mine-related excavations were present at the Corn site. Two former diamond drill platforms are located approximately 300 m southwest of the camp area (Photo MN 3).

Neither feature poses any risk to human health and safety.

Only a limited amount of "mining" related disturbance was found at the site. The drill pads were likely dug by hand, and were approximately 5 m by 3 metres in size, with a trivial amount of disturbance to the native soils (Photo MN3). Hand trenching was noted in the MINFILE, but not evident on the ground. Some sloughing was noted on the ridge west of the camp area, however this appears to be related to natural weathering processes.

MN 3. View to northwest, showing drill pad and natural weathering on ridge west of former camp.

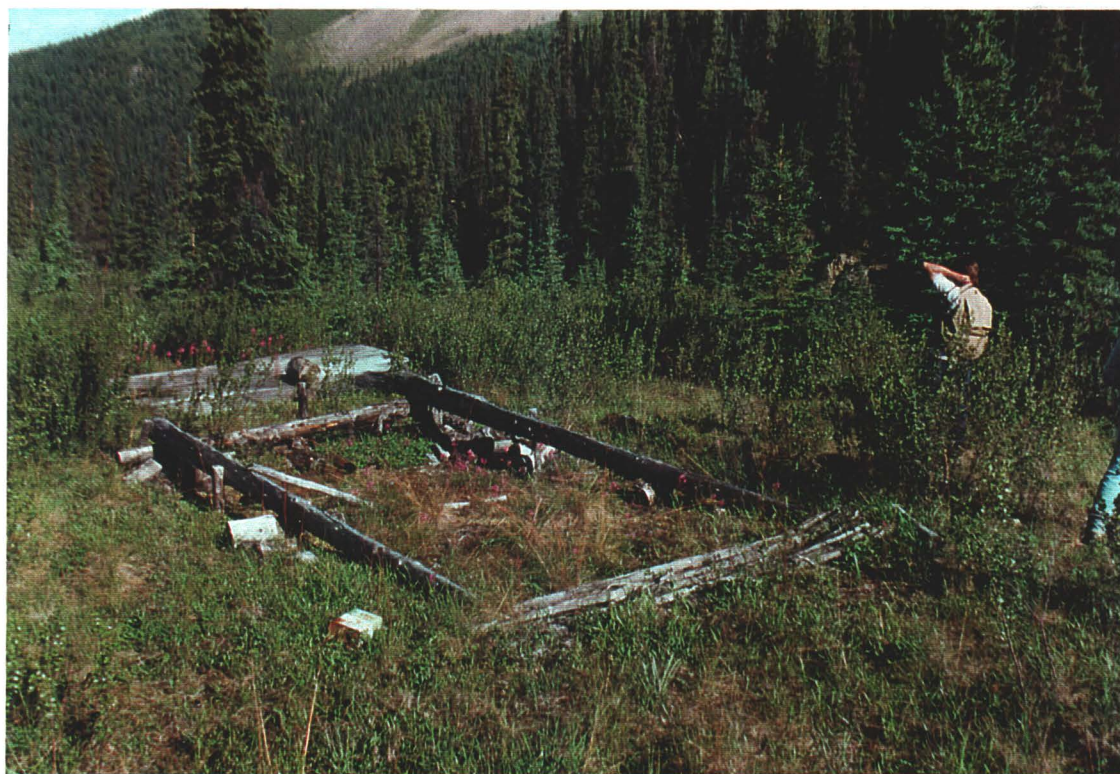
MN 4. Wooden remnants of tent platform at former camp area.

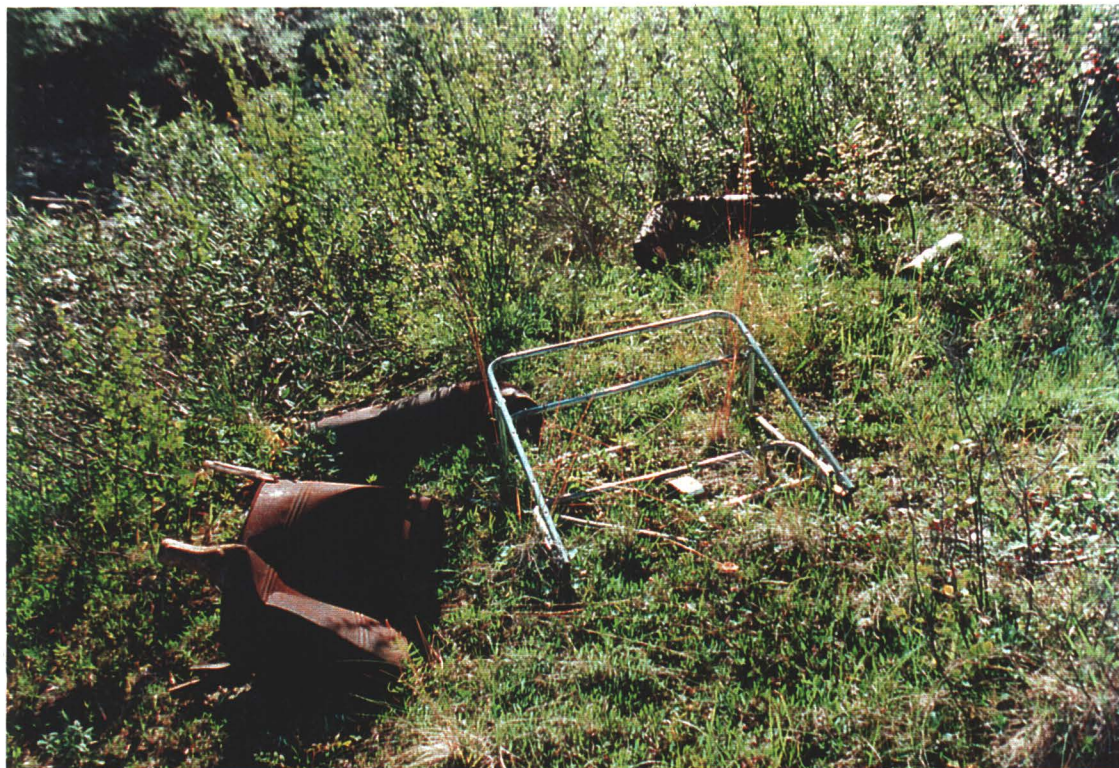
Non-hazardous wastes were limited to the remains of a camp stove and an aluminum frame (Photo MN 5, and several cans of tinned meat.

MN 5. Minor metal wastes south of former camp area.

No further assessment or cleanup work is required.

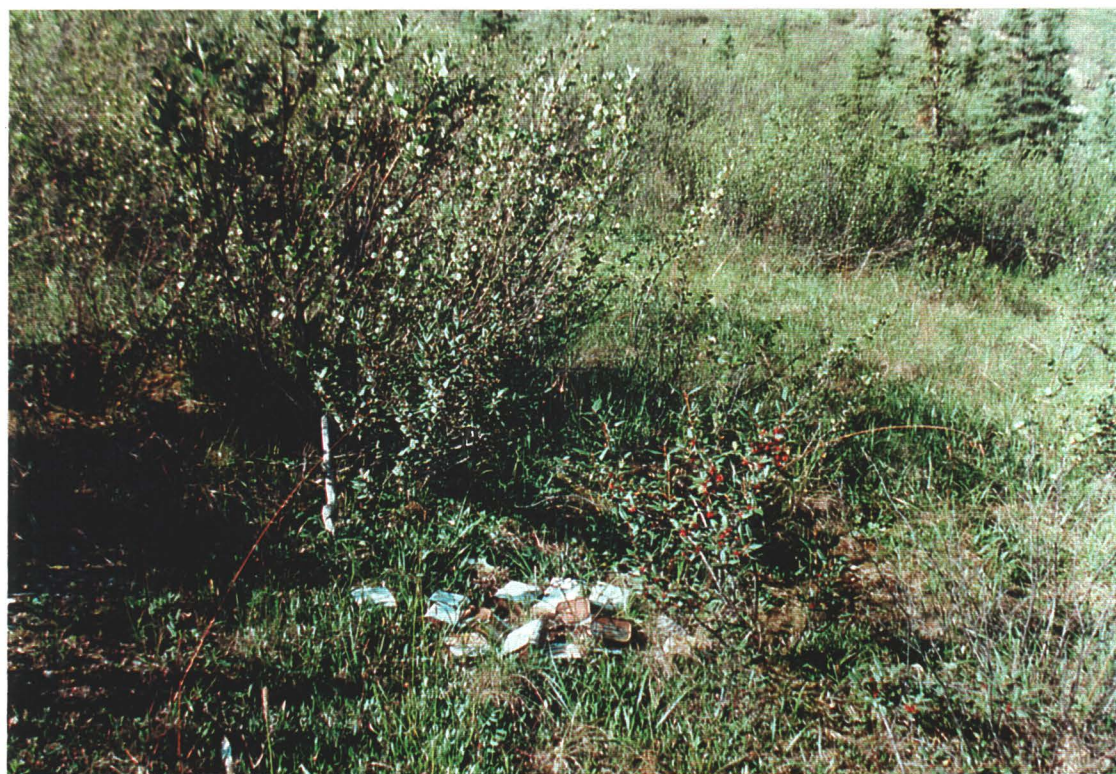
MN 6. Spork™ cans near unnamed creek (hence, "Spork Creek").
