**Phase III ENVIRONMENTAL ASSESSMENT**

**PESO MINE SITE**

**Interim Report**

Action on Waste Program  
Indian and Northern Affairs Canada

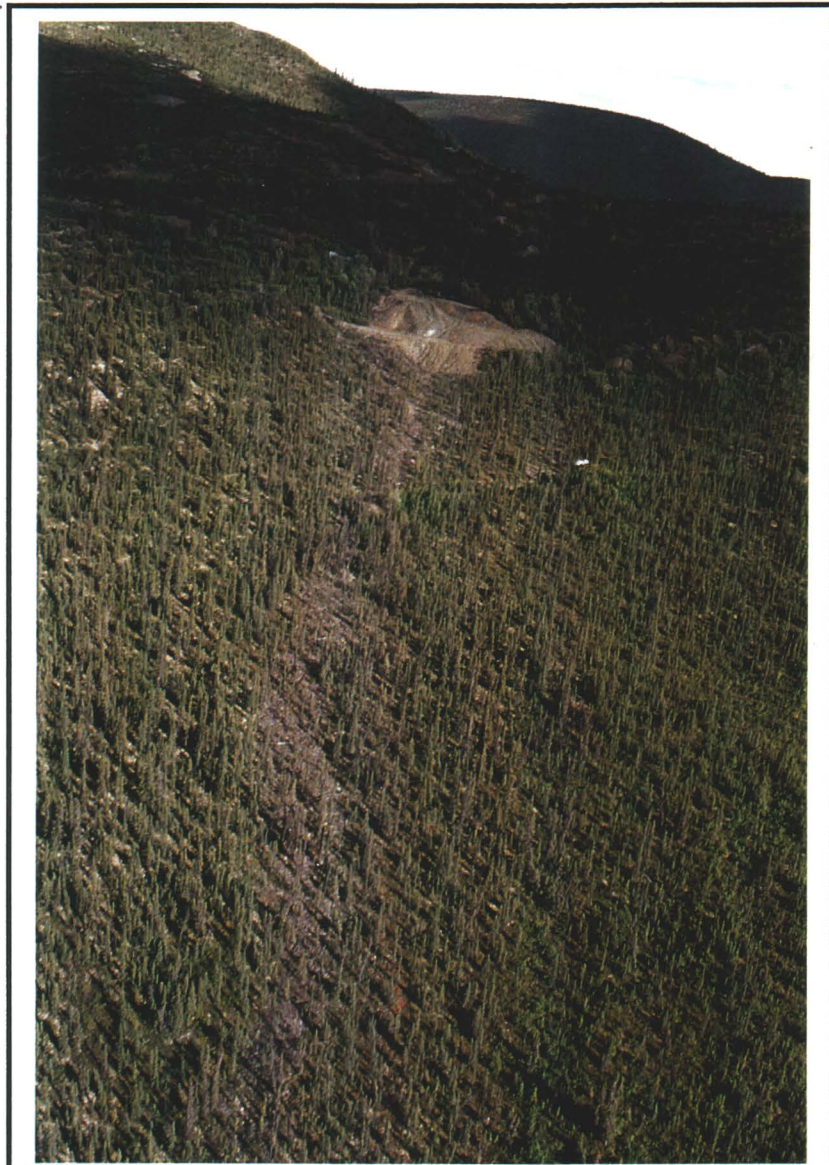
Photo 1. Peso mine waste rock dump. Note trail of distressed vegetation leading from waste rock.

***Recommendation 1.*** Prevent further leaching and transport of metals from waste rock by constructing a containment and isolation or migration control system. If a geomembrane cover with rock anchor is planned, conduct a geological assessment to identify a suitable source and volume of non-acid generating anchor rock.

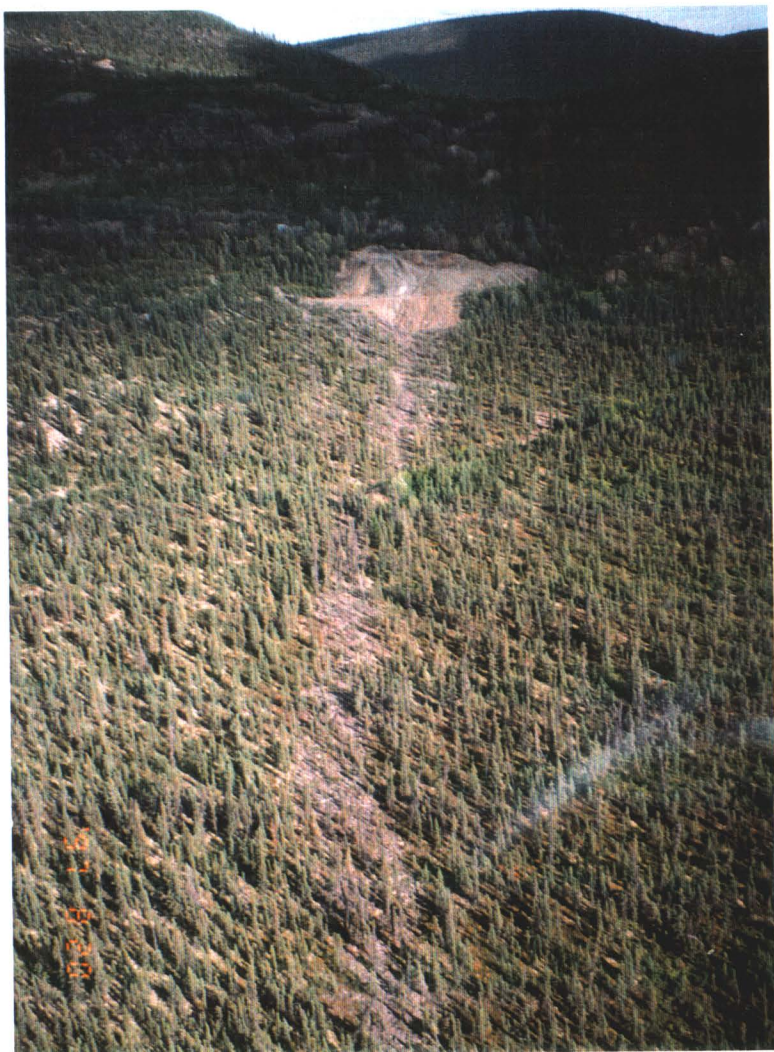
Photo #PE1: Looking east at waste rock pile near adit and stressed vegetation along slope. Note benched tailings.

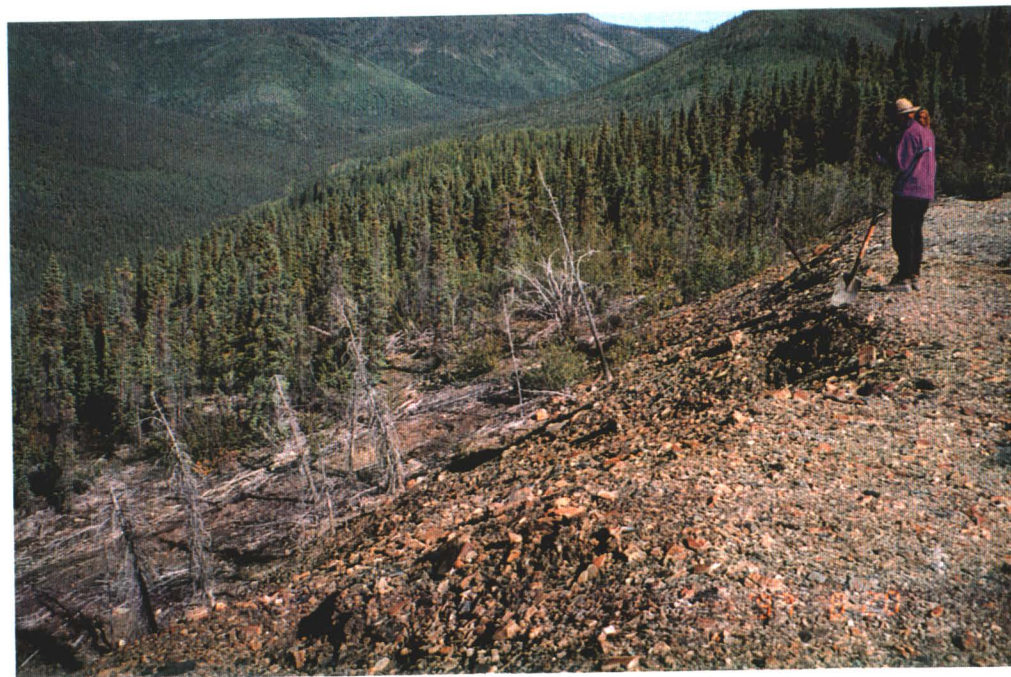
Photo #PE2: Looking north at top of lower bench slope . Note schistose rock, relatively fine grained. Note stressed vegetation.
