### **Phase III Environmental Assessment**

#### **Venus Abandoned Mine Site**

#### **Final Report**

Environmental Services  
Public Works and Government Services Canada  
Pacific & Western Regions

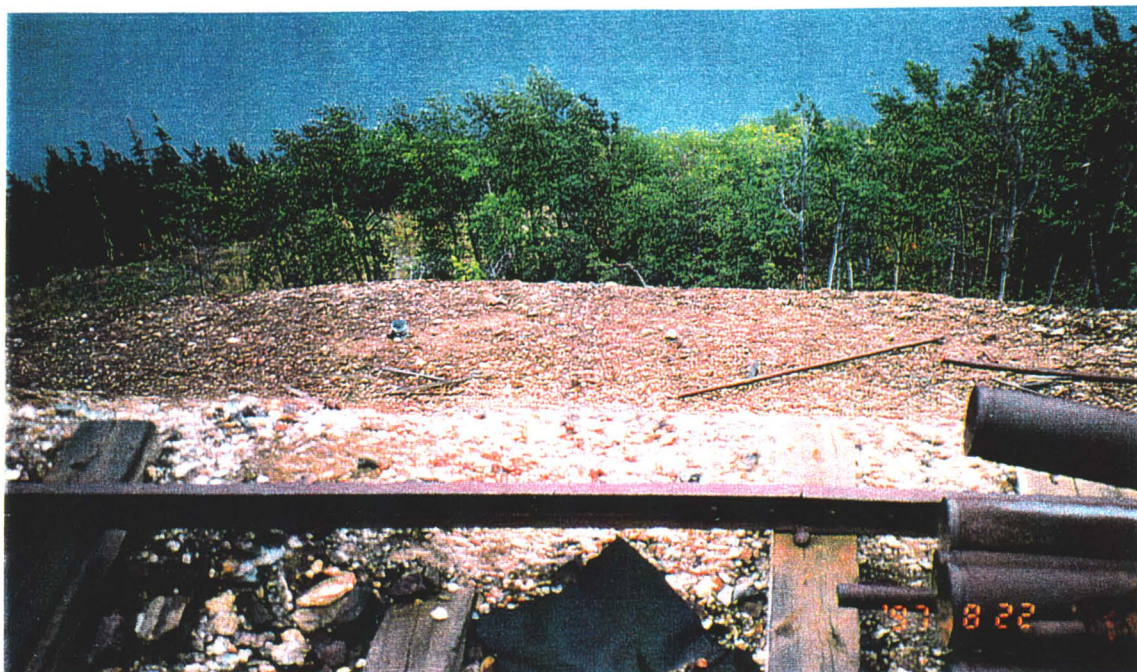
Photo #V1: Looking east down slope from adjacent to shack at north portion of area near adit 1. Note lower benches of waste rock and of access road. Note fallen pipes.

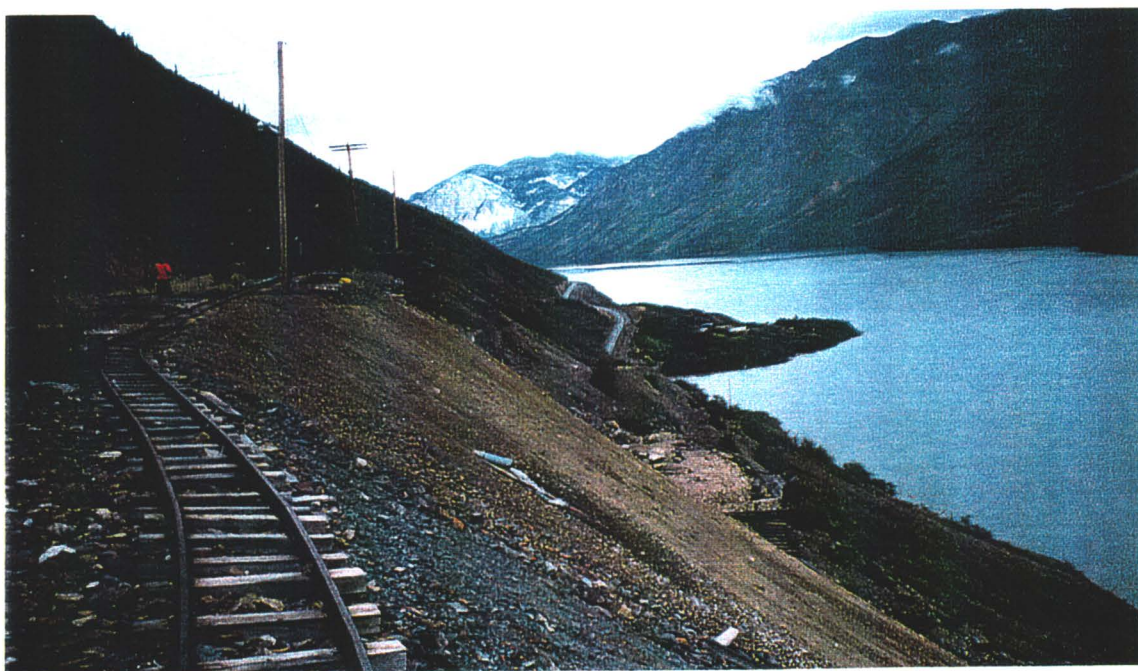
Photo #V2: Looking north along tracks at area of adit 2. Note culvert along waste rock pile slope; note lower retaining wall built of log cribbing.

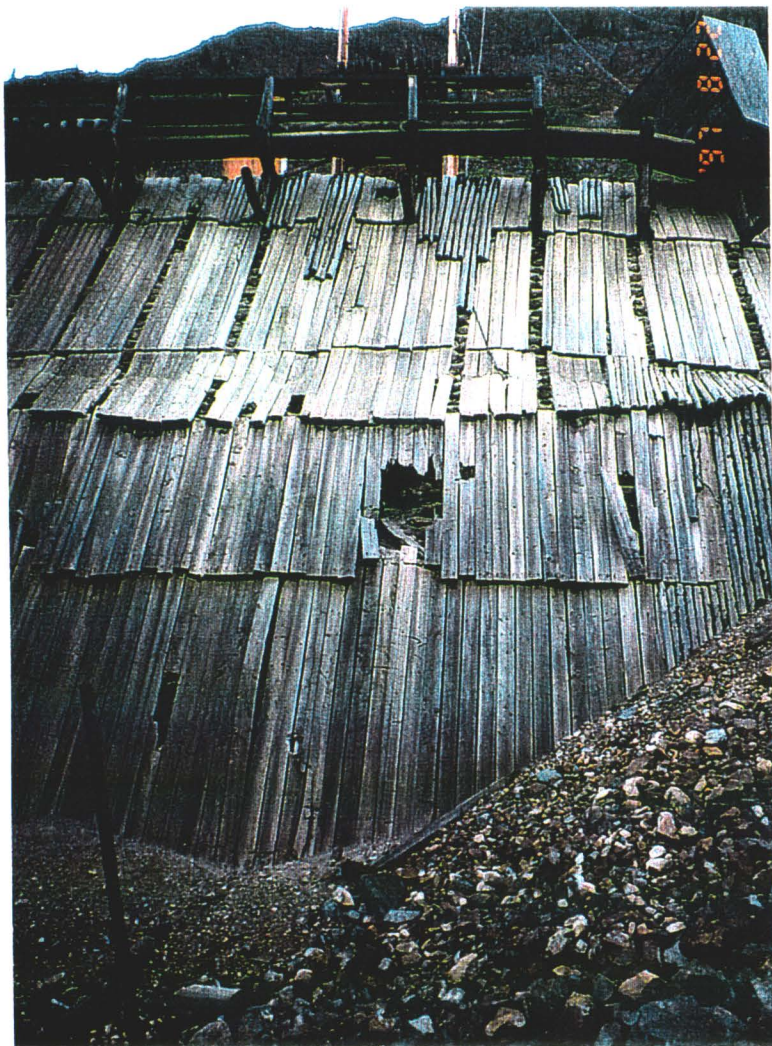
Photo #V3: Looking west at log cribbing retaining structure. Note log cribbing construction; note shack fallen over at top right;

The most significant feature in the area of Adit 2 was the presence of relatively unstable retaining walls along the waste rock slope. These are illustrated in plan drawing 12953-12 and profile 12953-13 as well as in photos #V3 and #V4. Of particular note were the two retaining walls built in series along the waste rock pile slope shown as section B-B on drawings 12953-12 and 12953-13. These have been constructed with log cribbing and have shown natural degradation over their 25 or more year existence. With respect to the lower wall, the log cribbing itself showed some natural decay and there were some failures noted at the joints along the edges. There was also extensive sloughing of the waste rock behind the wall and tension cracks parallel to the wall. As the integrity of the wall and waste rock mass is undermined by natural decay and slight movements, a sudden failure may eventually occur leading to a large mass of waste rock mobilizing downslope. This could occur if the joints along the cribbing continue to fail to the point where the waste rock begins to deform and the strength within the remaining cribbing support is insufficient to restrain the waste rock mass from

1. In regards to the two retaining walls located in the area of Adit 2, it is recommended to intentionally fail these structures to reduce the risk of a future impact on the South Klondike Highway. This could be accomplished by implementing option 1 which involves constructing a catchment area to restrain the fallen waste rock from extending to the highway during the demolition. The fallen waste rock would be moved from the catchment area in a stepwise fashion and hauled to a suitable disposal site within a close proximity to the Venus Mine Site. A second option to demolish these retaining walls would involve relocating the material behind the retaining wall to the bench area near adit 2. As requested, Class 'D' cost estimates to an accuracy of +/- 25% has been prepared and is enclosed under separate cover.

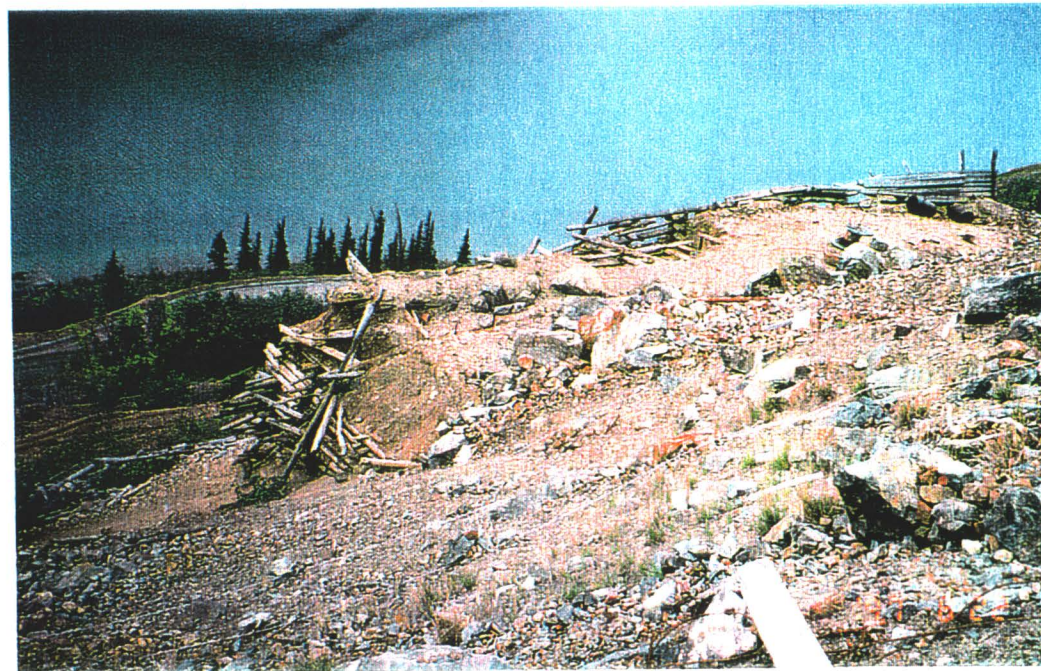
Photo #V4: Looking south east at lower retaining wall. Note sloughing of waste rock material; note poor condition of log cribbing supports.
