Environmental Assessment, Western Coppermine/Williams Creek, Yukon Region – Final Report

March, 2000

(Call Up No. 98-6195-03)

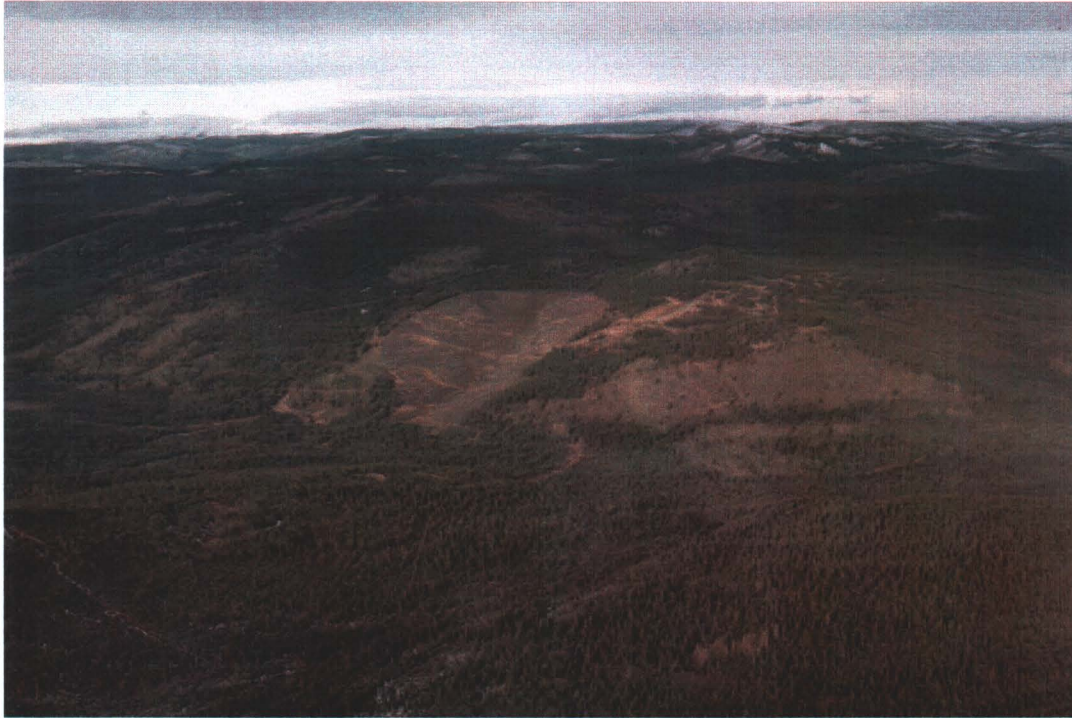
Photograph 1: Aerial overview of the Western Coppermine/Williams Creek site with main ore body shown right centre and cleared heap leach area in left centre

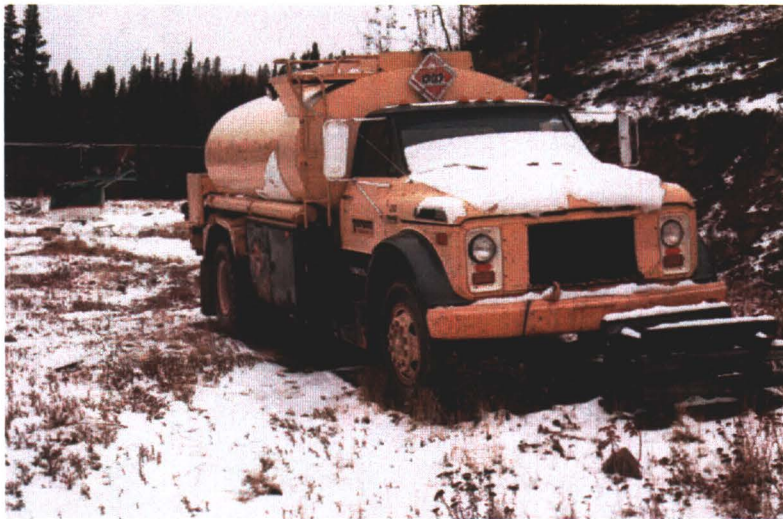
Photograph 2: Abandoned fuel truck near exploration camp

- There is no potential for spills and leaks from main tanks, oil drums and truck fuel tank of the fuel truck near the base camp as all were empty. There is a small risk of oil leaks from the crankcase, transmission and rearend; however, nothing was evident at the time of inspection.

1. Removal of the fuel truck;
2. The deepest exploration trenches and pits on the ore bodies should be re-contoured with the excavated debris;
3. The test wells from the proposed heap leach sites, and any others that may still be present at other locations, should be removed;
4. The geotechnical investigation trenches on the heap leach site should be re-contoured to minimize infiltration and reduce permafrost thawing and revegetation should be undertaken to enhance slope stability;
5. Exposed metal debris, including empty drums, well pipe, and reinforcing rods should be removed from the site and recycled or disposed of at an approved facility;
6. Cores and samples should be landfilled;
7. Combustible materials should be burned on site (e.g. core boxes, tent frame) and the ashes landfilled; and
8. The landfill should be contoured and leveled with native soils and revegetated.

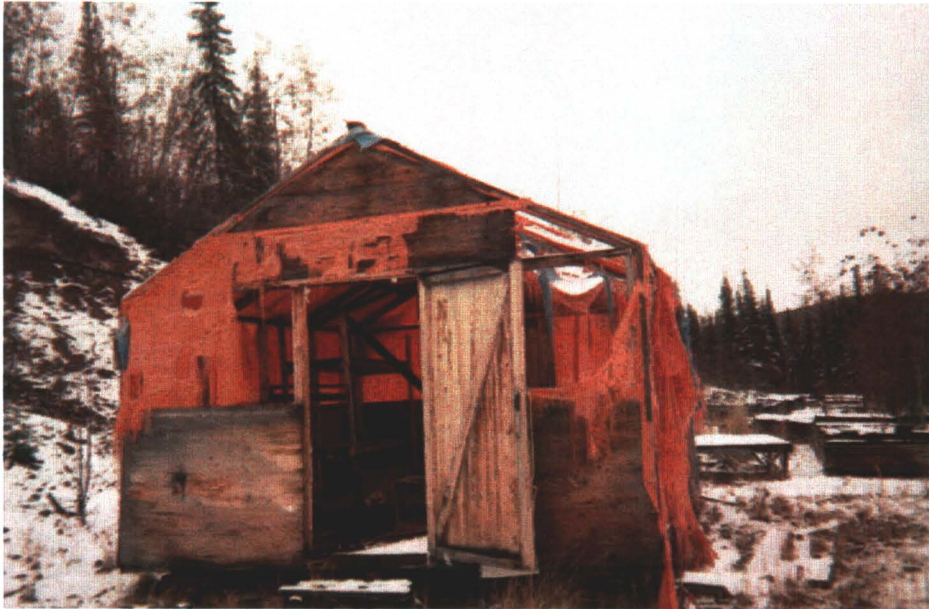
*Photograph 4:
Plywood tent frame
at exploration camp*

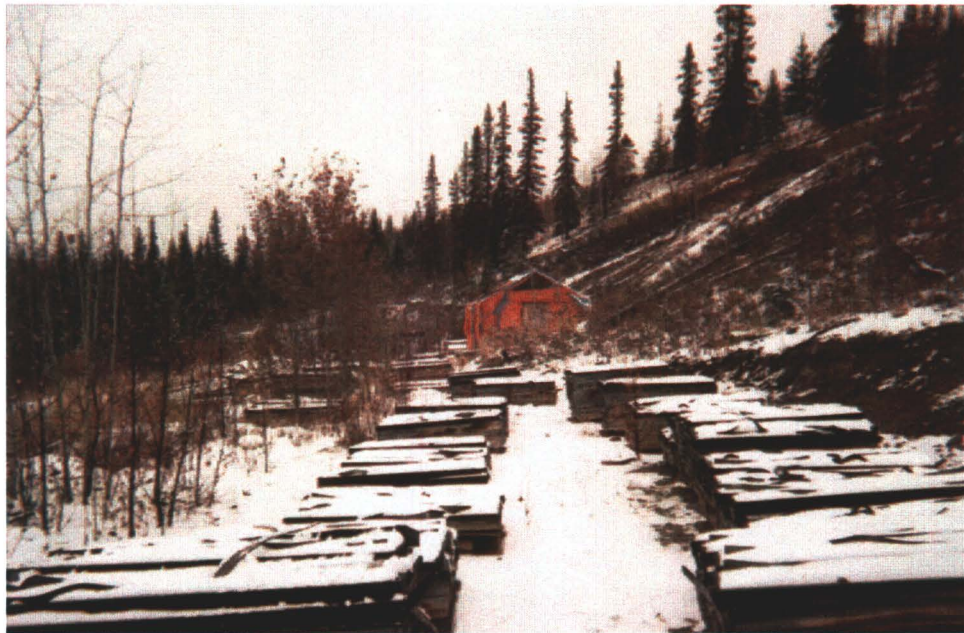
The only other structures present at the site, were the core and sample stocks illustrated in Photograph 5. These remain relatively neat at this time but the core boxes will continue to deteriorate until the piles collapse.

*Photograph 5:
Core and sample
box storage area
along road way in
vicinity of
exploration camp*

The other concern at the site is the hazard risk to people and wildlife in the sample storage area due to metal debris and falling storage piles. This will become a greater hazard as the core boxes and piles continue to deteriorate.

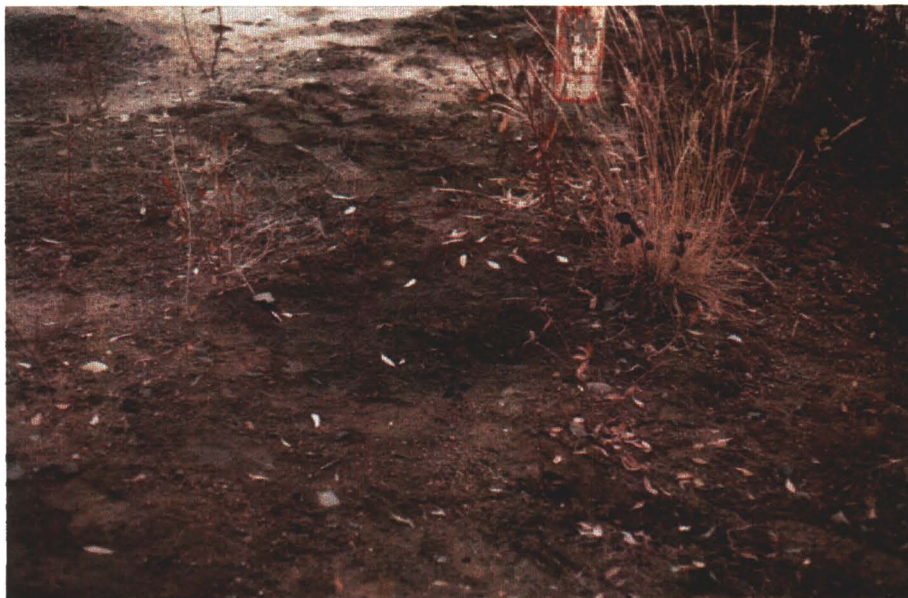
The initial visit did not identify any stained soils and thus no soil sampling was undertaken at that time. This was largely a result of the blanket of snow on the soil. However, by the time of the site visit on October 5, 1999, a great deal of the snow had melted permitting the identification of several stained soil areas. One was sampled near a piezometer at the base of the heap leach site (WC-HL-1) (see Photograph 6). This appeared to be the result of the leaking or spilling of oil from the drill rig. Other well sites were inspected but this was the only one with significant stained soil present. The staining covered an area of approximately 1 m by 3 m to an undetermined depth.

Photograph 6: Stained soil adjacent to well near base of the proposed heap leach site

- Very minor soil staining at one of the test well sites likely resulting from leaks or spills from the drill equipment. While similar staining may exist at other wells, it was not identified due to snow cover at the time of inspection. Soils tests indicate non-detectable concentrations of hydrocarbons and BTEX compounds, indicating that the spill is either very limited, has weathered to the point that the concentrations are now very low, or is not a typical hydrocarbon.

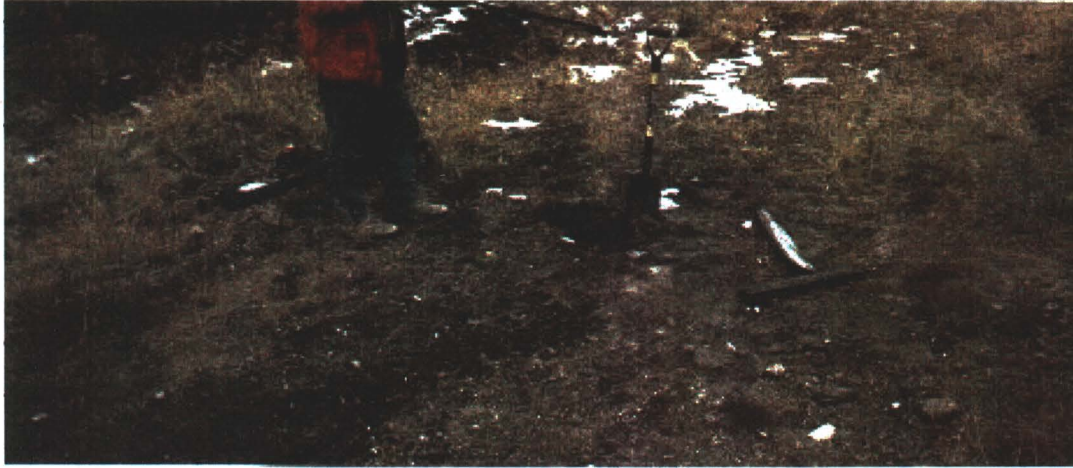
A second stained soil sample was collected in front of the log cabin near the road way on the west side of the camp. This also covered an area of approximately 1 m by 3 m to a depth of approximately 20 cm (Photograph 7). Stained soil was not observed in the vicinity of the fuel truck, the only vehicle left at the site.

Photograph 7: Stained soil in front of the log cabin tent frame (see Photograph 3) near the exploration camp

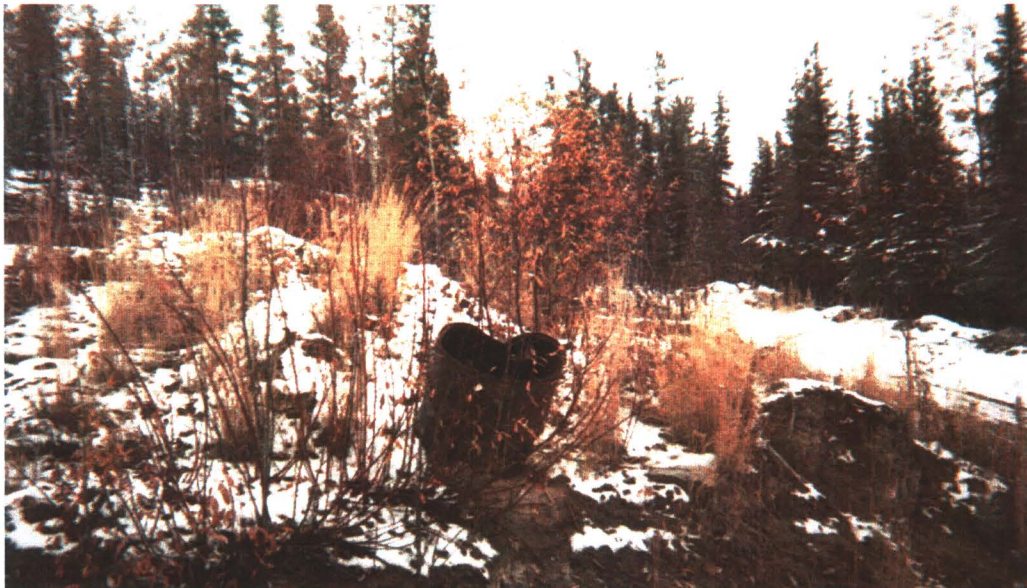
Photograph 8: Partially covered landfill site in the vicinity of the exploration camp

- There is an unknown and undefined quantity of mixed debris in the small landfill located adjacent to the camp. Surficial debris consisted of empty drums, tires, machine parts and miscellaneous camp items. There was no evidence of soil staining suggesting waste oil had been disposed of, and thus no soil samples were collected.

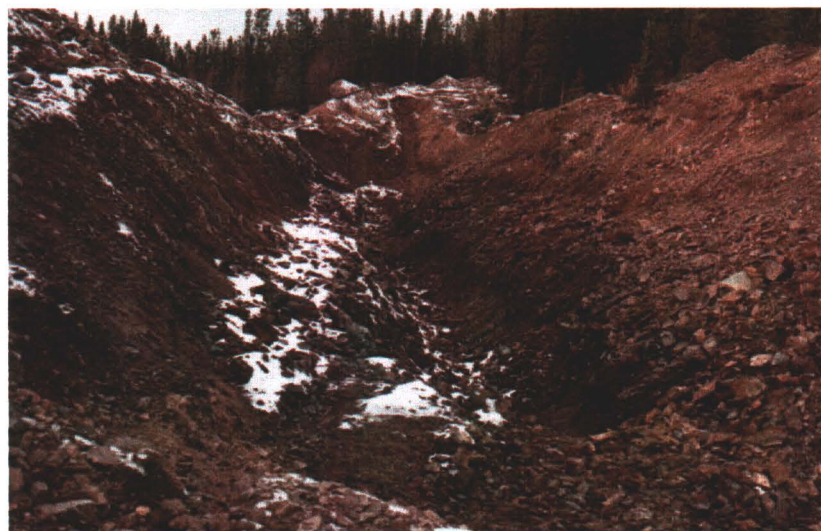
Mineral and geotechnical exploration activities at the site are extensive, and have severely altered the landscape of the site. Exploration trenches, and cat tracks radiate from the primary mineral site for more than a kilometre in some cases. The primary mineral site (see Figure 2) has been extensively disturbed and a majority of the native vegetation has been removed as shown in Photograph 12. In some cases the trenches are several metres deep as illustrated in Photograph 13. The native surficial material in the vicinity of the ore deposit is shallow gravelly till over the fractured bedrock containing the ore.

Photograph 12: Area of main ore body showing deforestation and extensive trenching which could result in increased erosion

The extensive trenching throughout the site is a definite aesthetic concern and may pose some risk to wildlife and humans. Some of the trenches are several metres deep with vertical sides in the bedrock and excavated debris piled along both sides of the trench creating a falling debris hazard as well as a physical danger.

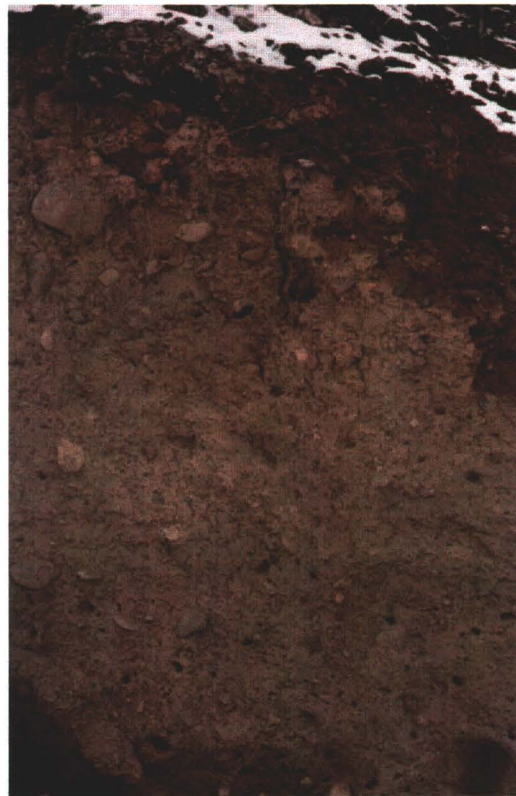
Photograph 15: Poorly sorted till material comprising the surficial sediments in a geotechnical test pit on the proposed heap leach site
