GALKENO 900
SITE #12
MINFILE # 105M001m

| Drawing title: Galkeno 900 Site #12 Site Assessment Yukon Territory | | Titre du dessin: _____ revisions: _____ |

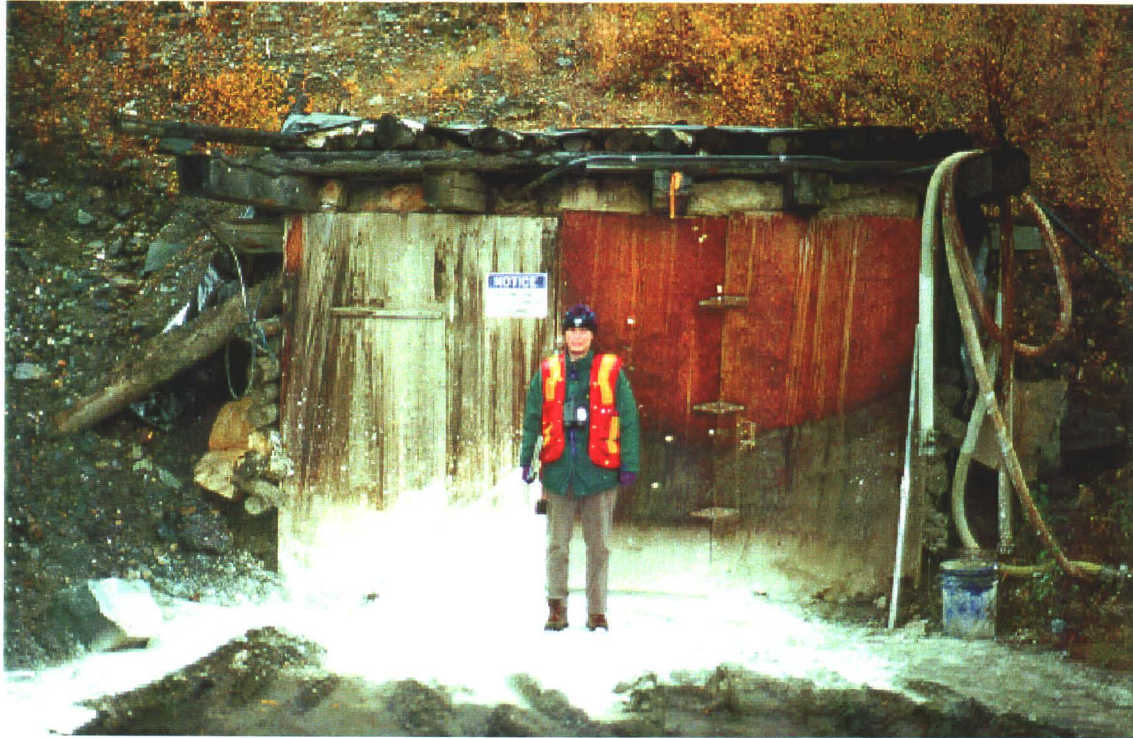
Galkeno 900 Adit (photo 12-1)

Location: Constructed into the base of the east side of Galena Hill, 200m west of Christal Lake.

Dimensions (L x W x H): 1,910m x 4.5m x 4.0m

Supports: A timber frame supports the portal.

Condition: The portal framing is in fair condition and appears stable.

Accessibility: The portal has wooden doors that are kept unlocked. It is possible to enter the adit beyond the treatment facility; however, the accessible length of the adit was not explored.

Photo 12-1: Galkeno 900 portal with spilt lime out front, the water treatment facility is located within the adit. (Azimuth 270°)

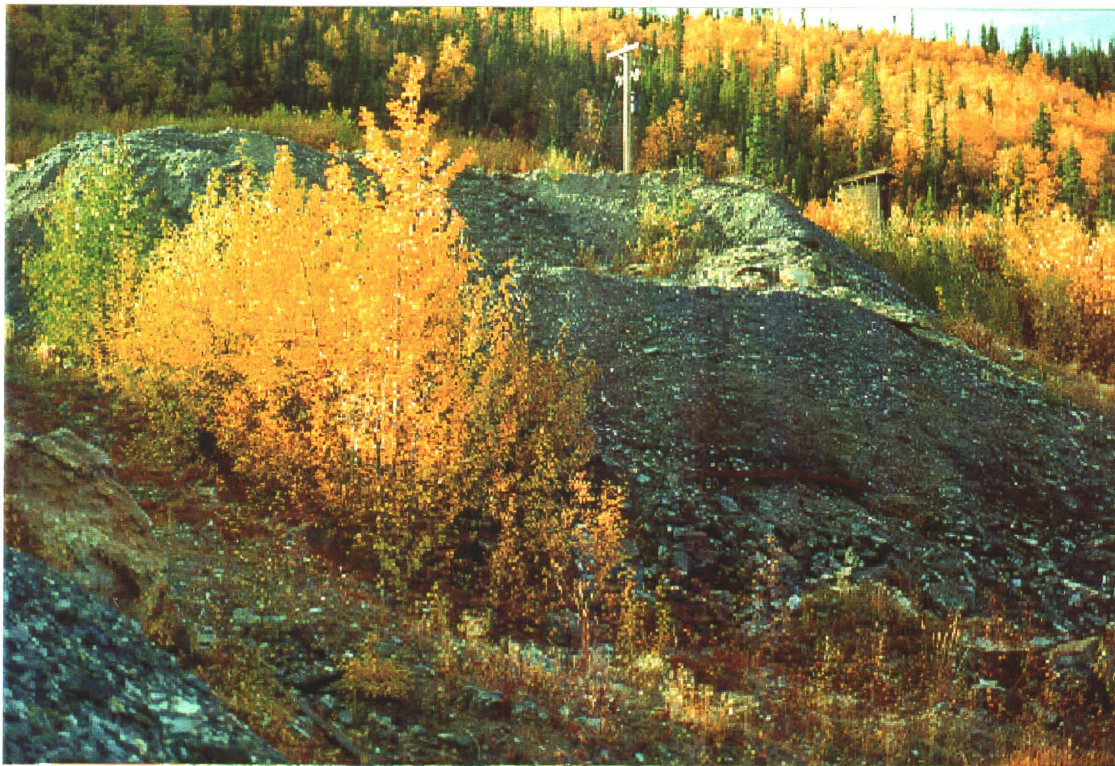
Waste Rock Pile #1 (photo 12-2)

The top of the rock pile has been levelled and forms a clearing along the road. The western edge of the pile slopes at a 30° angle down to the constructed trial wetland below.

Location: The waste rock pile begins 50m east of Galkeno 900 portal and ends at the western edge of the constructed trial wetland.

Dimensions (L x W x H): 20m x 28m x 4m

Stability: There is no evidence of the waste rock pile slumping. The waste rock pile appears stable.

Photo 12-2: Waste rock pile #1 with the outhouse in the background. (Azimuth 330°)

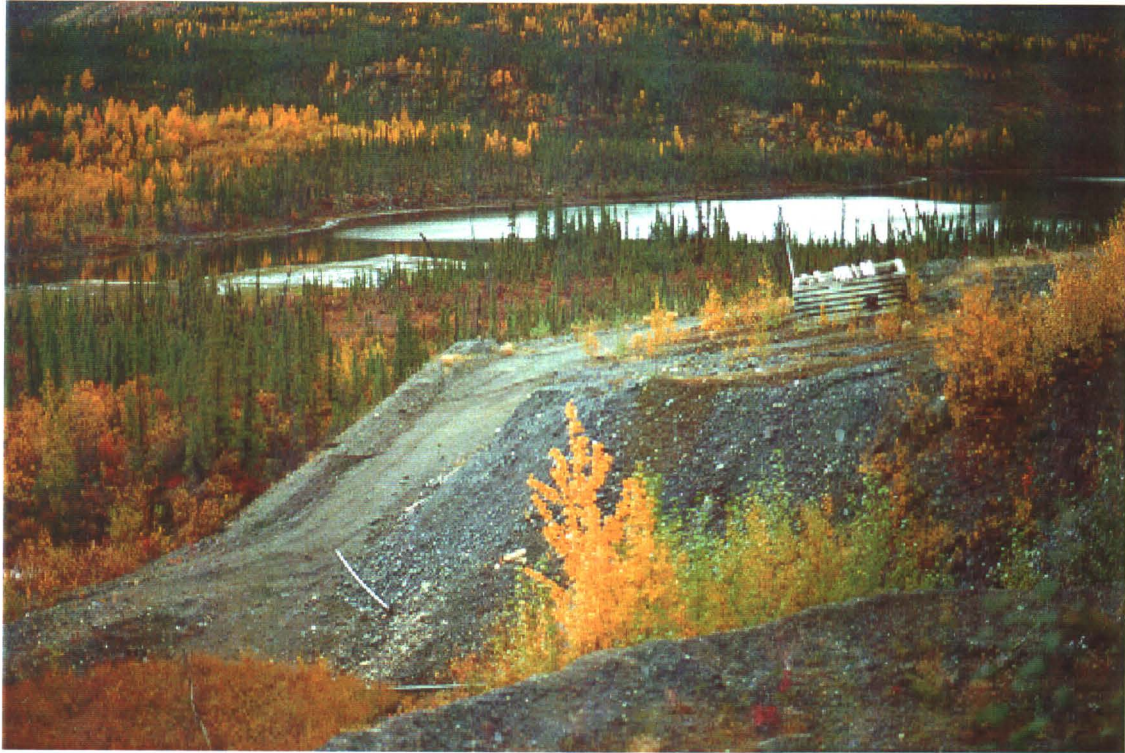
Waste Rock Pile #2 (photo 12-3)

This waste rock pile has been levelled and a log frame structure has been built upon it.

Location: Just south of waste rock pile #1 and the constructed trial wetland.

Dimensions (L x W x H): 30m x 25m x 2m

Stability: The edges of the waste rock pile are gently sloped and there is no evidence of slumping.

Photo 12-3: Waste rock pile #2, Christal Lake and building 12B in background. (Azimuth 135°)

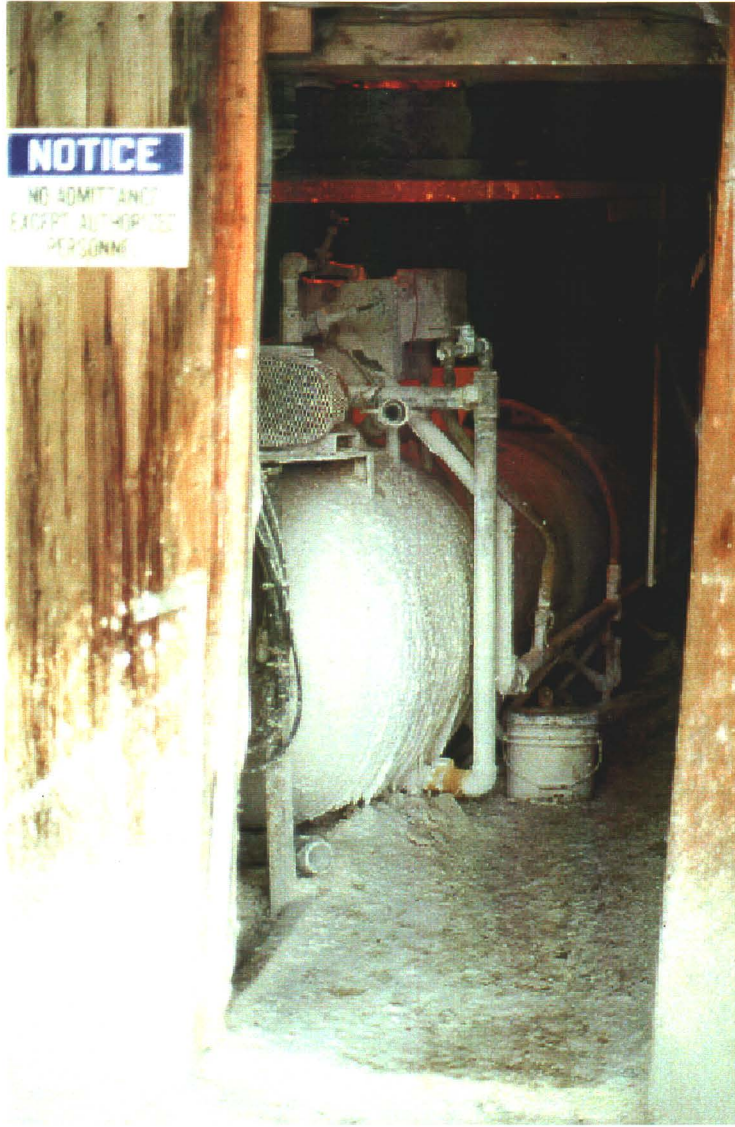
Wastewater treatment facility (photo 12-4)

Type: Lime treatment plant

Dimensions (L x Diameter): 10m x 1m

Location: Within the portal to the Galkeno 900 adit.

Drainage: According to site personnel, at the time of the site visit the treatment facility was treating approximately 4.5 L/s. United Keno Hill Mines Limited (1996) states that the drainage of mine water from the Hector-Calumet underground workings discharge flows to Galkeno 900 this site via the upper Galkeno workings and the McLeod vein fault.

Photo 12-4: Water treatment facility within the portal. (Azimuth 270°)

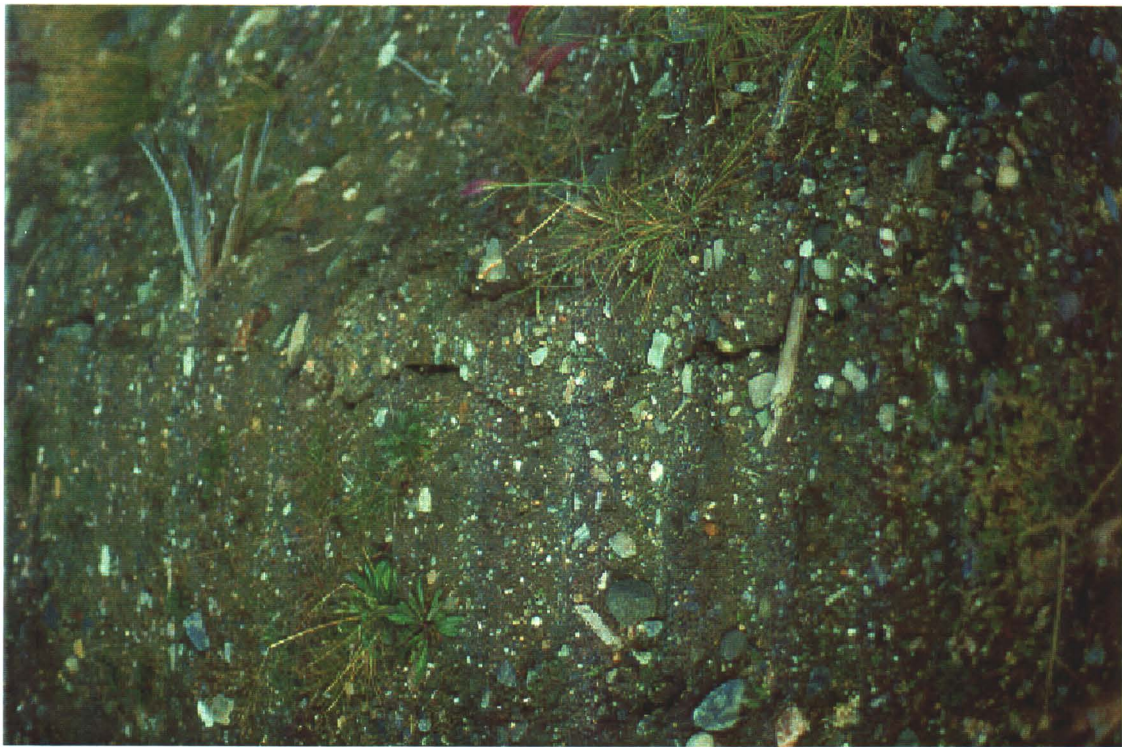
Stability: The eastern retaining wall has been recently resloped to increase stability. However, tension cracks in the eastern retaining wall were observed (photo 12-6). One crack (about 5 m in length) was oriented across the slope approximately 3m downslope from the settling ponds. Other cracks were seen along the edge of settling pond #2 and along the eastern edge of the resloped material. These cracks appear to be associated with the collapse of the soil adjacent to where the creek gully has formed. Tension cracks indicate the eastern retaining wall may be slumping.

Photo 12-6: Tension cracks in the settling pond retaining wall. (Azimuth 000°)

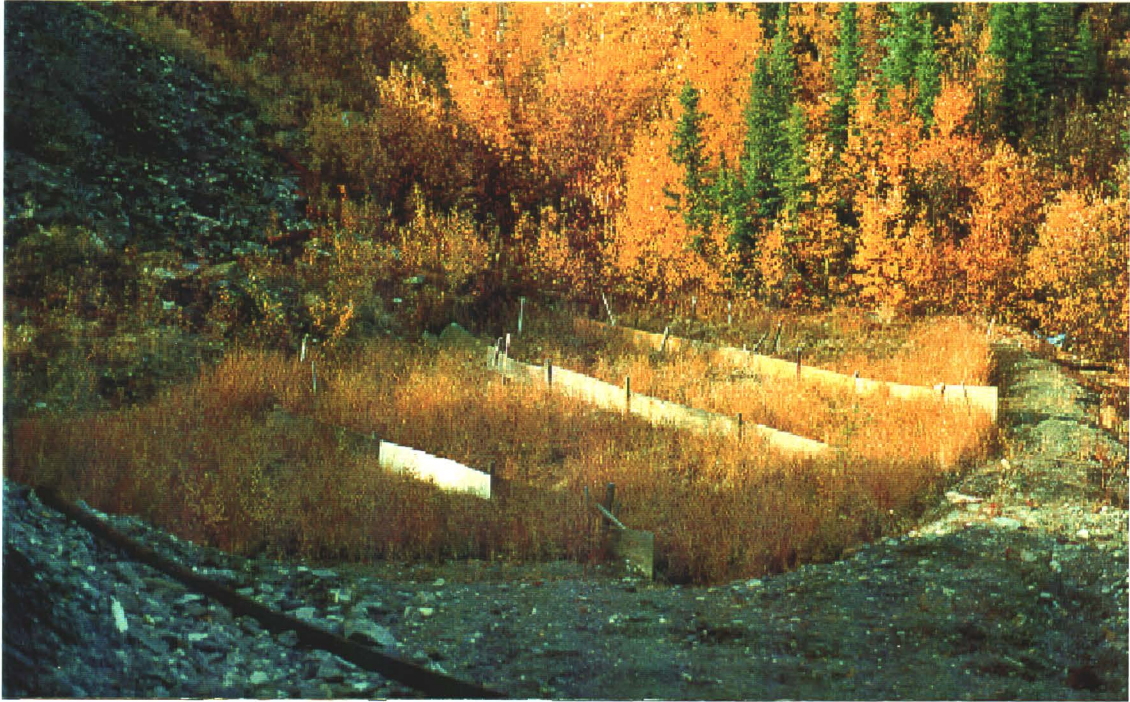
Constructed Trial Wetland (photo 12-7)

In the summer of 1995, a trial wetland was constructed to investigate the ability of the wetland to treat mine water. Sods of the sedge *Carex aquatilis* were transplanted from the reservoir that provides drinking water to Elsa and planted in an excavated plot. The wetland has one source of water input and one point of discharge. It has three plywood baffles across its width to help control the flow of water. It was designed to treat approximately 0.3L/s of the total discharge from the adit (Bill Dunn, interviewee).

Dimensions (L x W x Depth): 18.5m x 9m x 0.5m

Location: Located at the eastern side of waste rock pile #1, 75m east of the adit entrance.

Photo 12-7: Constructed wetland plot with wooden baffles. (Azimuth 345°)

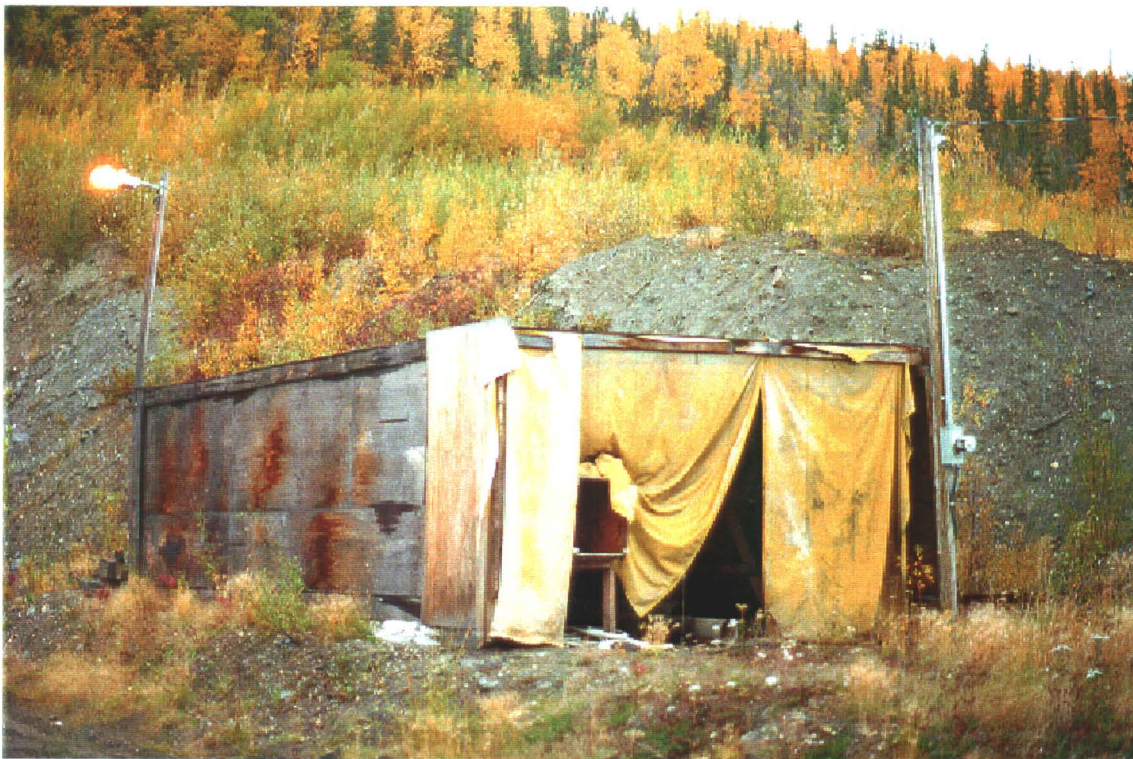
Building 12A: Storage Building (photos 12-8)

Dimensions (L x W x H): 8m x 4m x 3m

Construction: wood frame, wood siding, and wood roof; entrance is covered by a tarp

Stability: The building appears to be stable.

Contents: 4 steel pipes (8m x 6cm), 1 steel pipe (8m x 10cm), 1 galvanised/corrugated pipe (8m x 20cm), small amount of PVC piping, electrical centre for lights, pumps etc.

Hazardous products: 1m² oil stain in the dirt

Photo 12-8: Building 12A - a storage building currently in use. (Azimuth 320°)

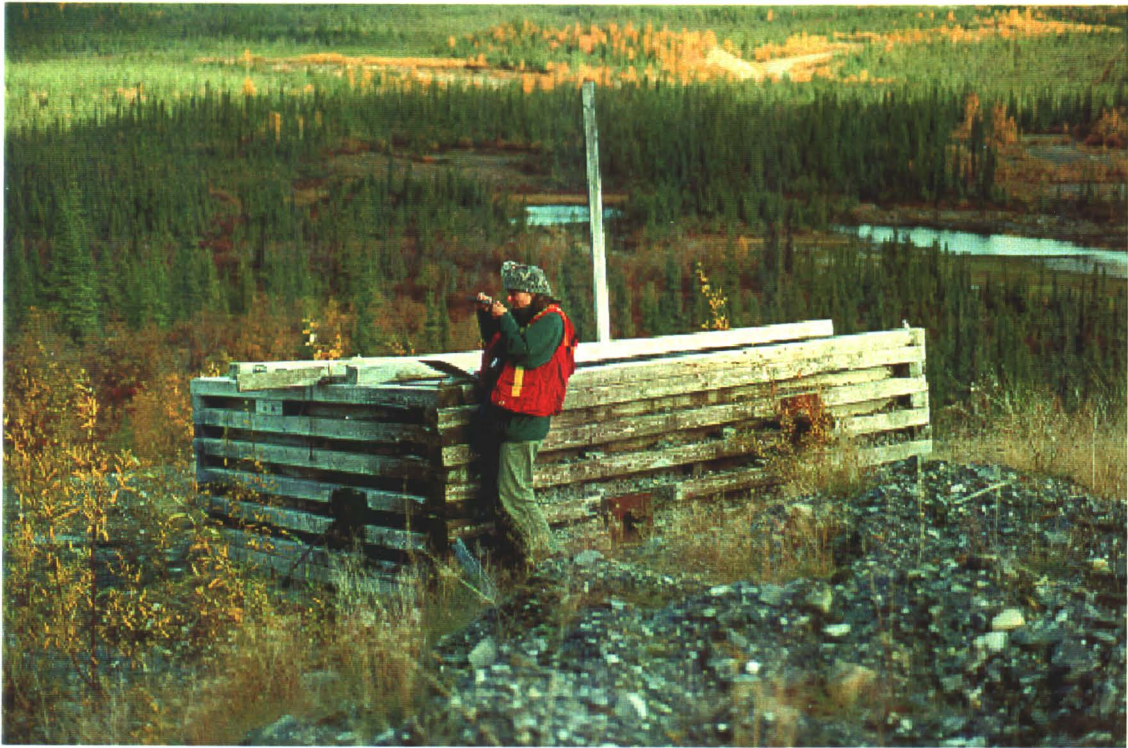
Building 12B: Log cabin frame (photo 12-9)

Dimensions (L x W x H): 5m x 5m x 1m

Construction: log frame – has only been partially completed, no roof

Stability: The logs are in good repair and the log frame appears stable.

Contents: filled part way with dirt

Photo 12-9: Building 12B - log frame structure with Christal Lake in background. (Azimuth 045°)

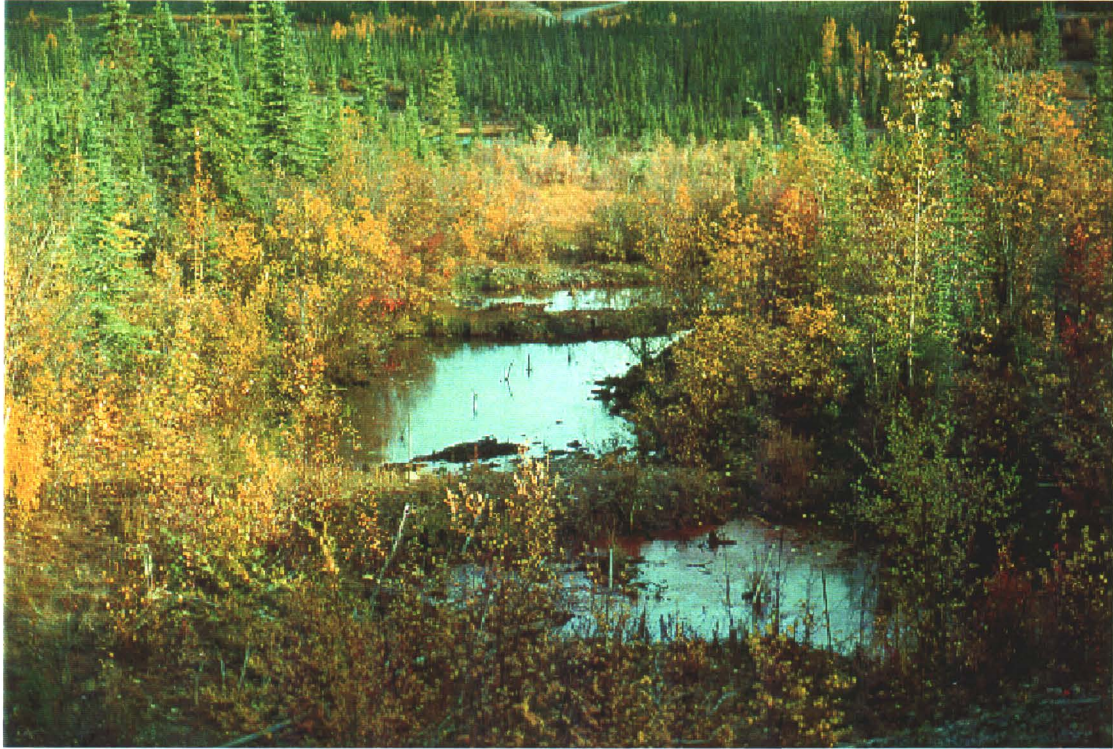
Photo 12-11: 3 small ponds, most likely old settling ponds.(Azimuth 070°)

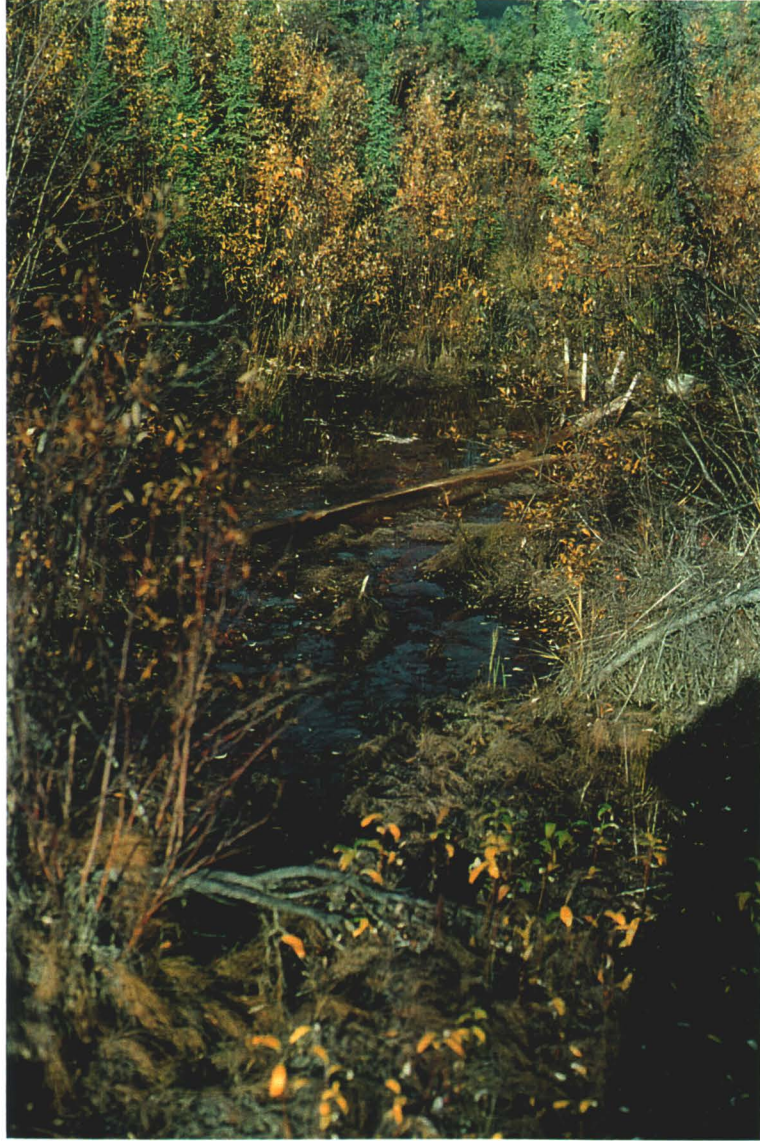
Photo 12-13: Natural wetland located just east of the trial wetland.
(Azimuth 075°)
