DUNCAN CREEK

Site No. 17

MINEFILE: 105M 001s

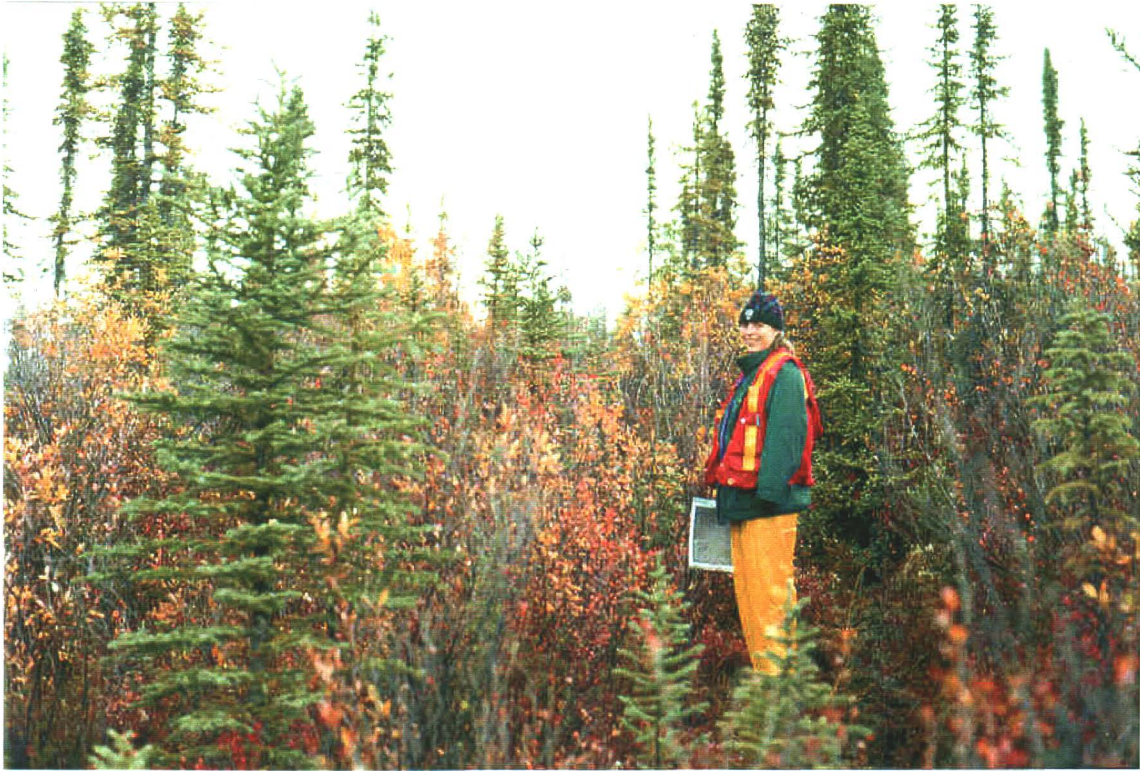
The site has almost fully revegetated naturally. All trenches are well overgrown with a thick carpet of moss, and willows (1-2m high), and small evergreens up to 2 meters tall (Photos 17-1).

Photo 17-1: View of overgrown trench at the Duncan Creek site, looking northward.
