CROESUS NUMBER #1

SITE #24

MINFILE#105M001ab

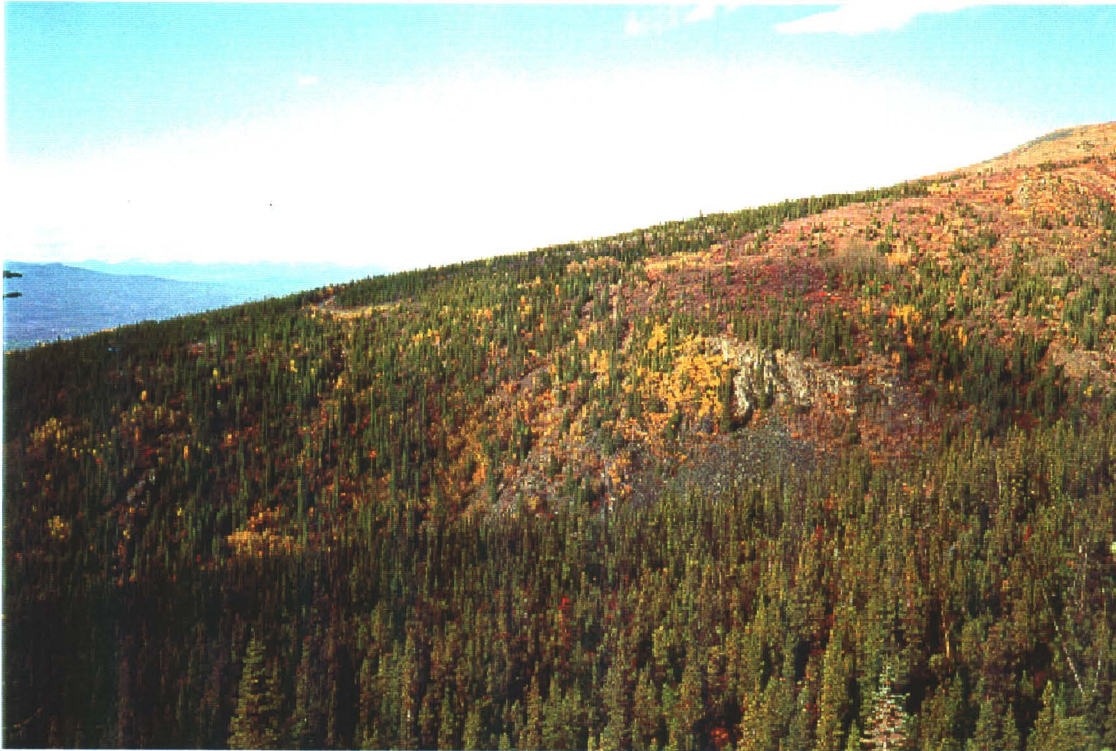
Photo 24-1: Overview of Croesus site. Note waste rock dump WR-02 from Adit #2 at phot centre; also Blackcap (Site #25) waste rock dumps at top right corner. (Azimuth 350°)

Croesus No. 1 is located on a moderately steep, 26° slope within Erickson Gulch on the west side of Keno Hill. The site has a southern aspect and is thickly vegetated with spruce, fir, alder and willow. Below 1230m, the site occurs within the talus debris fan of a prominent outcrop of greenstone that extends up the slope of the hill. Soils are poorly developed, derived from colluvial materials and ranging in thickness up to 1.5m. Above 1230m, bedrock is covered with a blanket of glacial gravels. Permafrost is likely, especially in the shadow of the gulch on the lower portions of the slope. Minor earth flows are evident on the slope immediately west of the site.

No surface water was observed associated with the Croesus No.1 mine workings. Shallow seeps are likely based on the presence of coarse talus below 1230m. All runoff from the mine site flows southward to Erikson Gulch, a tributary of Christal Creek. Shallow ditches, probably cut by the early miners to channel spring runoff to the mine workings, were found above the site. Runoff from the upper section of the Blackcap Road is channeled off the end of the switchback and down the slope adjacent to the Croesus No.1 workings. There are no culverts or waterbars along the Blackcap Road to dissipate the runoff on to the shallow west facing slope above. The excess runoff has cut a gully into the unstable slope adjacent to the Croesus No.1 site.

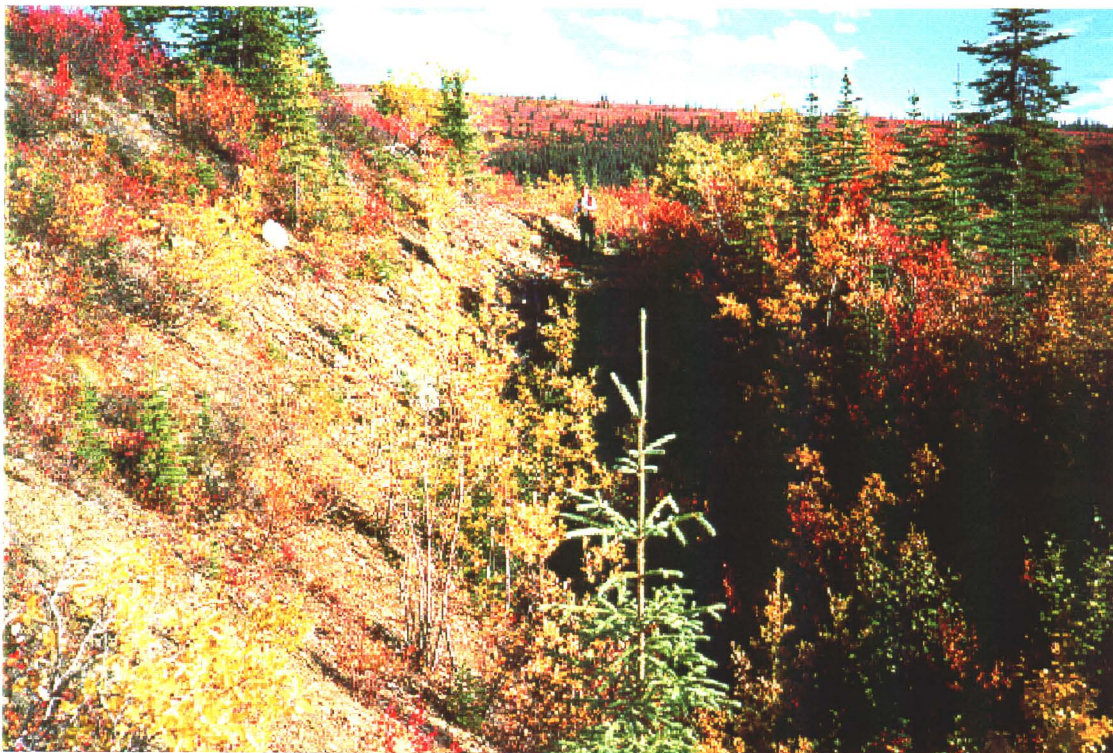
Photo 24-2: Upper Trench #1 into thick colluvial soils.(Azimuth 130°)

Trench #1 (Photo 24-2)

Trench #1 occurs at roughly 150m northeast of the Blackcap Road switchback. The trench was cut by bulldozer into glacial gravel and broken phyllite bedrock to a depth of 5m. The trench arcs in a 30m long semi-circle with steep sides that slope up to 40° into a narrow v-shape. The slopes are loose, but not a hazard. The site is partially revegetated with willows.

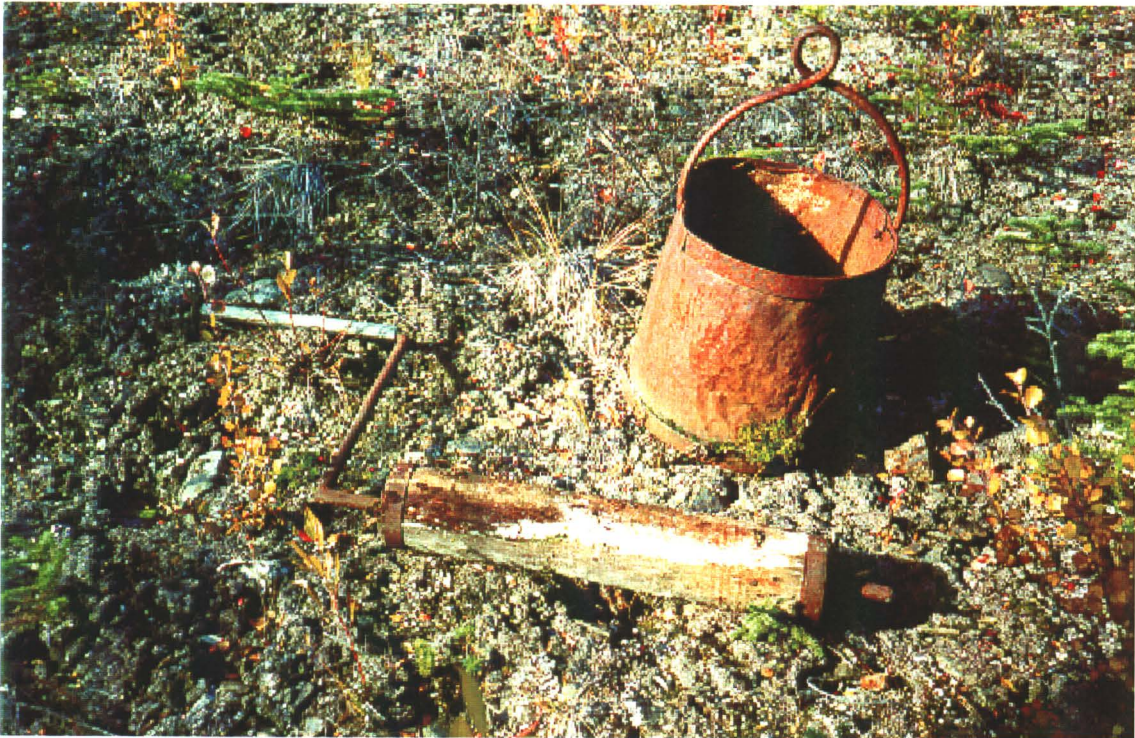
Photo 24-3: Windless and shaft bucket from backfilled shaft in area of upper trench (Shaft#1).

There are three shafts indicated on a map prepared in the 1960's by Boyle. A windless and a shaft bucket found in the base of the Trench #1 likely indicate the location of Shaft #1 (Photo 24-3). The shaft appears to have been filled by later trenching. A shallow boxhole dug into the overburden just above Adit #1 correlates to the site of Shaft #2 as indicated on Boyle's map. It is located at an elevation of roughly 1250m. The sides of the shaft have collapsed in and it is now less than a metre deep. There are no structures or equipment associated with it and it poses no risks. Shaft #3 is indicated by Boyle to be on the eastern side of Erickson Gulch just above the creek. This shaft was not investigated.

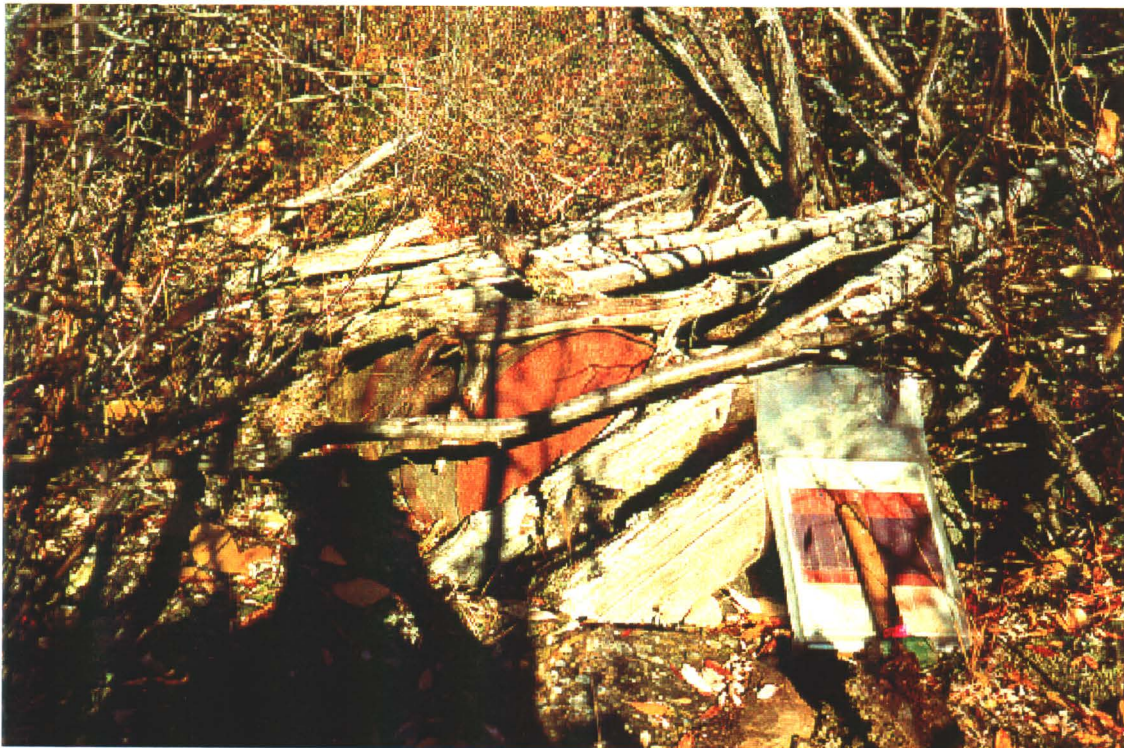
Photo 24-4: Adit #1 portal area. (Azimuth 030°)

The adits are numbered in sequence, Adit #1 being the uppermost at an elevation of 1225m. Dimensions for the adits are estimated from the portal timbers and the sizes of the associated waste rock piles. The portals were constructed with log timbers but have collapsed and are no longer accessible. None of the adits produced any water and no samples were collected.

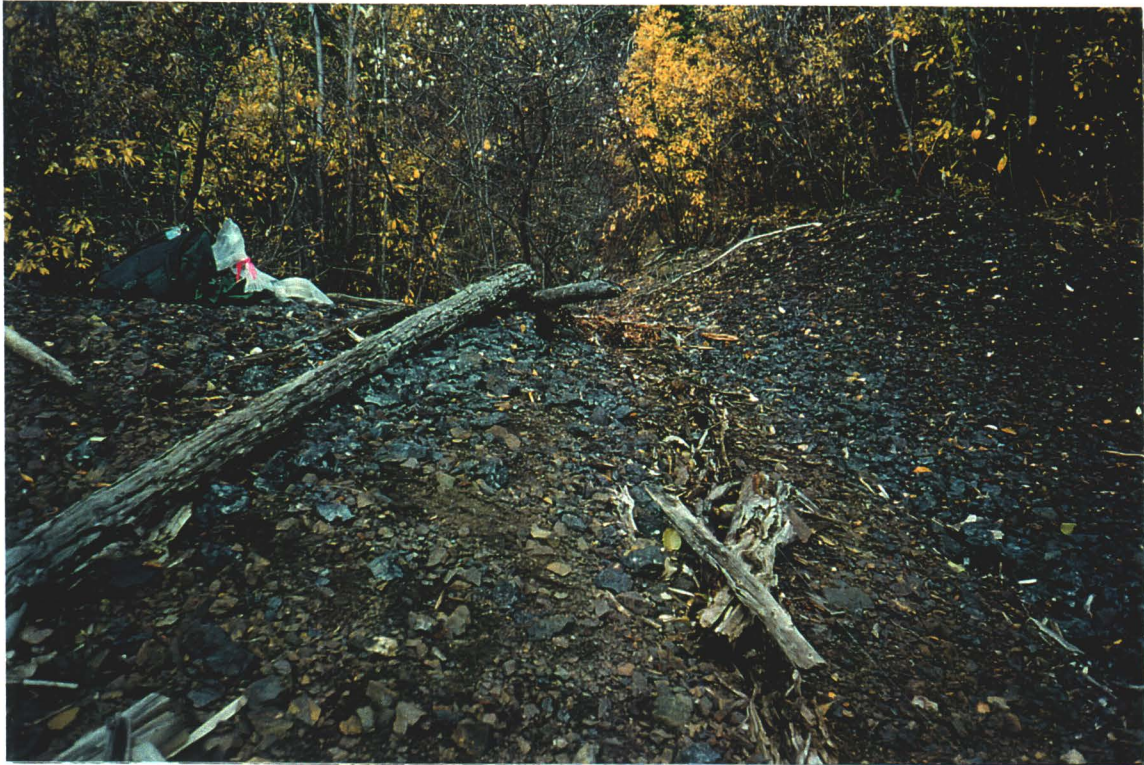
Photo 24-5: Top of waste rock dump WR-02. Note abundant manganese stained siderite vein material. (Azimuth 010°)

Waste Rock Pile WR-02 (photo 24-5, 24-624-7)

This waste rock pile was formed by end dumping from Adit #2. The majority (~67%) of the surface rock is coarse crystalline siderite, roughly 30% is blocky greenstone, 3% is quartz and there is trace calcite. The slope of the pile is about 30°. There is abundant manganese staining in the siderite vein material. Strong oxidation occurs to a depth of at least 50cm.

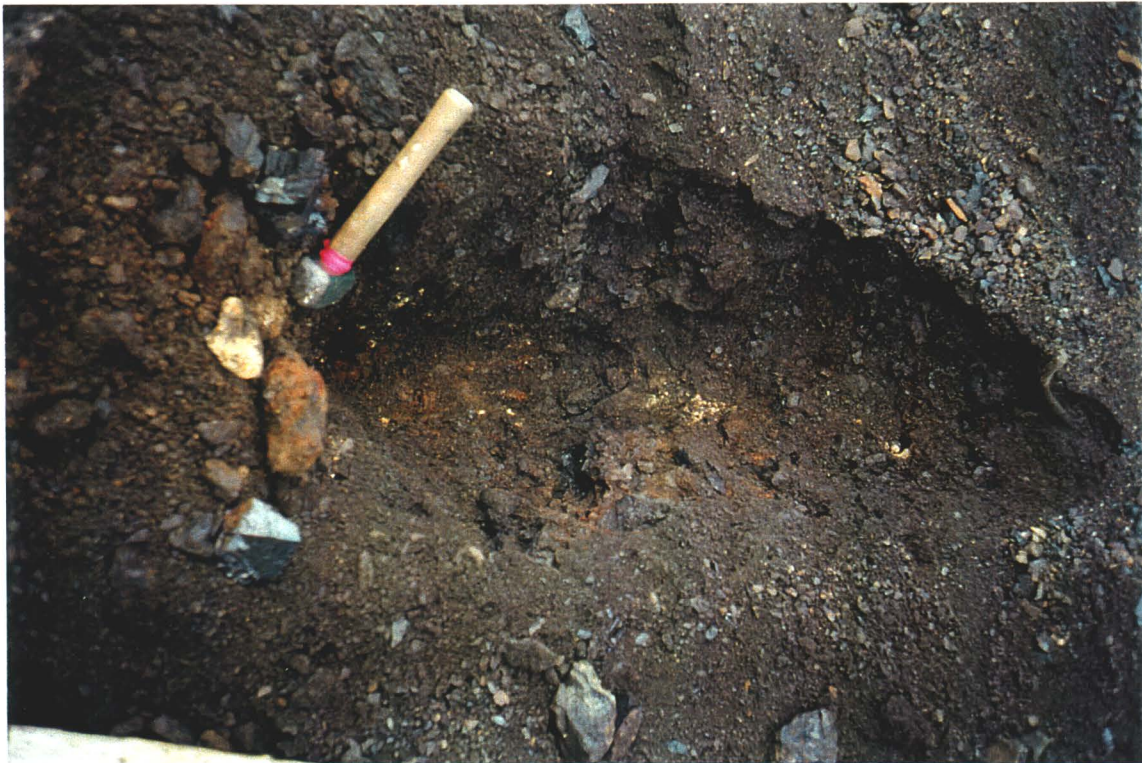
Photo 24-6: Waste rock dump WR-02 test pit (sample 24WR01-01) at Adit#2. Note strong oxidation at depth in pit and abundant siderite vein cobbles.

Sampling: Sample 24WR-01 was collected from the north end of the pile (see attachments for analytical results). Field test results included a paste pH of 6.7 and conductivity of 1090µS/cm.

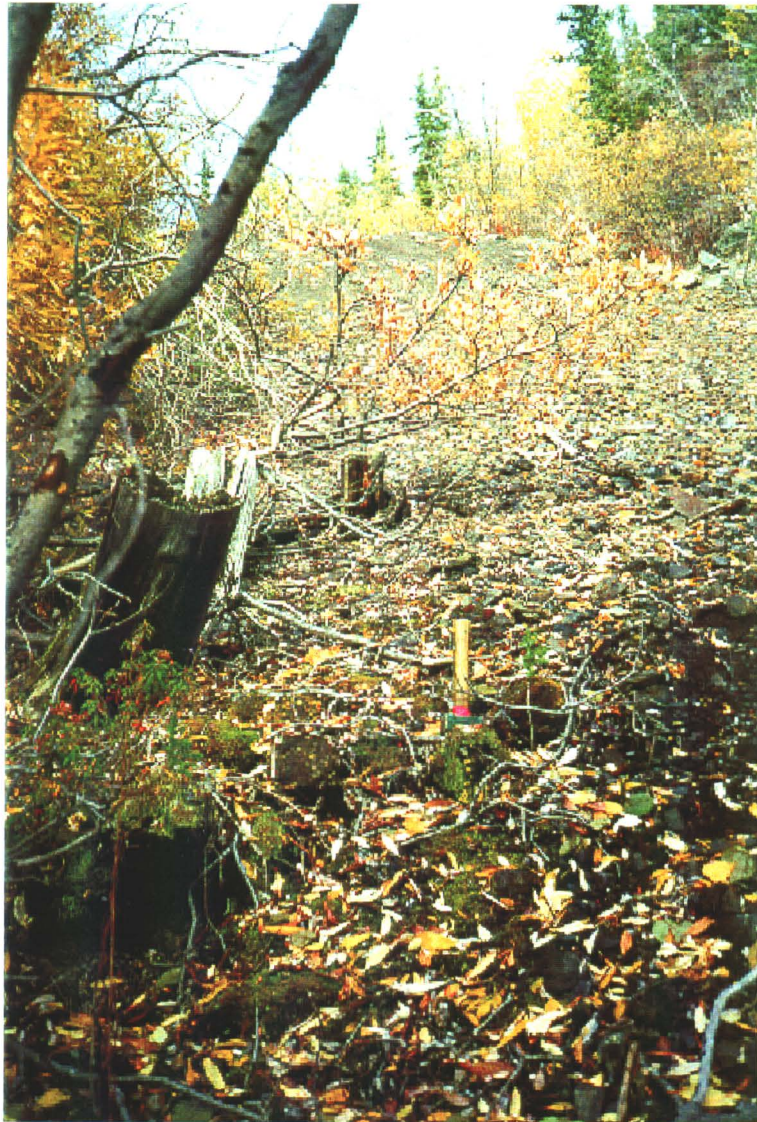
Photo 24-7: Adit #3 at base of rock dump WR-02. Note portal timbers to left of hammer. (Azimuth 000°)

This waste rock pile was formed by end dumping from Adit #3. It has the same surface composition as waste rock pile #2.

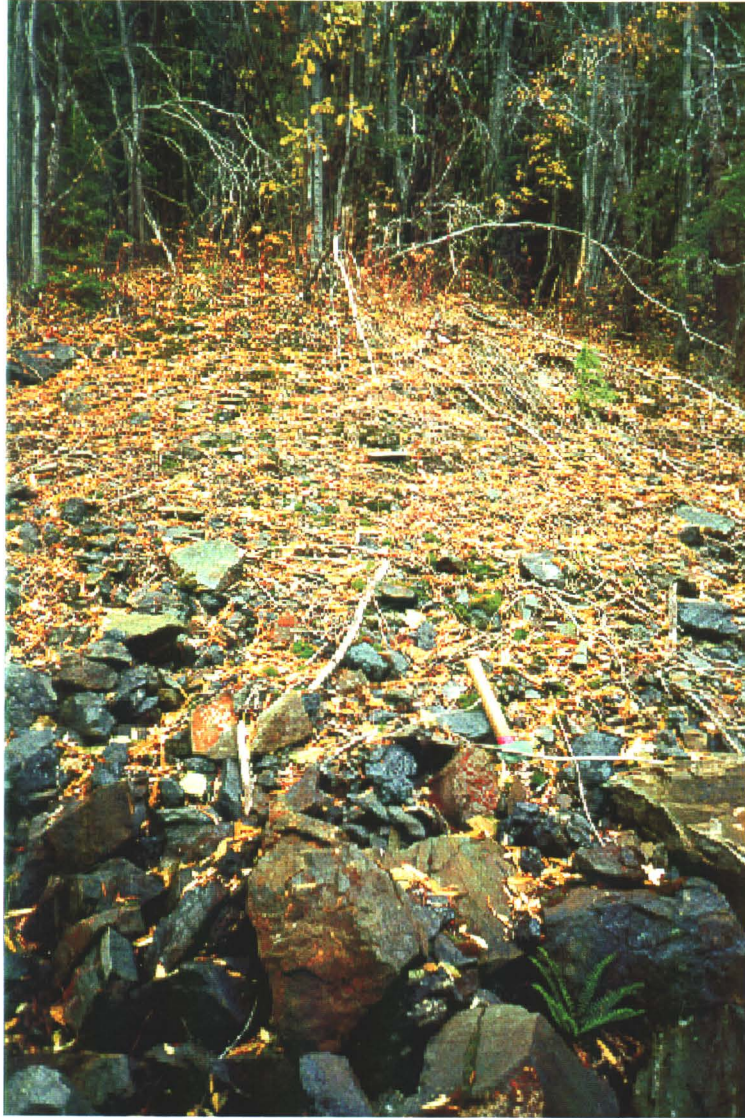
Photo 24-9: Rock dump WR-04. Note blocky greenstone and siderite vein material. (Azimuth 040°)

Waste Rock Pile WR-04 (Photo 24-9)

This waste rock pile formed by end dumping out of Adit #4. It is composed of 60% blocky greenstone and 40% medium grained, crystalline siderite. Moderate oxidation was observed.
