**BLACK CAP, SHEPHERD AND LUCKY QUEEN ADITS**

**SITE# 25**

**MINFILE# 105M001ac**

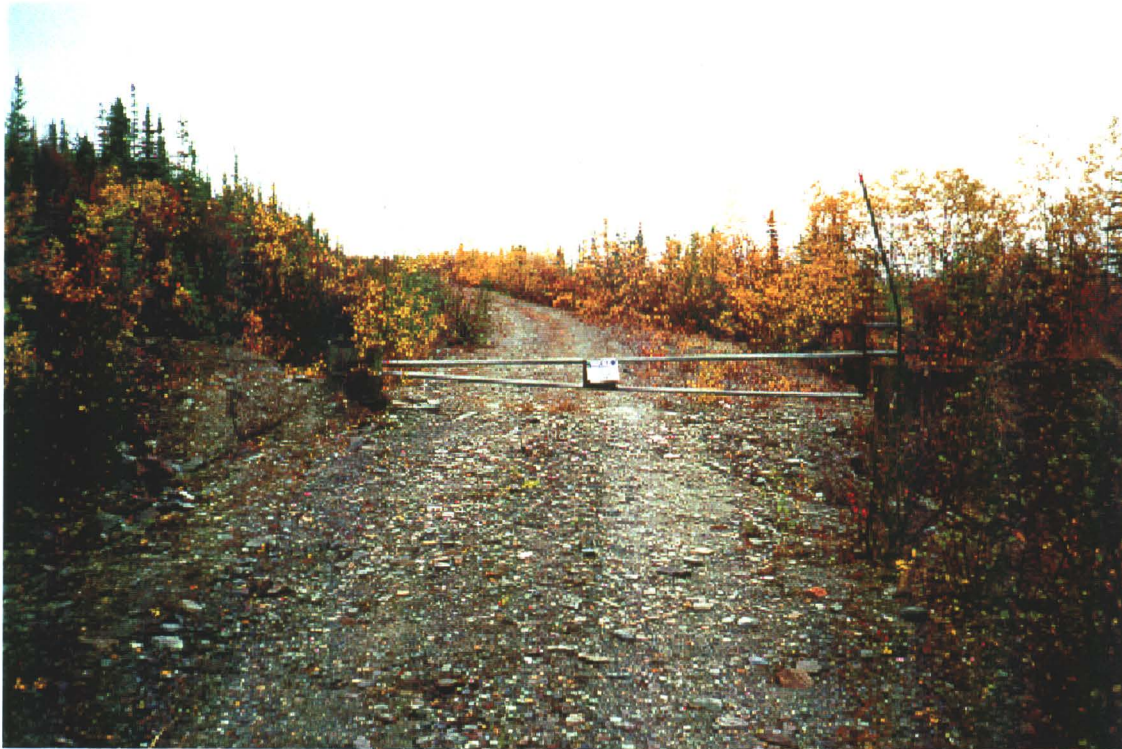
Photo 25-3: Locked gate at bottom of road limiting access to the Blackcap, Shepherd and Lucky Queen sites.(Azimuth 160°)

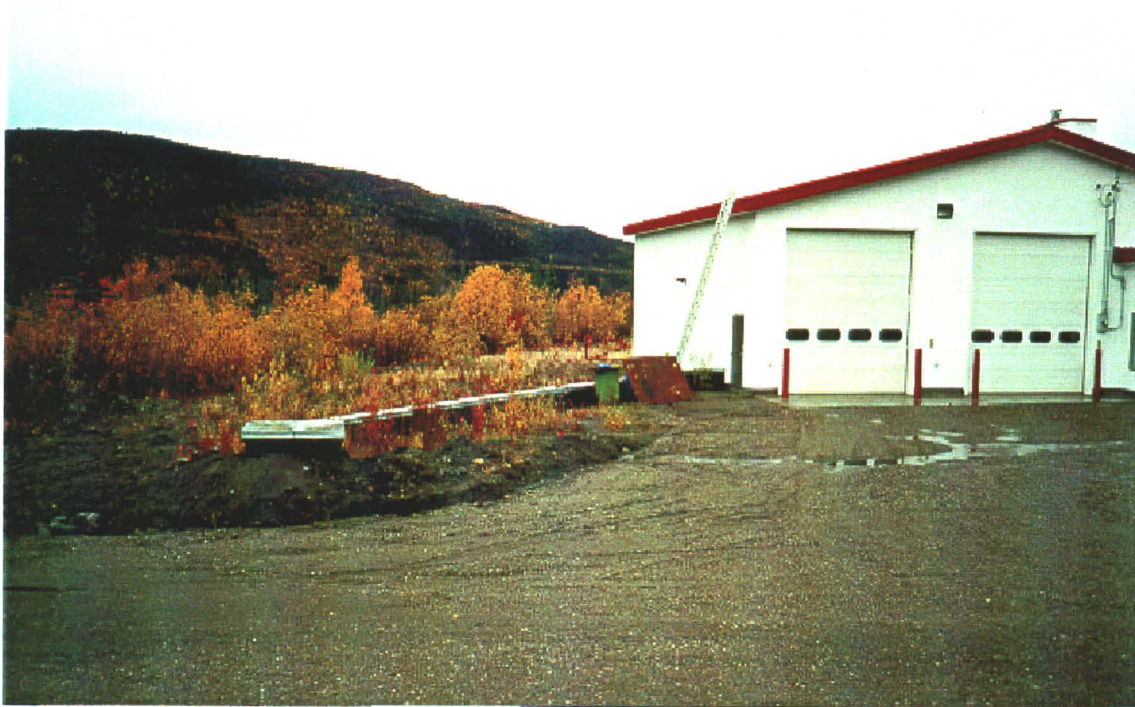
Photo 25-6: Shepherd adit. Note mine drainage dammed behind gravel berm.(Azimuth 090°)

The entrance to the adit is located roughly 100m south of the south end of the North Black Cap Pit. The opening measures about 2m high by 2.5m wide and is supported by timbers. No collapses were visible in the first 50m. The adit is filled with approximately 40cm of standing water making further investigation of the adit unpractical. A gravel berm located outside of the portal was built to damn mine drainage; however, water is seeping through the berm and a large puddle has formed on the other side. Water flowing from the puddle continues down the road for at least 50m before seeping back into the ground.

Three water samples were collected on the site. Mine drainage water was collected from both the Black Cap and Lucky Queen adits. At the Blackcap adit, water seeps through gravel berm located just outside the portal and down the road at least 50m before seeping back into the ground. Sample 25WQ-A01-01/02 was collected from the water flowing outside the berm. Sample 25WQ-A02-01/02 was collected from water flowing in the mine ditch inside the portal of the Lucky Queen adit. A third sample was also collected from a seep above the Black Cap Road, down slope and roughly 170m southwest of the Lucky Queen adit (25WQ-S01-01/02). Analytical results are attached.

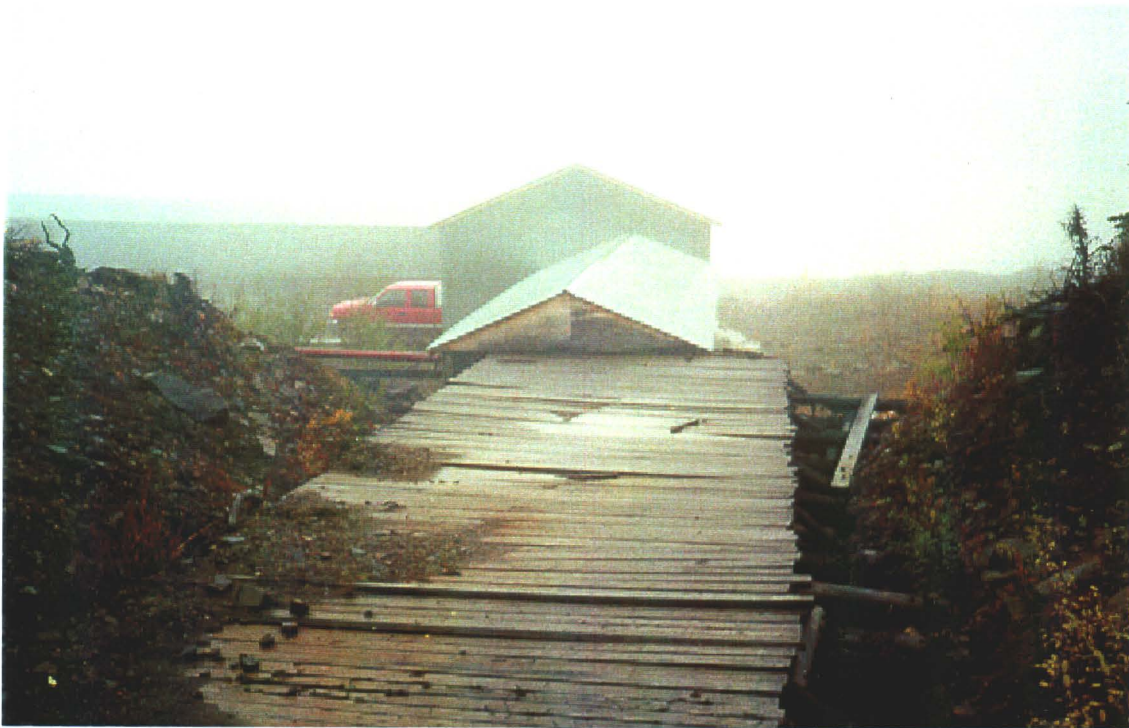
Photo 25-7: Lucky Queen load out building and portal structure. Note cribbed portal in foreground and load-out in background. (Azimuth 200°)

The adit is on the east side of the Black Cap Road, downslope of the Black Cap Pits. There is timber cribbing and wooden door at the collar of the adit. The timbers behind the adit door have collapsed, making the entrance impassible. An exterior wooden portal structure 4m wide by 2.5m high extends 15m between the door to the adit and the load-out building (building 25A). All the water lines (2 inch steel), air lines (6 inch steel), vent

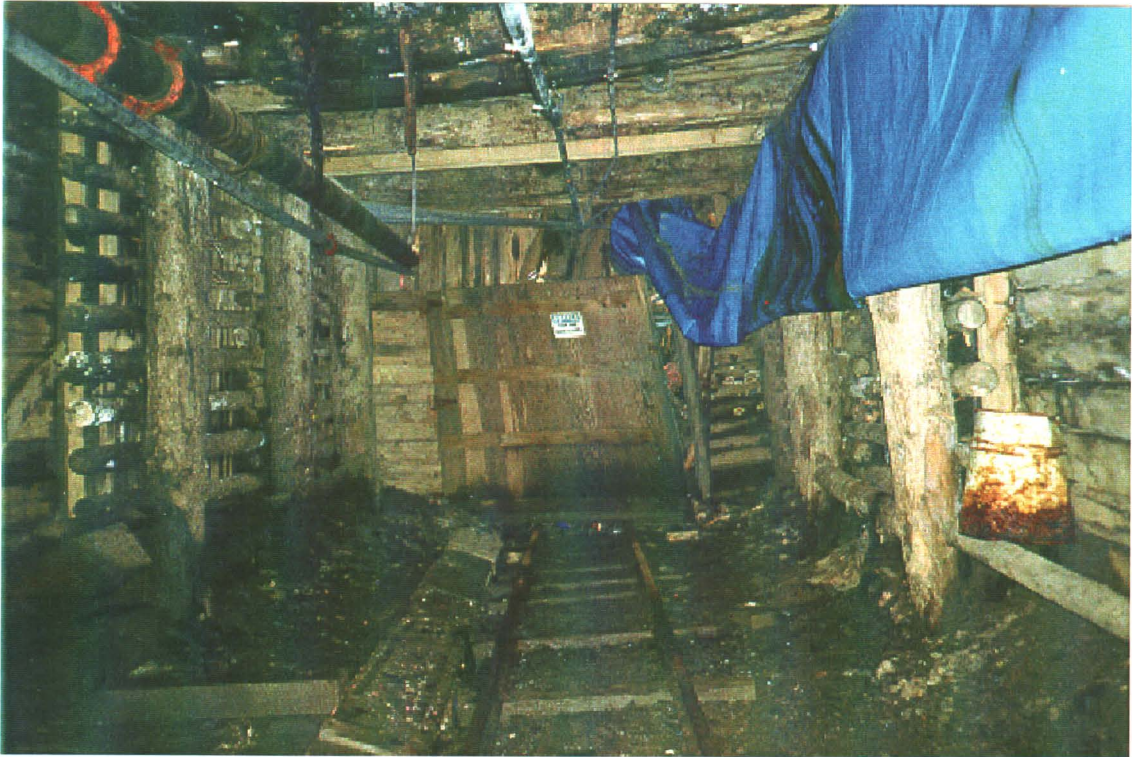
Photo 25-8: Interior of portal. Note drainage ditch to bottom left and partially collapsed door.  
(Azimuth 060°)

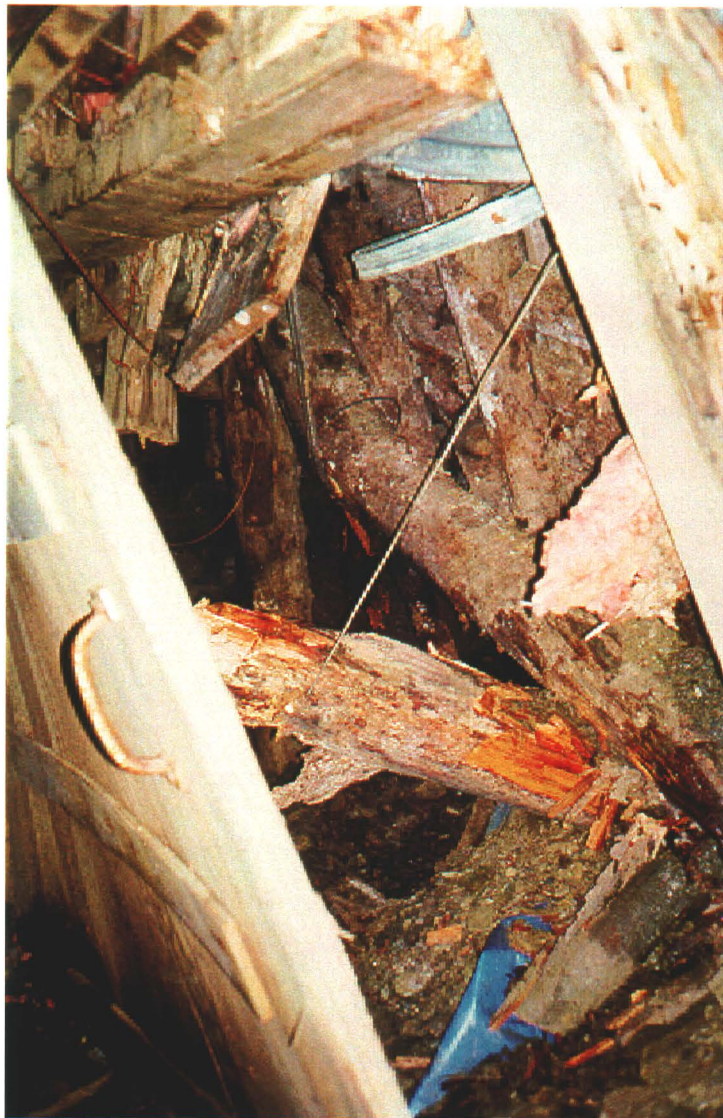
Photo 25-9: Collapsed portal timbers behind door.

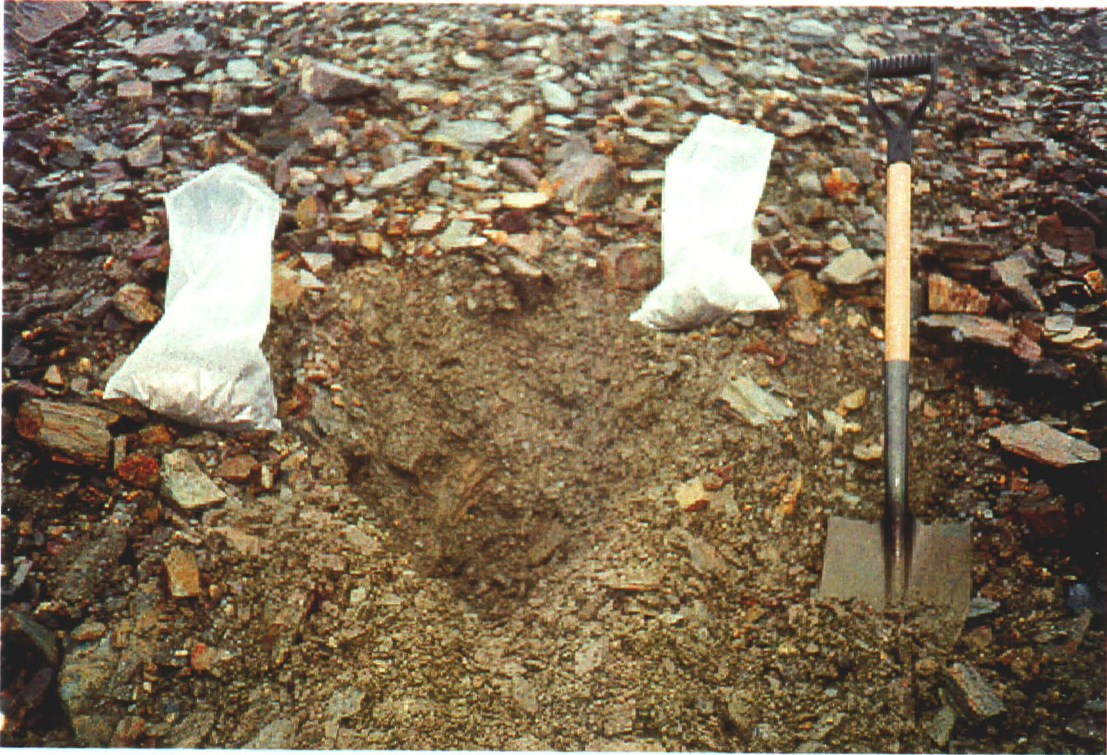
Photo 25-10: Waste rock pile WR03 sample (25WR03-01).

This waste rock is likely from the North Black Cap Pit but may also contain rock from the South Black Cap Pit. The pile is comprised of predominately phyllitic schist (50%) and massive, blocky quartzite (30%), with lesser amounts of thin to moderately banded quartzite (10%), quartzite with trace to 1% pyrite (5%), manganese stained siderite-quartz veins (3%) and stacked quartz veins and veinlets (1%). Tension cracks observed on the top of the pile and the over-steepened (40°), convex sides indicate that the toe of the slope is possibly moving due to solifluction.

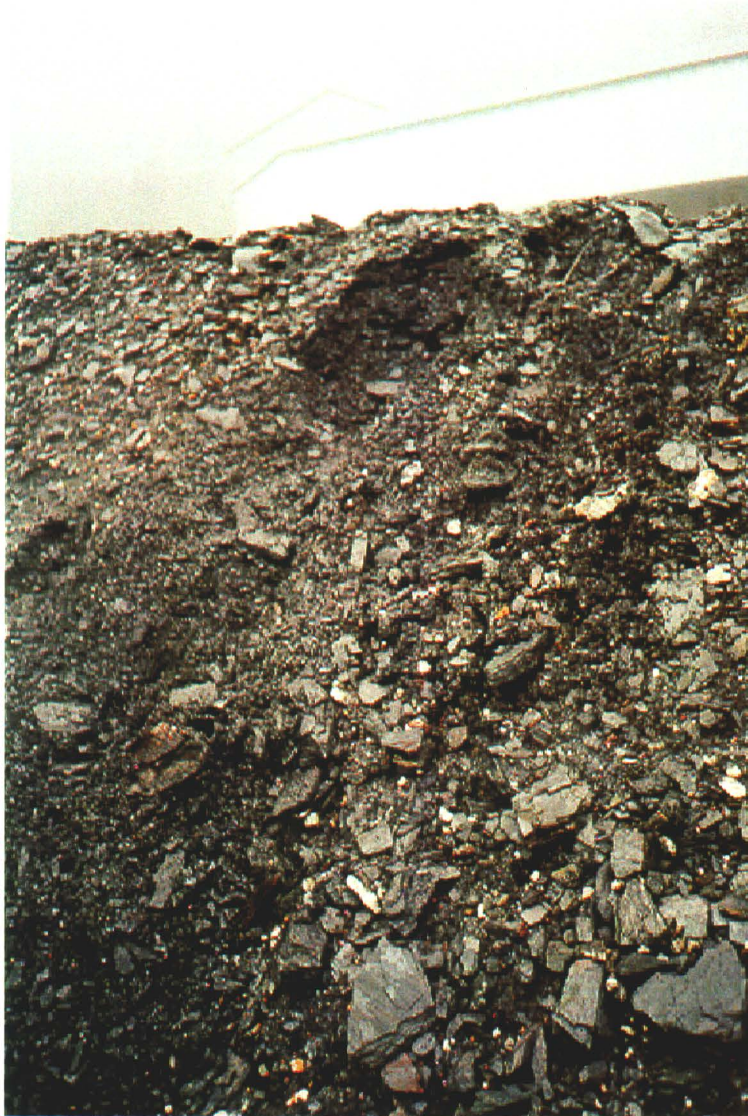
Photo 25-11: Waste rock sample site (25WR05-01) at Lucky Queen waste rock pile WRO5.

The waste rock in this pile was excavated from the Lucky Queen Adit. It is mostly quartzite, 50% banded with trace to 1% pyrite, and 20% massive. There is roughly 15% phyllitic schist, 10% greenstone and 5% stacked quartz veins and veinlets.

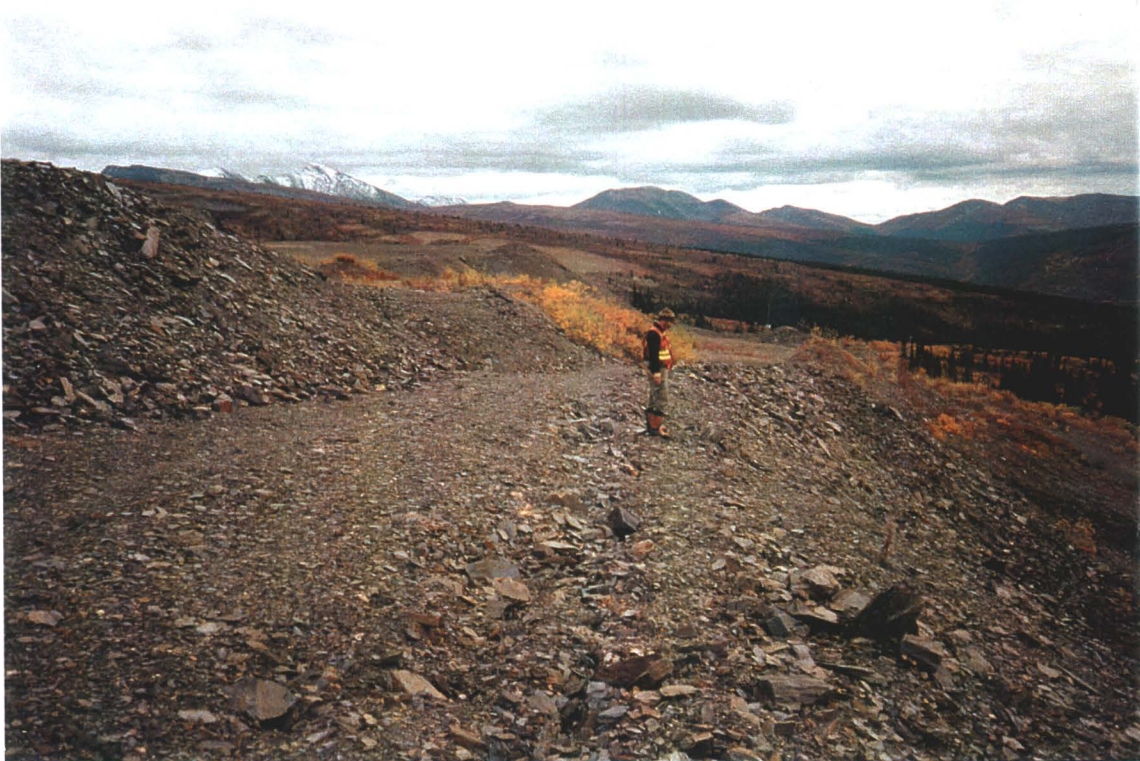
Photo 25-12: Tension cracks on edge of waste rock pile. Note slumped edge running along edge to mapper. (Azimuth 180°)

WR-03 is potentially unstable. Large active solifluction lobes were observed in the natural soils at the toe of the southwest slope of WR-03. The southwest slope was also observed to be convex in shape and to have a profile of up to 40°.

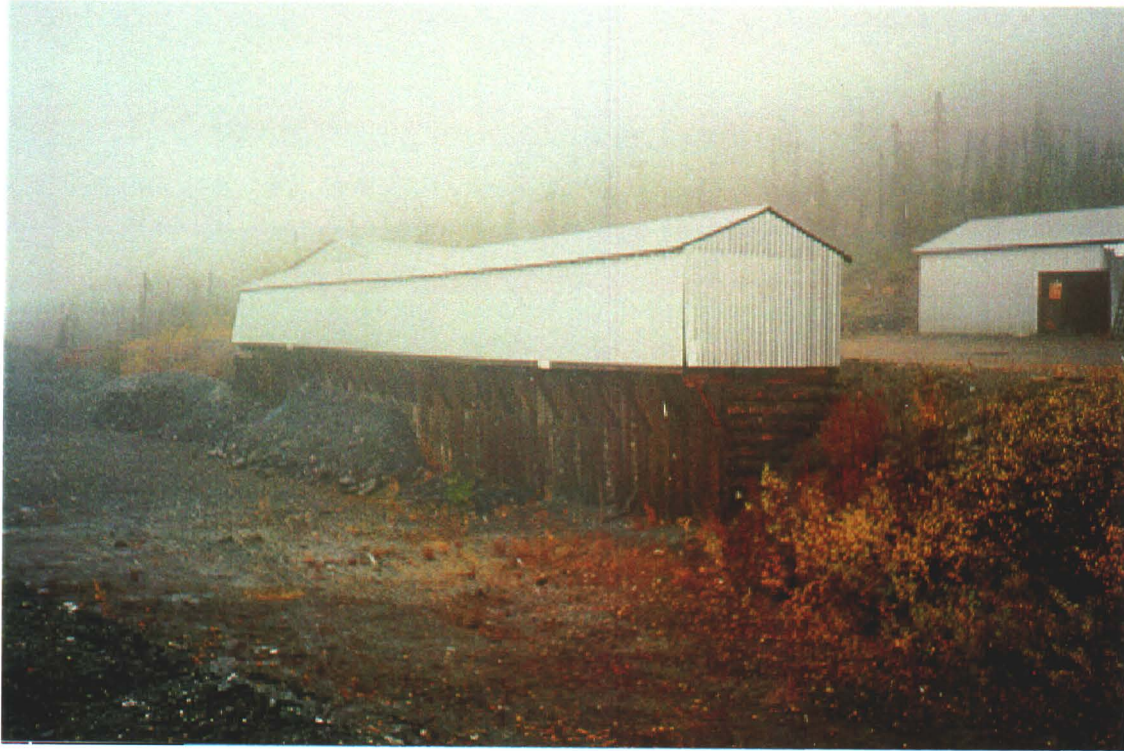
Photo 25-13: Lucky Queen load-out area. Workshop in background to right. (Azimuth 000°)

There are roughly 75m of tracks that come out of the Lucky Queen Adit and into the load-out building (building 25A). The loadout is built up on a 3m high cribbed wall roughly 30m long. The track and loadout are in good condition and still functional.

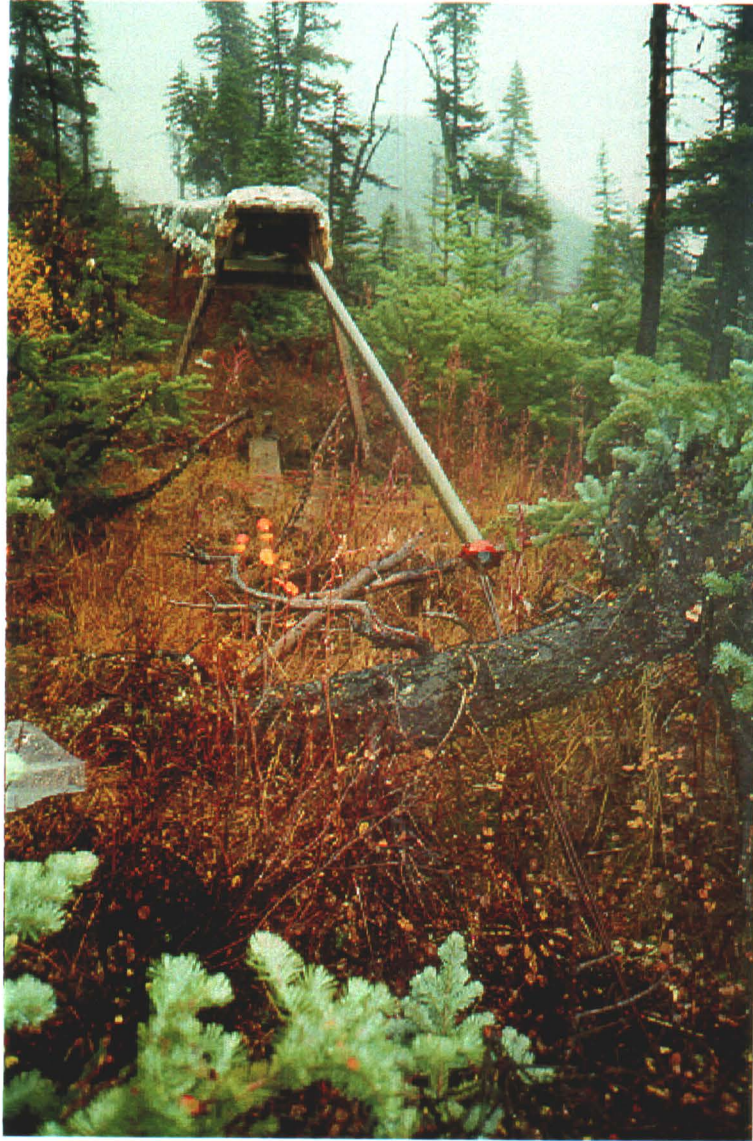
Photo 25-14: Mine drainage flume. Note copper heater coils extending out of pipe. (Azimuth 130°)

tubing (0.5m plastic material) and electrical cable remain intact extending from the end of the portal underground. A 2 inch steel water line with a doubled copper heater coil inside it was installed to provide winter drainage. The water line drain and coil runs along the ditchline from underground, out the side of the load out building and then 70m northwest at azimuth 300° across the side hill. The heater coil extends a further 30m beyond the end of the pipe.

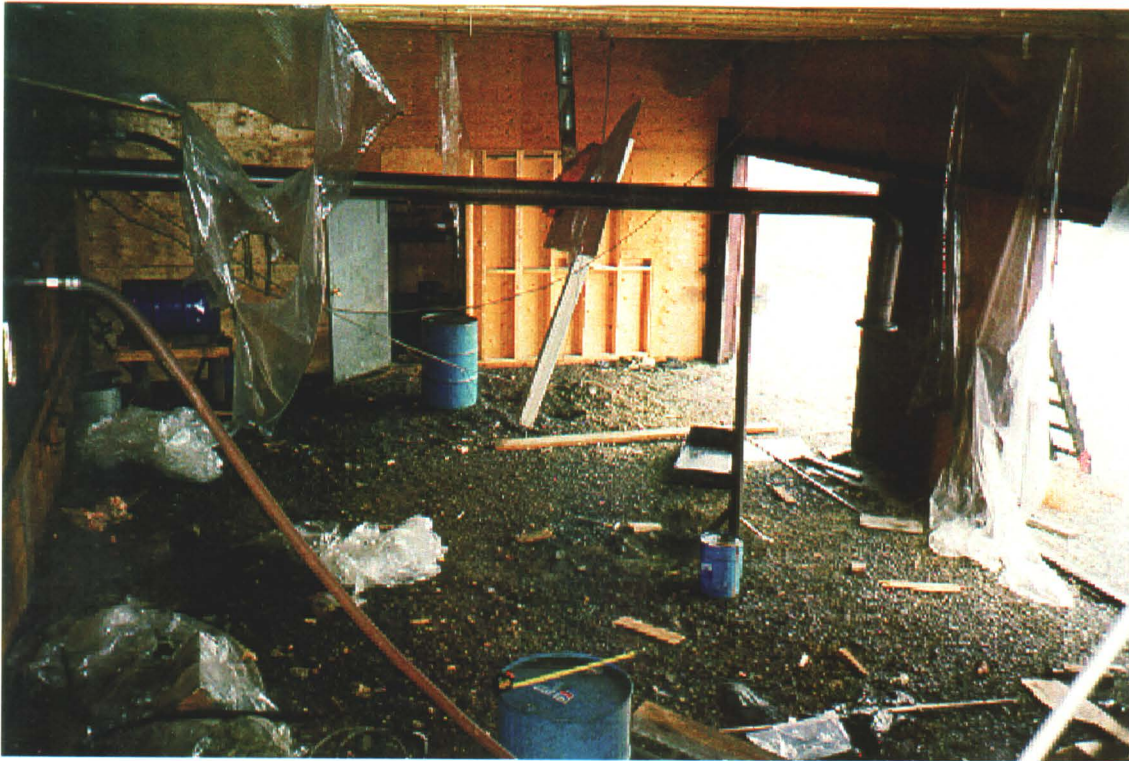
Photo 25-15: Interior of workshop bays. Note drum of transmission oil and pails of waste oil in left corner. Test pits located just right of far up-right drum (TP01) and blue pail of solvent near centre (Tp02). Workshop area through door on far wall. (Azimuth 180°)

Inside the workshop there are three 45-gallon drums; one contains gasoline, one contains transmission oil and one is empty. There are a number of smaller pails that contain hydraulic oil, waste oil, transmission oil and some solvents. A number of stains were observed inside of the shop both on the wooden floorboards and on the gravel floor. One small stain was observed outside of the bay doors. Two soil samples were collected from each of two pits and analyzed for metals and petroleum hydrocarbons (LEPH/HEPH and VPH). Samples 25TP01-S01 and -02 were collected from soils inside the workshop (building 25B) where contamination from solvent was suspected. Samples 25TP04-S01 and -02 were background samples collected in front of the shop away from the suspected contamination. The area surrounding and inside the shop was graveled with up to 5cm of crushed rock from an unknown source.

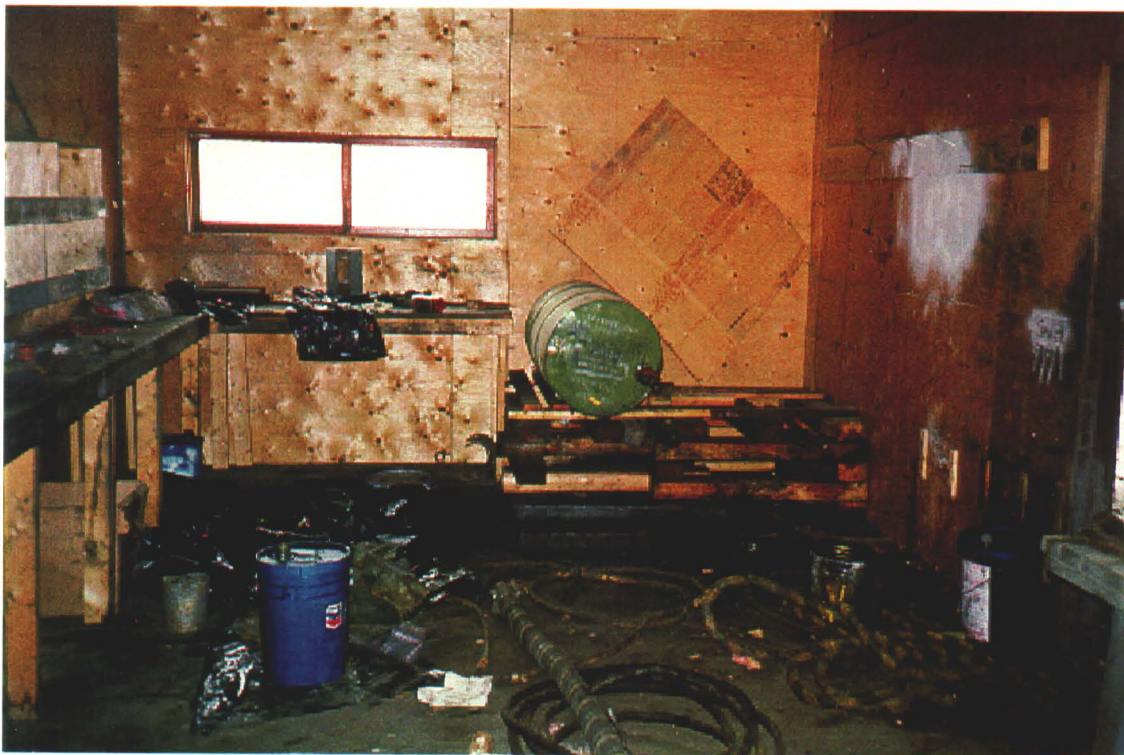
Photo 25-16: Interior of workshop area. Note leaking drum of hydraulic oil and full pan below. (Azimuth 250°)

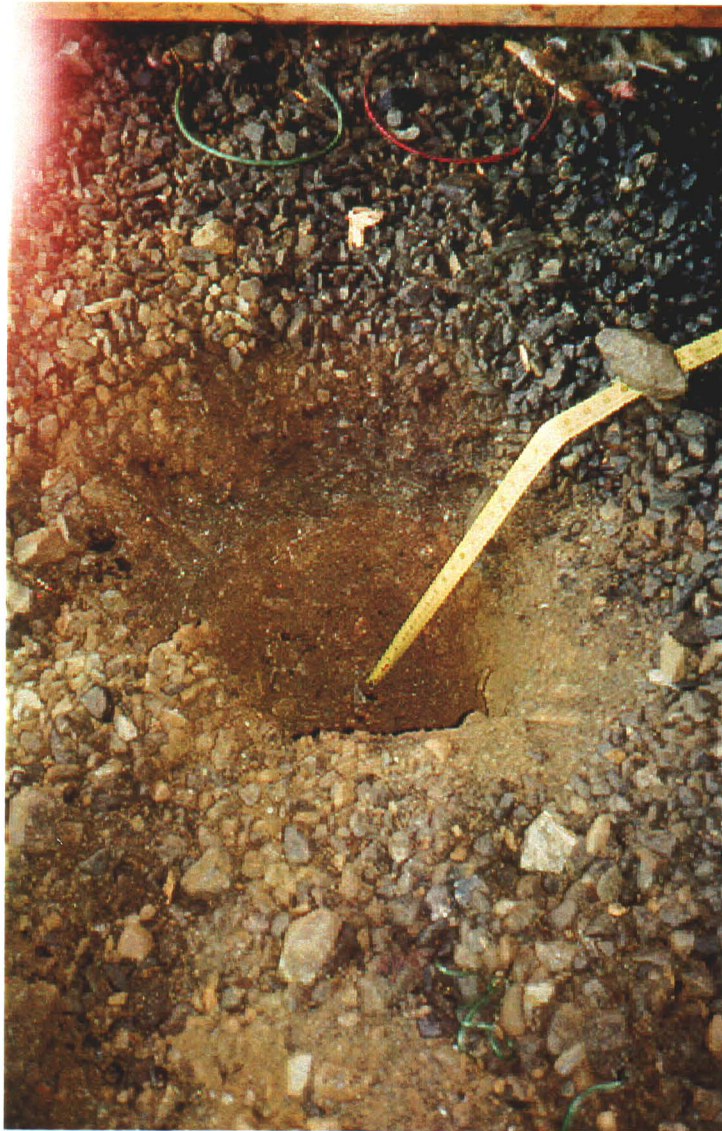
Photo 25-17: Test pit TP01 in Lucky Queen shop.  
Note heavy oil stain on surface gravel.

There is impact associated with petroleum staining in the workshop. See Section 6.2 above for details. Other contaminants of concern are any metals washing from the pit walls, waste rock piles or underground workings.
