LUCKY QUEEN

SITE #26

MINFILE# 105M001ad

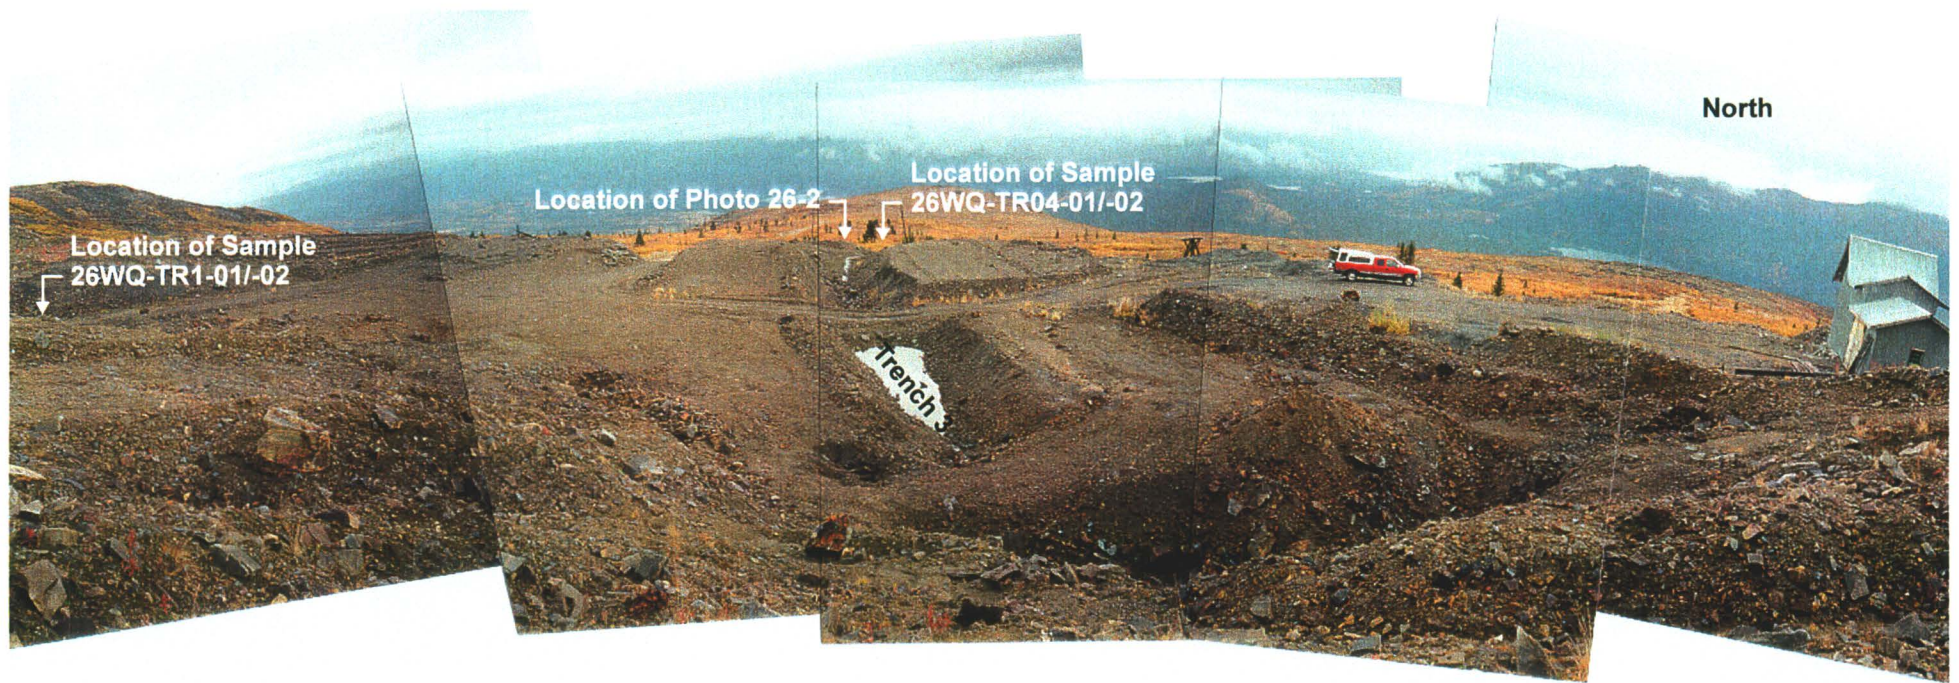
The Lucky Queen site area gently slopes down to the northwest. It is located at the upper limit of the subalpine and is vegetated with grasses, willows and a few lone spruce trees. Soil cover is sparse and is composed mostly of residual soils formed by the weathering of the underlying bedrock and from the decomposition of granular till.

Photo 26-1: Panorama of site showing trenches, shaft building and overburden and waste rock dumps. Note old shaft just left of Trench 3 in foreground and powerline and haulage tram towers in background.

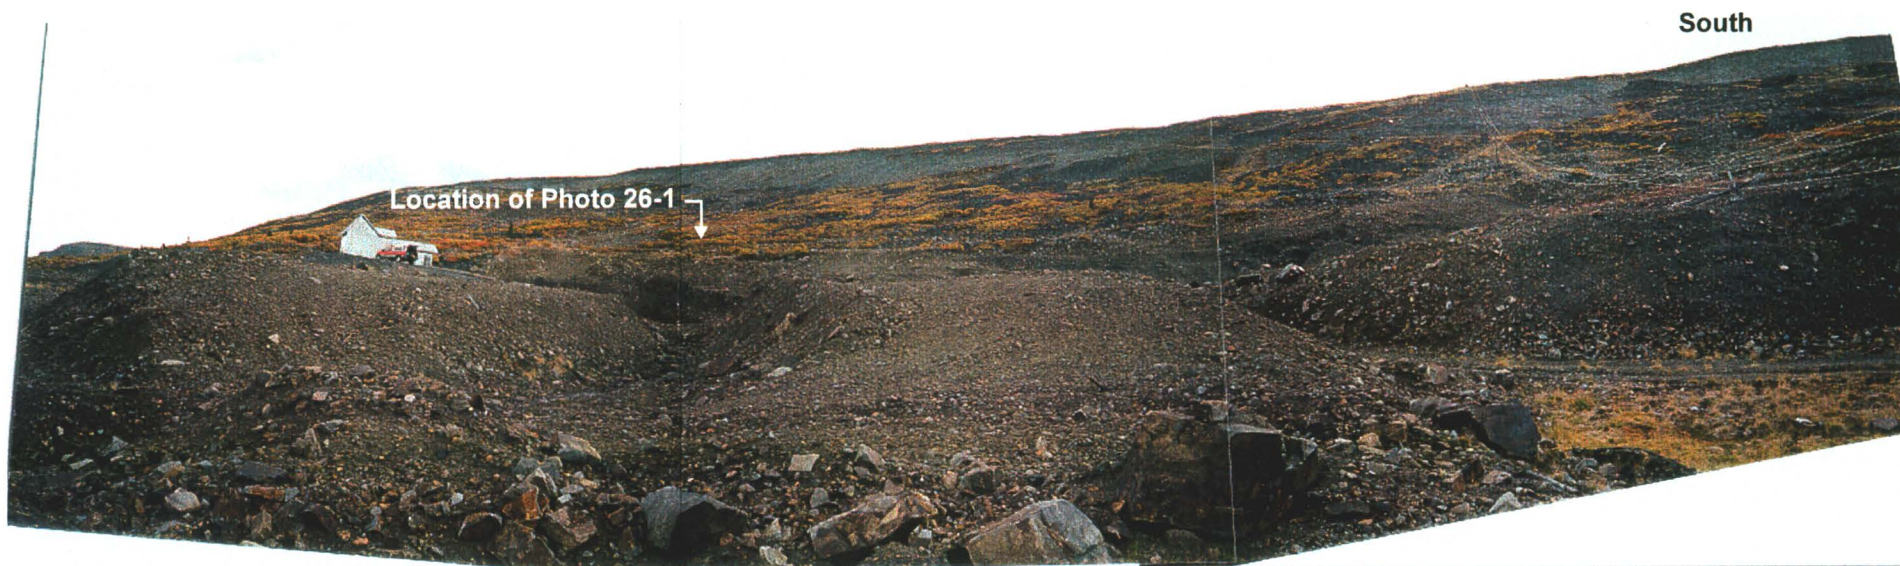
There is a decommissioned power line that runs across the west side of the site and continues further up the hill. One of the power poles located on waste rock pile #1 has collapsed so that the line lies along the ground for roughly 20 metres.

Photo 26-2: Panorama of Lucky Queen site. Note trench 4 drainage to left of centre and downed power pole to far right.

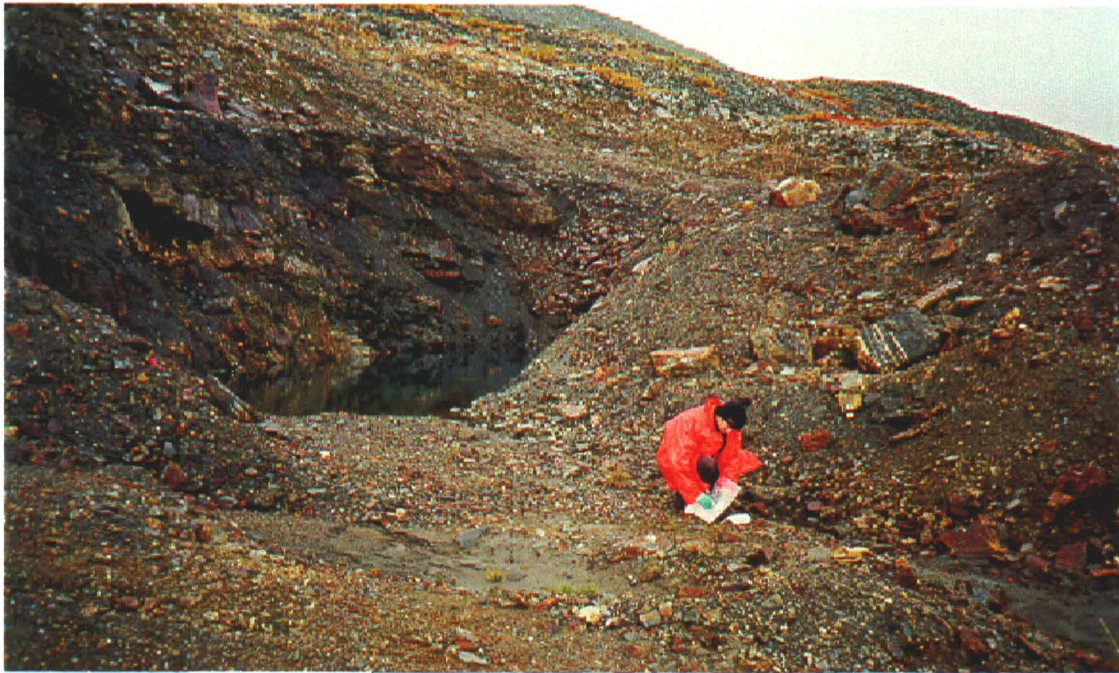
There is a small pond of water within Trench #1. The back wall is approximately 4 metres high. The depth of the pit was not determined, although it is estimated to be less than 2 metres.

Dimensions (L x W x H): 28m x 7.0m x ≥4m (depth not determined.)

Condition: Stable; minor loose rock.

Accessibility: Access to the edge of the trench/pit is easily made on foot, notable the higher upper edge. However it is full of water which limits access inside.

Photo 26-3: Trench 1 sample site (26-WQ-TR01-01/02).
Photo Direction (Azimuth 230°)

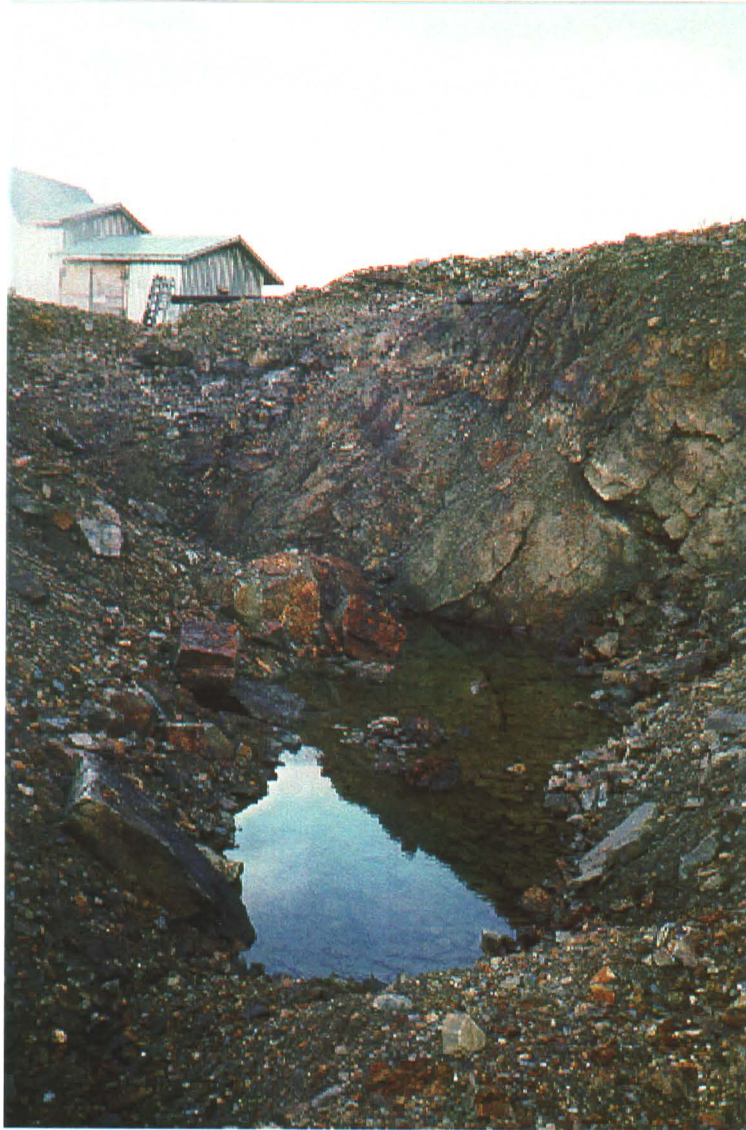
This trench is L-shaped; there is a small L-shaped pond of water within it. There is a large outcrop along the eastern wall. Depth of the water is less than 1 metre.

Dimensions (L x W x H): 19m x 14m x 1m – 3m

Condition: Stable; minor loose rock.

Accessibility: The trench can be easily accessed by foot. The water limits access inside the trench.

Photo 26-4: Trench 2 with shaft building behind.
(Azimuth 065°)

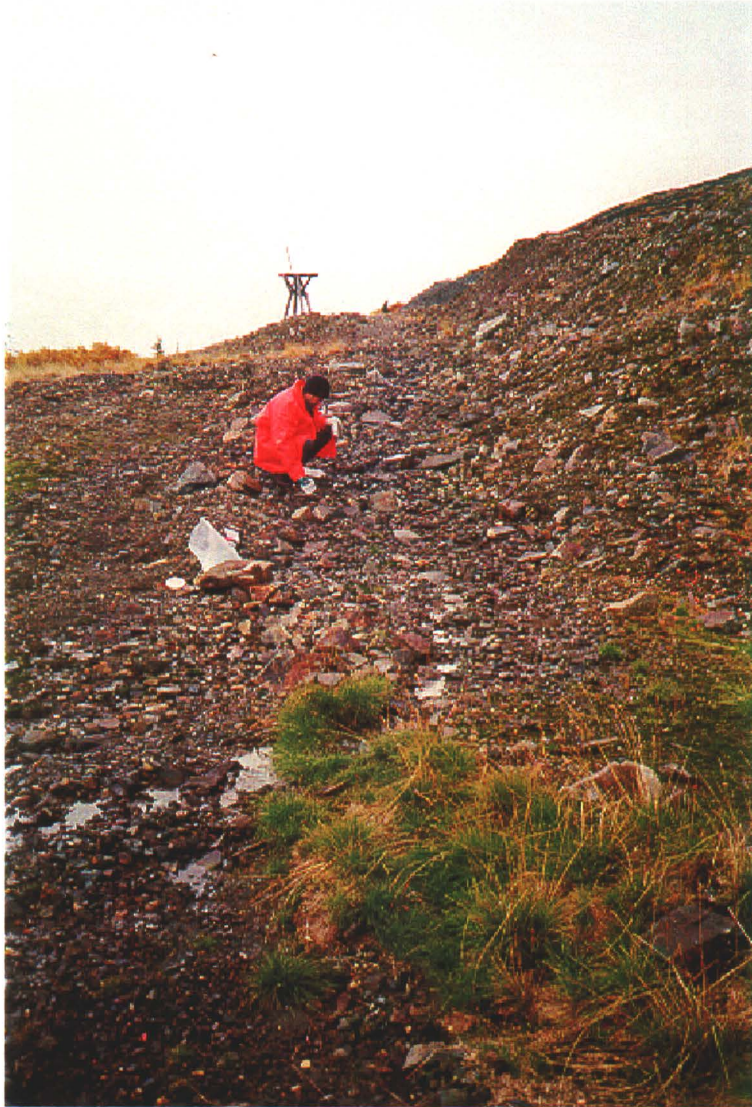
Trench #4 has been excavated in overburden. There is no surface water within Trench #4. There is a minor, intermittent flow along the bed of the trench.

Dimensions (L x W x H): 46m x 8.0m x 1.5m

Condition: Stable.

Photo 26-5: Trench 4 sample site (26-WQ-TR04-01/02).
Note haulage tram tower. (Azimuth 090°)

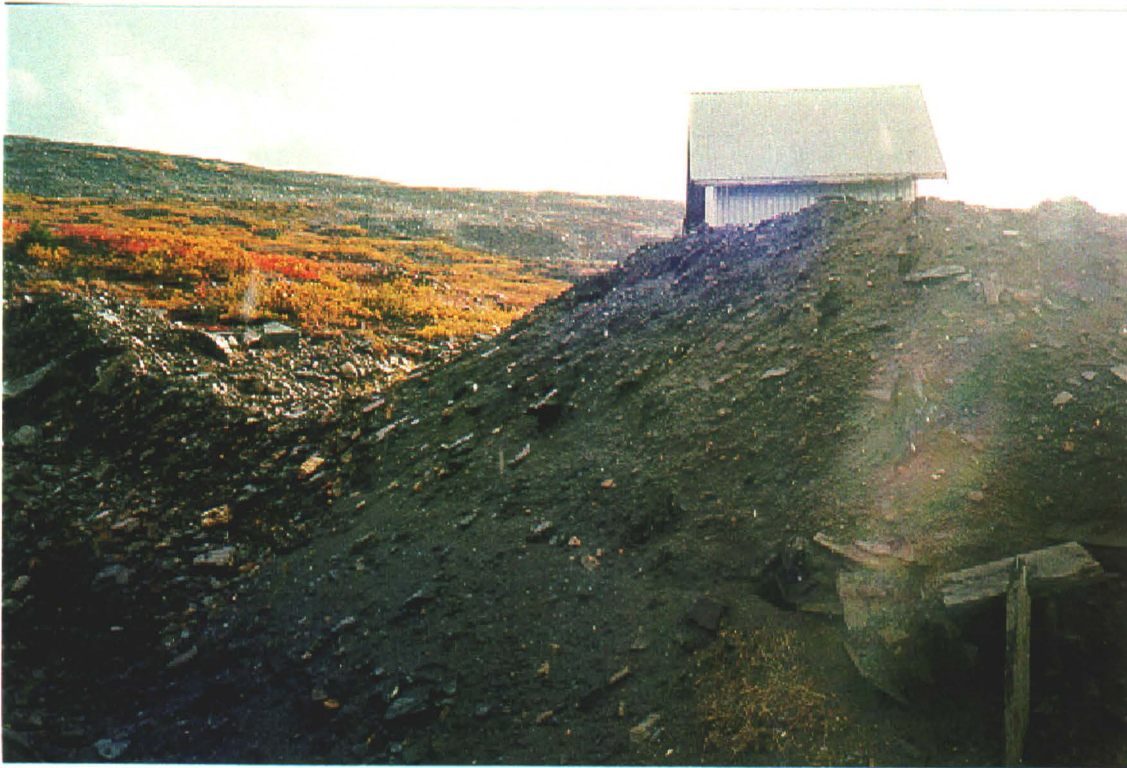
Trench #5 is T-shaped. There is no surface water within Trench #5.

Dimensions (L x W x H): 52m x 5.0m x 1.5m (top part), 25m x 5.0m x 1.5m

Condition: Stable.

Photo 26-6: Trench east of shaft building. Note waste rock dump from underground development forming slope at right of photo. Photo Direction (Azimuth 130°)

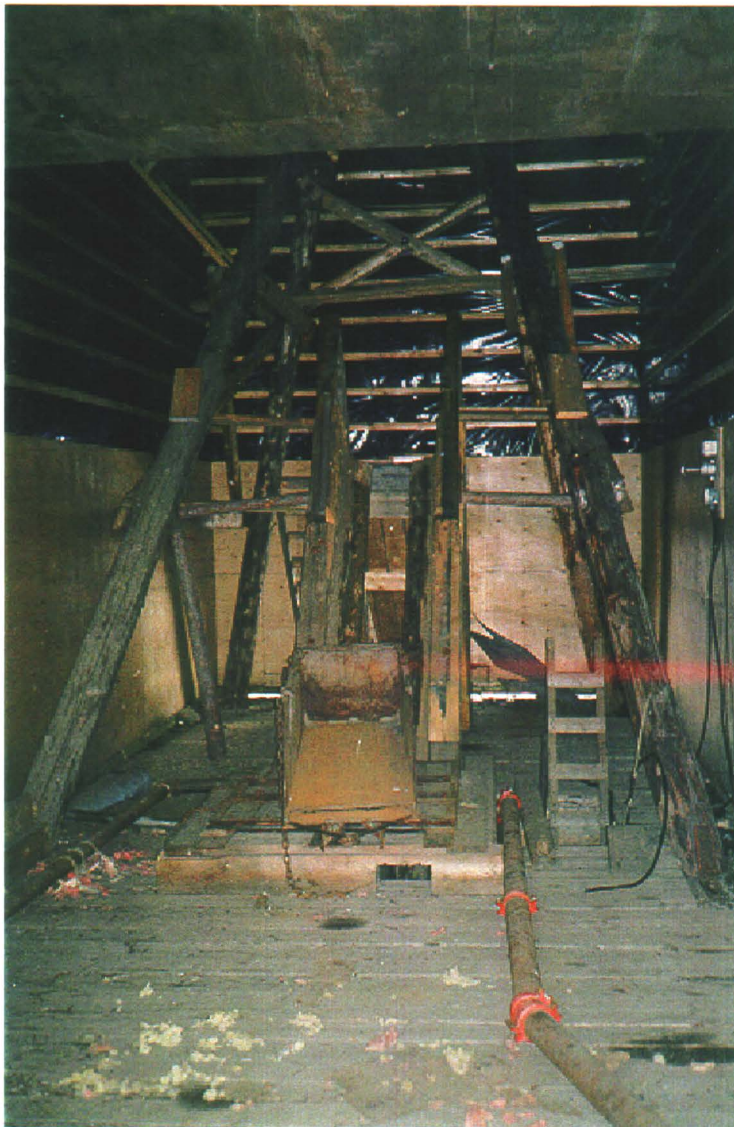
Condition: Sound, safe.

Accessibility: The shaft is enclosed in building 26-A, although access is easily gained through the unsealed ore dump. Inside, the manway and ladders are open and easily accessed.

This building was built to protect the entrance to the Shaft #1 and house a generator plant (since removed). The building is in good condition.

Construction: Wood construction with steel sheet siding and roofing

Foundation: Concrete pillars with wood flooring

Photo 26-7: Interior of Lucky Queen headframe building (Bldg. 26-A) showing open manway and boarded shaft opening.
