CUB AND BUNNY (#30)
(MINFILE# 105M 001aj)

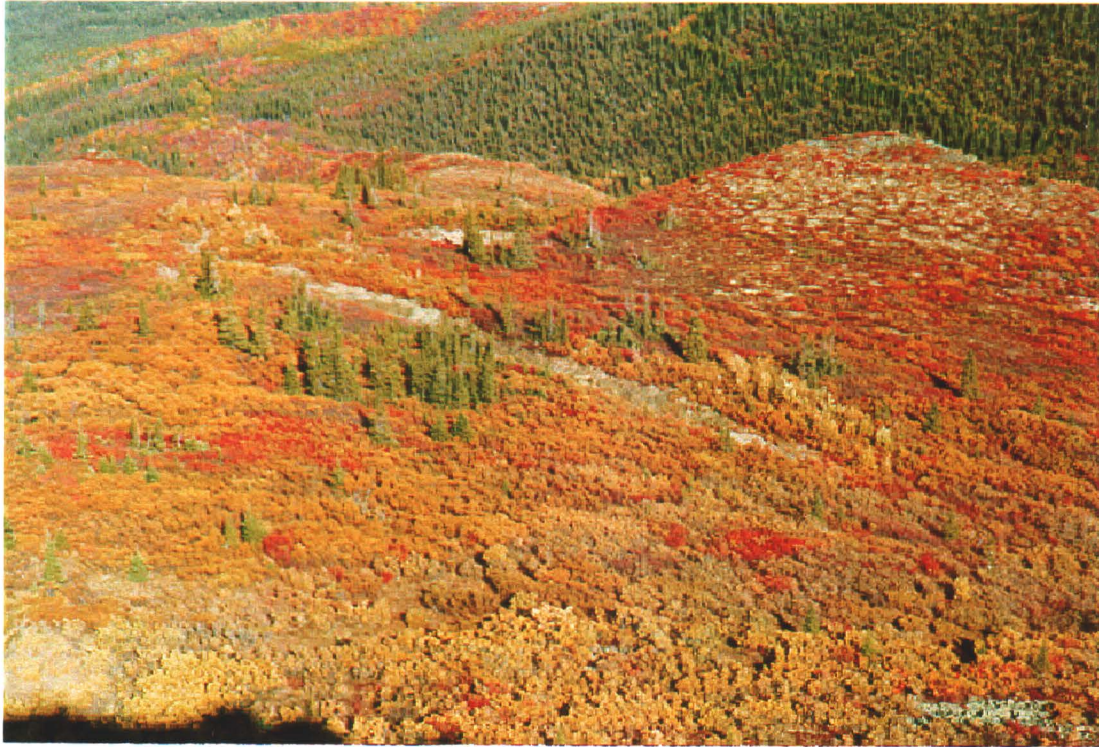
Trench 1 at the Cub and Bunny site lies on a plateau below the Upper Faro Gulch Trail to the north (photo 30-1). Pit 1 lies just north of the trail at the top of a hill sloping northeast towards the trench and Faro Gulch. Surface water drainage runs down this slope towards Faro Gulch.

Photo 30-1: View of trench at Cub and Bunny site (Trench1) from above

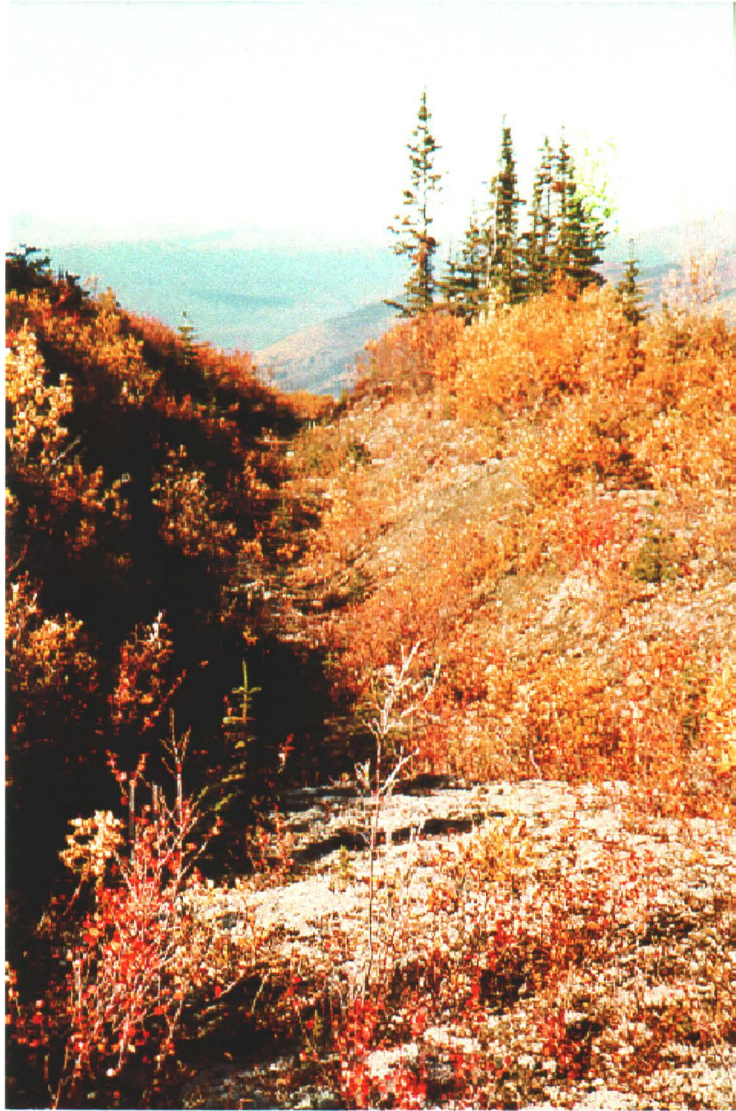
Trench 1 (photo 30-2)

Location: 300 m NW of Pit 1

Dimensions: 110 m x 2-4 m x 2 m – longitudinal bearing AZ 338

Condition: stable – 40% revegetated

Photo 30-2: View along length of Trench1. (Azimuth 338°)

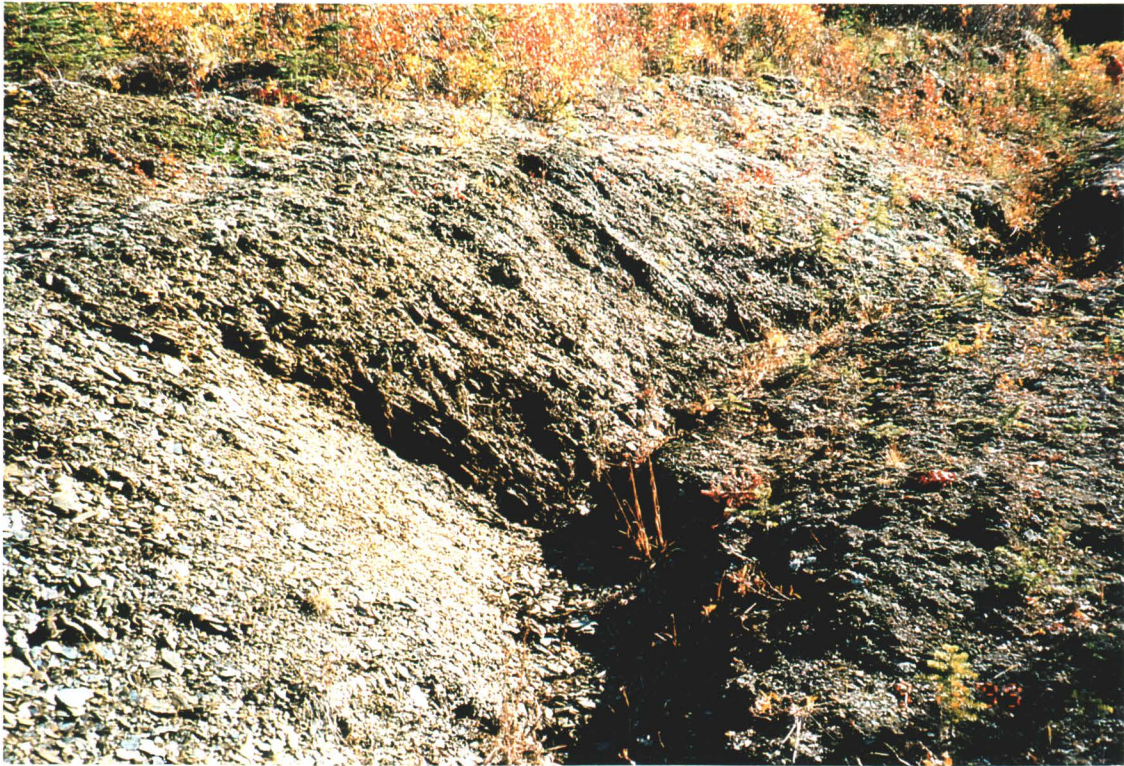
The major rock types observed at the Cub and Bunny site included grey biotite quartz phyllite and greenstone. Quartz siderite veining with disseminated fine-grained galena were evident in Pit 1. Traces of disseminated fine-grained pyrite were found in Trench 1. The minfile reports the presence of two parallel vein faults at the site. The western vein is reported to be hosted in greenstone and contain siderite, galena, freibergite and sphalerite; the eastern vein is reported to be hosted in sercite schist and graphitic phyllite (photo 30-3).

Photo 30-3: Exposed rock and soil inside of Trench1

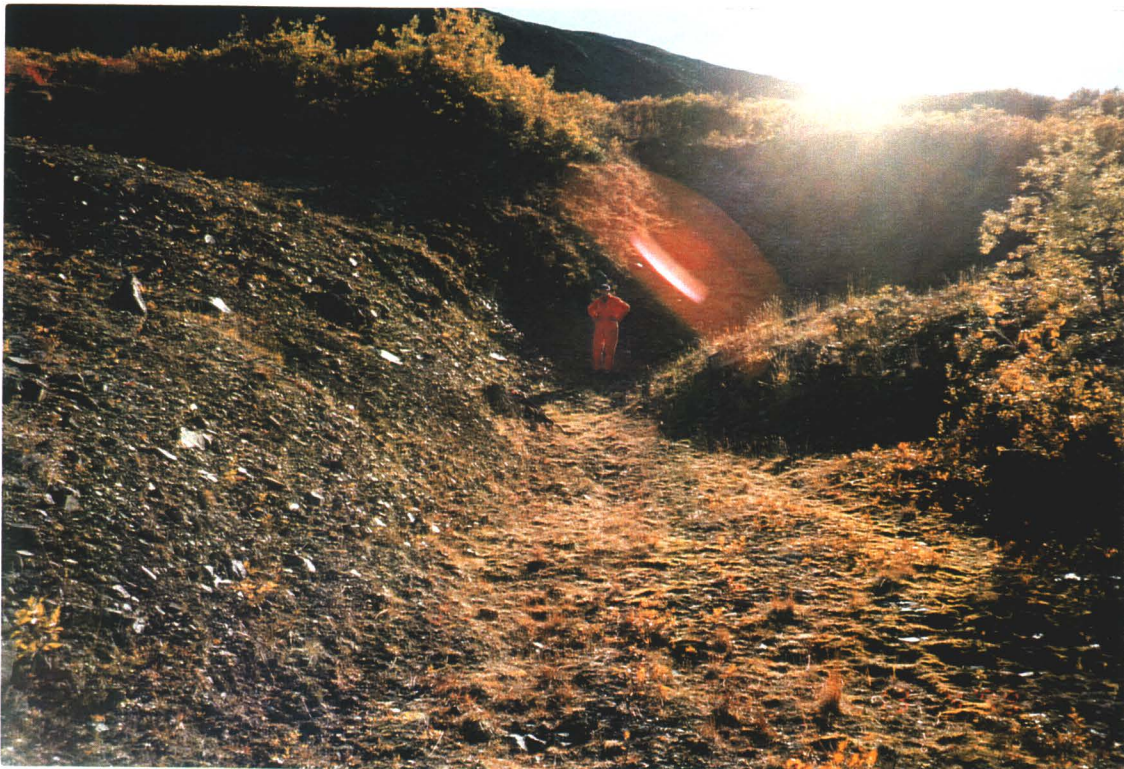
Pit 1 (photo 30-4)

Location: 100 m north of Upper Faro Gulch Trail, 1 km east of Lucky Queen site

Dimensions: 35 m x 5-10 m x 3 m

Condition: stable – 20% revegetated

A waste rock pile is located at the north end of Pit 1. The pile is 15 m long, 10 m wide and 3 m high. It consists mainly of broken rock and overburden with pieces up to 40 cm. 30% of the material has weakly rusted surfaces. The rusting is likely to be caused by ferro-magnesium minerals in greenstone. The paste pH of an undocumented rock sample taken of the waste rock pile was 8.0. The paste conductivity was 3.6 $\mu\text{S}/\text{cm}$. There is some natural reclamation of the waste rock pile the by moss and small shrubs.

Photo 30-4: View of Pit1 at Cub and Bunny site.
