NABOB #2
SITE #35
MINFILE # 105M 001as

One old shaft and a bulldozer trench were visited. No ore was processed at the site and no tailings were encountered. There is no wastewater treatment facility at the site. Site photos are located in Attachment 1 and laboratory results for sampling are in Attachment 2.

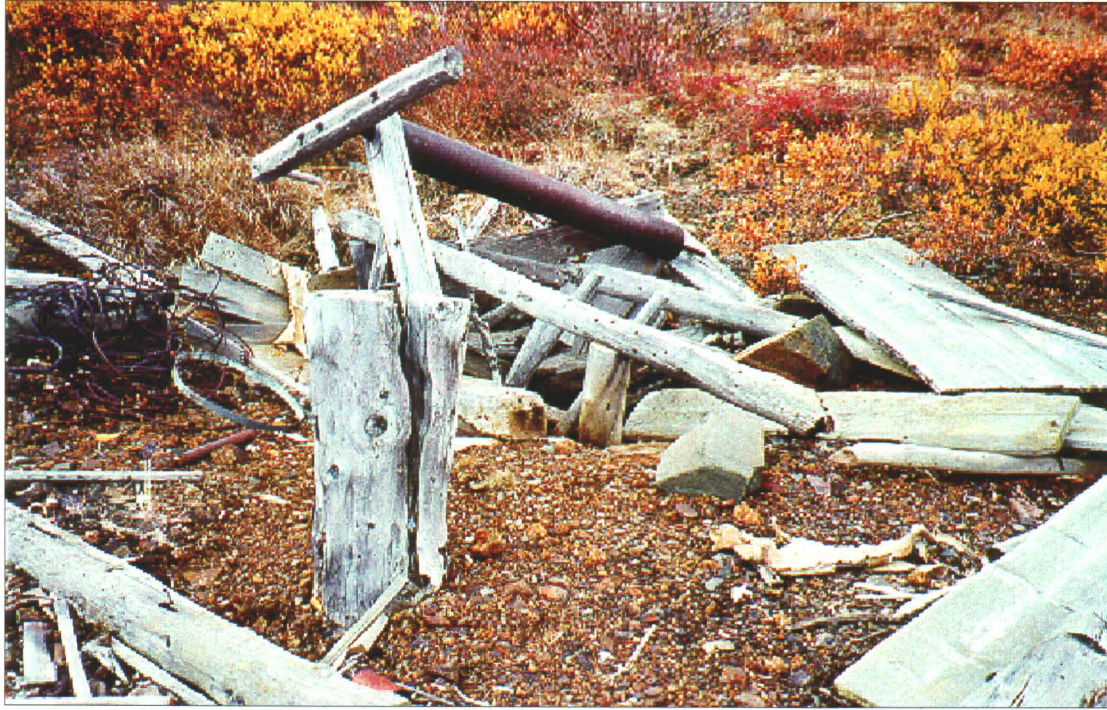
The 1.5m by 1.5m shaft is collapsed about 1m below surface. The log cribbing which supported the collar has broken and fallen into the shaft. There is a large windless above the shaft opening.

Photo 35-1 : Nabob #2. View of the collapsed Nabob #2 shaft. (Azimuth 050°)

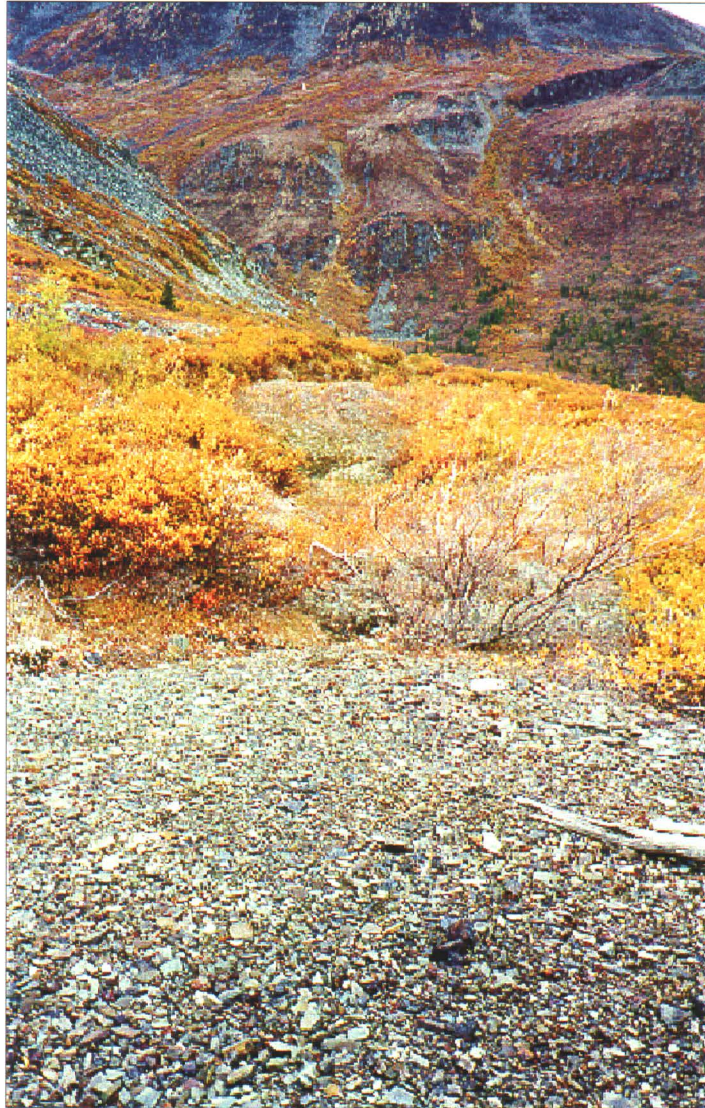
The bulldozer trench is excavated in greenstone with an irregular weak vein containing quartz and fresh to oxidized siderite. It is located approximately 65m to the southeast of the shaft.

Dimensions (L x W x H): 15m x 4m x 2m

Condition: The trench is shallow and poses no stability concerns.

There are roughly 160m³ of waste rock outside of the shaft. The waste rock is composed of greenstone and oxidized siderite with small pods of crystalline and gneissic galena. There was no surface water flowing over the waste rock at the time of the site visit. A sample (Nabob #2-Waste Rock-Sept.18/99) was collected for laboratory analysis. The field paste pH was 7.8 and the conductivity was 100µS/cm.

Photo 35-2 : Nabob #2. The waste rock pile from the shaft is in the foreground and Trench #1 is in the background. (Azimuth 230^o)

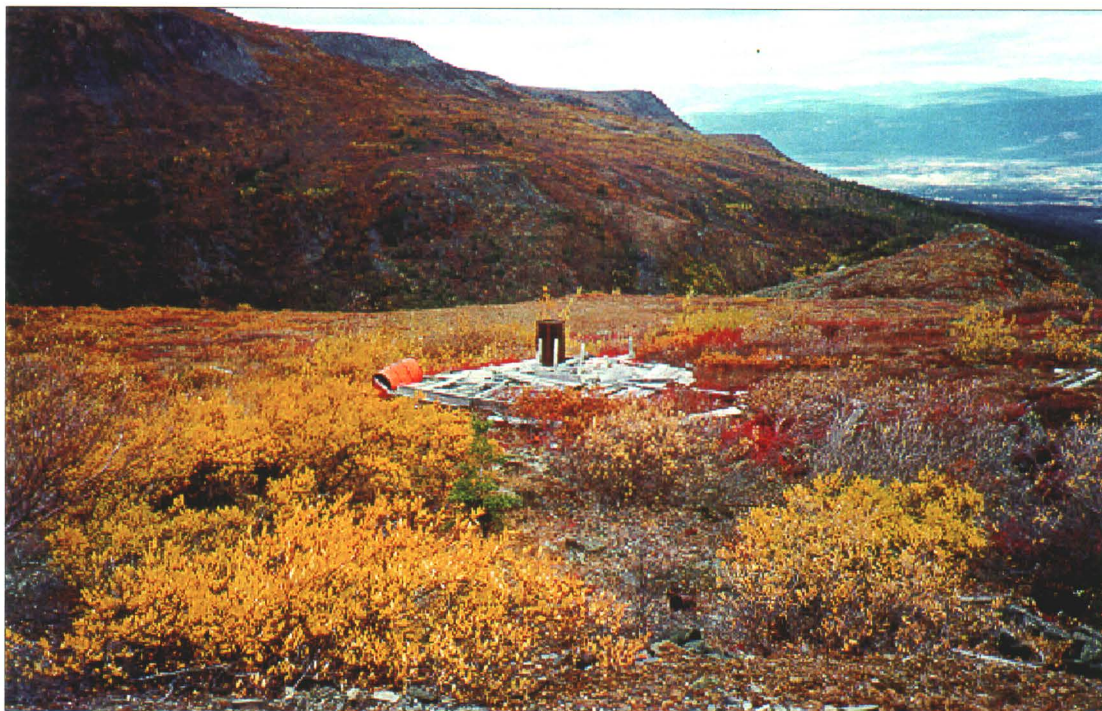
The remains of an old log cabin are located near the shaft. The building has completely collapsed.

Dimensions (L x W x H): 4m x 3m x 0.4m (current height)

Non-Hazardous Contents: There is an empty fuel drum and an old stove at the cabin site.

Photo 35-3 : Nabob #2. Building 35A, an old cabin foundation. (Azimuth 235 °)
