GOLD HILL NUMBER 2

SITE #37

MINFILE# 105M 001au

Public Works and Government Services Canada	Travaux publics et Services gouvernementaux Canada	designed by:	date:
	Architectural & Engineering Services Western Region		drawn by: C.S.	Nov. /99
Drawing title: Gold Hill No.2 Site #37 Site Assessment Yukon Territory		Titre du dessin:		revisions:
project no. no. du projet:	125-12.01	dig. no. dessin no.:	1 of 1

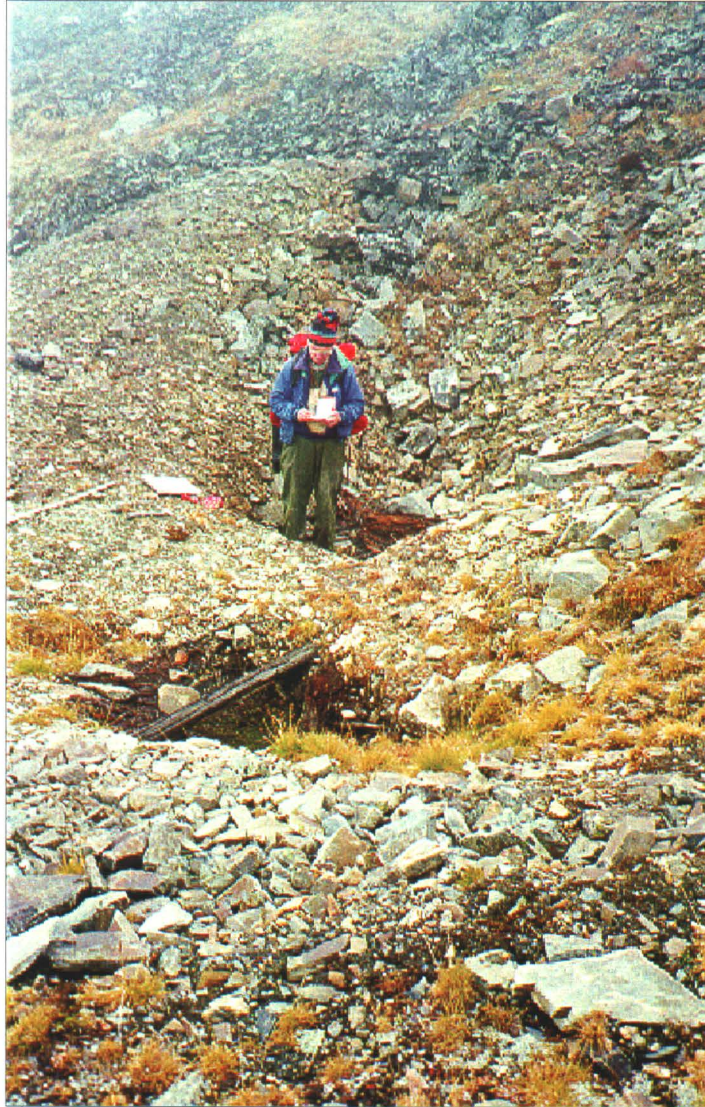
Gold Hill Number 2/Discovery Shaft (photo 37-1)

At the northeast end, beside the Discovery Showing, of the site is a 1.5m by 1.5m collapsed shaft. Waste and mineralized dump material beside the timbered collapsed discovery shaft suggest it is about 3m deep.

Supports: Log cribbing was used to support the collar of the shaft.

Condition: The log cribbing has rotted and the shaft is collapsed.

Accessibility: The shaft cannot be accessed.

Photo 37-1 : Gold Hill No. 2. View of the Discovery shaft and showing. (Azimuth320°)

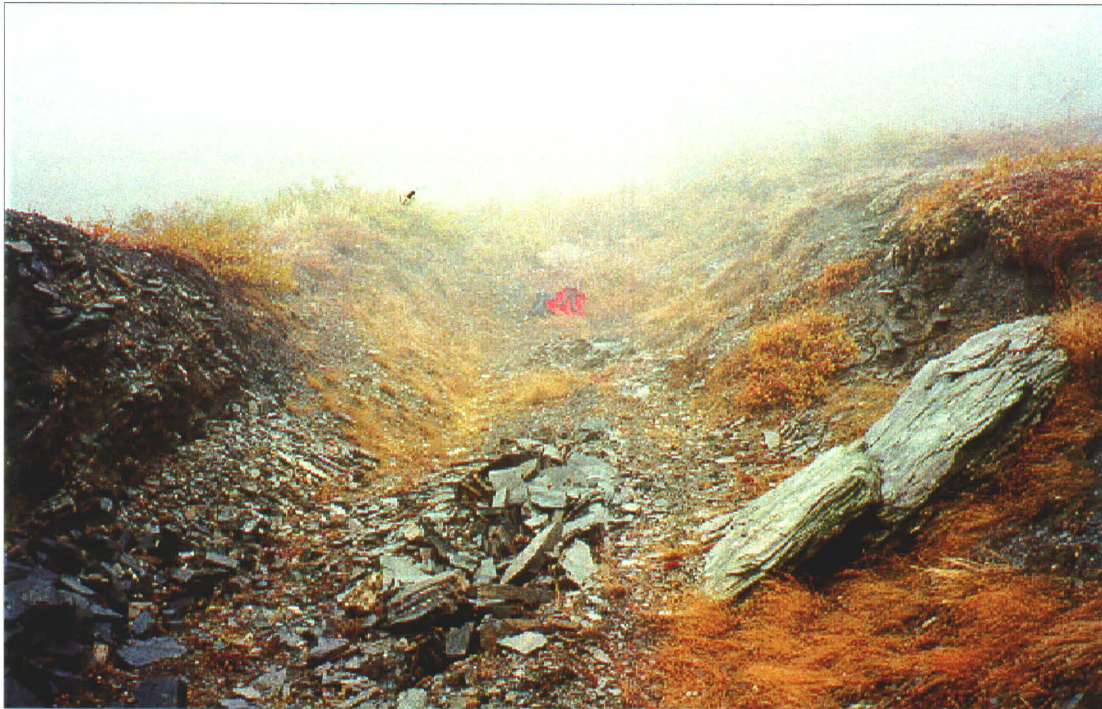
Trenches (photo 37-2)

There are twelve trenches at this site. The trenches are excavated from the Discovery Shaft and to the southwest for roughly a kilometer. The trenches range in size from 15m to 63m in length, 1m to 12m in width and 1m to 8m in depth. The gentle to moderately sloped walls of the trenches do not pose any stability concerns. All of the trenches could be easily accessed.

Photo 37-2 : Gold Hill No.2. View of Trench #5. (Azimuth 340°)

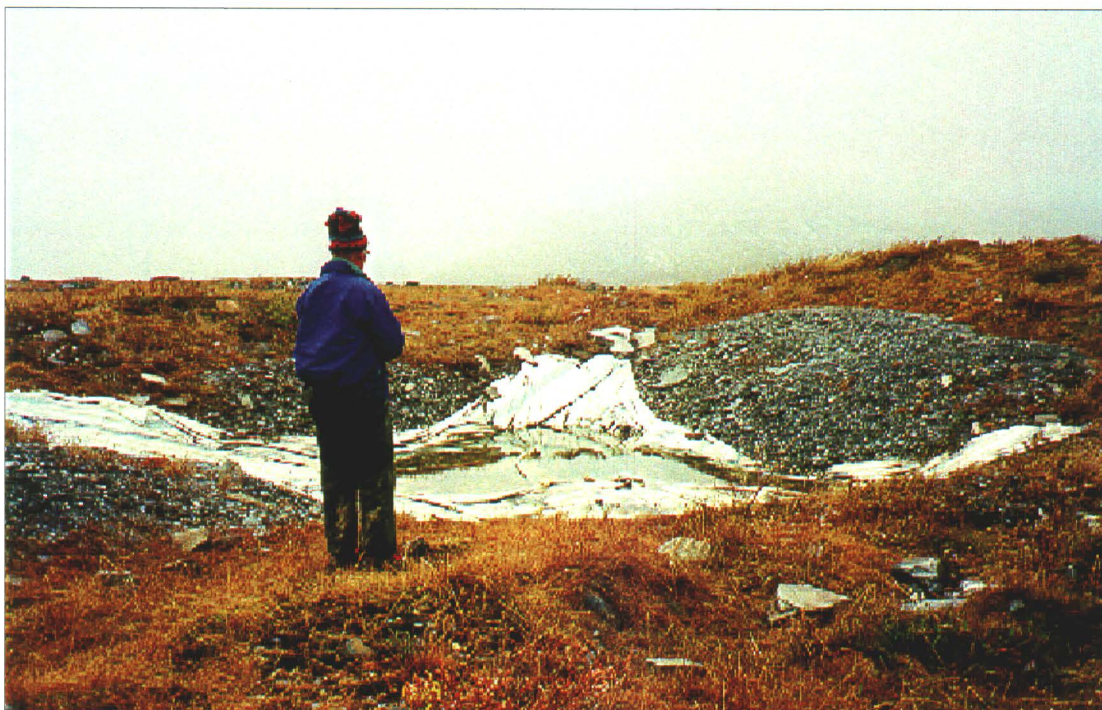
There are no buildings at the Gold Hill Number 2 site. On the western side of the Monument Hill Trail, there is a 10m x 10m x 2.5m sump (photo 37-3) lined with old style geotextile that was used for holding drill water. A hose leads from the sump to a metal tank at trench #4 (photo 37-4). No other mine site infrastructure was encountered at the site.

There was no water in any of the trenches at the time of the site visit. A lined pond (photo 37-3) is located to the west of the Monument Hill Trail.

Photo 37-3 : Gold Hill No.2. Lined sump used for holding water for diamond drilling.
(Azimuth 280°)

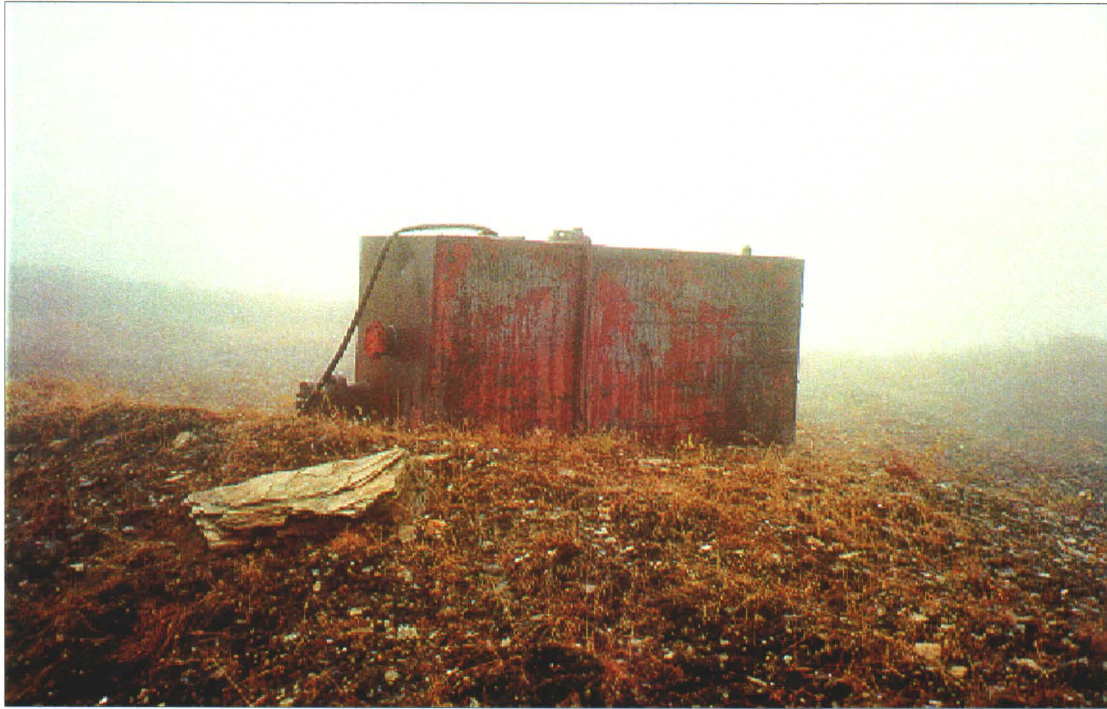
Photo 37-4 : Gold Hill No.2. Metal water tank near Trench #4. (Azimuth212°)
