**AVENUE (#69)**  
**MINFILE# 105M 053**

**1. LOCATION AND ACCESS**

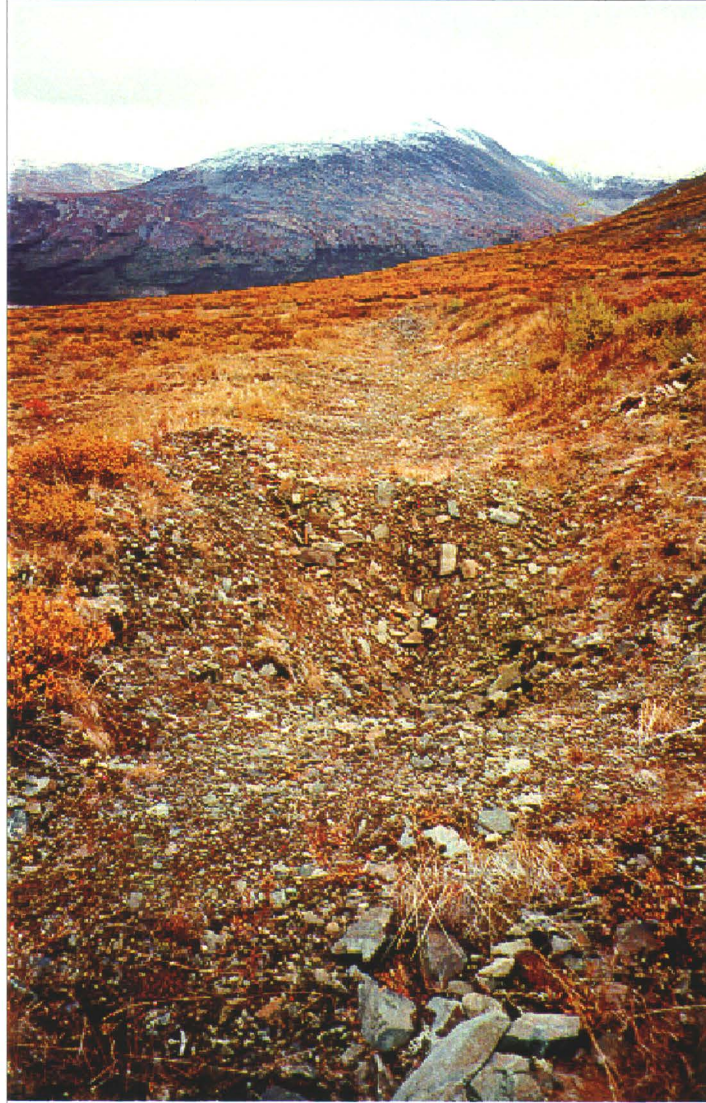
Shallow trench with a small pit at the NW end (photo 69-3)

Dimensions (L x W x H): 78 m x 4 m x 1 m – longitudinal bearing AZ 330

Condition: stable - 30% revegetated

Photo 69-3: View along length of Trench 2 with small pit in foreground. (AZ 149)

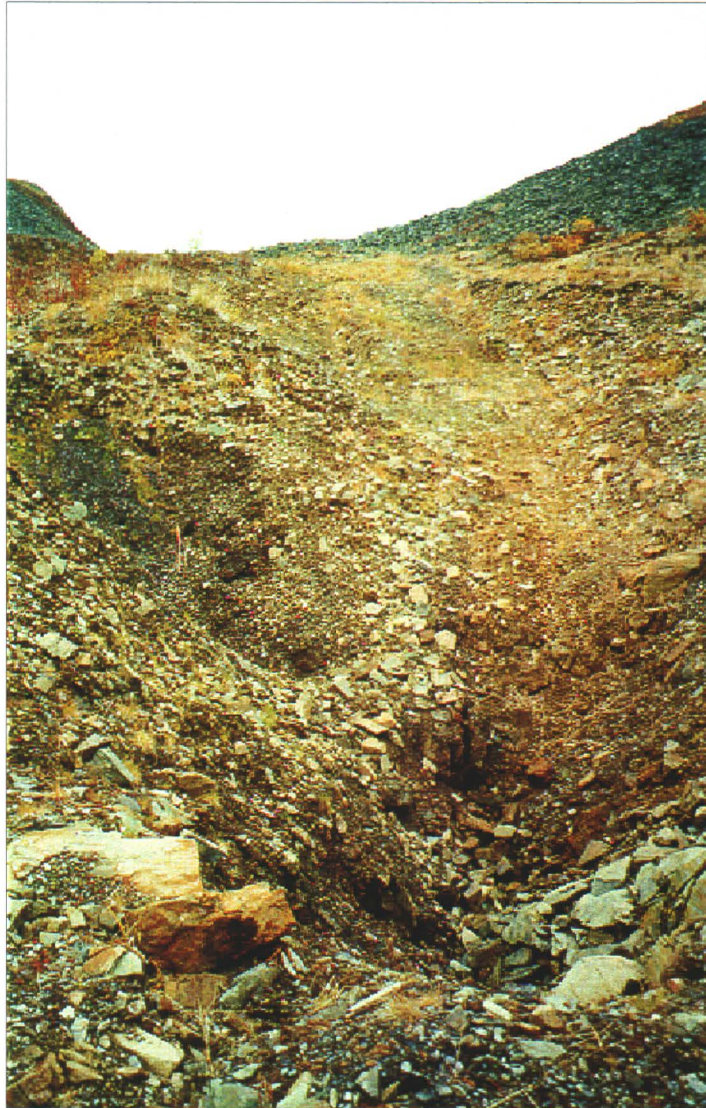
Narrow pit

Dimensions (L x W x H): 6 m x 3 m x 3 m – longitudinal bearing AZ 260

Condition: stable – gentle slopes are 30% revegetated

Photo 69-4: View of Pit 1 at Avenue site. (AZ 266)

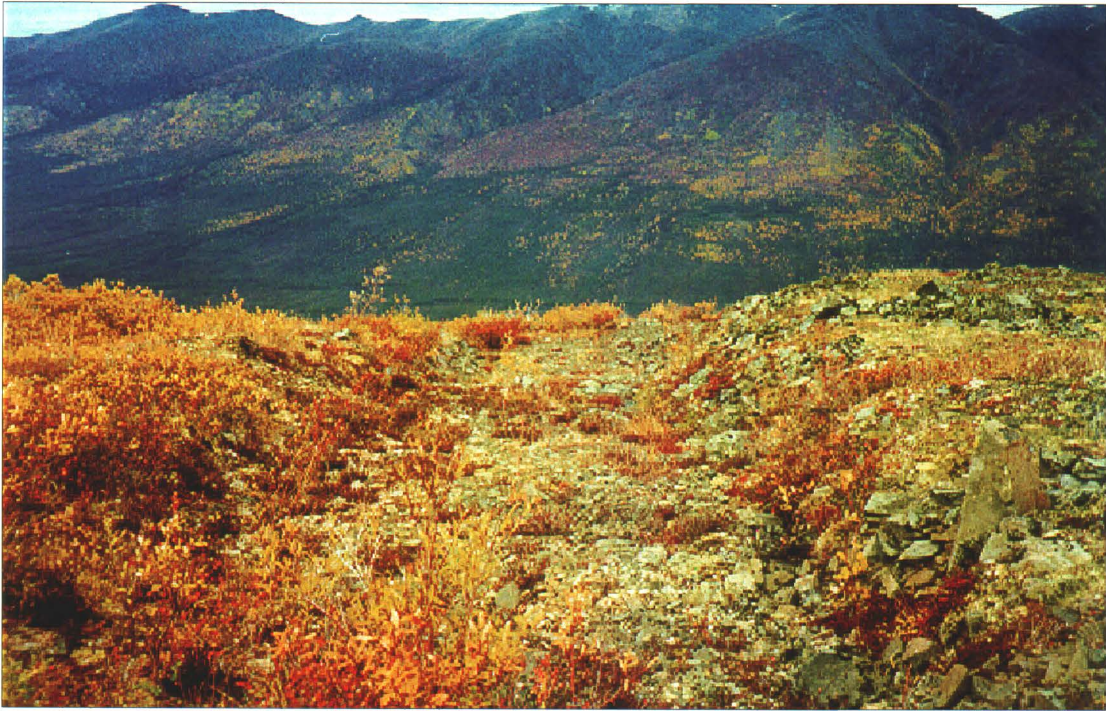
Trench

Dimensions (L x W x H): 30 m x 3 m x 1.5 m

Condition: stable - 70% revegetated

Photo 69-6: View about NNW along length of Trench 6.

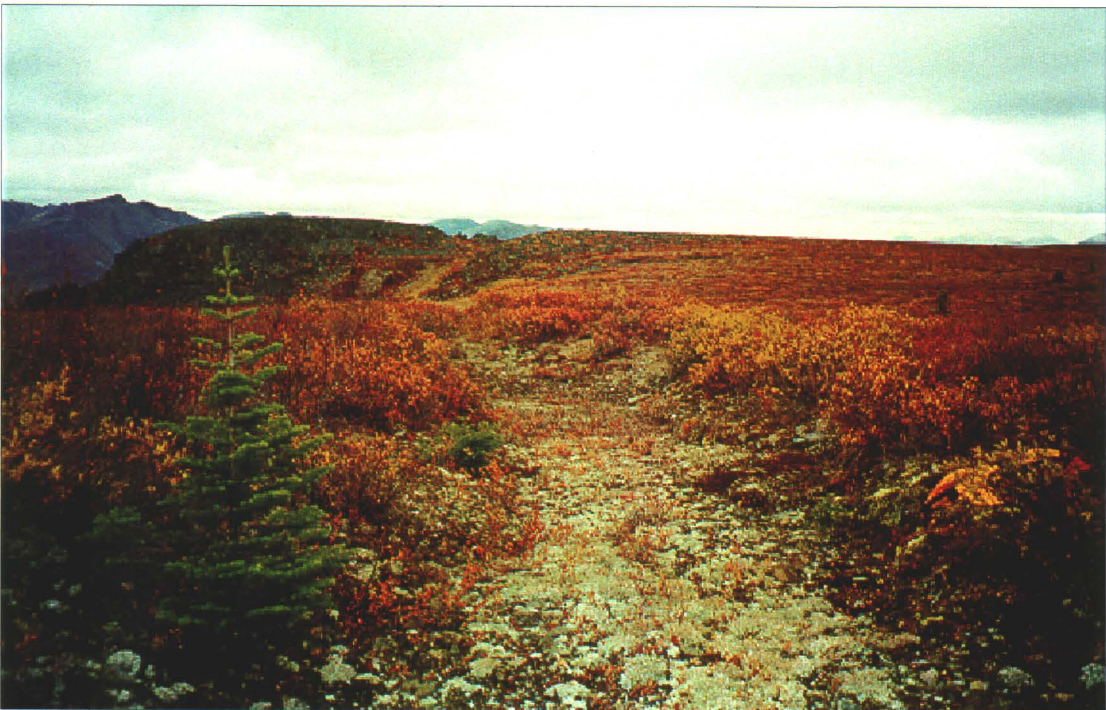
Trench

Dimensions (L x W x H): 30 m x 2.5 m x 1 m – longitudinal bearing AZ 33

Condition: stable - 70% revegetated

Photo 69-7: View along length of Trench 8. (AZ 033)
