HOMESTAKE
SITE #50
MINFILE# 105M011

Public Works And Government Services Canada Travaux publics et Services gouvernementaux Canada Architectural & Engineering Services Western Region	designed by: _____ date: _____ concu par: _____ drawn by: C.S. Nov. / 99 dessiné par: _____ approved by: _____ approuvé par: _____ revisions: _____
	Drawing title: Homestake Site #50 Site Assessment Yukon Territory

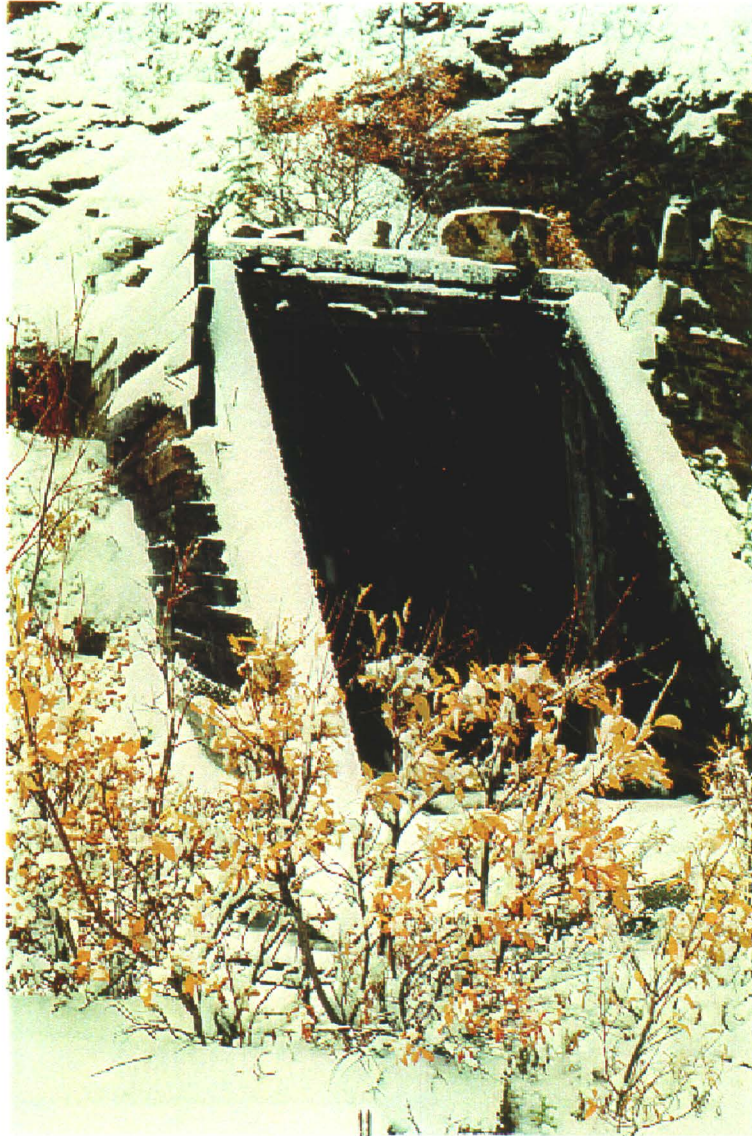
There is a level, cleared area outside of the portal. A 10m long wooden structure protects the entrance to the adit. Railway tracks are still in place within the wooden structure and along the level ground to the east. There was a small amount of fiberglass insulation and metal piping found within the wooden structure.

Supports: Timber and concrete support the portal.

Condition: The portal entrance and the wooden structure appear stable. The condition of the adit is unknown, however there is no evidence of subsidence of the adit from the surface.

Accessibility: The portal entrance is boarded up and cannot be accessed.

Photo 50-1: The large wooden structure is the portal to the Homestake adit. (Azimuth 225°)

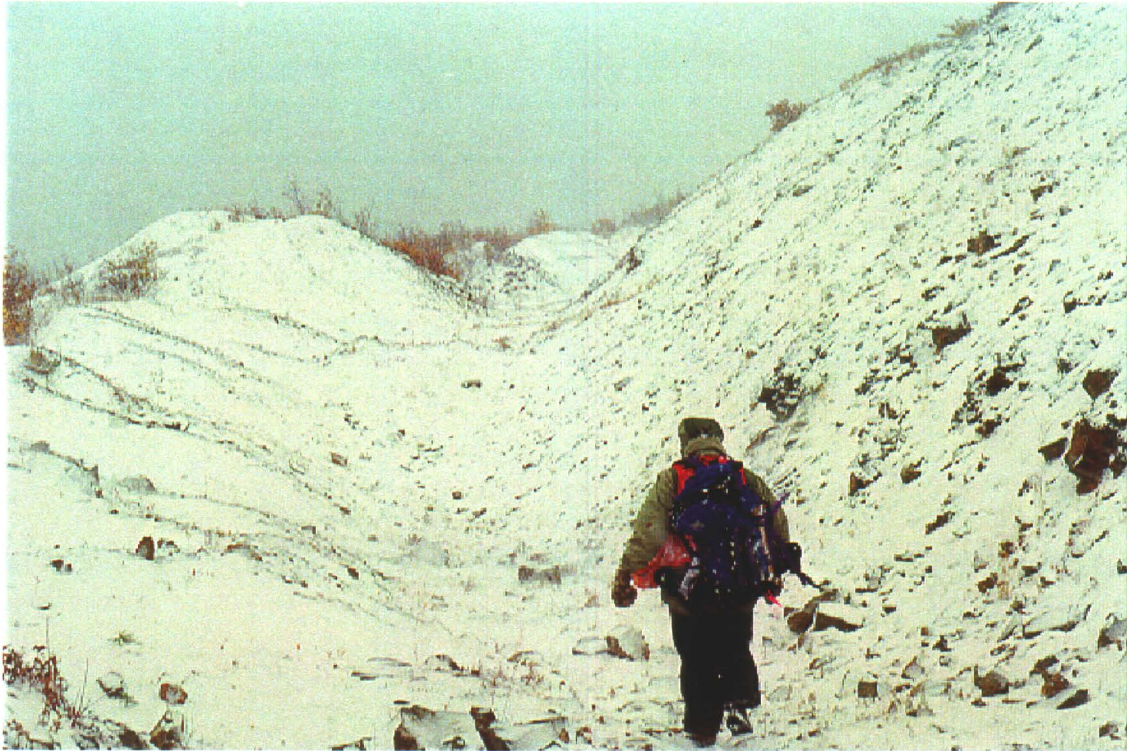
This trench is oriented downslope northeast-southwest and is largest of the four trenches. Outcrop is exposed on both sides of the trench walls, however the southeastern wall is much higher. The walls are composed primarily of quartzite and small zones of quartz-carbonate veining. A pile of chlorite schist boulders is exposed near the top of the trench, on the west side.

Dimensions (L x W x H): 330m x 75m (at the widest point) x 4.5m (at the highest point)

Condition: Some fragments have broken off the trench walls and been deposited on the trench floor, however the walls appear stable.

Photo 50-2: Trench 1, the largest trench at the site. (Azimuth 235°)

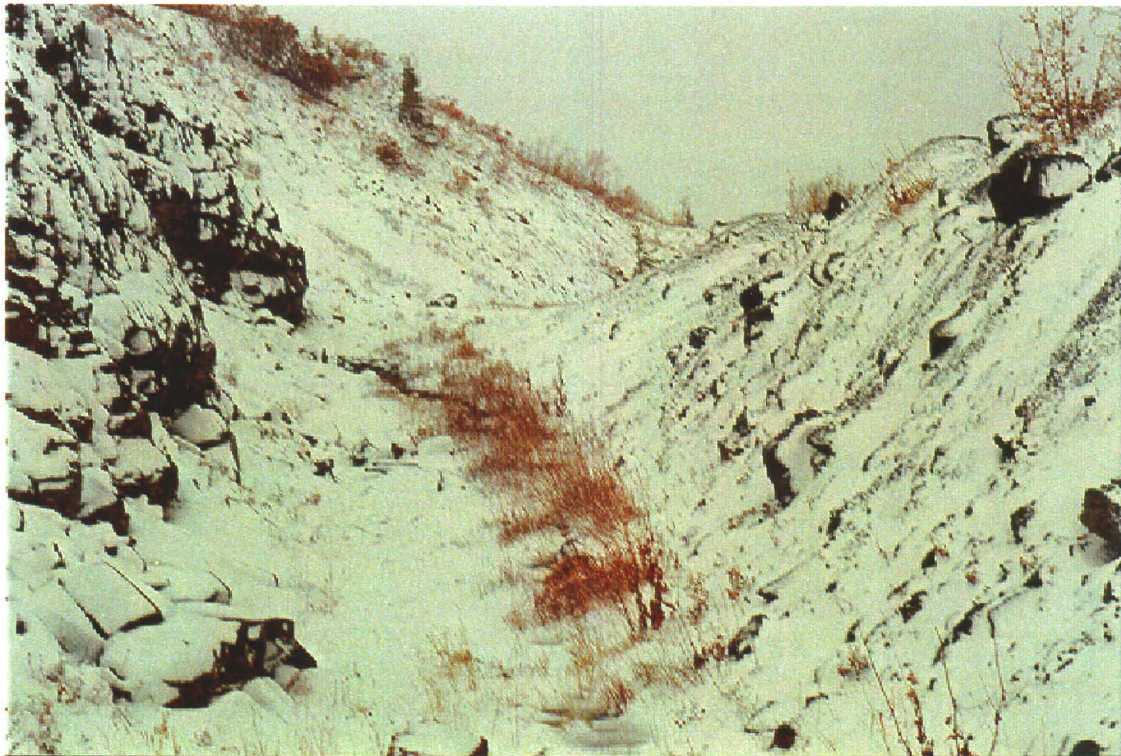
Trench 4 is excavated across slope, downslope of the other 3 trenches. Quartzite outcrop is exposed on the southern side of the trench and a waste rock pile is on the northern side. Long grass grows in the bottom of the trench; no other vegetation grows within the trench.

Dimensions (L x W x H): 142m x 25m (at the rim) x 4.0m

Condition: Big blocks of rock have broken off the southern trench wall.

Photo 50-3: Trench 4. Note the high trench walls on the left and waste rock pile #2 on the right. (Azimuth 260°)

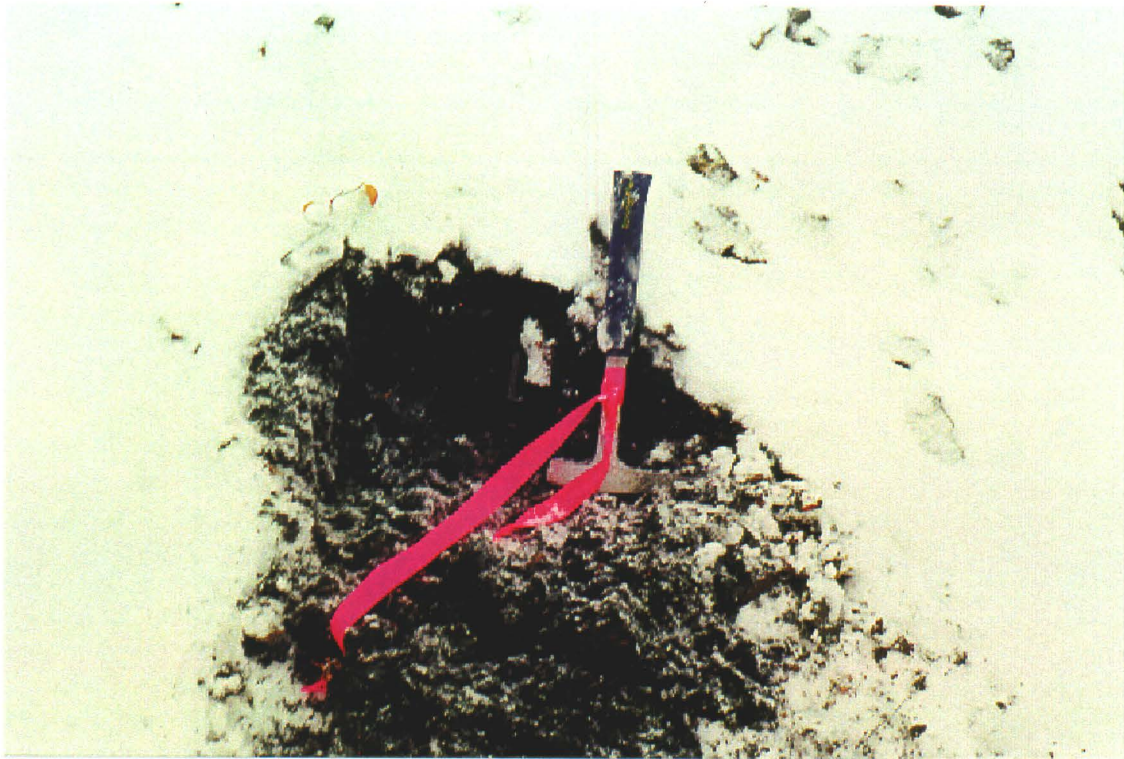
The source of the waste rock in this pile is from the excavation of Trench 1. Due to weather constraints, the overall geology of the waste rock could not be determined. The rock fragments found in the test pit were mostly quartzite and minor amounts of unmineralized quartz vein and schist fragments with roughly 20% overburden. There was minor iron (Fe) staining on the surface of the waste rock pile; there is no evidence of oxidation below the surface. The pile is bimodal ranging in grain size from silt to cobble sized.

Sampling: A 30cm test pit was dug and sample #Home-WR-01 was collected (photo 50-4).

Photo 50-4: Test pit 1, waste rock pile #1. Note there is no oxidized horizon, only minor Fe-staining at the surface. (Azimuth 350°)

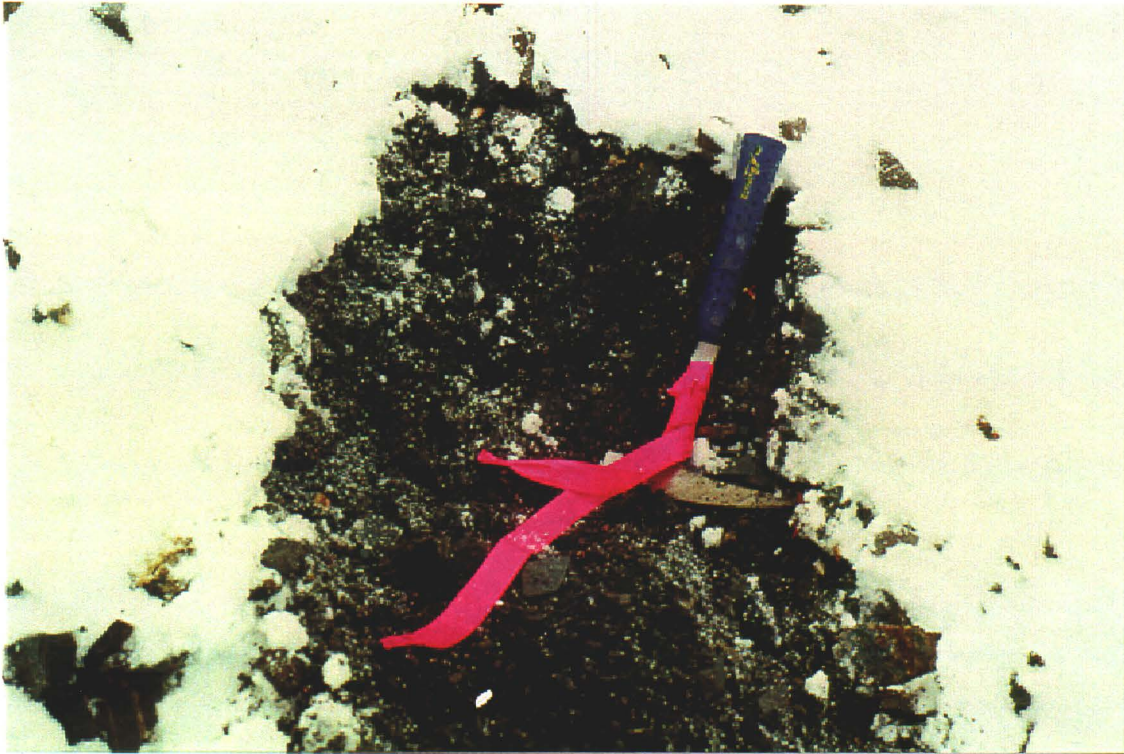
The waste rock has been excavated from Trench 4 and is similar in characteristics as waste rock pile #1.

Sampling: A 30cm test pit was dug and sample #Home-WR-02 was collected (photo 50-5)

Photo 50-5: Test pit 2, waste rock pile #2, minor Fe-staining at the surface. (Azimuth 000°)

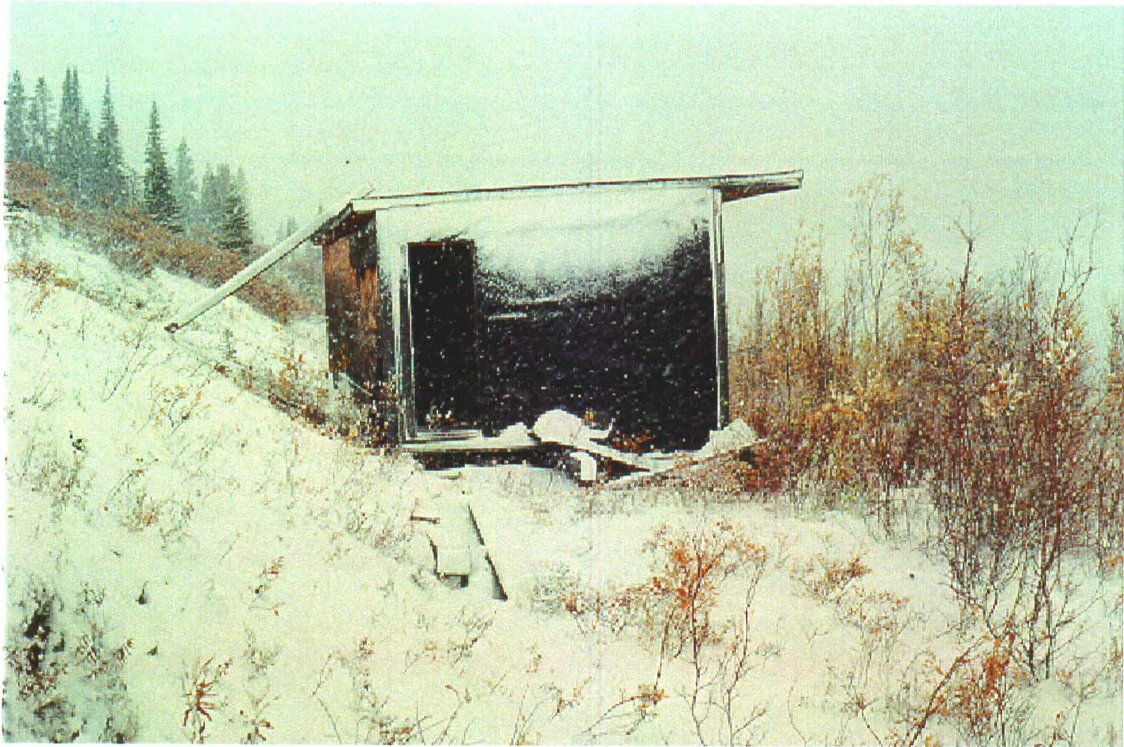
Dimensions (L x W x H): 17m x 4m x 3m

Construction: wood sheeting

Non-Hazardous Contents: sink, toilet, table, metal bedframe, shelves, diesel stove

Photo 50-6: Building 50A with a small pile of wood debris out front (Azimuth 270°)

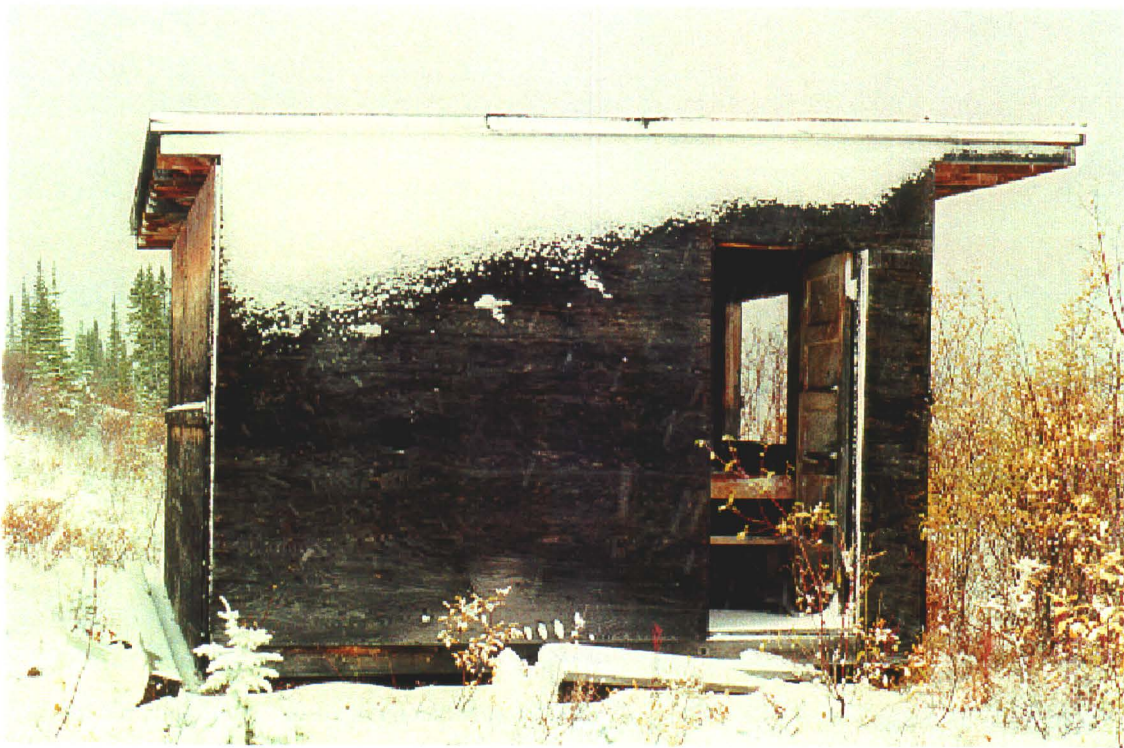
Dimensions (L x W x H): 3.5m x 3.5m x 3.0m

Construction: wood sheeting

Non-Hazardous Contents: table, benches, and clothes

Photo 50-7: Building 50B, the table is visible through the doorway. (Azimuth 270°)

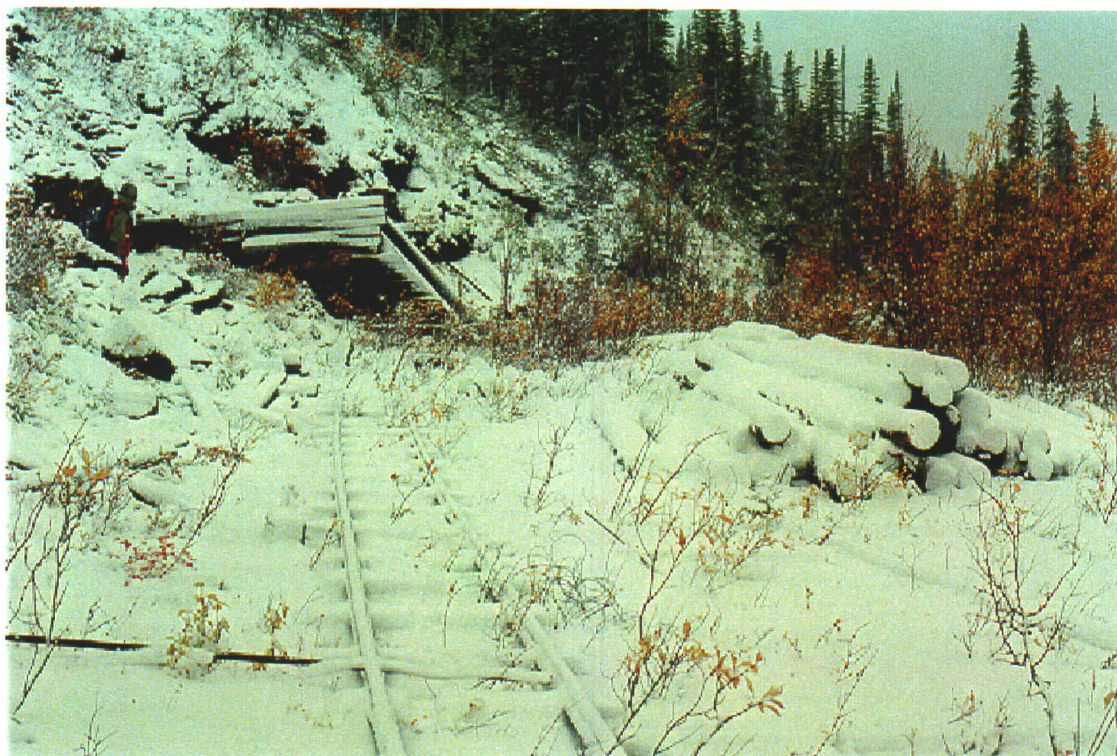
There were two small lengths of rail encountered. The first comes goes from the portal to the end of the wooden structure. The second section is to the east of the adit, in the level clearing. No trestle was encountered.

Fabrication: steel rail and wooden ties

Amount of materials: The total length of rail is approximately 35m.

Condition: The ties are in good condition, the rail has begun to rust.

Photo 50-8: Rail and ties, old poles on right and portal to adit in the background. (Azimuth 270°)

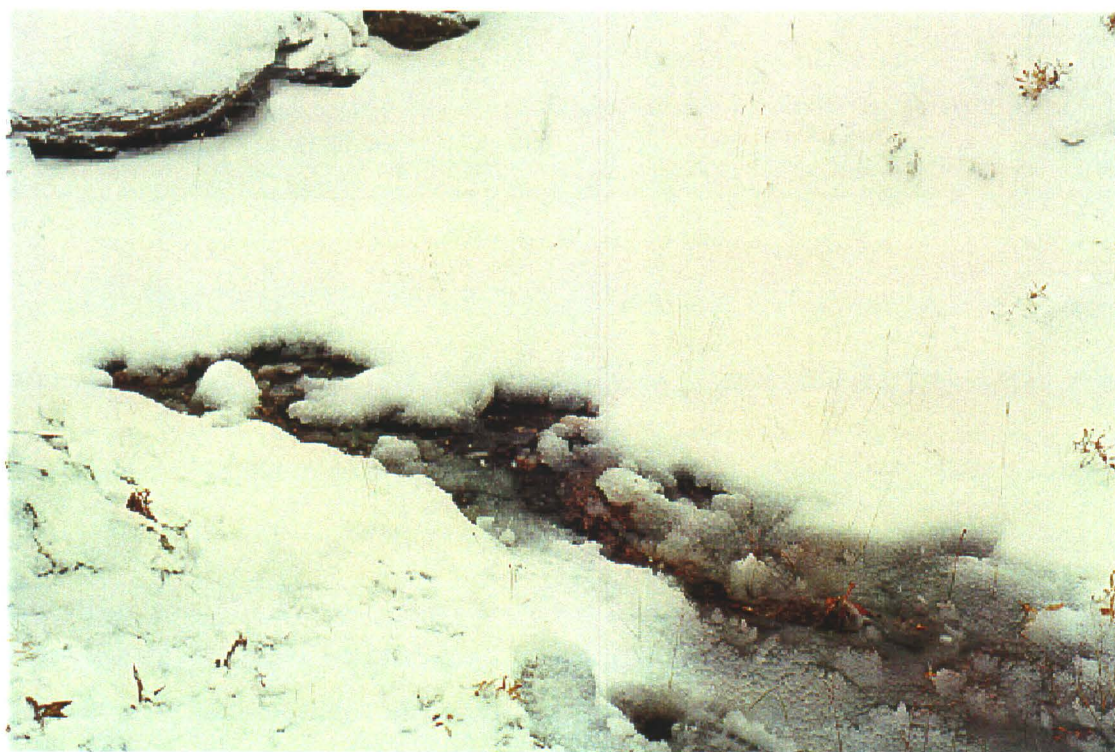
There were two small streams encountered at this site. The beginning of one stream seeps out of the top of Trench 1, following the base of the trench before seeping back into the ground 30m later (photo 50-9). A water sample (Home-WQ-US-01) was collected at the top of the stream. The water had no visible particulates and did not appear to be depositing any sediment. The flow rate was less than 1 L/s (visual estimation). The second stream exits the Homestake portal flowing at a rate of less than 1 L/s (visual estimation). A sample was collected (Home-WQ-02) from just outside the portal. The water has no visible particulates and does not appear to be depositing sediment. The stream continued downhill.

Photo 50-9: Water sample site for HOME-WQ-US-01 (Azimuth 240°)
