**GERLITSKI**  
**SITE #63**  
**MINFILE# 105M026**

**1. LOCATION AND ACCESS**

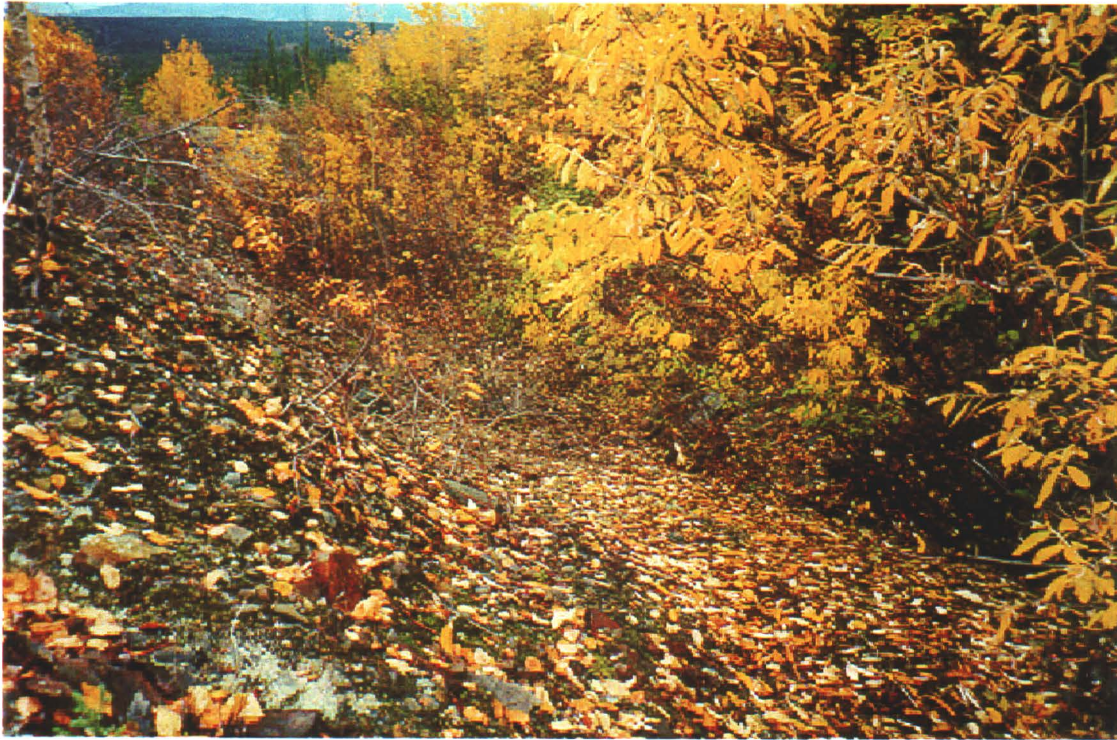
Trench 1 has exposed bedrock along its eastern side; the western side is much lower and has been covered with waste rock piles. The southern end is narrow and overgrown with alders and bushes. There is a clearing at the northern end; core boxes and small pieces of core scattered in this open area indicate that the trench was drilled (photo 63-2).

Dimensions (L x W x H): 242m x 2.5m x 2m (maximum width and height)

Condition: The trench walls are nearly vertical but not very high. At the time of inspection the walls appeared stable, however there is a small volume of rock debris on the trench floor that has broken off.

Photo 63-1: Trench 1 with waste rock pile #2 on left side. (Azimuth 070°)

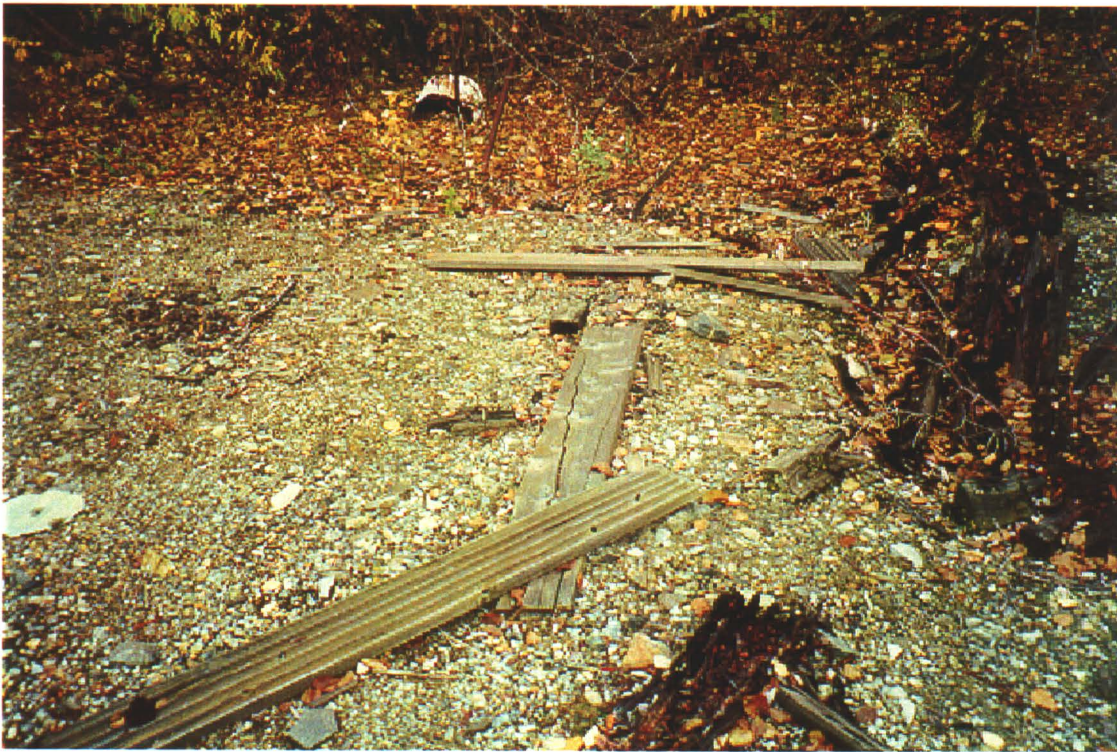
Photo 63-2: Core boxes and other debris lying in trench 1. (Azimuth 170°)

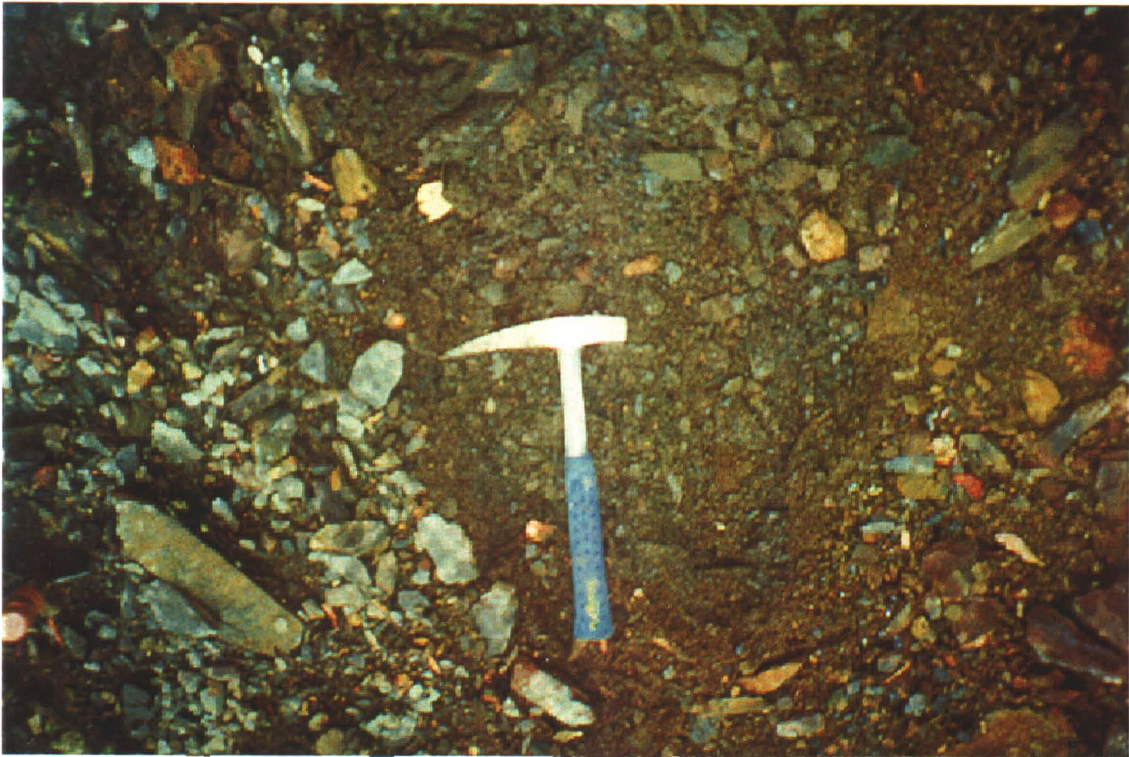
This is the highest of the waste rock piles and it is sparsely vegetated with small spruce trees and bushes. The waste rock is from Trench 1 and is composed of predominantly quartzite and some mineralized (3-5% disseminated pyrite and trace amounts of other sulphides) quartz veining; roughly 20% of the waste rock is overburden. It also contains minor amount of sandstone and schist.

Sampling: A 30cm deep test pit was dug and sample #63-02-waste was collected (photo 63-3). The surface 2-4mm of the waste rock pile is oxidized but there is no oxidation observed occurring below this surface layer. The waste rock is bimodal; grain size is from sand to cobble sized. The field pH of the sample was 6.8 and the conductivity was 26 uS/cm.

Photo 63-3: Test pit from waste rock pile #2. Note the shallow oxidation horizon. (Azimuth 170°)

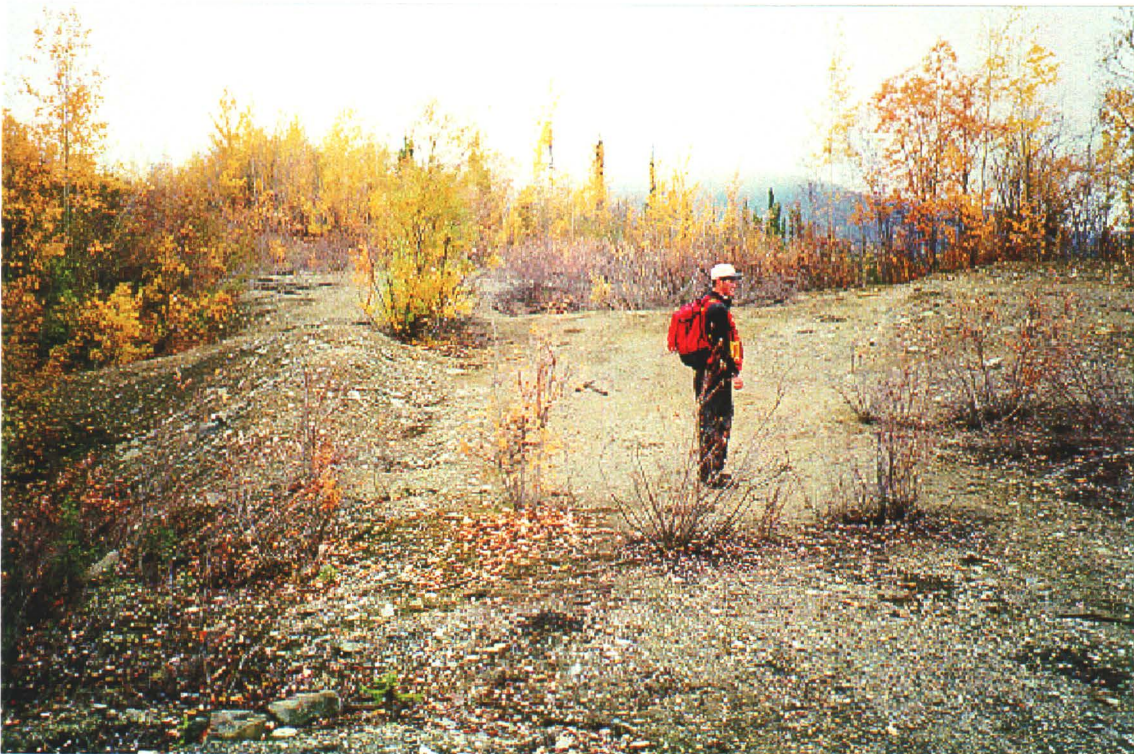
This waste rock pile has been leveled to an average width of roughly 1m to form a large cleared area. The waste rock in this pile was excavated from the northern half of Trench 1. It is composed of predominantly of unmineralized quartzite and overburden. The pile has small areas of quartzite and quartz veining with higher mineralization and with stronger iron (Fe) staining. Besides a few clumps of grasses, very little vegetation is growing on this pile.

Dimensions (L x W x H): 65m x 45m x 1m

Photo 63-4: The large, leveled area is Waste rock pile #3, trench # is to the right just off the photo. (Azimuth 080°)

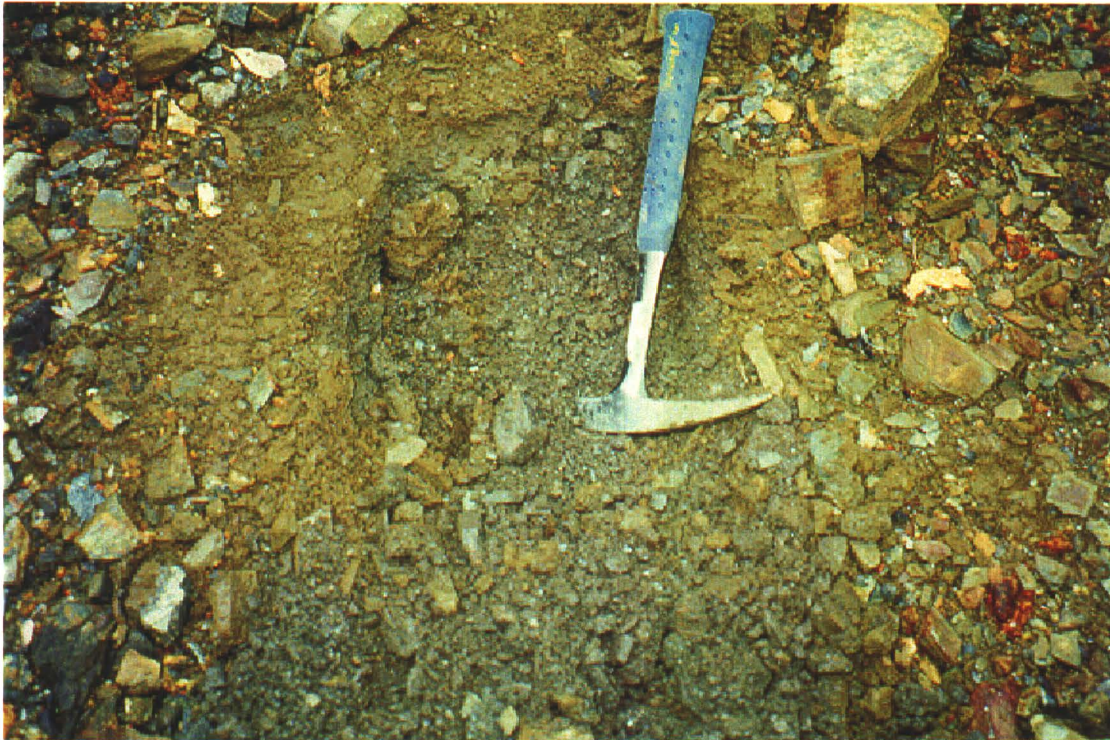
Sampling: A 30cm test pit was dug in an area of stronger Fe-staining and sample #63-01-waste was collected (photo 63-5). The waste rock was oxidized at surface but there is no oxidation occurring below surface. The waste rock is bimodal; grain size is from sand to cobble sized. The field pH of the sample was 5.5 and the conductivity was 510 uS/cm.

Photo 63-5: Test pit from waste rock pile #3. Note the oxidation at the surface of the pit.  
(Azimuth 240°)
