MOON
SITE #66
MINFILE# 105M 046

Public Works And Government Services Canada Travaux publics et Services gouvernementaux Canada Architectural & Engineering Services Western Region	designed by: conce: per: drawn by:	date: C.S. Nov. /99
	approved by: approuve per: revisions:	project no. no. du projet:
Drawing title: Moon Site #66 Site Assessment Yukon Territory	Titre du dessin:	125-12.01 1 of 1

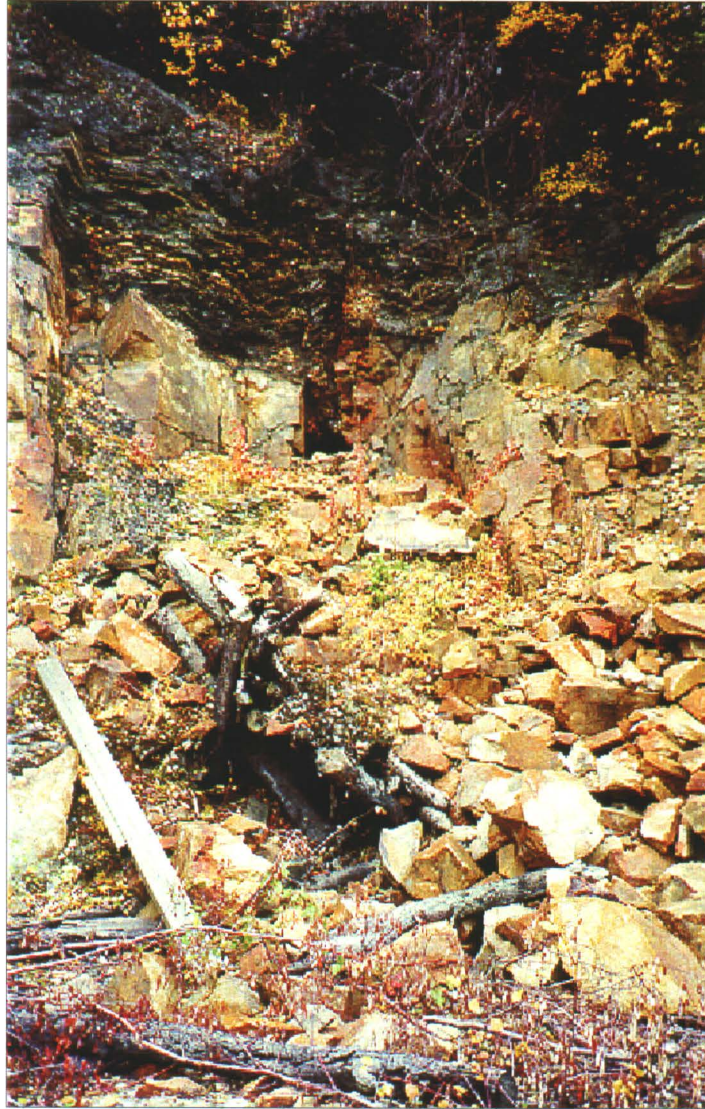
Moon Adit (photo 66-1)

The adit is located at the north end of the site area, 120m north of the campsite area. The portal and the first 10m of the adit have collapsed.

Supports: Log cribbing supported the portal.

Condition: The log cribbing is broken up and has collapsed. The first 10m of the adit has caved-in. The ground above the remainder of the adit appears stable.

Accessibility: The adit can still be accessed by an opening exposed by the cave-in.

Photo 66-1 : Moon. The first 10m of the portal structure into the Moon adit has collapsed. (Azimuth 216°)

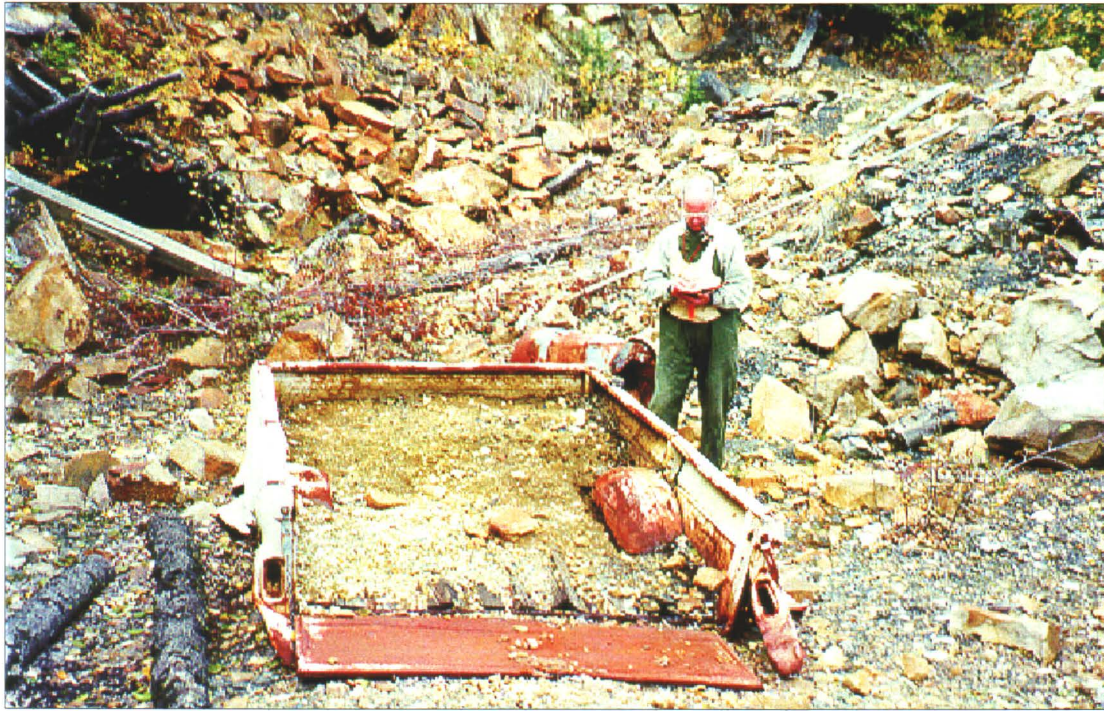
5.2 Waste Rock Disposal Areas (photo 66-2)

There is a waste rock pile located near the entrance to the adit. Mineralized vein material on the dump has quartz and minor siderite gangue, often containing abundant pyrite and lesser amounts of chalcopyrite, sphalerite, arsenopyrite and galena. Oxidization is absent to very weak. On the waste rock pile are metal drums and a truck box containing sorted highly oxidized vein material are likely ore stockpiles. A waste rock sample (Moon-waste rock-Sept 18/99) was collected for analysis. The field paste pH was 3.6 and the conductivity was >1000 μ S/cm.

Thick second growth vegetation of willows and alders has revegetated the disturbed ground in most areas. Small bushes are growing on the adit cave-in and the waste rock pile. The ore stockpile is in the bed of a truck and therefore has no vegetation growing on it.

Photo 66-2 : Moon. Ore stockpiled in a truck box, portal structure in the background. (Azimuth 275°)

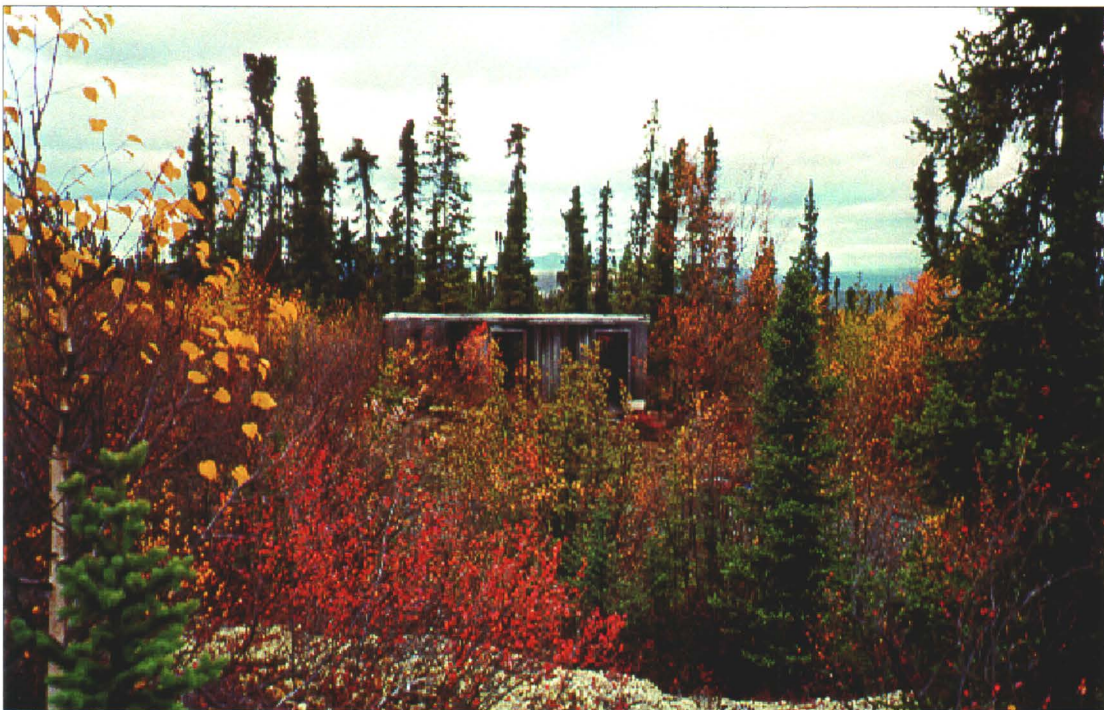
Building 66A (photo 66-3)

There is a flat roofed wooden shack located on the west side of the site. The building was likely used as sleeping quarters.

Asbestos: The roof is covered in asphalt asbestos roofing.

Non-Hazardous Contents: The shack was filled with non-hazardous debris such as glass and metal.

Photo 66-3 : Moon. Building 66A, most likely it was used as sleeping quarters. (Azimuth 315°)

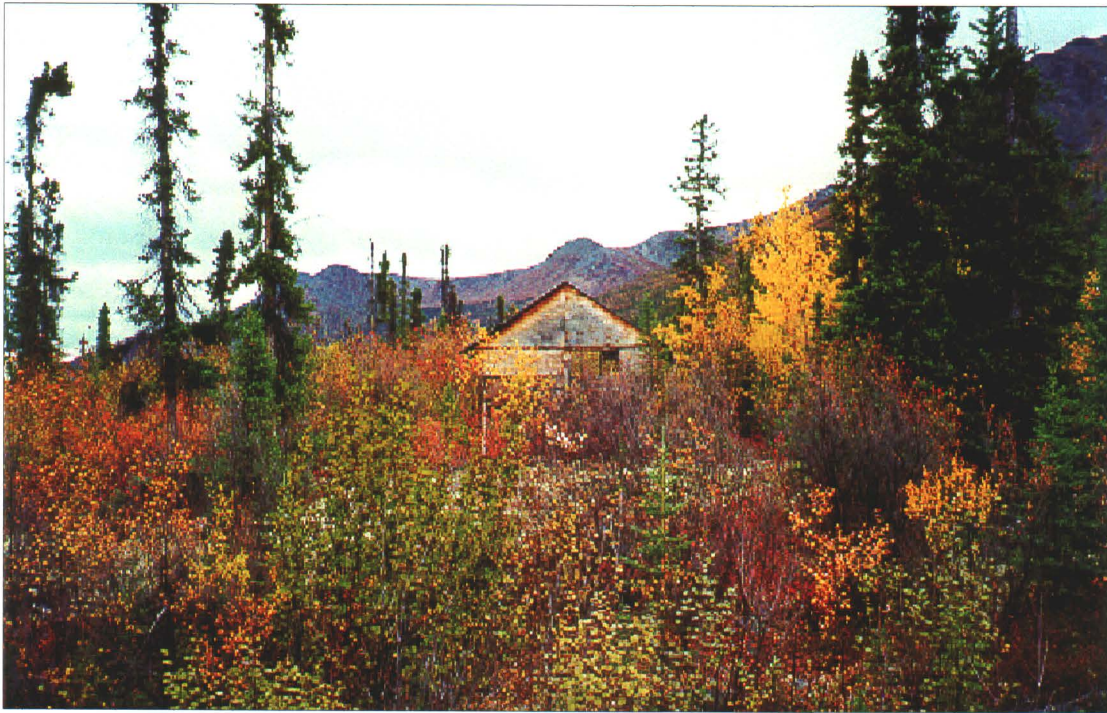
Building 66B (photo 66-4)

This peaked plywood and stud frame building is located 29m east of building 66A. It appears to have been a workshop.

Non-Hazardous Contents: Inside the building there is assorted non-hazardous debris such as glass and metal and an empty 45-gallon drum.

Hazardous Contents: Inside and scattered outside there are three truck batteries and other car parts.

Photo 66-4 : Moon. Building 66B, possibly it was a workshop. (Azimuth 135°)

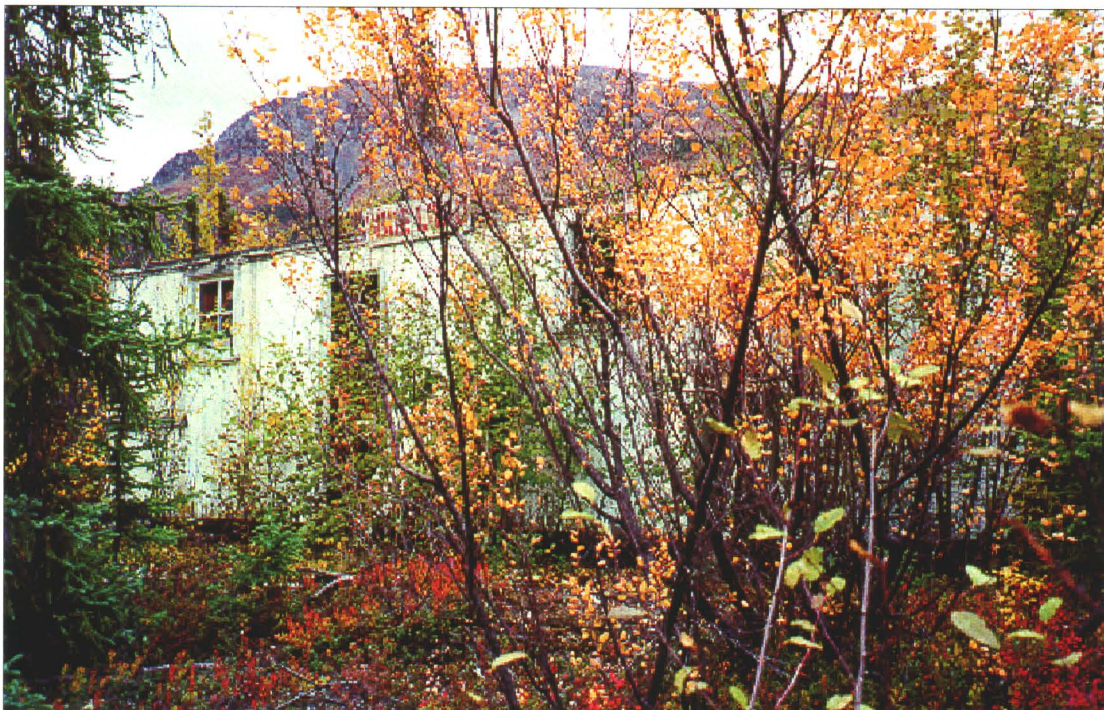
Building 66C (photo 66-5)

This building is a portable wooden structure on an iron skid that houses a kitchen inside.

Foundation: The building rests on iron skids.

Photo 66-5 : Moon. Building 66C, the kitchen is on an iron skid. (Azimuth 180°)
