SADIE LADUE 600 ADIT (#77)
(NO MINFILE)

1. LOCATION AND ACCESS

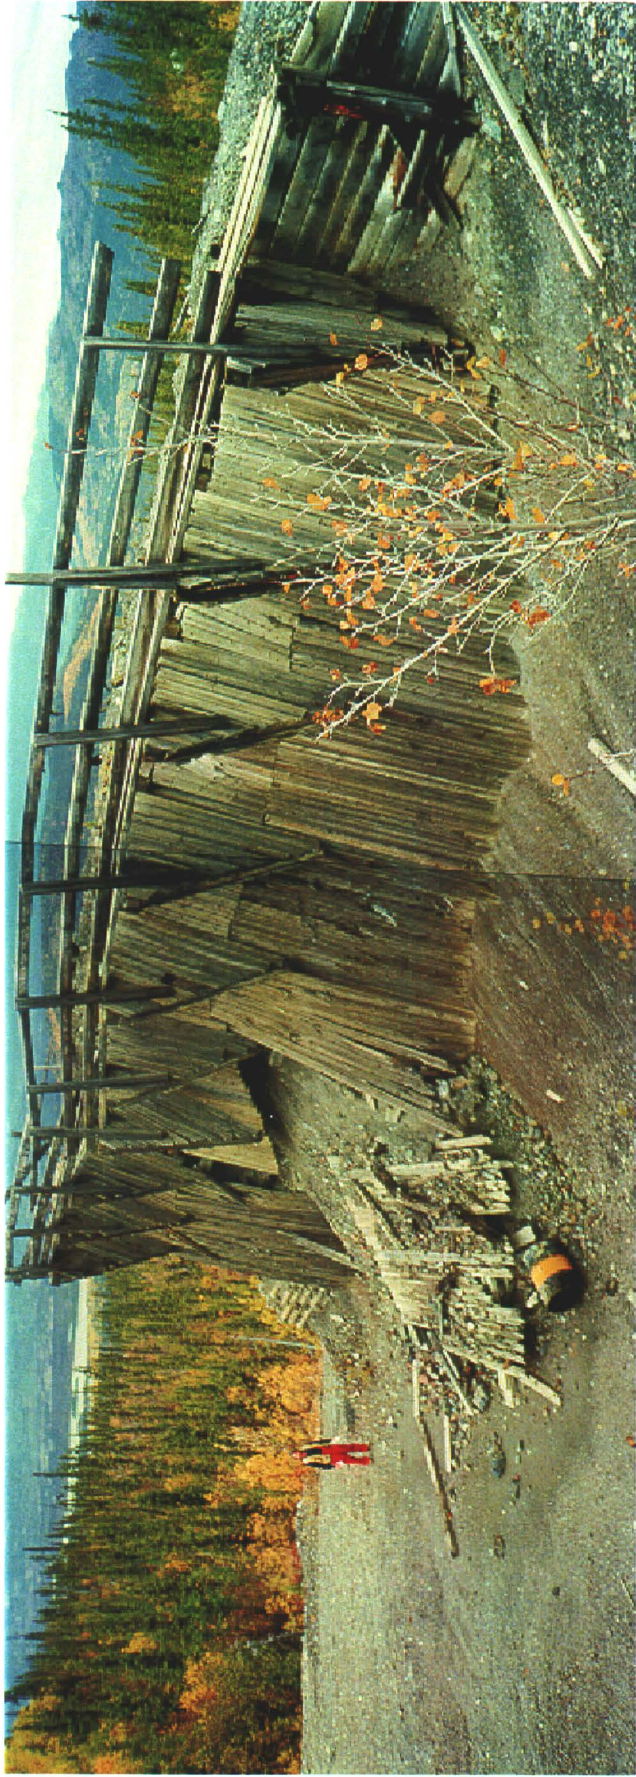
Stability: There is no evidence of the waste rock pile slumping. The waste rock pile appears stable, although the wooden loadout structure is deteriorating and could fail at any time.

Photo 77-2: Load out area.

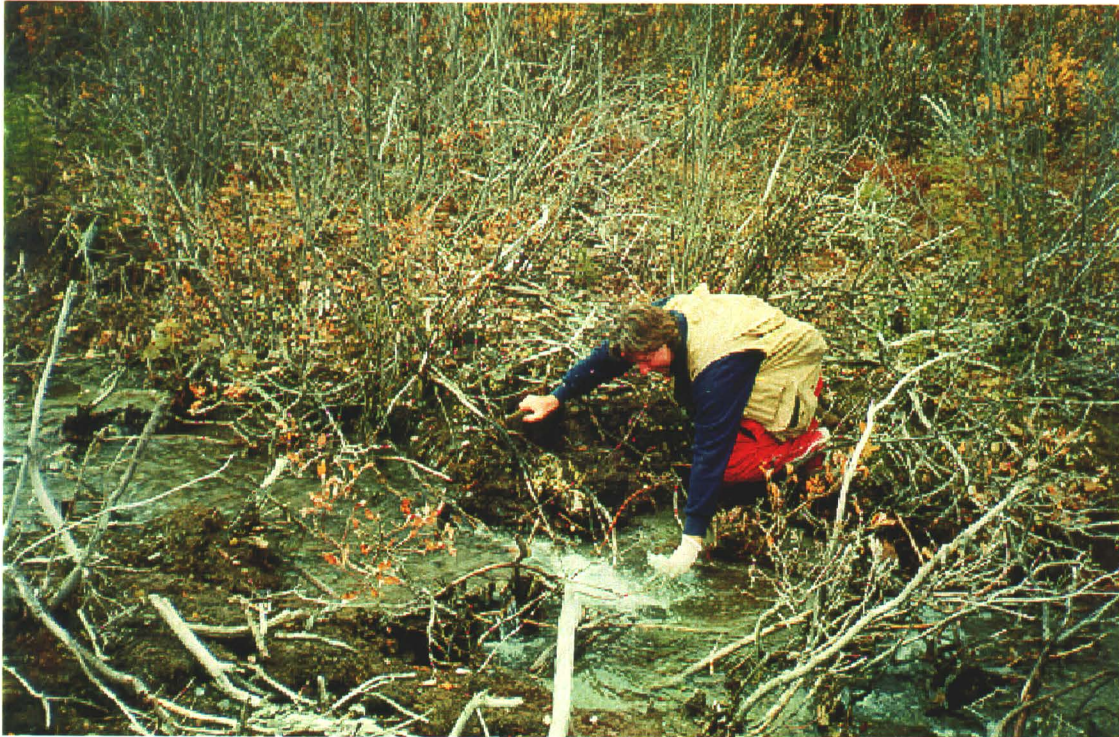
Mine water from this mine and the Ladue mill and mine site at Wemecke flows through the adit and is directed into a 0.5 m corrugated steel culvert. The culvert passes directly beneath the waste rock dump and discharges at the northwest end of the site, 85m downslope of the adit entrance. The estimated flow of the mine seepage at the time of site assessment was 4 - 5 liters/second. Discharged water flows along an unnamed stream channel toward the unnamed lake west of Gambler Lake. No discoloration or precipitated oxides were observed in the mine water or discharge stream channel.

Photo 77-3: Drainage from culvert downslope of waste rock dumps.
