MEILECKE
SITE #86
(MINFILE #106D 023)

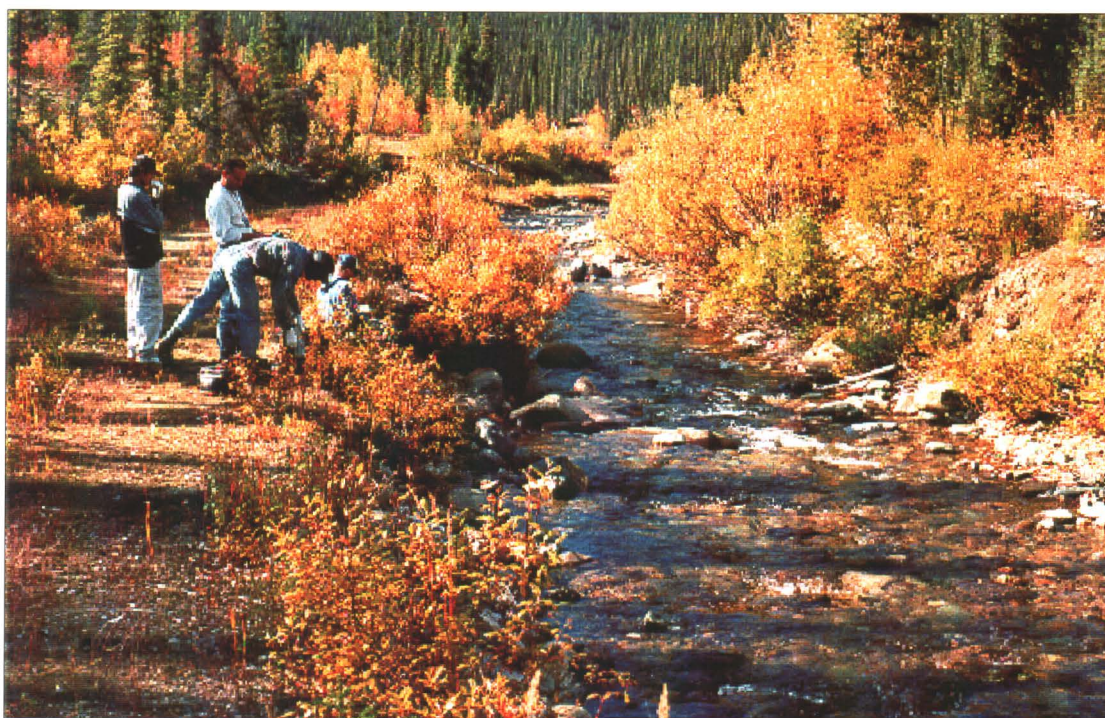
The site faces north-northwest along a series of raised shoreline out-wash terraces on the south site of Haggart Creek, approximately 850 m northeast of its confluence with Iron Rust Creek (Photo 86-1). The presence of permafrost soils could not be ascertained; however, the presence of smaller trees and the high elevation suggests the possibility of discontinuous permafrost.

Photo 86-1 : Upstream of Meilecke Site looking west.

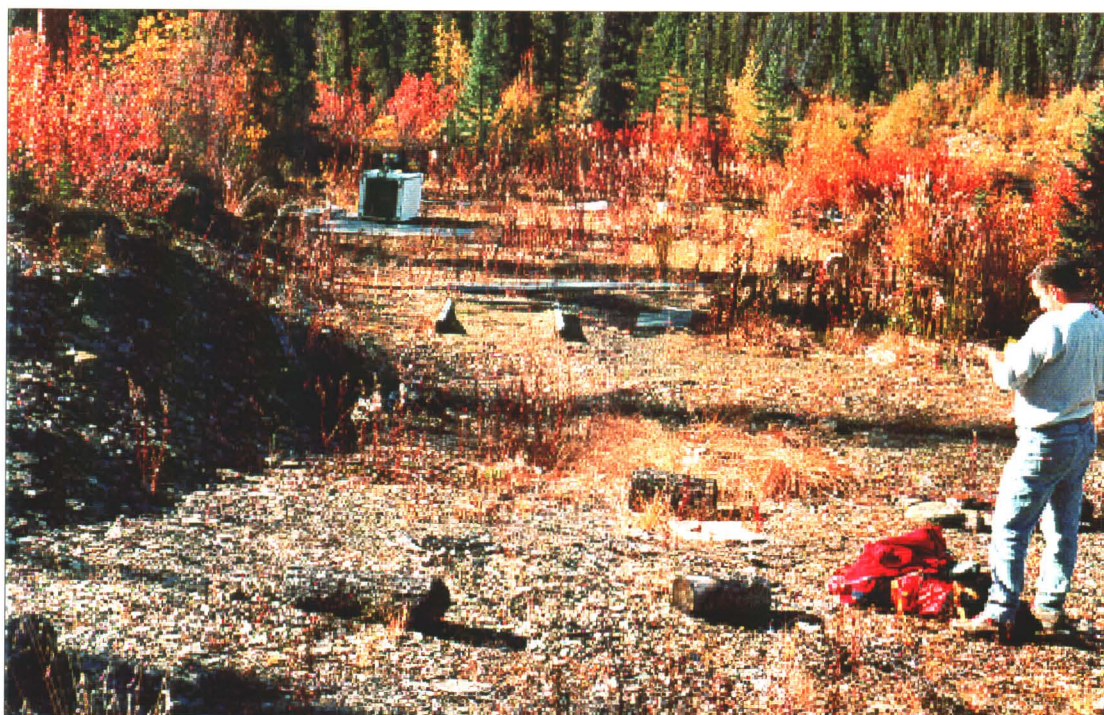
Possible old trench along terrace on south shore terrace by Haggart Creek running east-west; recently used as camp site (Photos 86-2 and 86-3).

Dimensions (L x W x H): ~ 30 m x 15 m x 0.75 m

Condition: hard-packed and overgrown; appears to be stable

Photo 86-2 : Meilecke Site. Camp site located in old trench (looking west).

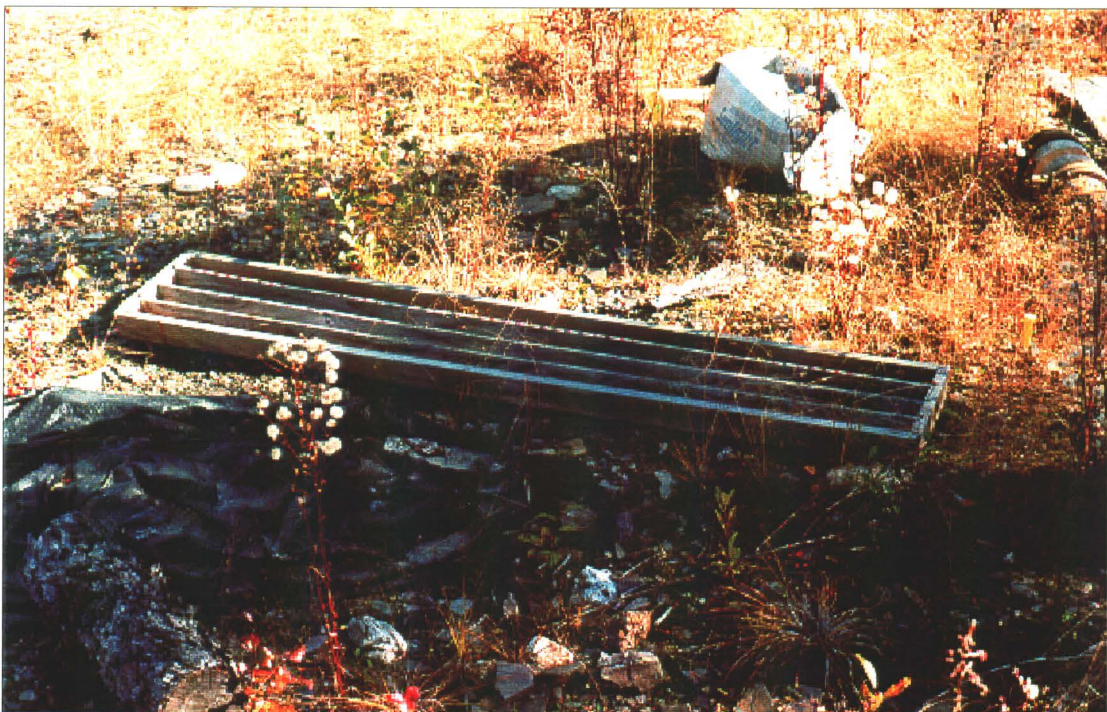
No apparent waste dumps; however, scattered debris over site including core boxes, wood, plastic, appliances (fridge and stove), cans, wooden flowerbox, plastic and metals cans containing ash from camp fire, old mattress and other camp equipment, number of empty 10 gallon cans, old portable generator and car battery (Photo 86-4 and 86-5).

Photo 86-4 : Meilecke Site, core box.

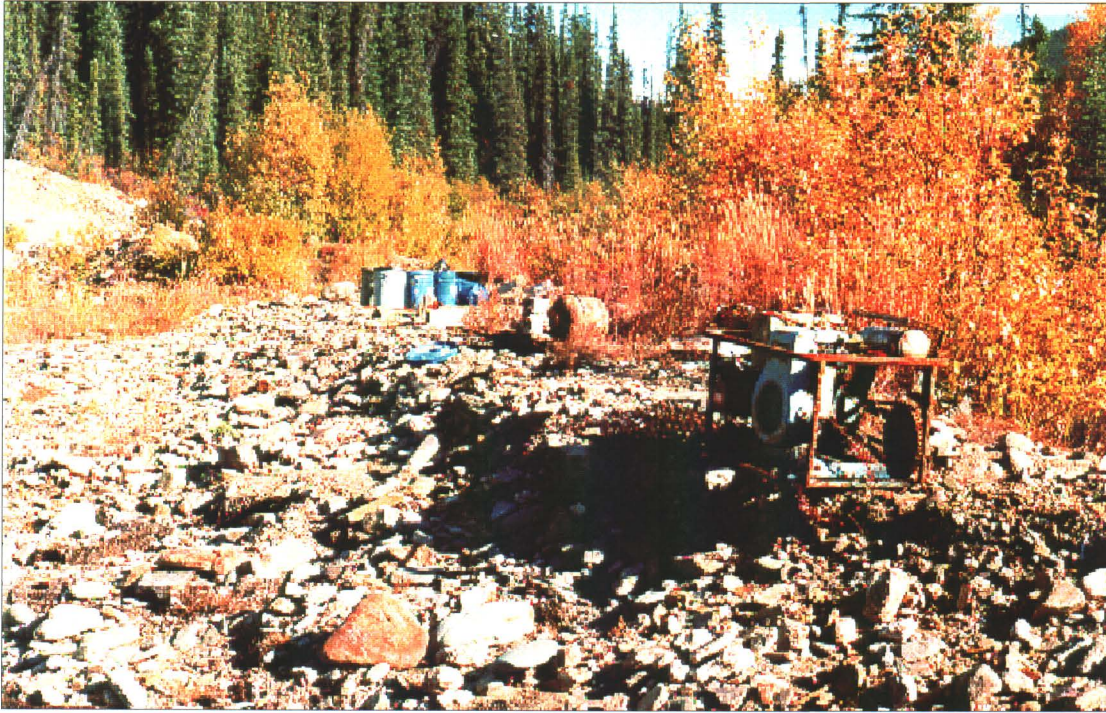
Photo 86-5 : Meilecke Site, generator & debris along creek looking east.

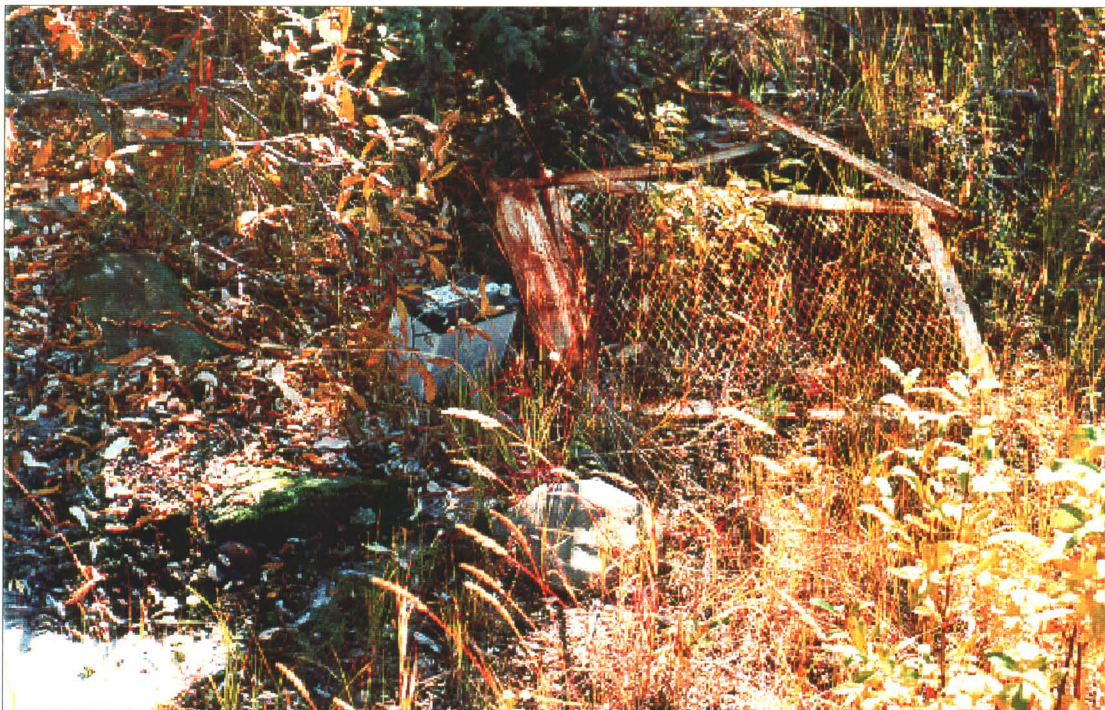
Old car battery located 100 m SW of camp above stream bank. No samples taken, given isolated location of material from stream (Photo 86-6).

Photo 86-6 : Meilecke Site, battery near stream (100m S.W. of camp site).

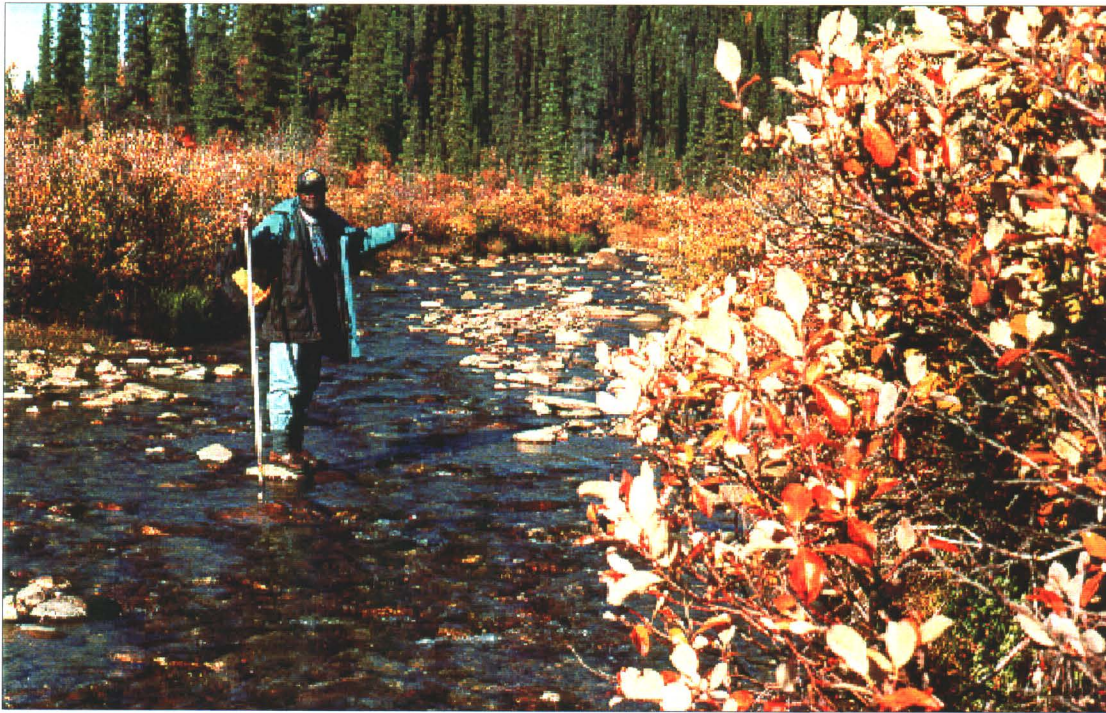
Surface water quality samples were collected 160 m upstream (background) of the site (99-86-WQ-01) and downstream, approximately 50 m east and upstream of the Iron Rust Creek confluence (99-86-WQ-02, Photo 86-7). Results of the geochemistry are listed in Attachment 2.

Photo 86-7 : Meilecke Site. Downstream water sample location 50m E. of confluence of Haggart & Iron Rust Creeks.
