## DUBLIN GULCH - STEWART & CATTO

SITE #91

(MINFILE #106D 025d)

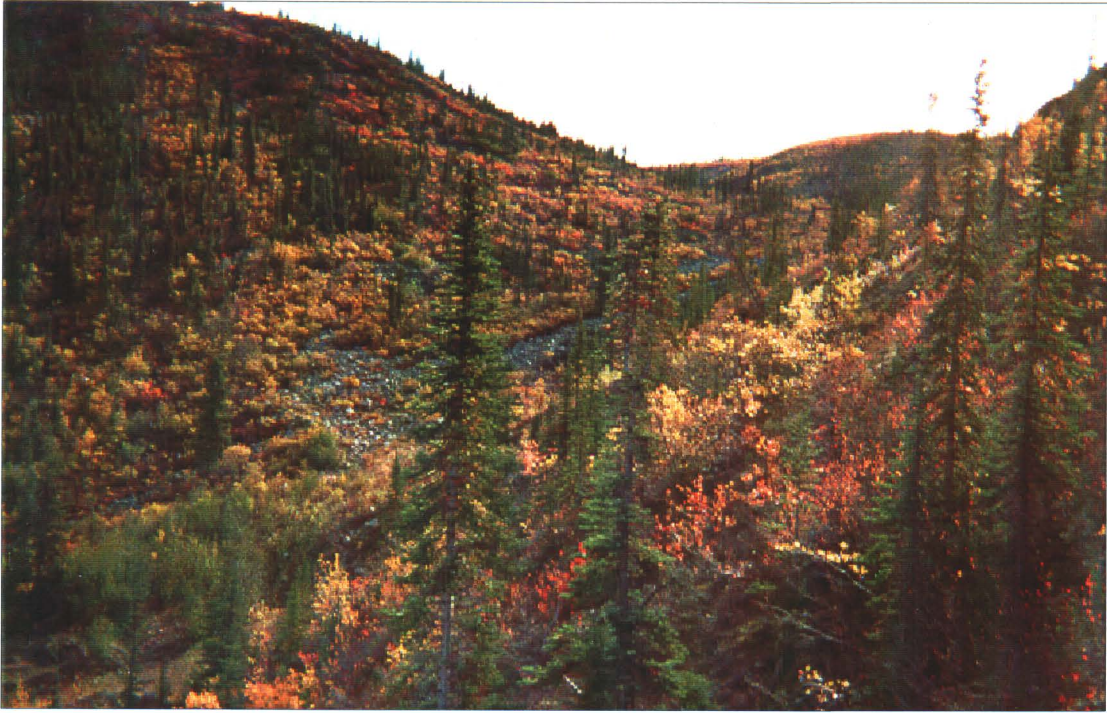
The site is located along the northeast side of a relatively-dry ridge leading into Olive Gulch. A small semi-subterranean creek runs down into the gulch under large boulders from the southeast (Photo 91-1), daylighting alongside a small placer mining camp along the site access road (see Photo 91-7). The stream splits into two channels at a small placer campsite located there with one of the forks following into a dugout trench while the other follows the Olive Gulch access road to the northwest. The stream drainage beyond this point has been altered by overburden from placer activities and trenching, resulting in flooding and wet, soggy conditions along Olive Gulch access road (Photo 91-2). This gulch eventually drains into Dublin Gulch to the northwest. The presence of permafrost soils could not be ascertained; however, the sparse cover of smaller trees and the high elevation suggests the possibility of discontinuous permafrost (Photo 91-3).

Photo 91-1 : Stewart-Catto. View from hill looking at top of gulch upstream & east of site.

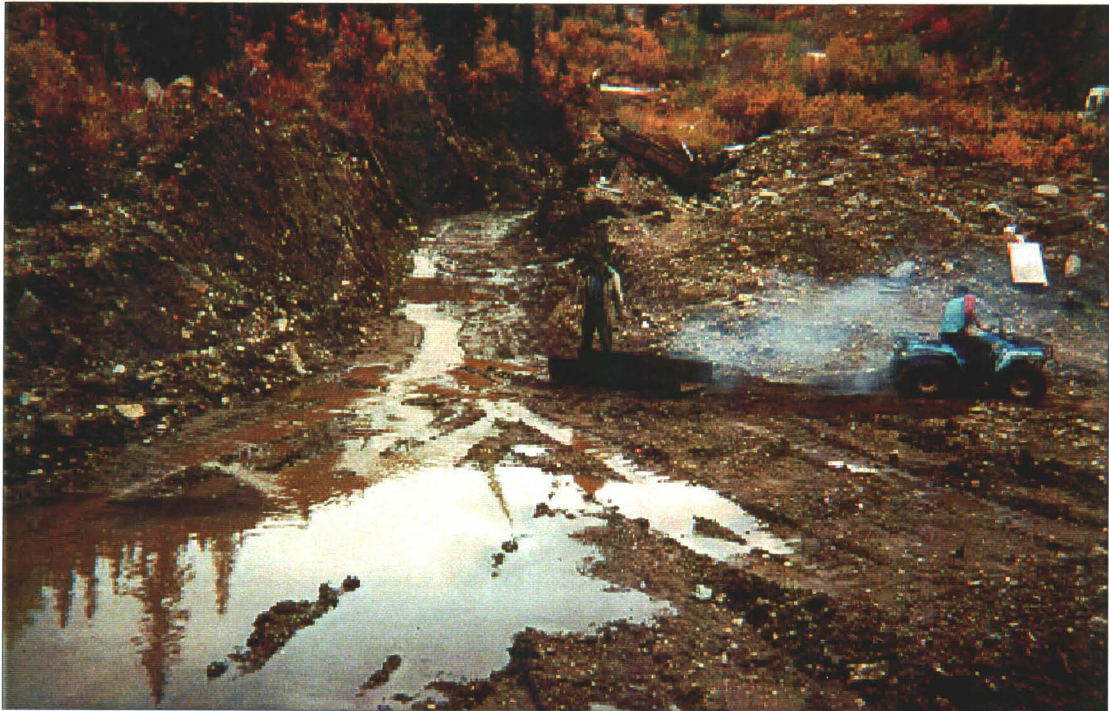
Recent, large, flooded bulldozer trench along Olive Gulch water course, opposite placer camp (Photo 91-7, see also Photo 91-2); approximately 100 m from Dublin Gulch Road.

Condition: loose packed soil and gravel; erosion occurring from surface run-off; potentially unstable during high flow/runoff conditions.

Surface water quality samples were collected in the watercourse of Olive Gulch at the campsite (99-91-WQ-01) and 5 m downstream of the base of the dugout trench situated 100 m northwest of the camp (99-91-WQ-02, see Photo 91-2). Results of the geochemistry are listed in Attachment 2.

Photo 91-2 : Stewart-Catto. Trench N.W. of site looking E.

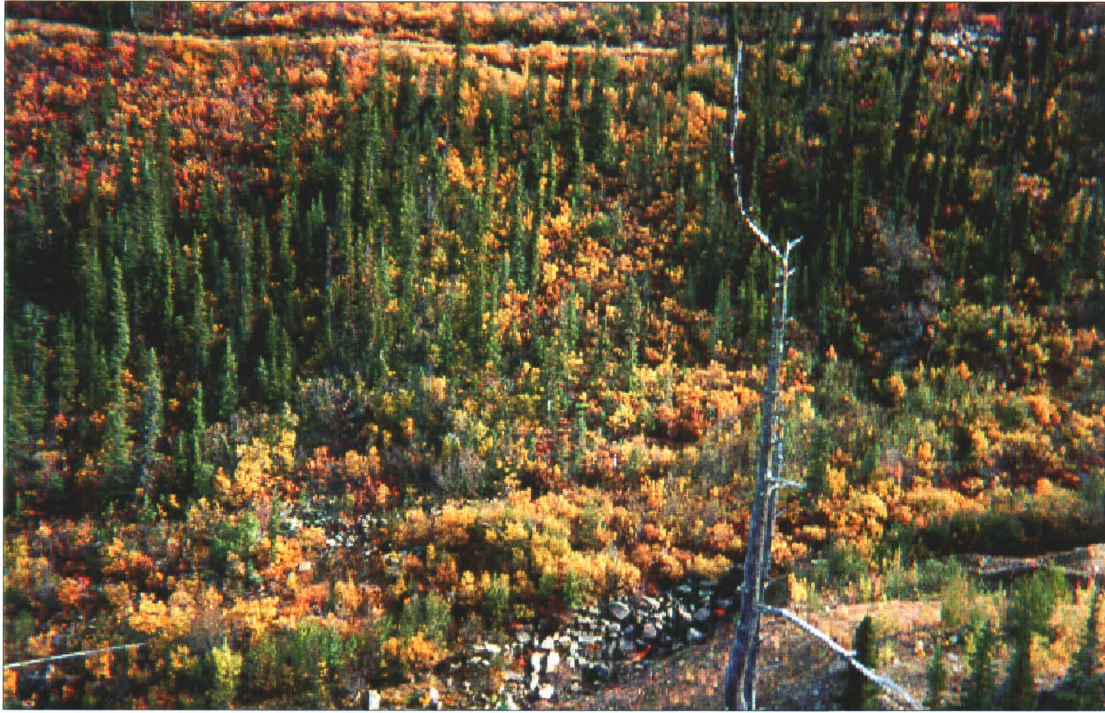
Photo 91-3 : Stewart-Catto. View from hill looking E. Showing "upstream area" of camp site.

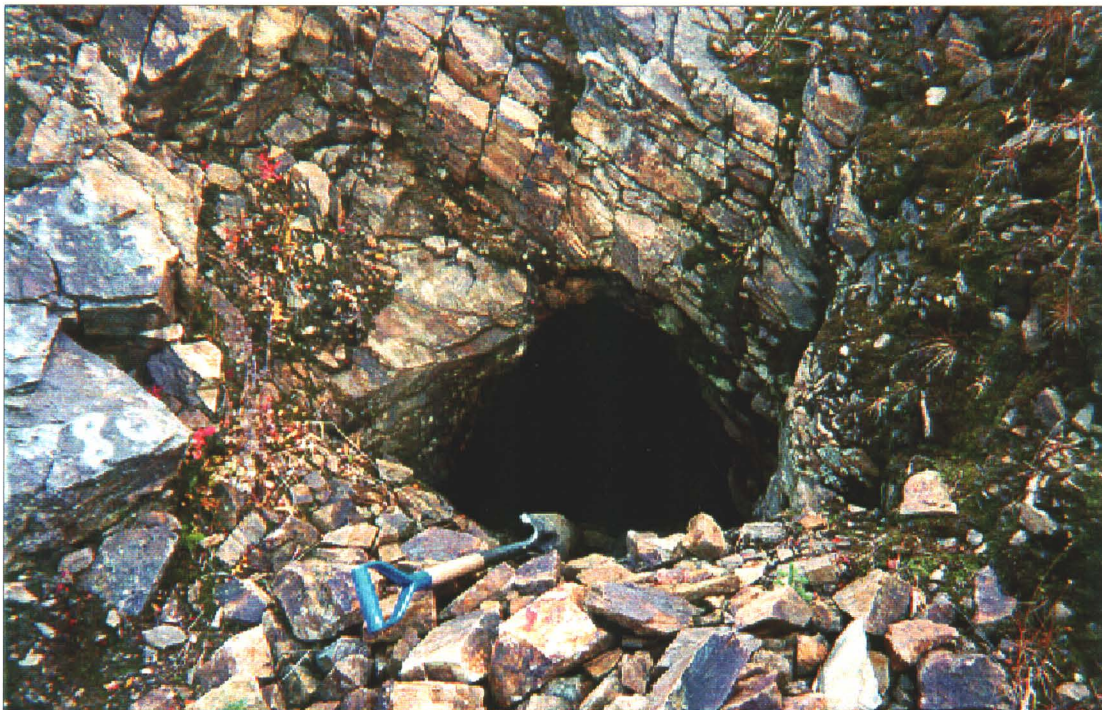
One of the old adits developed between 1908 and 1914, "Victoria" was discovered along the upper access road winding up the northeast-facing slope of Olive Gulch. The opening was located 200m upslope and due southeast from the bottom of the gulch and approximately 80 m down from the top of the ridge. The adit opening was exposed and partially filled with rocks (Photo 91-4). Two drill-casing pipes were also noted sticking out of the ground above the adit at a 45 degree angle, possibly from old drilling activities or for shaft-venting.

Dimensions (L x W x H): ~83 m x 1.5 m x 1.75 m)

Supports: No structural supports in place

Condition: Appears to be stable.

No apparent waste rock, aside from overburden and large boulders. Although no physical indications of Acid Rock Drainage were noted at the Stewart Catto site Victoria adit such as staining, the results of the Acid Base Accounting from the adit sample suggest the potential for acid generation (AP/NP = 0.6). A visual assessment of a rock sample collected at the subject site did not indicate any visual indications of sulphide minerals.

Photo 91-4 : Stewart-Catto. Old 1914 mine adit along old access road to top of hill.

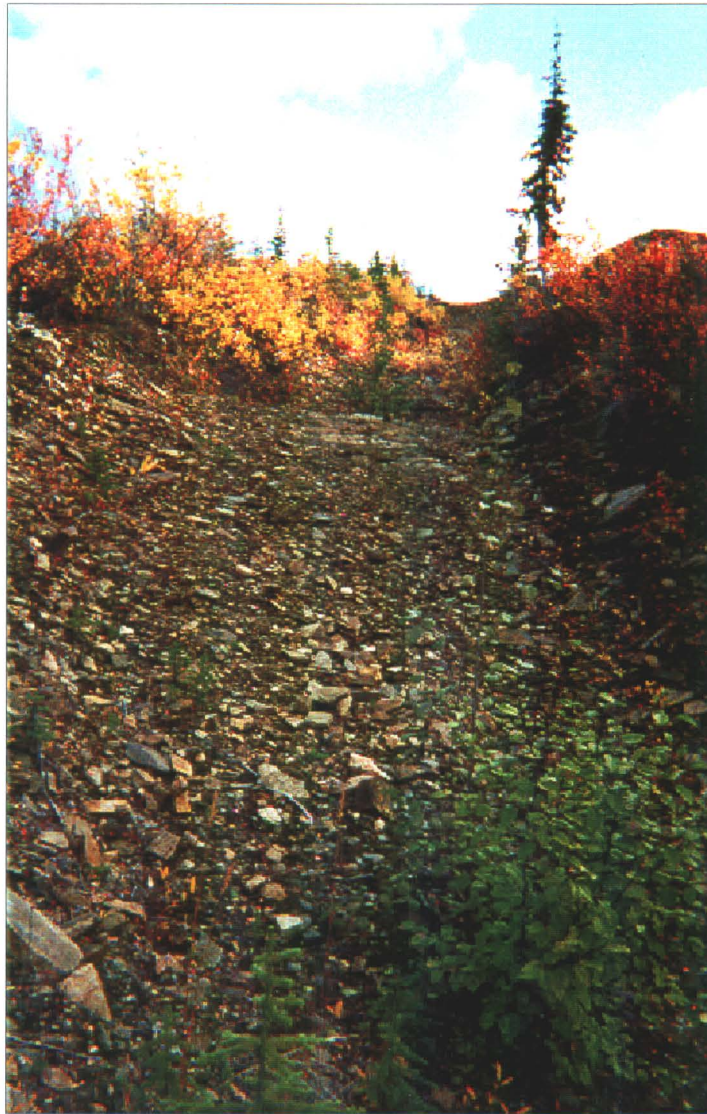
A number of (40 to 70 m) long bulldozer and backhoe trenches were found near the top of the ridge towards its northwest side, among extensive roadworks, above the adit opening (Photos 91-5 and 91-6).

Dimensions (L x W x H): ~ 40-70 m x 2-3 m x 1-2 m

Condition: loose packed overburden; some natural re-colonization evident (see Photos 91-5 and 91-6); appear to be relatively stable

Natural revegetation is beginning to occur both in the trench areas above the adit (see Photo 91.5) and less disturbed areas around the camp site (see Photo 91-7). No evidence of any reclamation measures at this site aside from local salvaging operations.

Photo 91-5 : Stewart-Catto. Long trench looking upslope  
& S.W. to hill top.

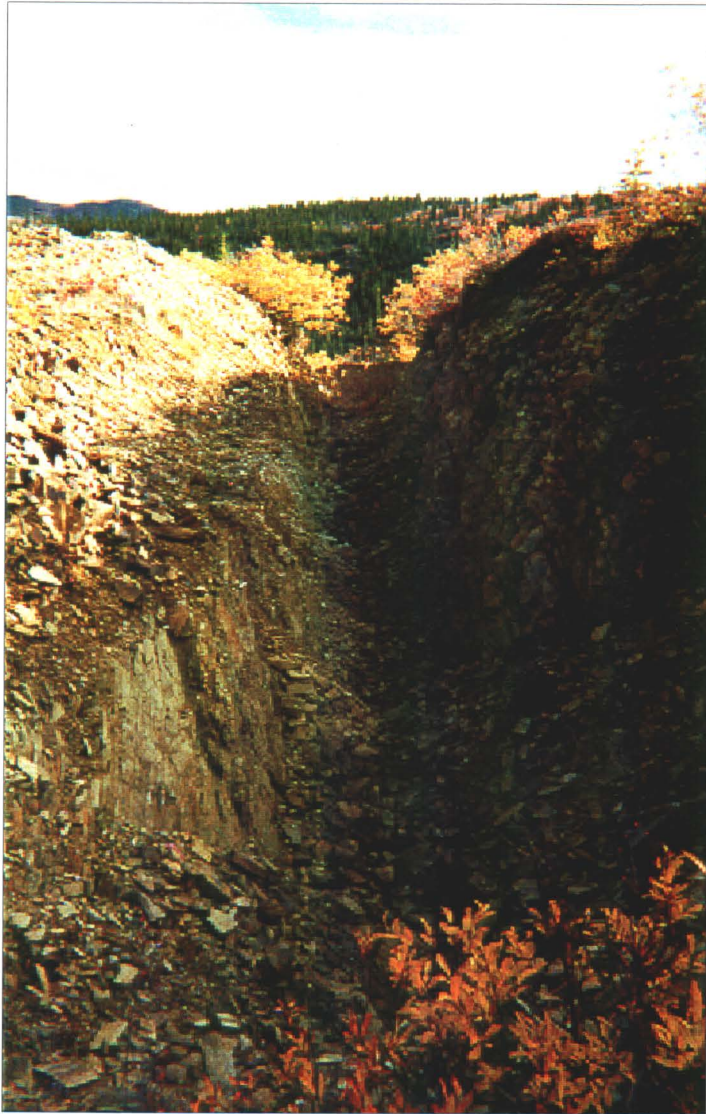
Photo 91-6 : Stewart-Catto. One of many bulldoze trenches near top of hill looking N.E.

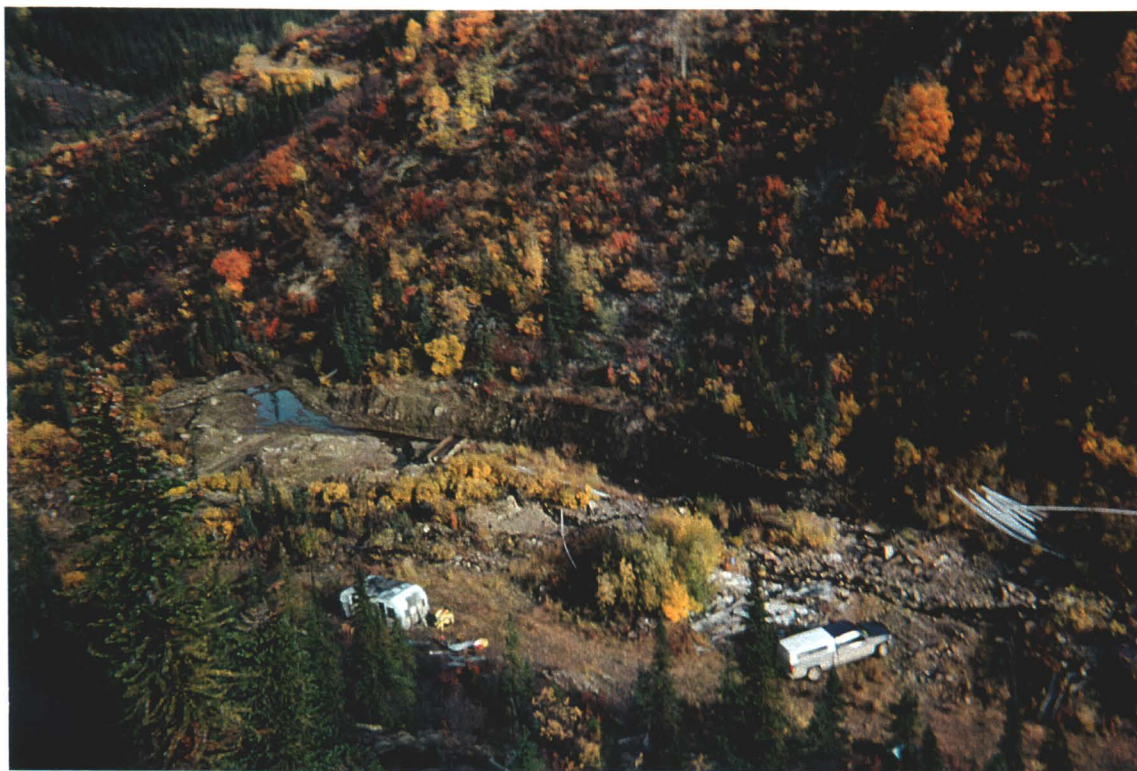
Dimensions: (L x W x H): ~ 40 m x 4 m x 5 m

No apparent intact buildings, aside from two trailers being used as a camp for current placer mining and salvage activities (Photos 91-7 and 91-8). Two miners were camping on site at the time of the 1999 investigation. Two old, collapsing burned-out log cabins were located on the opposite side of the watercourse, in addition to an old demolished wood and siding building by the campsite along the southwest side of the watercourse.

No apparent waste dumps; however, wood and metal debris (pieces of mining equipment and siding) were scattered across the site. Some PVC piping was also recently piled on the opposite side of the watercourse from the camp (Photos 91-7 and 91-8).

Photo 91-7 : Stewart-Catto. View from hill looking N. showing lower portion of camp site & debris.

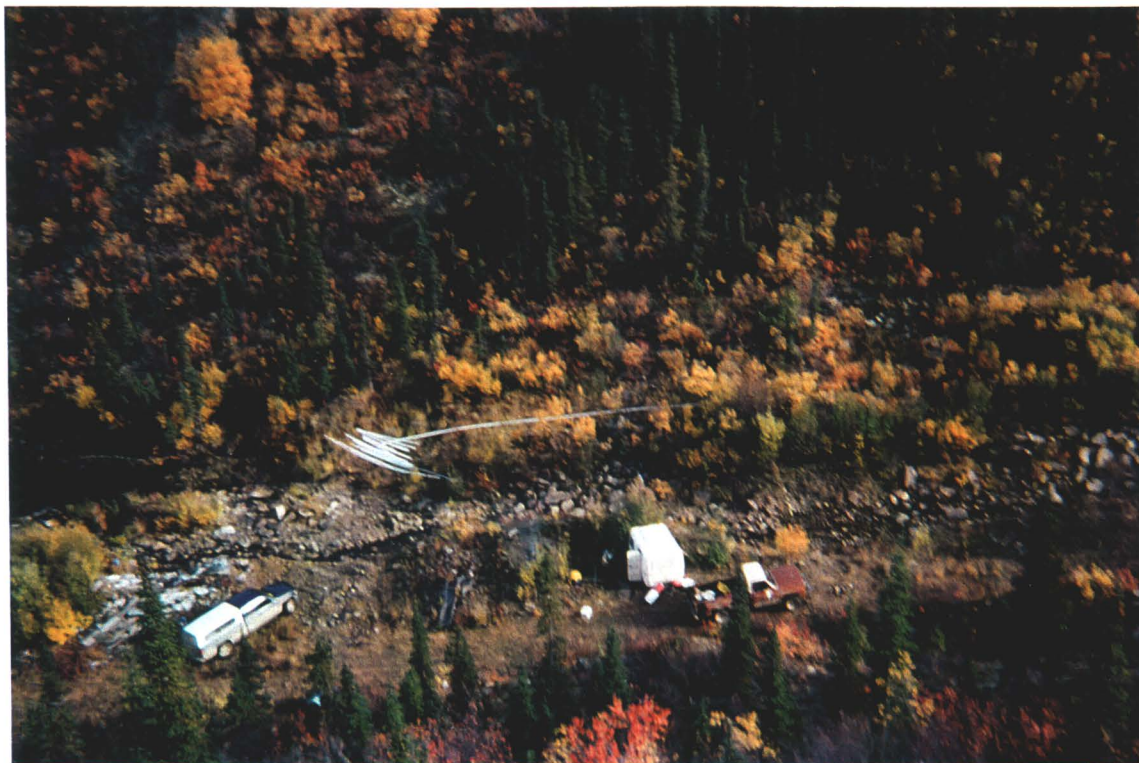
Photo 91-8 : Stewart-Catto. View from hill looking N.E. Showing upper portion of camp site & debris.
