ELLIS
SITE #94
(MINFILE #106D 028)

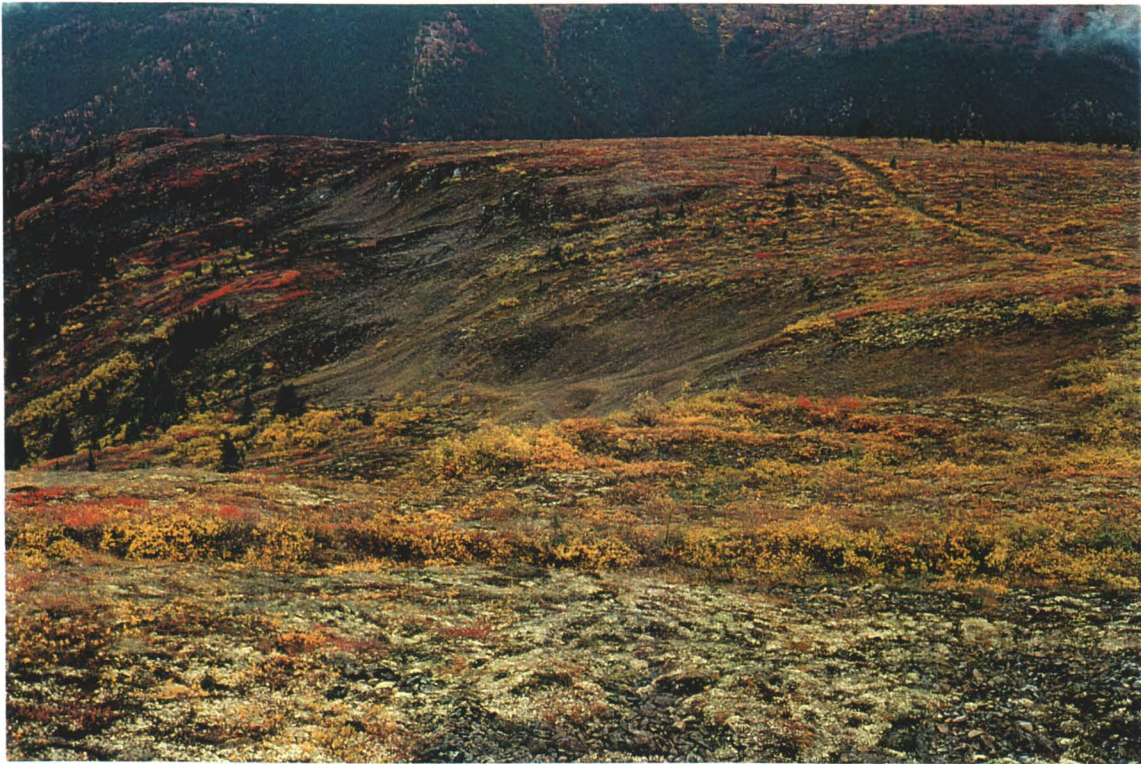
The site faces north to northwest along the top of a dry, unnamed gulch running north-northwest. This gulch eventually meets the beginning of Haggart Creek further to the north. The site is above the treeline, located in alpine tundra terrain with characteristic vegetation. Raised frost-heave areas, polygons and the high altitude suggest the presence of continuous permafrost in the area (Photo 94-1).

Two old bulldozed trenches from early 60's along the northeast slope of gulch approximately 1500 m down the side of the slope (Photos 94-1 and 94-2).

Dimensions: (L x W x H): ~ 30 m x 15 m x 1 m

Condition: loose packed overburden; appears to be stable

Photo 94-1 : Potato Hill (Ellis). One of 1964 bulldoze trenches (3) (centre) #1 looking N. - N.W.

Natural revegetation is beginning to occur at the site in the suspected trench areas along the top of the gulch (see Photos 94-3 and 94-4). The trench area along the east slope of the gulch, however, remains bare (see Photos 94-1 and 94-2). No evidence of any reclamation measures at this site.

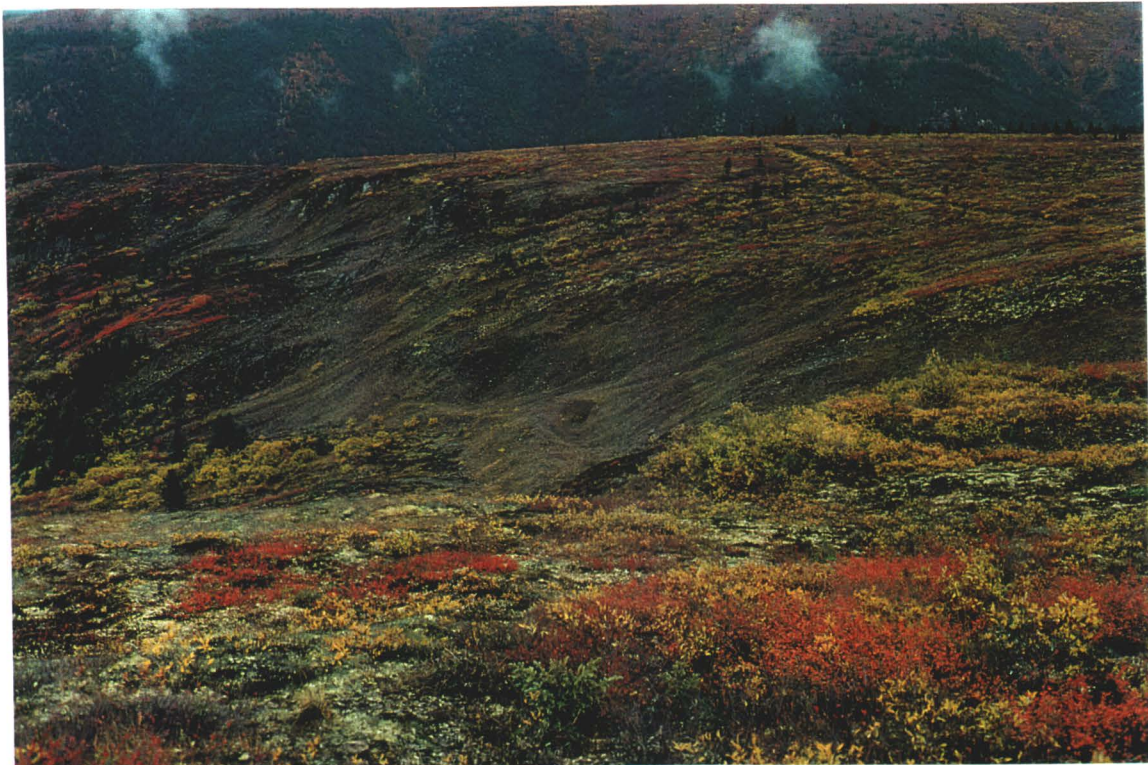
Waste rock was associated with trenching along the northeast slope of gulch (see Photo 94-2). This was limited to soil overburden and a limited volume of host rock as well as quartz vein material for the trenches along the northeastern slope. There was no evidence of sulphide mineralization in the associated waste rock.

Photo 94-2 : Potato Hill. One of 1964 bulldoze trenches (centre) #1 looking N. - N.W.
from access trail.

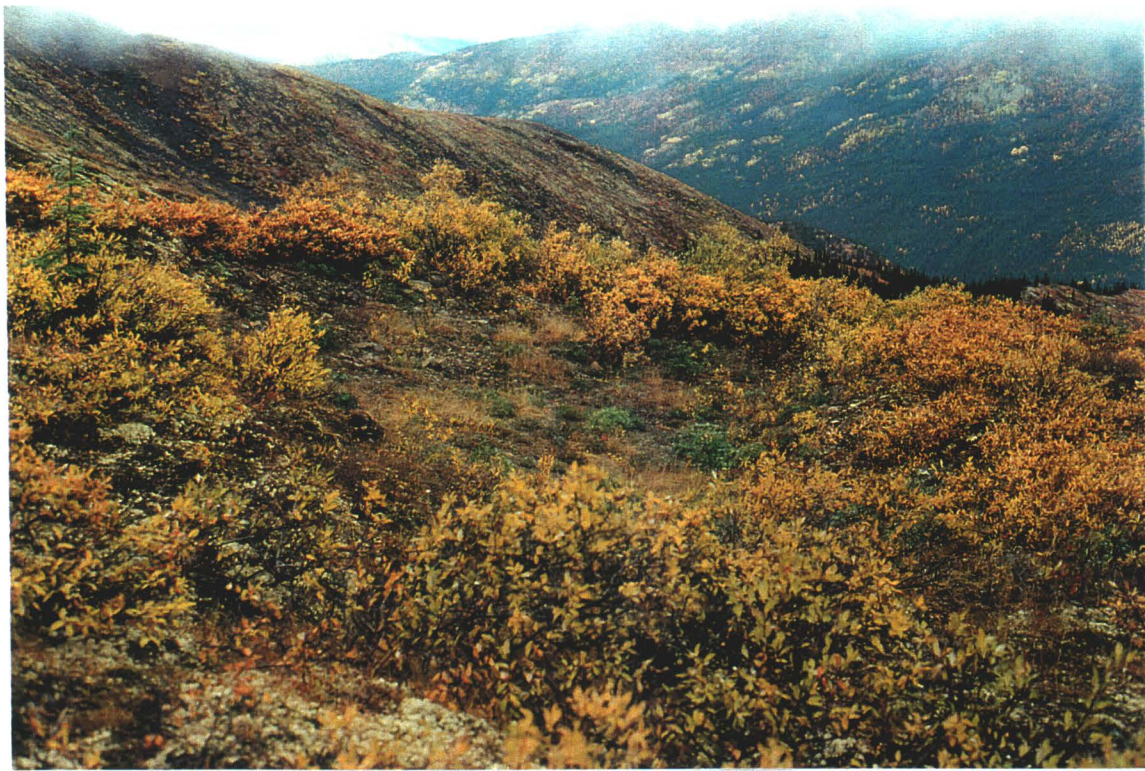
Two old bulldozed trenches from early 60's at top of gulch along access trail at 45 degree angles from each other leading north and north-northeast (Photo 94-3 and 94-4).

Dimensions: (L x W x H): ~ 35 m x 6 m x 0.5 m

Condition: hard-packed overburden; natural revegetation occurring; appears to be stable

Photo 94-3 : Potato Hill. One of 1964 bulldoze trenches (3) (centre) #2 looking W.

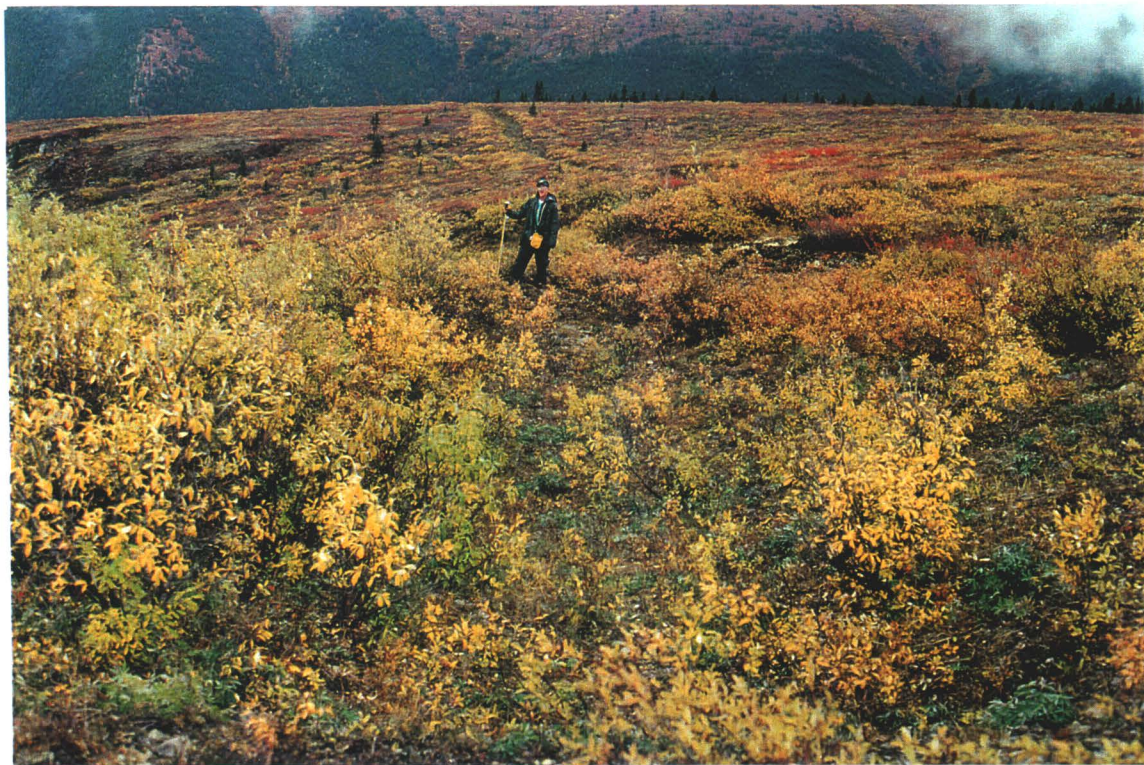
Photo 94-4 : Potato Hill. One of 1964 bulldoze trenches (3) (centre) #3 looking E. (upslope).
