Summary of climate- and geohazard-related vulnerabilities for the Dempster Highway corridor

YC-2018-100

Northern Climate ExChange
YUKON RESEARCH CENTRE • Yukon College

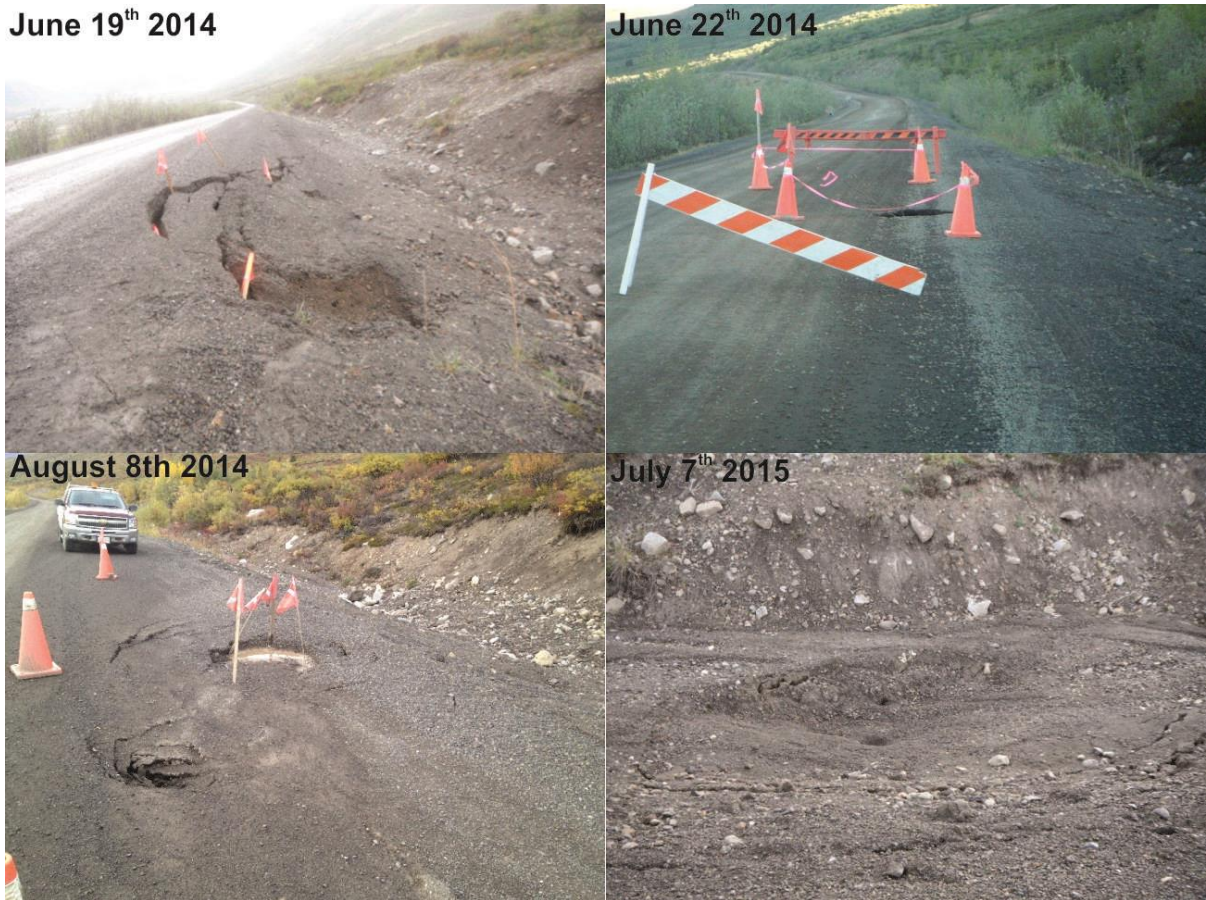
Figure 3.1.1 Degradation observed at site DH82 in 2014 and 2015.

- Relatively high ground temperatures and coarse materials suggest permafrost is vulnerable to thawing
- Of the two hypotheses for the cause of the sinkholes, fine material leaching and ground ice thaw, investigations favour fine material leaching as the main cause
- With either hypothetical cause, permafrost degradation contributes to the problem
- Permafrost degradation at this site is potentially influenced by:
 - The road cut on the RHS increasing the active layer
 - Snow accumulation on the shoulder increasing the active layer
 - New pathways for ground infiltration by precipitation due to retreating permafrost
 - Increase in annual precipitation in the region

The depletion in coarse material suggest leaching of sediments by ground water. The absence of ice suggests that ground ice thaw is not the cause of the observed subsidence and subsequent sinkhole formation.

Results from the ERT surveys could support either of the two hypotheses for causes of sinkhole formation (i.e., either fine material being leached away, or ground ice being thawed). However, the borehole data favor the leaching hypothesis.

In both cases permafrost degradation is contributing to the issue. The cut on the right-hand side may have triggered active layer thickening, but also favors the presence of snow accumulating on the shoulder of the embankment, promoting thickening of the active layer. The retreat of the permafrost table may have opened new pathways for the ground water originating from precipitation to flow through and leach sediments. Similarly, an increase of the precipitation in the area over decades may have led to the situation. Ground temperature records prove that infiltrating water is significantly impacting permafrost at this site and is likely responsible for the sinkhole by leaching fine sediment between approximately 6 and 12 m depth.

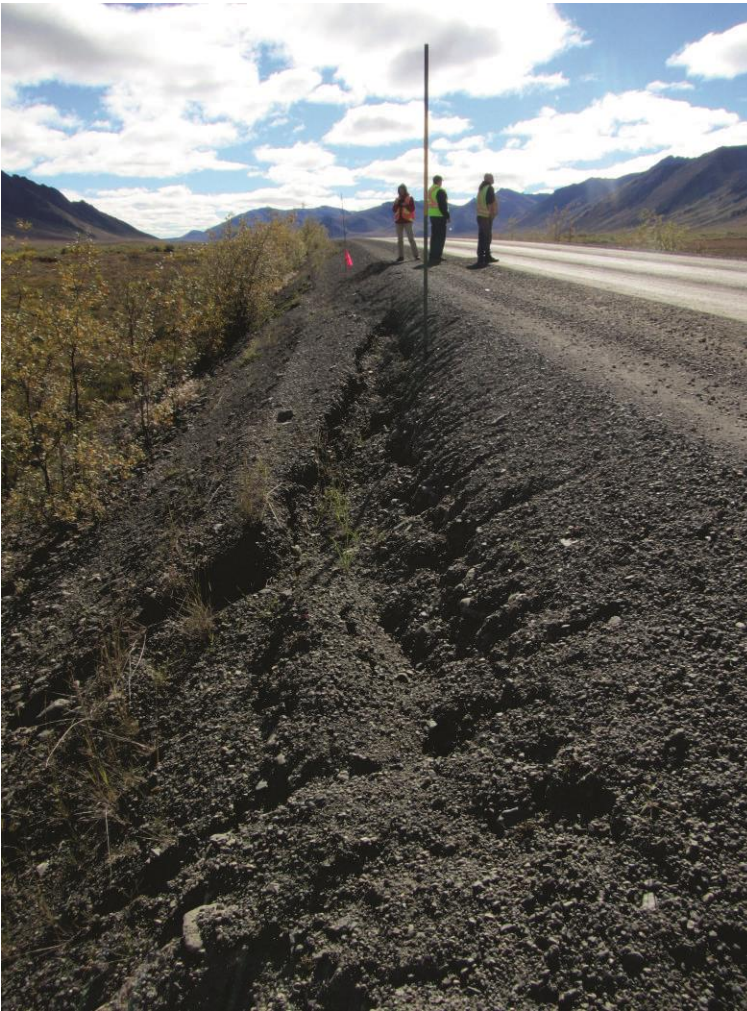
Figure 3.2.1 20m failure located on the RHS of the road at site DH95.

The observed settling along the road section can be attributable to two phenomena:

The ice wedges are of unknown width and probably don't exceed 2 m high. The loss of this volume of ice could induce major settling in the road. However, when the active layer reaches a little bit lower than 2m (i.e. the height of the ice wedge), the degradation due to their thawing should cease. Water leaching and the thawing of deeper ice bodies could be a greater concern in the long term.

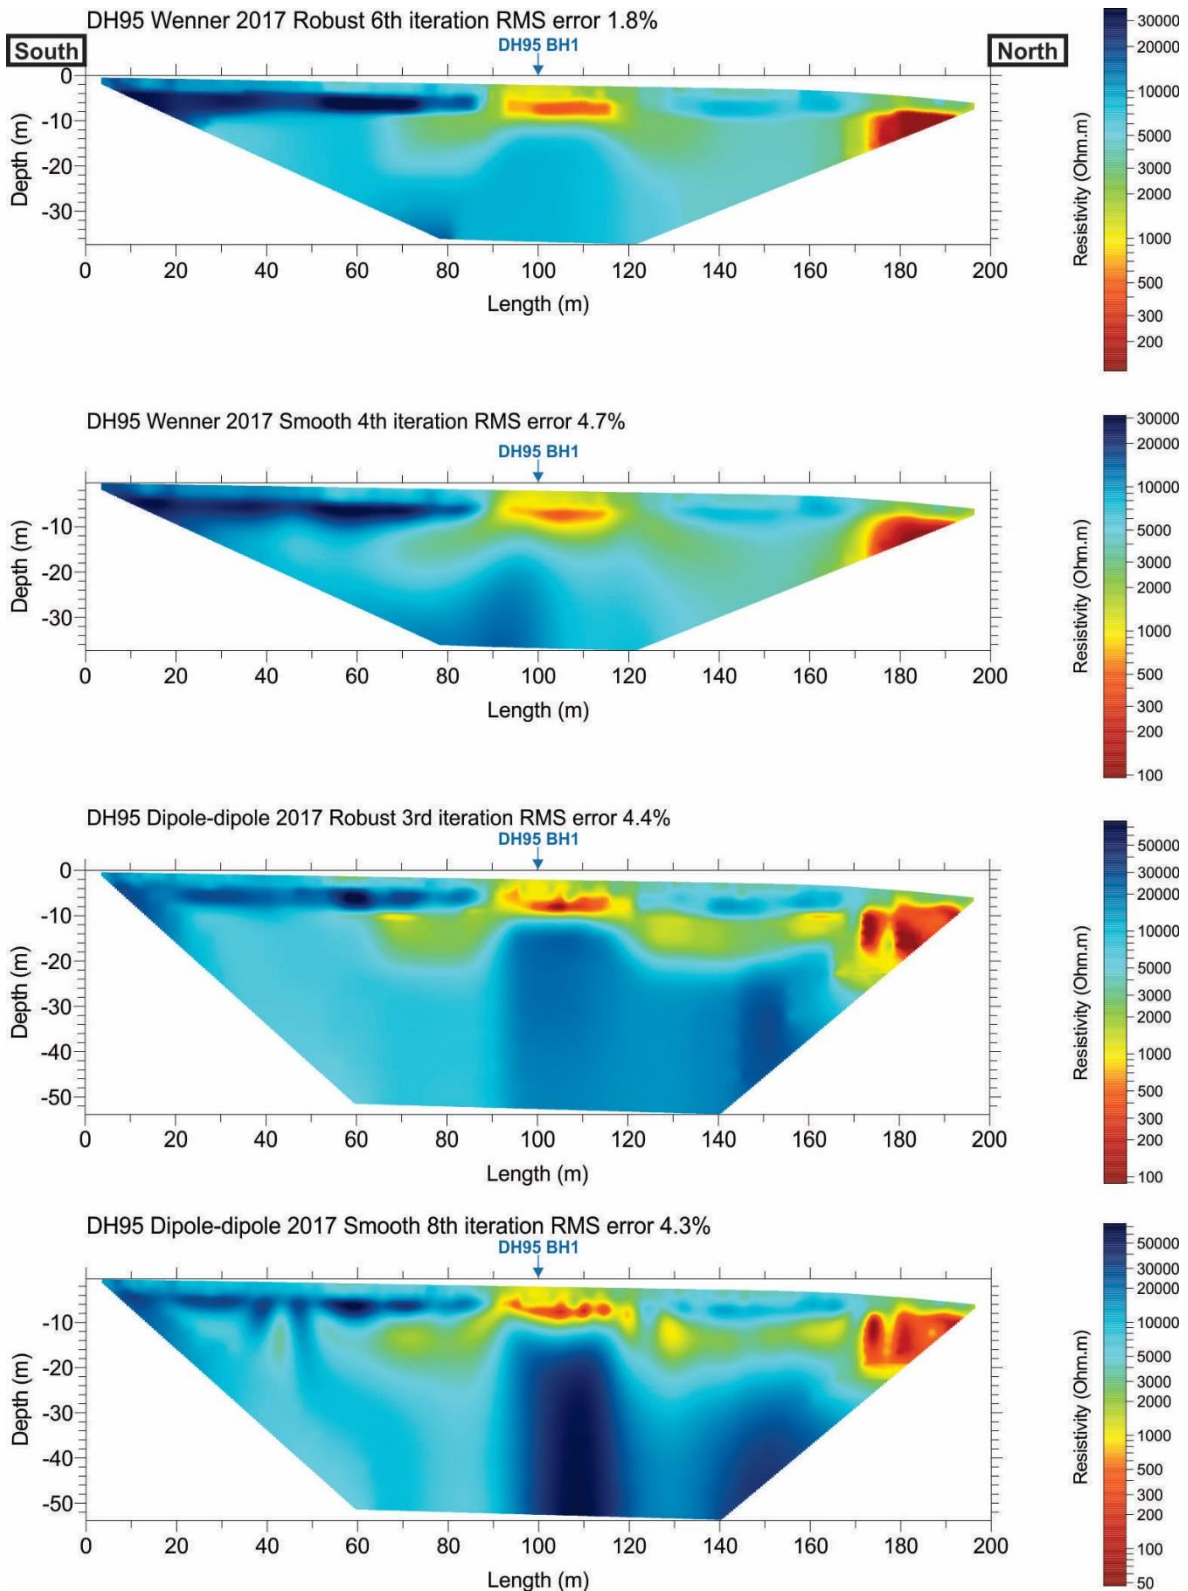
The darkest blue colors are the highest resistivity values, and can be interpreted as cold and/or ice rich permafrost. They are mainly concentrated in the south side of the profiles and in the first 6-8 m of the profile. It can be assumed that the ice wedges are located in the first 3 m of

Figure 3.2.5 Wenner and dipole-dipole ERT surveys at site DH95.

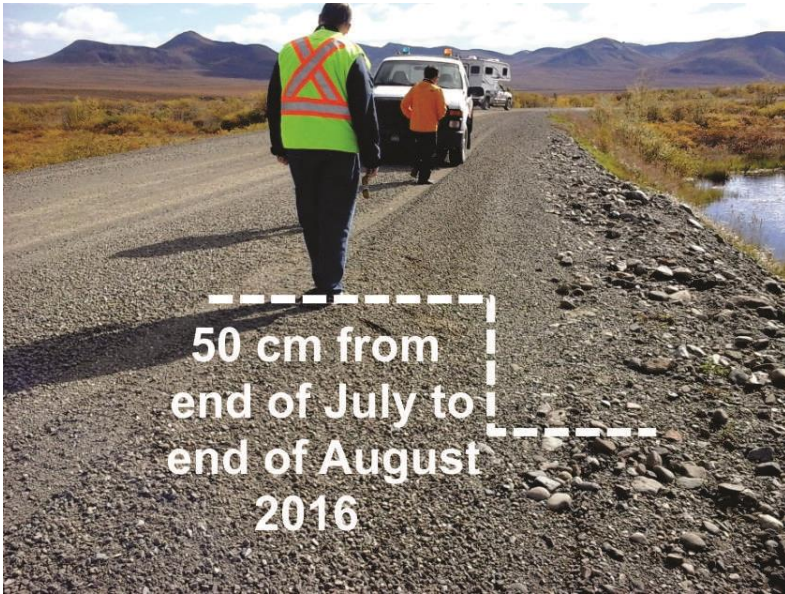
Figure 3.4.1 Subsidence observed at site DH103.

The permafrost at this site is relatively cold, below -2 °C, and therefore can be more resilient to an increase of air temperature in the next decades.

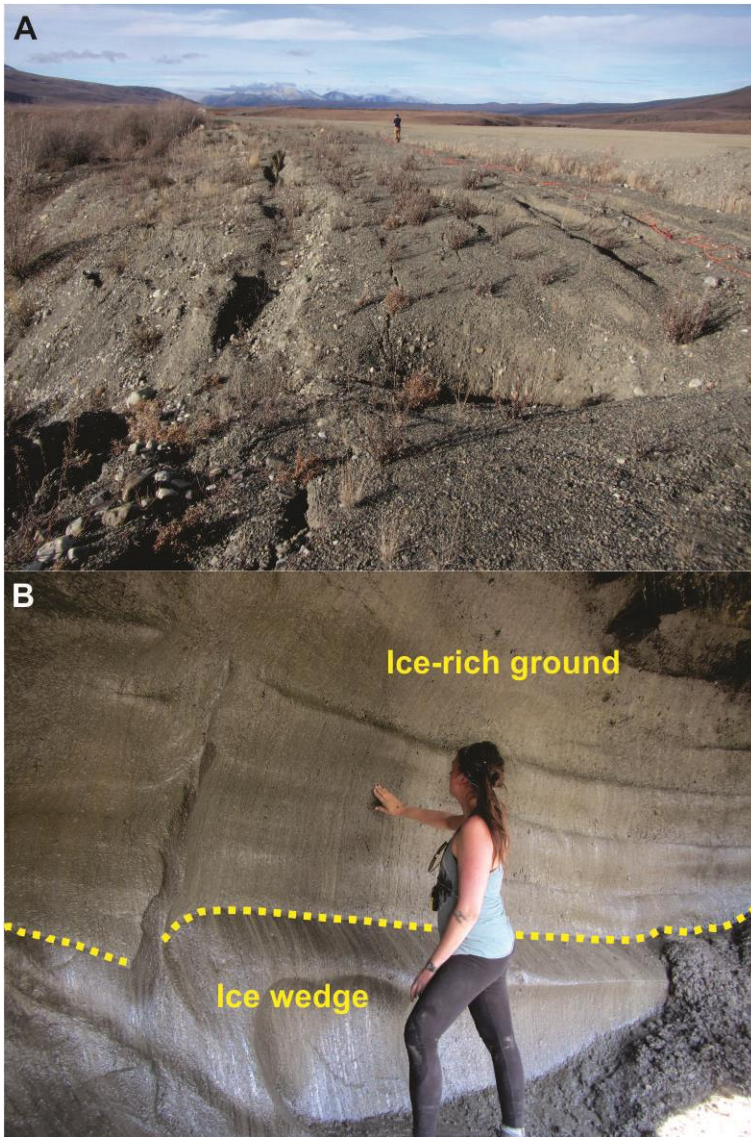
Figure 3.5.1 Degradations observed at DH116. A- Former embankment at right-hand side affected by permafrost degradation; B- ice-rich ground and ice-wedge observed at landslides along the cliff.

The combined thicknesses of upper wedge ice (up to 8 m) and of deeper massive ice bodies (>6 m) may exceed 14 m at some locations. The difference in elevation between the lake surface and the ground surface at DH116 BH2 is 14.5 m. Should the ice thaw or be removed and underground water seepage occur, the possibility of the lake draining cannot be excluded. The situation should be monitored to prevent or anticipate this catastrophic event.

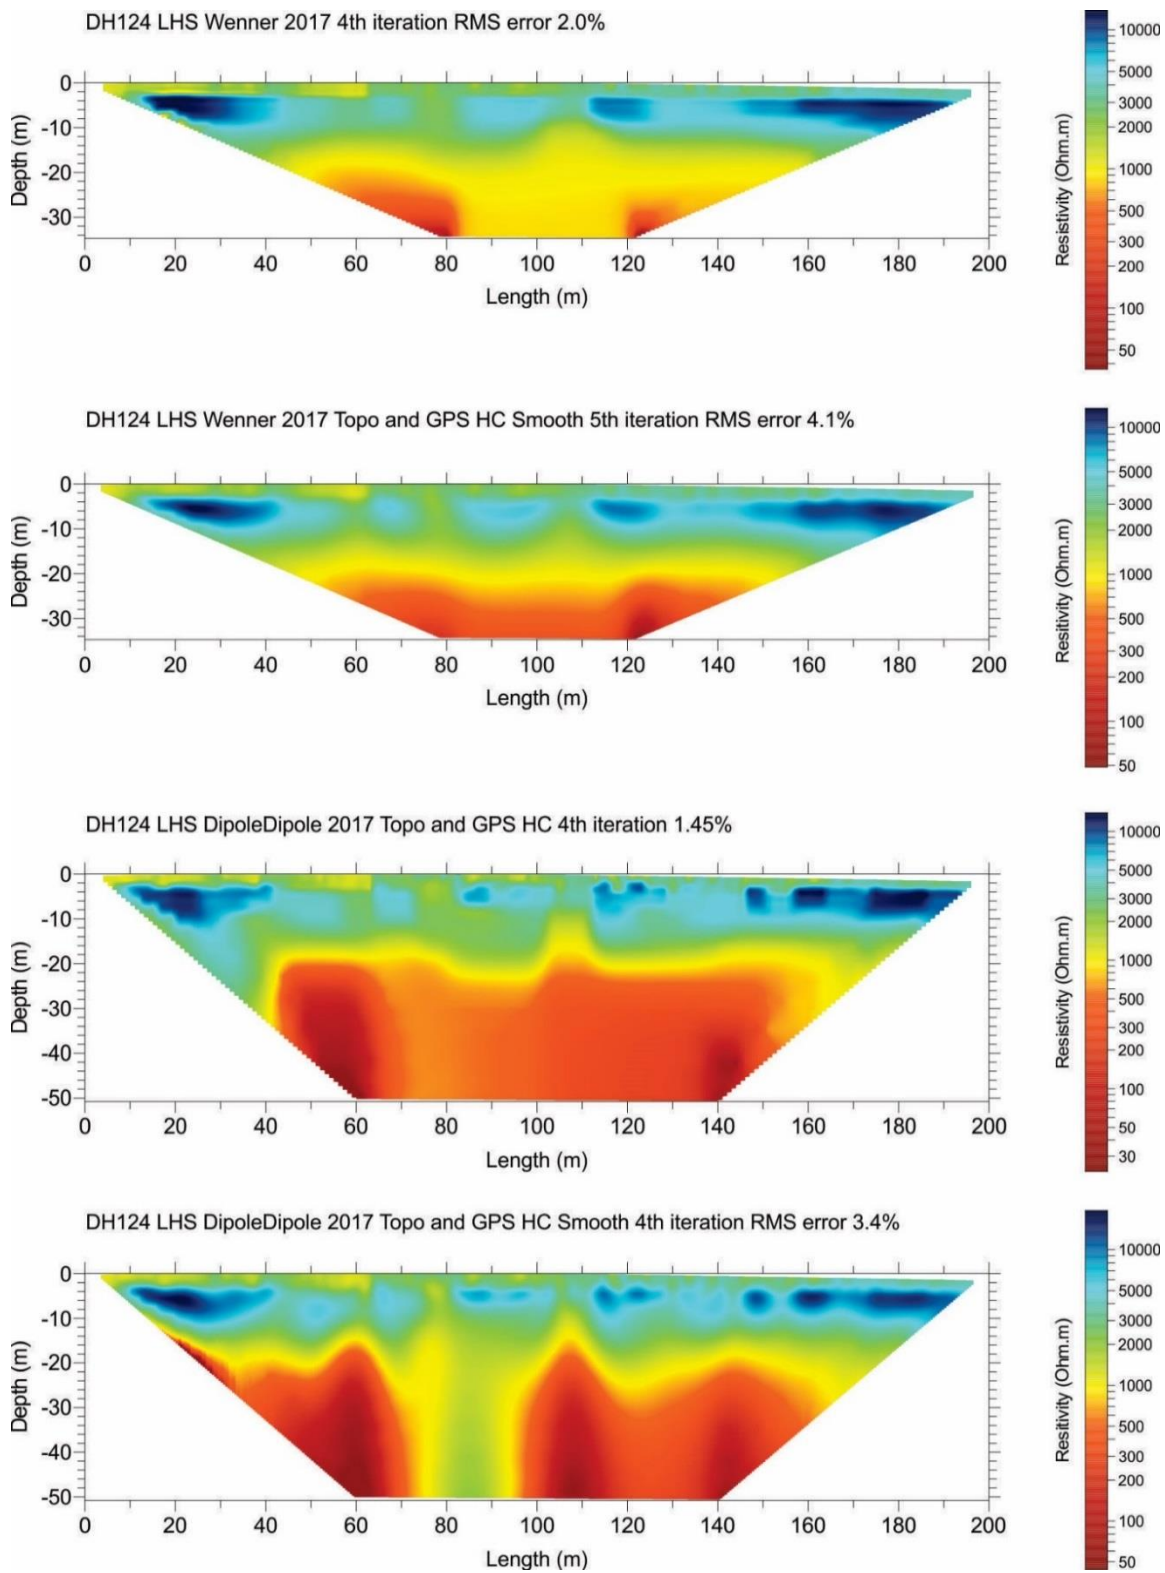
Figure 3.6.8 Wenner and dipole-dipole ERT surveys at site DH124, left-hand side (LHS), using robust and smoothed inversion processes.

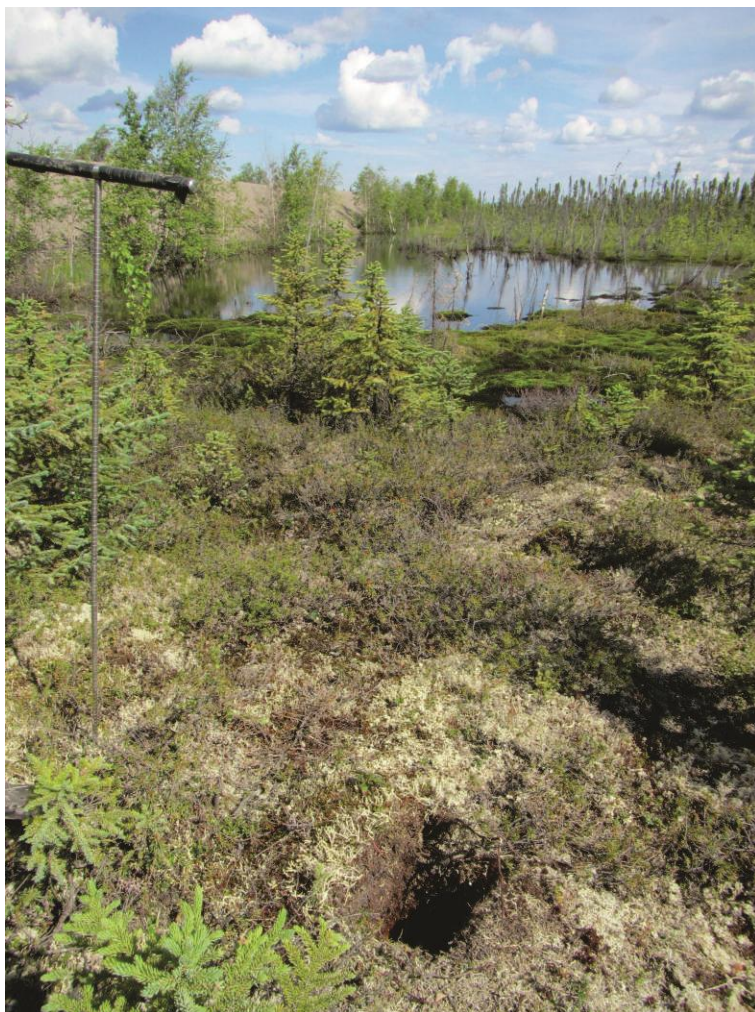
- Thermokarst lakes are forming on either side of the highway
- Observed subsidence in the embankment and burying of the culvert

Figure 3.9.1 Thermokarst pond along right-hand side at site DH375 (view from the field).

While the slumps still are located at more than 100 m from the road; drainage remediation should be considered cautiously so as not to exacerbate the phenomenon.

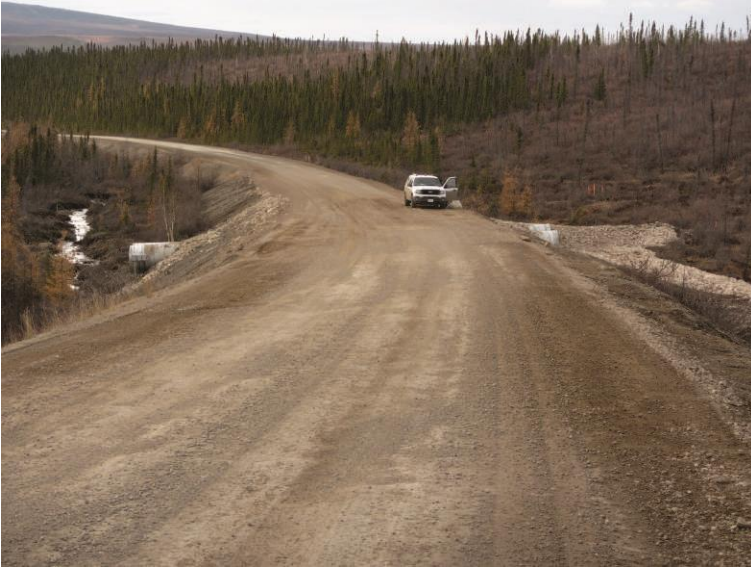
Figure 3.10.1 Culvert at site DH381.

However, DH381 has a very warm permafrost, 1 °C above DH375, with ground temperature close to 0 °C, and consequently has very limited, possibly even no thermal resiliency to climate warming or other thermal disturbance. This difference could be because DH375 is located at a hillcrest, on a plateau, while DH381 is in a small valley bottom, on its south facing hillslope.

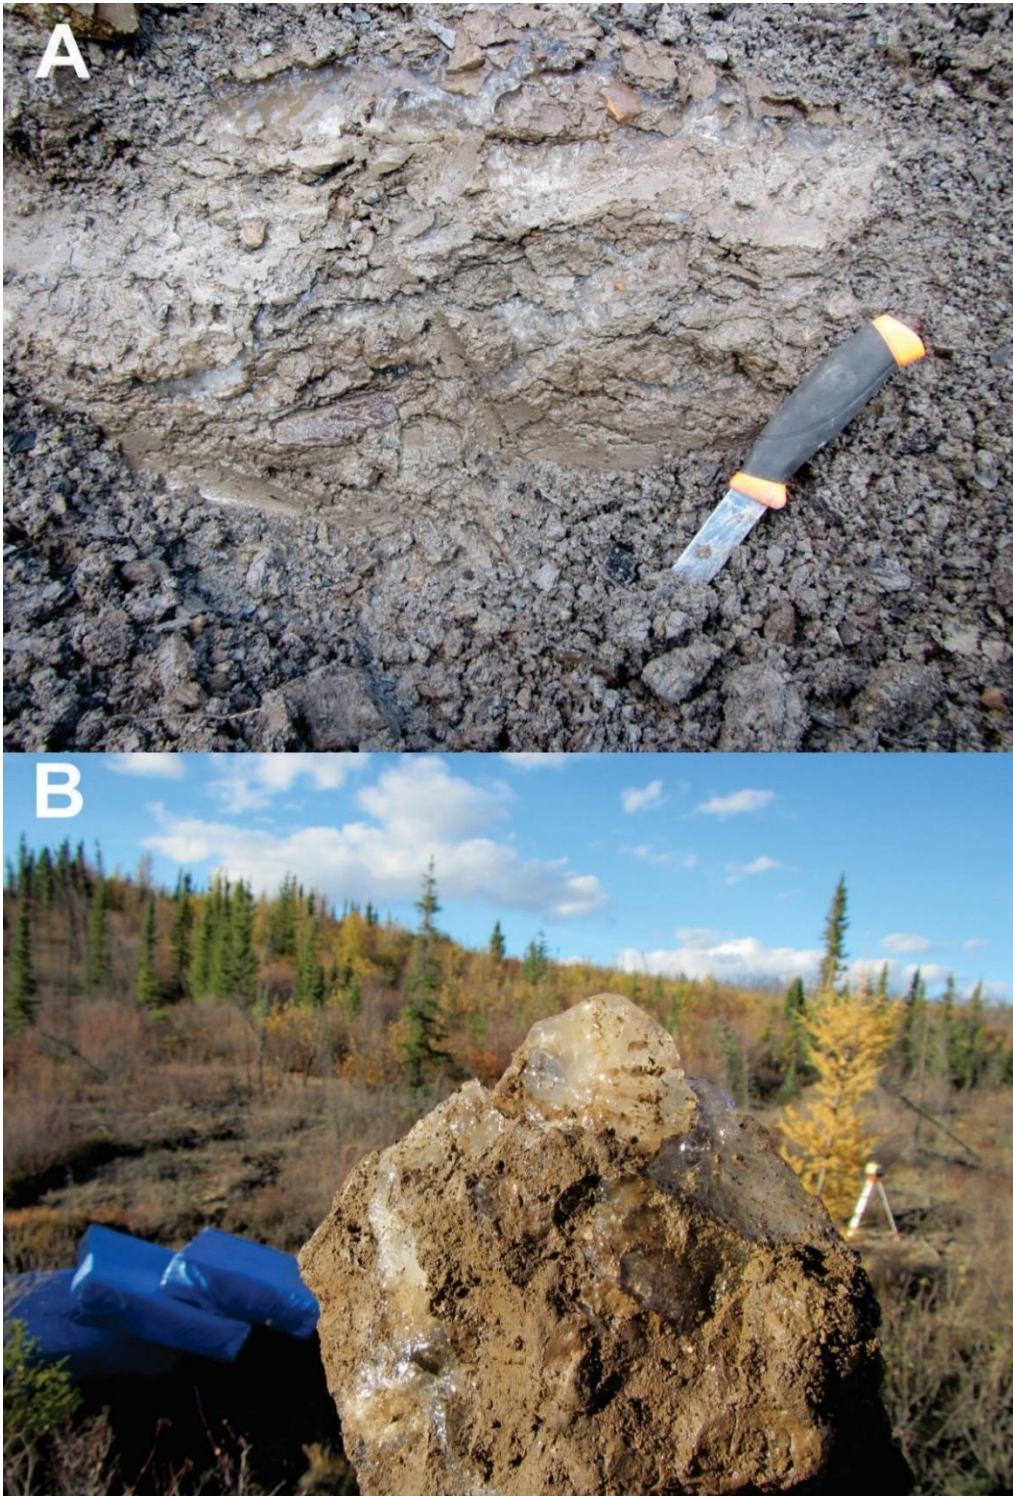
Figure 3.10.4 Permafrost observed during culvert installation at site DH381. A- ice-rich fine grained soil excavated below the embankment; B- close-up of an ice-rich permafrost sample collected during the excavation works

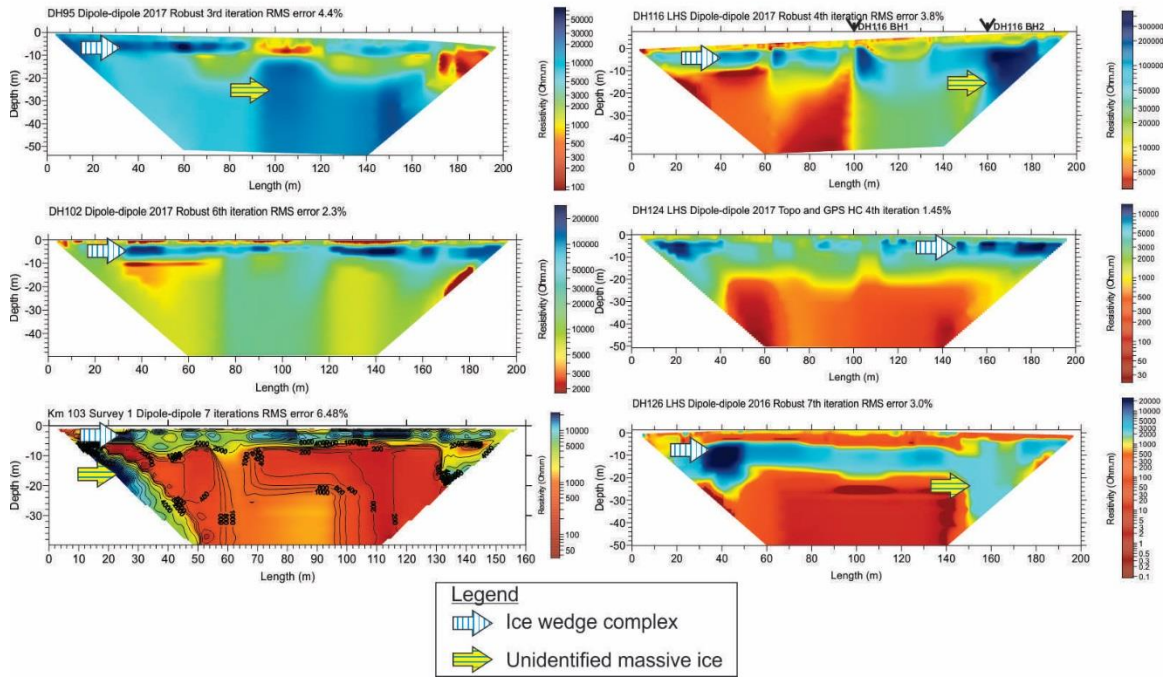
Figure 4.5.3 ERT surveys in the southern area with potential ground ice body locations

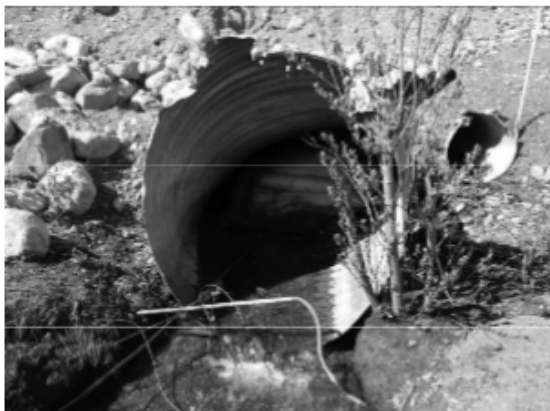
Figure 7. Culvert at km 32.5 (North Klondike River valley), filled with icing, May 2014. Photo by C.R. Burn.

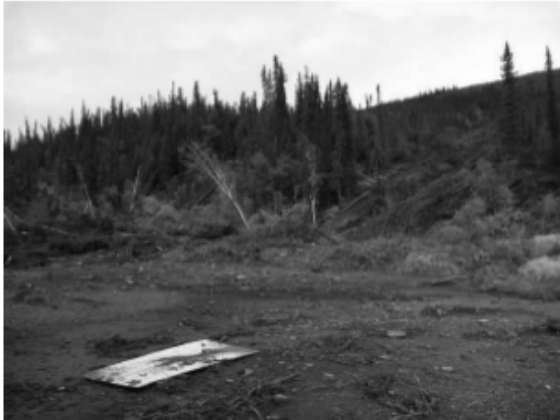
Figure 9. Debris flow at km 244, August 2010. Photo by C.R. Burn.

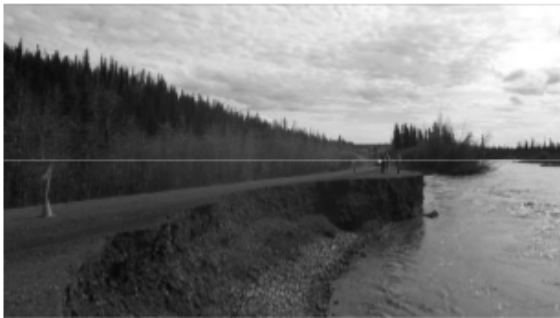
Figure 10. Wash out of the road by Ogilvie River at km 245, June 2013. Photo by S.N. Orban

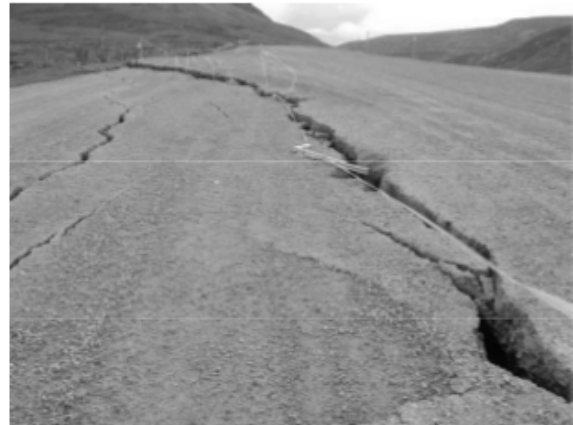
Figure 11. Thaw subsidence of the embankment at NT km 27, August 2011. Photo by C.R. Burn.

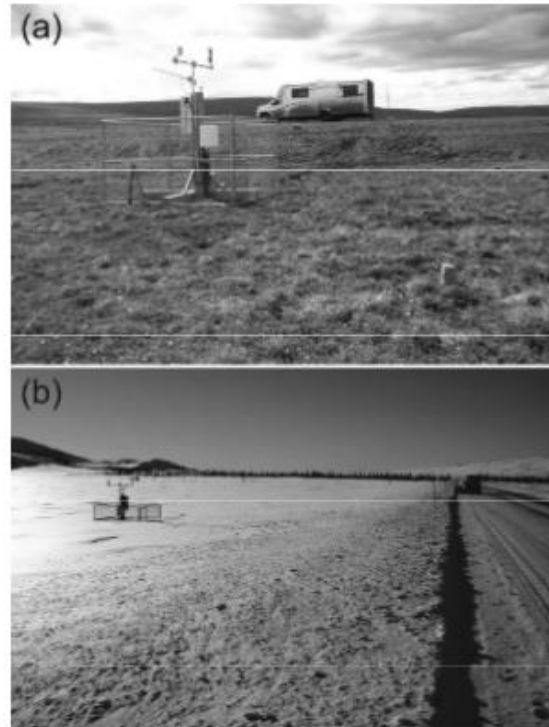
Figure 4. Site 2 shown (a) in summer and (b) in winter to illustrate the accumulation of snow beside the road embankment.
