EBA Engineering Consultants Ltd.		PROJECT SMALL PUBLIC WATER SYSTEMS ASSESSMENT WHITEHORSE REGION	
CLIENT

Whitehorse Region – Tagish Firehall
Building # 1953

SMALL PUBLIC WATER SYSTEM ASSESSMENT

WELL ID #	Owner	Location Description
1953	YTG	Tangish Fire Hall

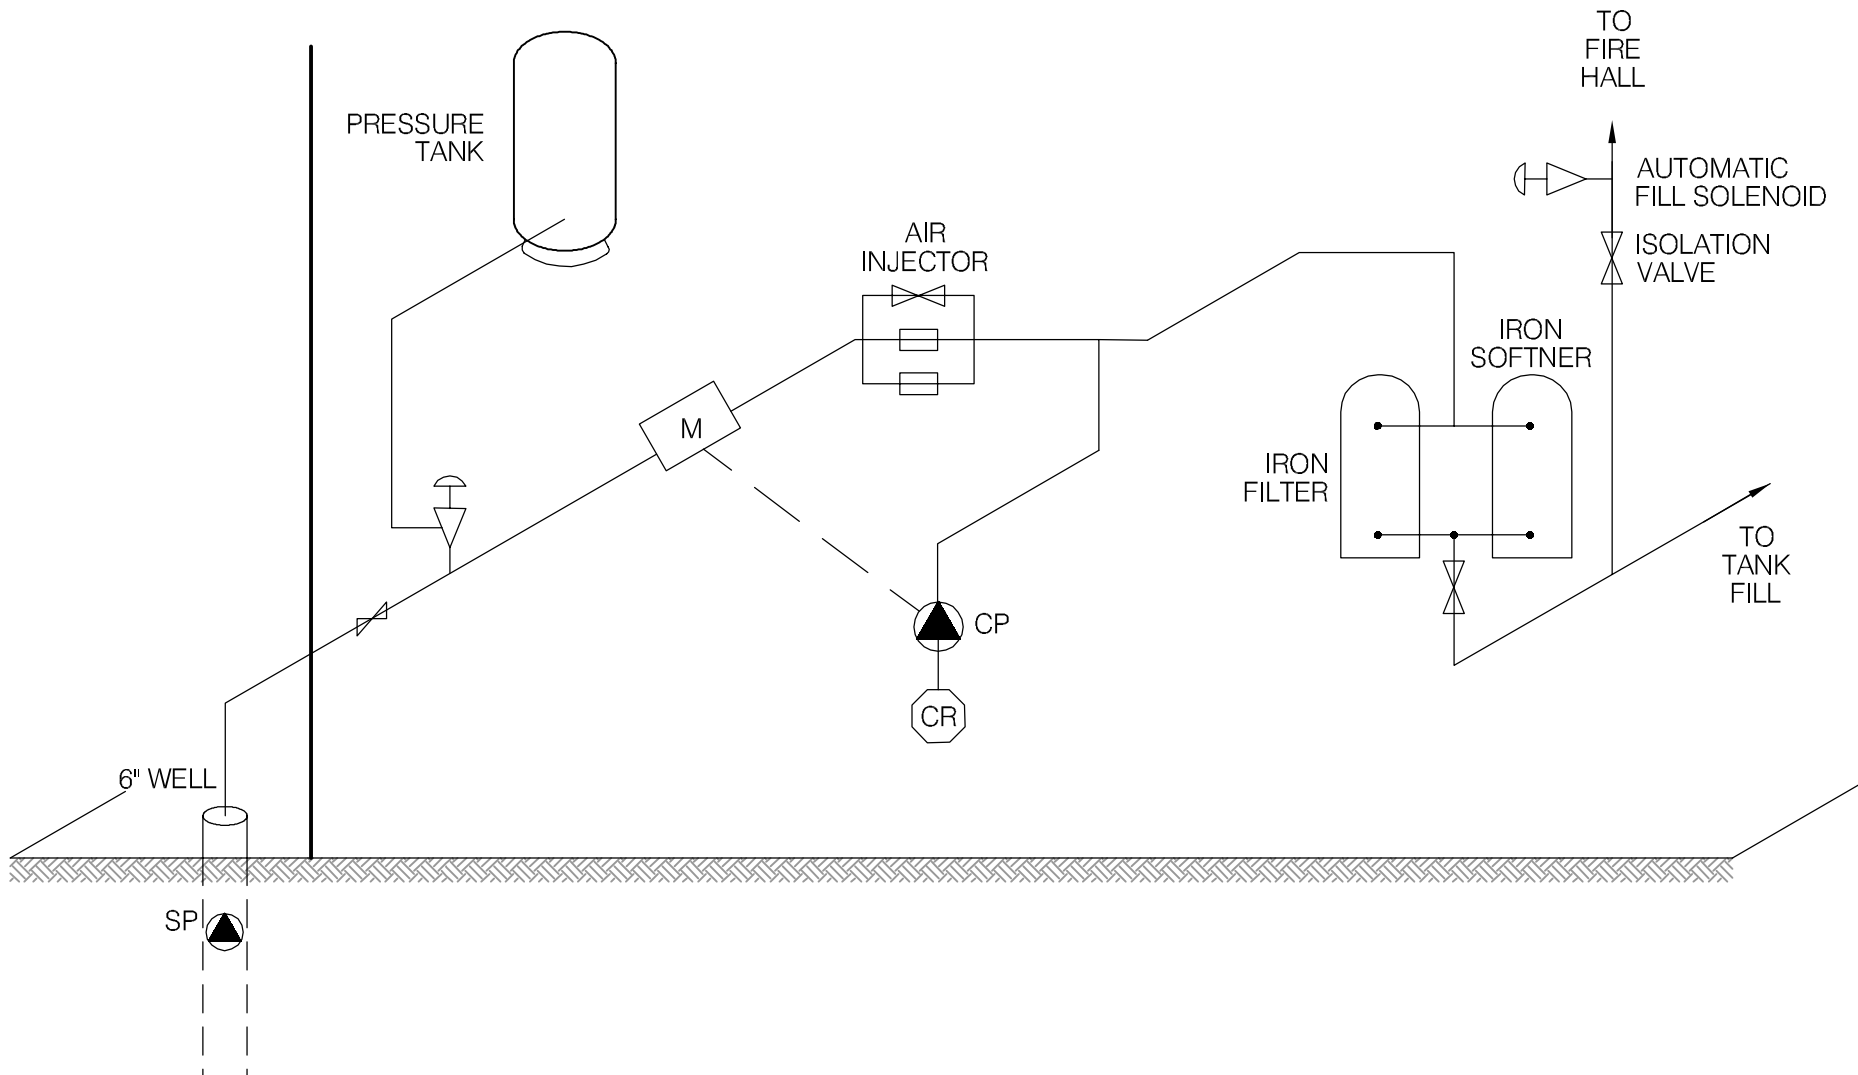
TITLE WATER SYSTEM DISTRIBUTION/TREATMENT SCHEMATIC SYSTEM ID.: 1953 TAGISH FIRE HALL	
DATE	APRIL 2006	DWN.	JSB
CHKD.	FMM	FILE NO.	1260002.001
		DWG.:	FIGURE 1953B

SCHEMATIC PRODUCED BY BERT ALBISSER OF AQUA TECH SUPPLIES & SERVICES LTD.

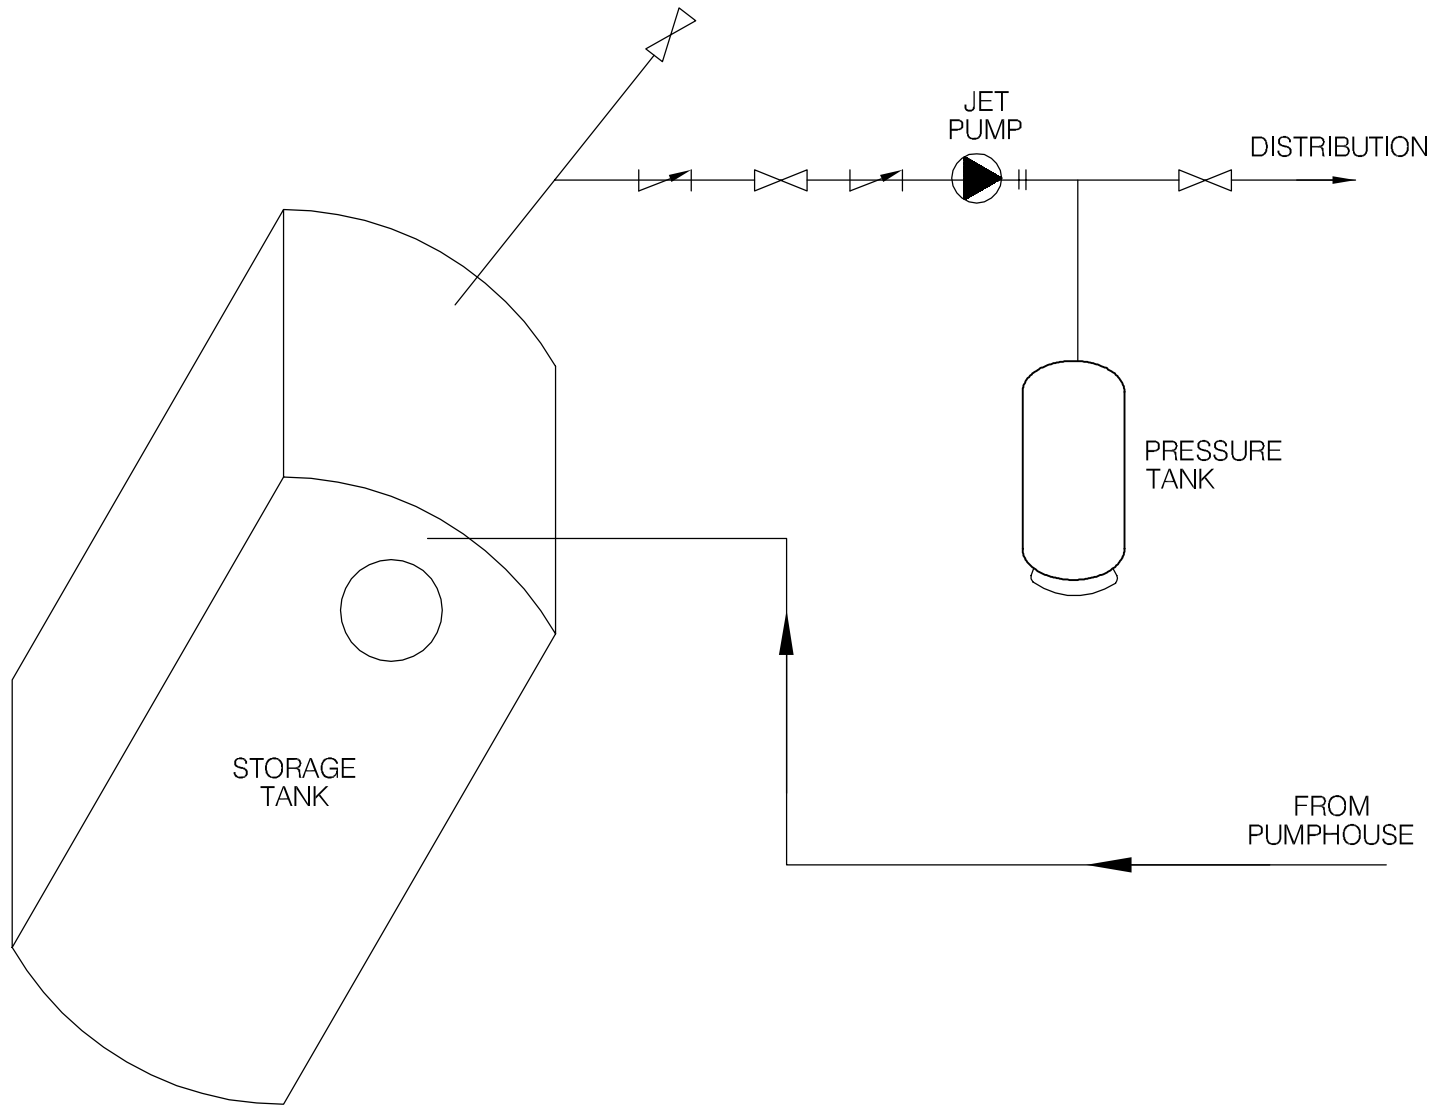
DWG.: FIGURE 1953C

WATER SYSTEM DISTRIBUTION/TREATMENT
SCHEMATIC SYSTEM ID.: 1953
TAGISH FIRE HALL

Item	Description	Manufacturer	Model	Part No.	Serial No.	Size
1	4" SUBMERSIBLE	RED JACKET	8 FC	(175530) 9F 1996.		3HP 2"
2	PRESSURE CONTROL	RED JACKET	HYDROSWANT			2"
3	FLOW METER PULSER	LMI	RFP-020			2"
4	CHLORINE INJECTION	GRUNDOS	DME 8-10	96472847		
5	IRON FILTERS	WATERTECH	BTW-30 DUPLEX REF 3072			TANK 30x72 RING 1/2"
6	WATER METER	NEPTUNO	2" TRIDENTO			2" FLANGED.
7	PRESSURE TANK	AMTROL	WX-30R			
8	SOL. FILL VALVE	KECO	2" BRONZE			2" FIPT
9	PRESS CONTROL	WATTS	45BLP.			1/2" FIPT
10	AIR CHARGER	WATERTECH	30" DUPLEX			2x1" HYDRO CHARGER

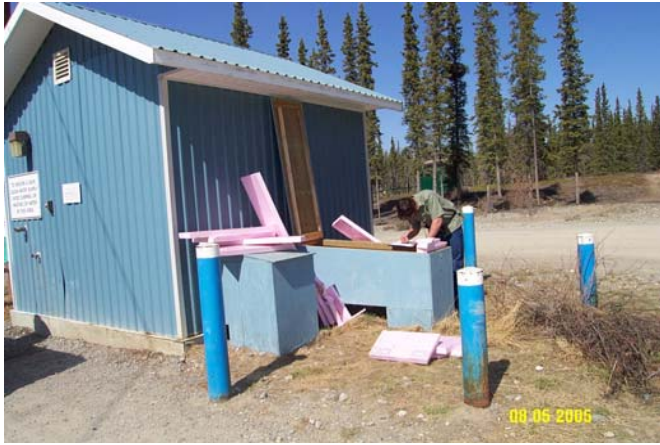
- well enclosure accessible to rodents

Photo 0062: 1953 Well Enclosure (right) and Pumphouse

- design enclosure that is mouse proof
- consider raising casing slightly

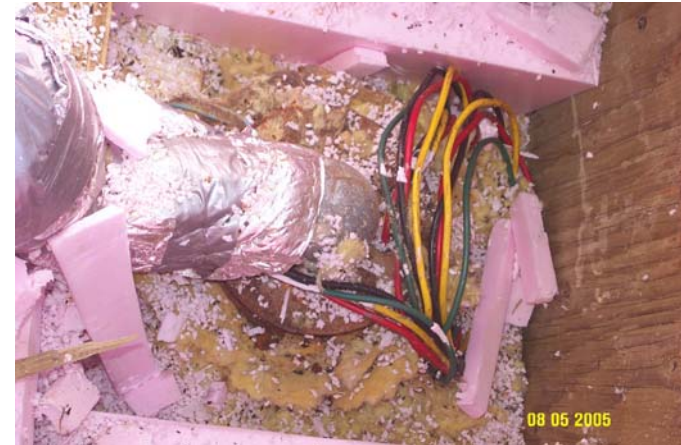
- i. Is the well head below grade? describe in detail Above grade (0.2 m)
- ii. Are there signs of ponding on the enclosure(e.g. water stains, etc.)? Yes No
- iii. Is the wellhead enclosed by fiberglass insulations? Yes No - styrofoam SM.
- iv. Any evidence of rodents? Specify Yes, mouse droppings.
- v. Does the well casing have a proper seal cap? Yes No

If no, describe condition SPLIT GASKET CAP -
NOTE MOUSE DROPPINGS ON TOP OF CAP

Photo 0059: 1953 Well Head

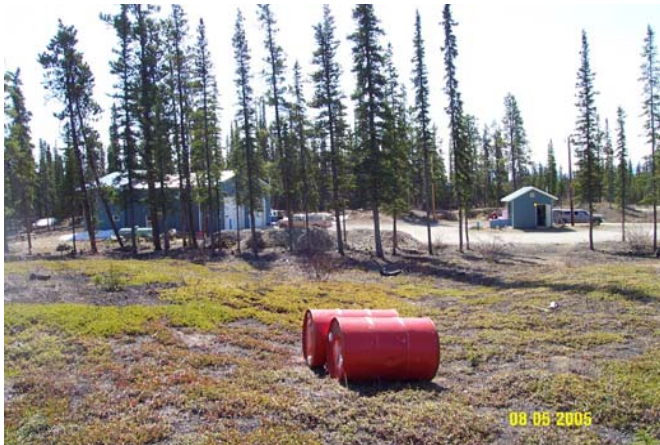
Potential Source 2: Av. gas; Distance from well to Potential Source 2: 48m

Photo 0061: 1953 45 gal. Aviation Fuel Drums (front), Pumphouse (back right), and Firehall (back left)

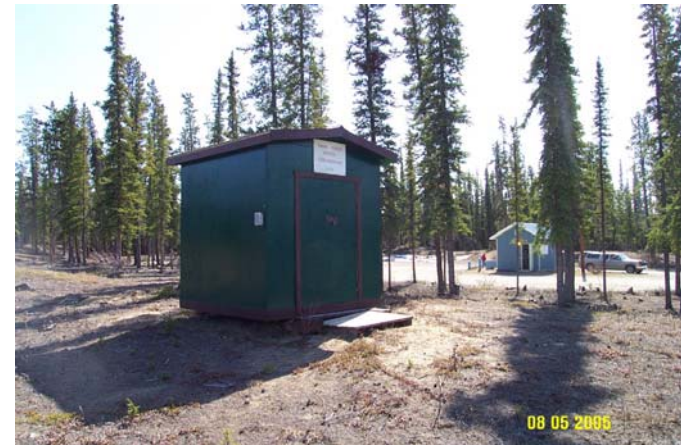
Potential Source 1: fire equip. cache; Distance from well to Potential Source 1: 30m

Photo 0060: 1953 Fire Equipment Cache (front), Pumphouse (back left)

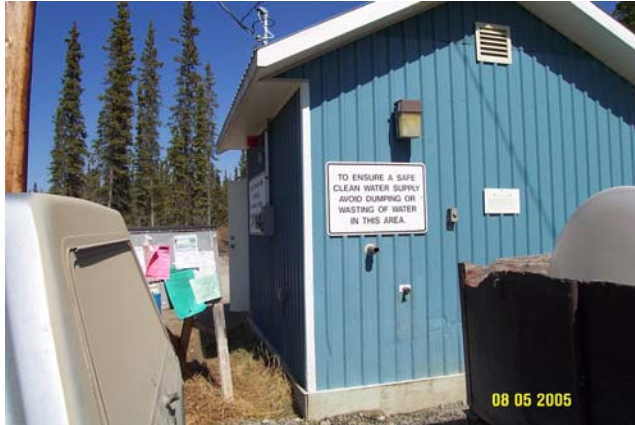
Photo 0063: 1953 Fill Station

The tank that feeds the water truck tank should be cleaned
The piping should be changed, that feeds the domestic
water to the fireball 11/11

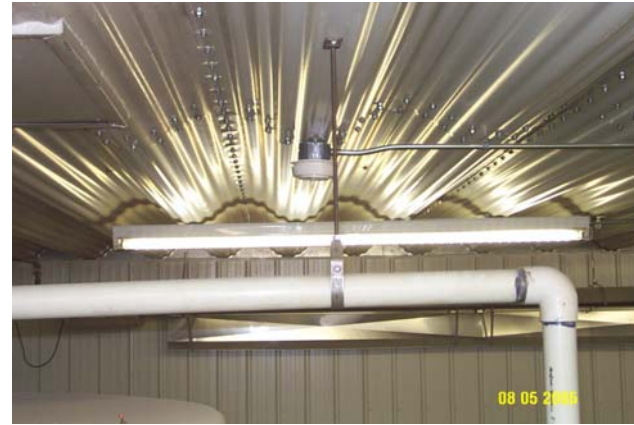
Photo 0067: 1953 Pipe Hangar – Potential Location for Solenoid

MOVE SOLENOID CONTROL VALVE FOR FIRE
WATER STORAGE FROM PUMP HOUSE TO
VICINITY OF TANK. PUMP DOMESTIC
WATER TAKE OFF UPSTREAM OF SOLENOID
VALVE. THIS WILL FEED TREATED,
CHLORINATED WATER TO THE JET PUMP,
SUPPLYING POTABLE WATER TO THE
BUILDING.

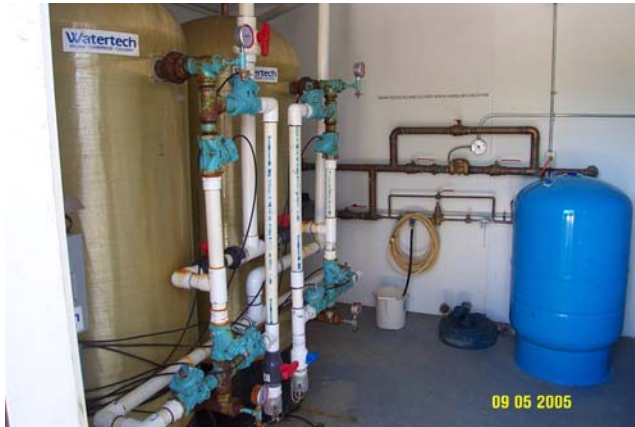
Photo 0068: 1953 Water Supply System, Pressure Tank (left), Iron Removal Tanks (right)

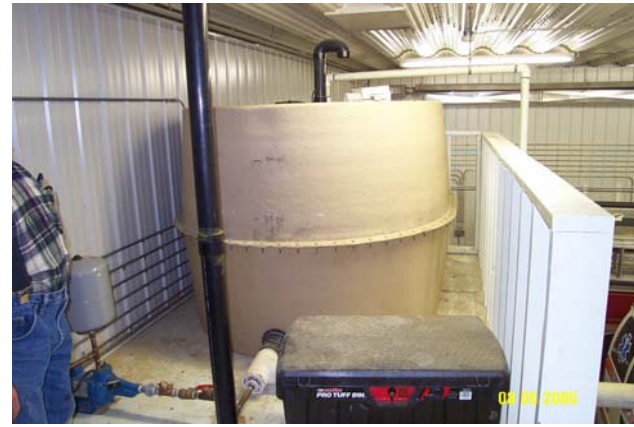
Comments: SLIGHT

Comments: SOME RUST SEDIMENT

Photo 0066: 1953 Firehall 1250gal Water Storage Tank

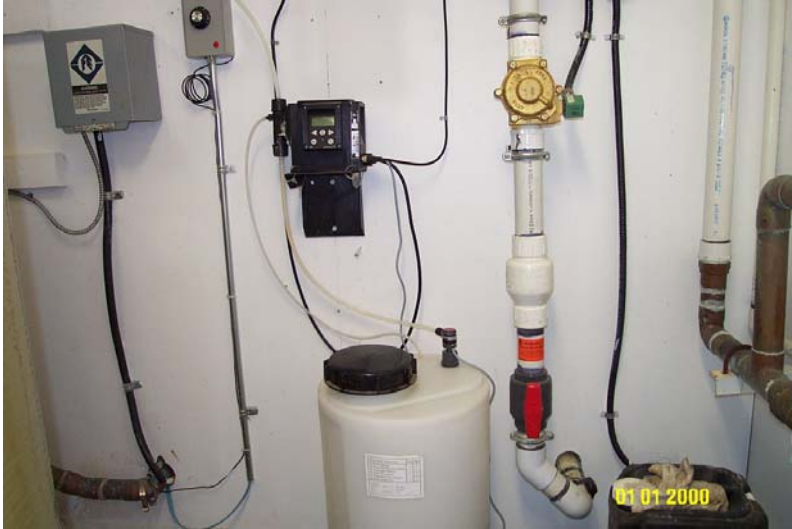
Photo 0069: 1953 Grundfos DME Chlorinator

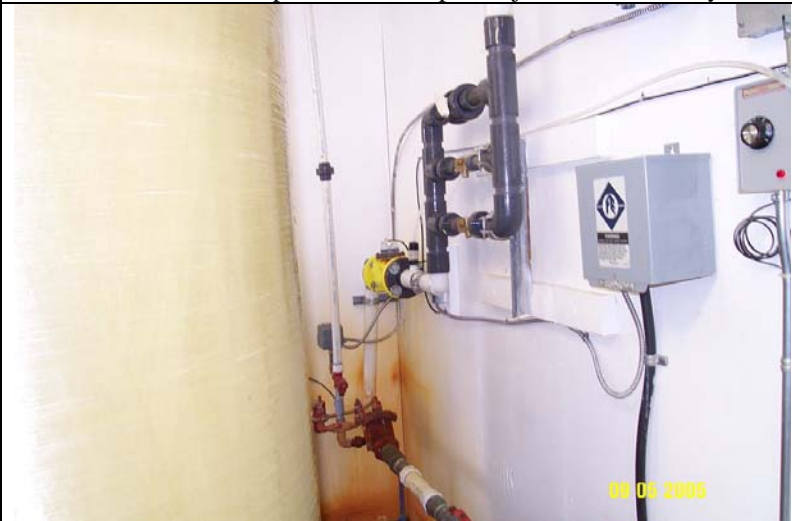
Photo 0070: 1953 Pumphouse Iron Duplex Injection Chlorine System
