SMALL PUBLIC WATER SYSTEMS ASSESSMENT
 WHITEHORSE REGION

CARMACKS RCMP RESIDENCE
 BUILDING M0064
 LOCATION DIAGRAM
 WELL ID: M0064A

TITLE WATER SYSTEM DISTRIBUTION/TREATMENT SCHEMATIC SYSTEM ID.: M0094 CARMACKS RCMP DETACHMENT							
DATE	APRIL 2006	DWN.	JSB	CHKD.	FMM	FILE NO.	1260002.001	DWG.:	FIGURE M0094B

SMALL PUBLIC WATER SYSTEM ASSESSMENT

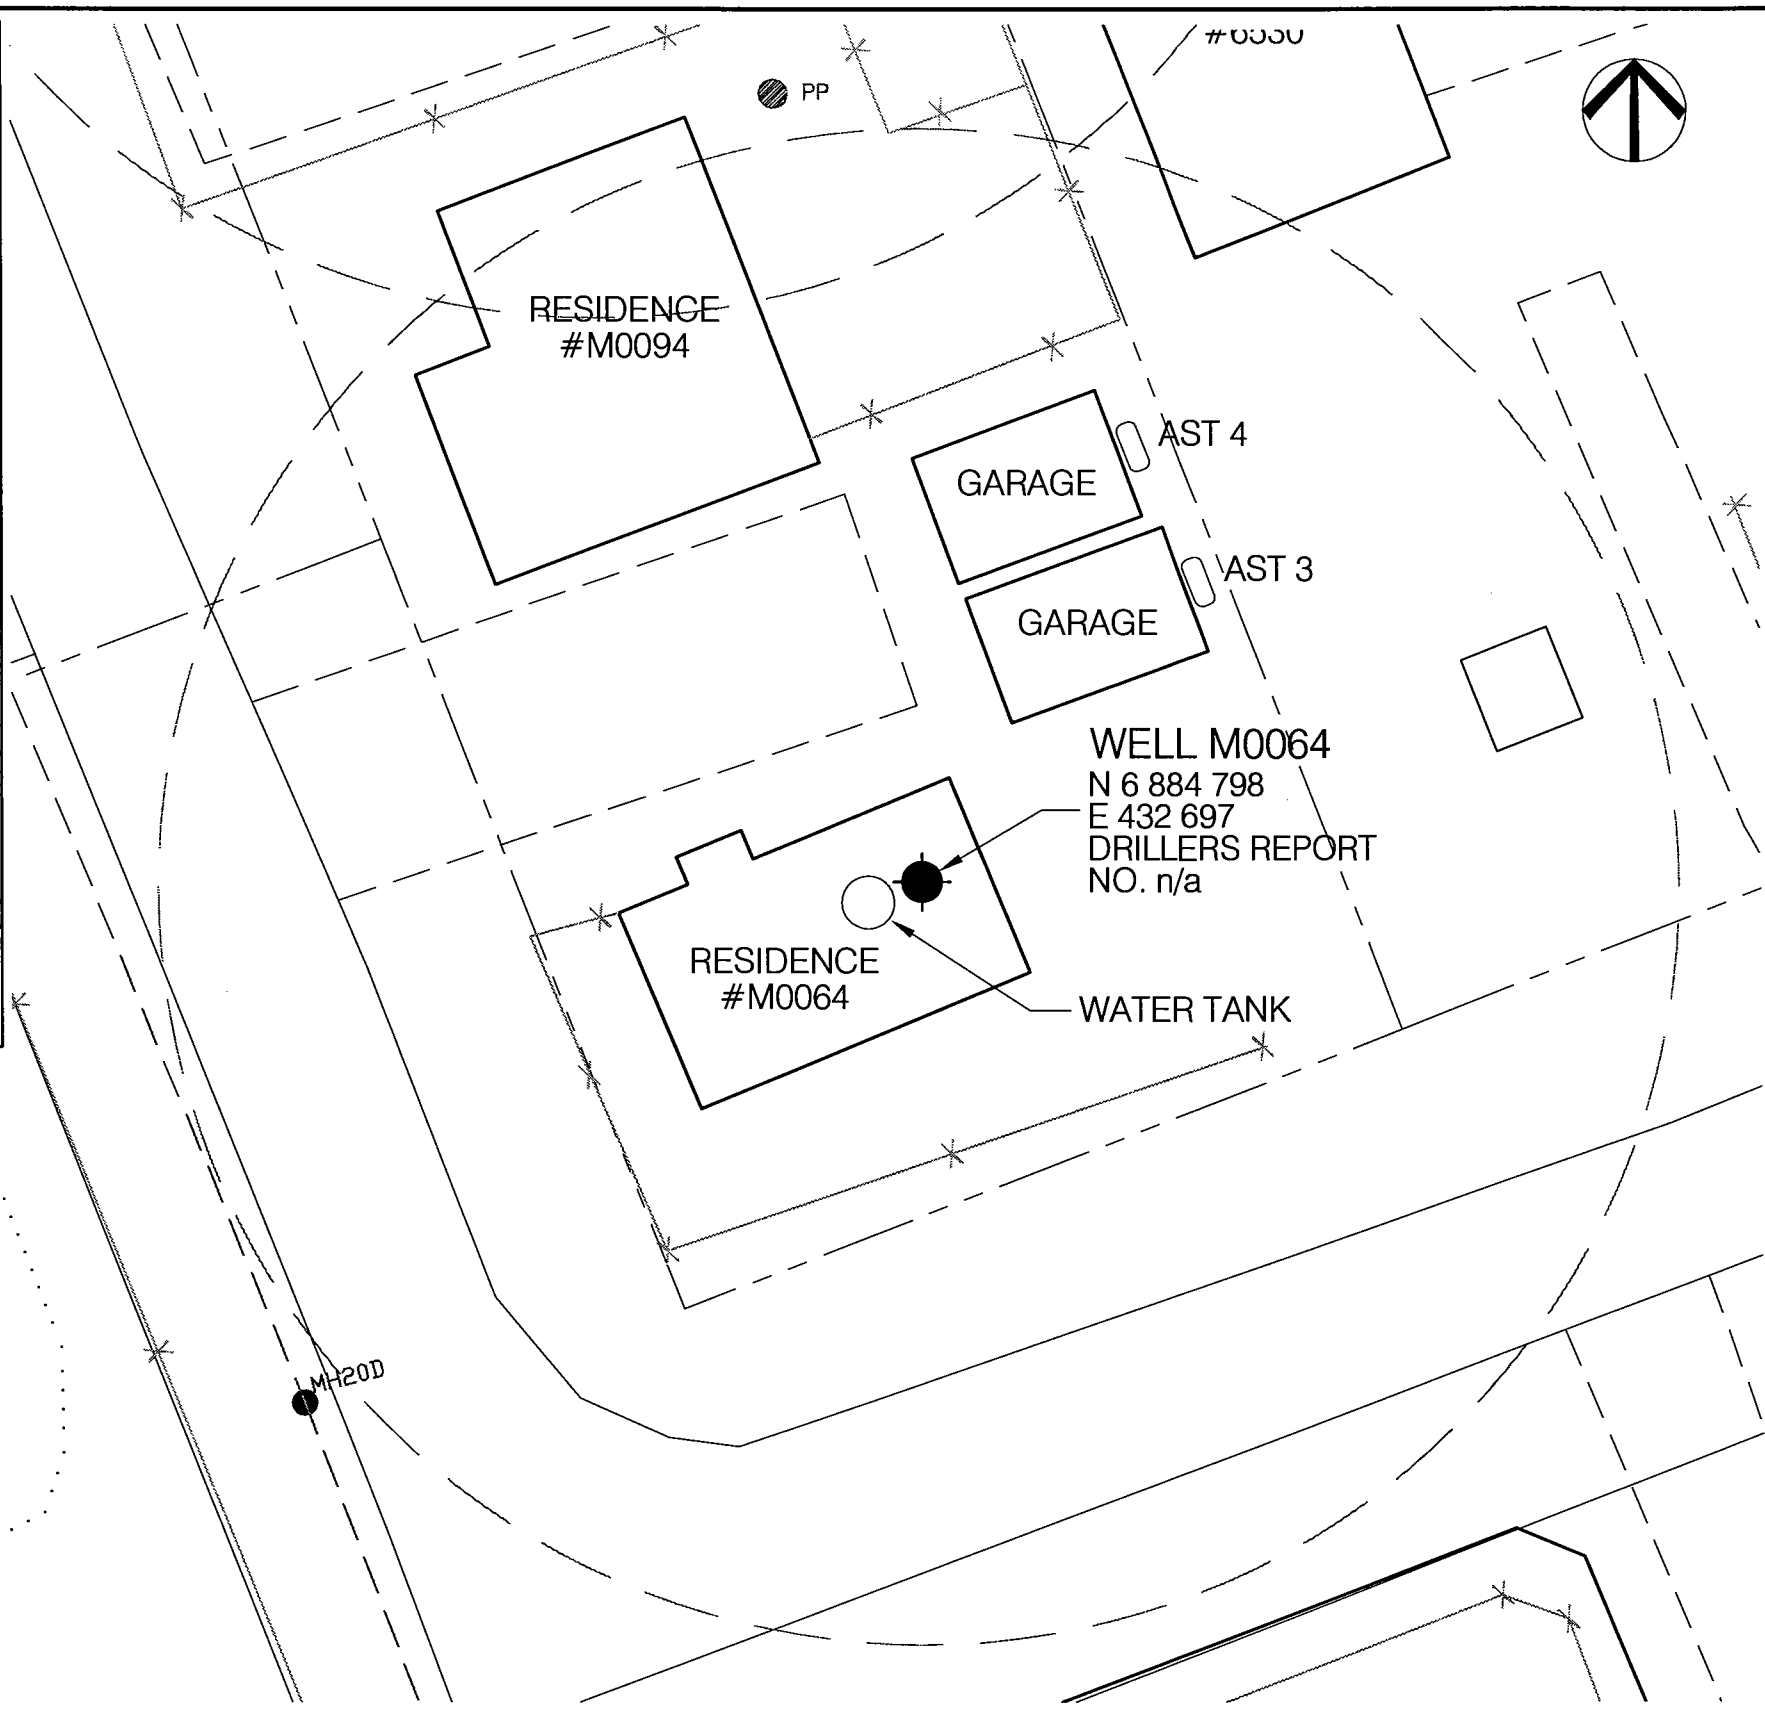
DRAWING No.
 FIGURE M0064A

30 m RADIUS FROM WATER WELL FOR CONSIDERATION OF PROXIMITY TO POTENTIAL CONTAMINANT SOURCES.

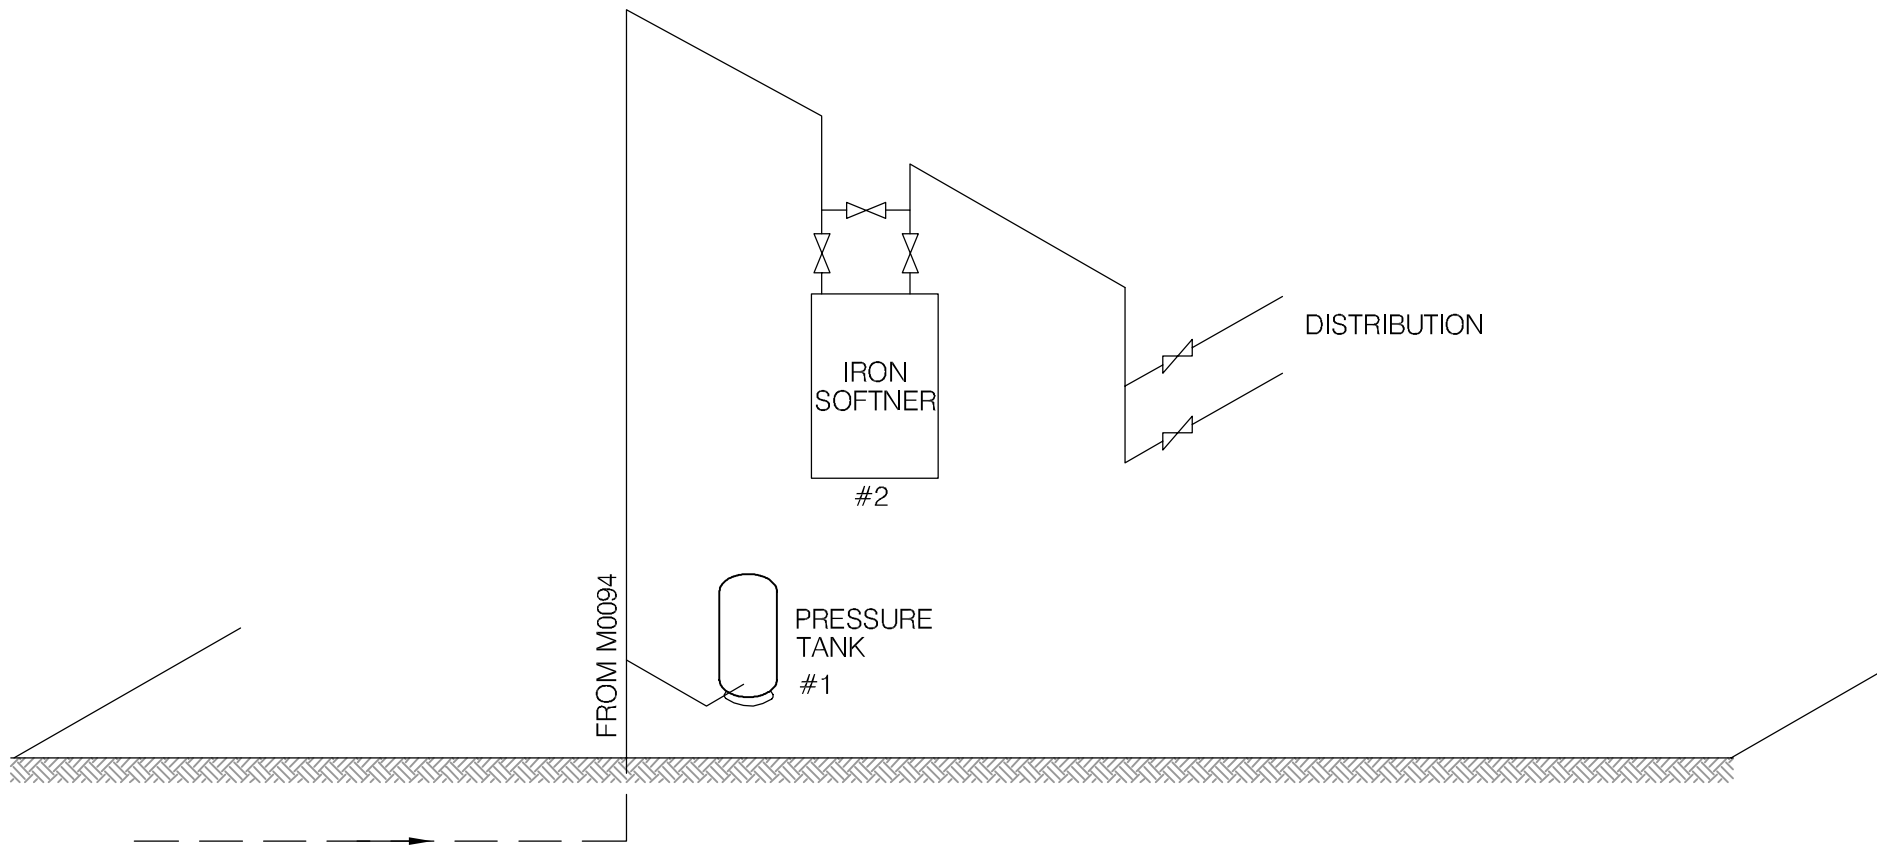
Item	Description	Manufacturer	Model	Part No.	Serial No.	Size
1	PRESSURE TANK	WELL RITE	WR260-02			
2	IRON SOFTNER	MYERS	MISF30IN		1192	
3						
4						
5						
6						
7						
8						
9						
10

ADD UV SYSTEM & FILTRATION

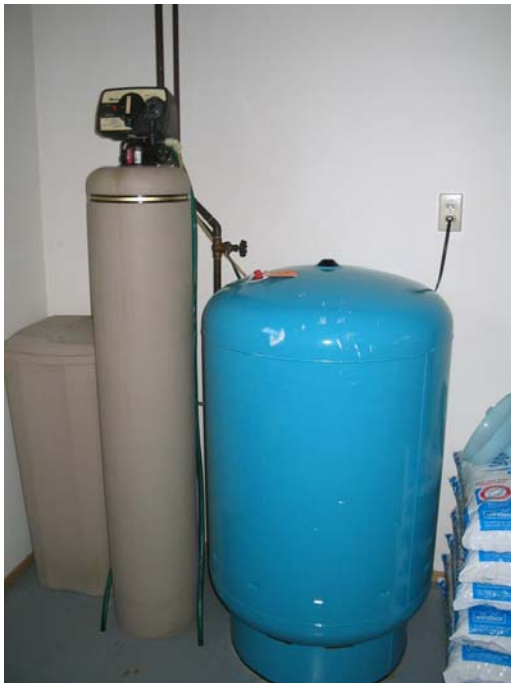
Photo 0011: M0094 Water Softener (left) and Pressure Tank (right)
