SMALL PUBLIC WATER SYSTEMS ASSESSMENT
WHITEHORSE REGION

WATER SYSTEM DISTRIBUTION/TREATMENT
SCHEMATIC SYSTEM ID.: 1322
GOLDEN HORN SCHOOL

DWG.: FIGURE 1322B

**Whitehorse Region – Golden Horn School
Building # 1322**

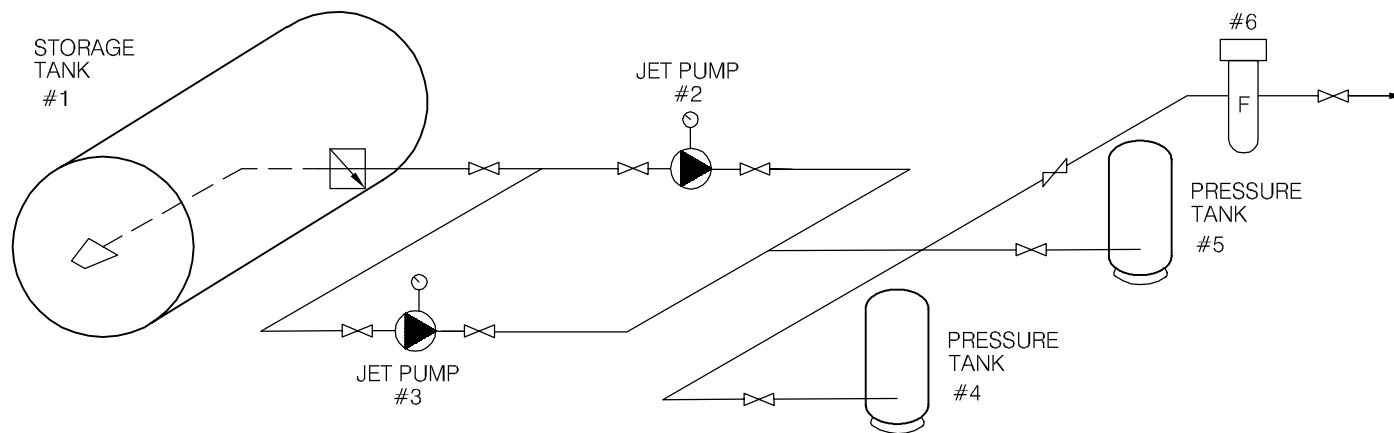
Item	Description	Manufacturer	Model	Part No.	Serial No.	Size
1	STORAGE TANK					6Ft ϕ x 10'L
2	JET PUMP #1	MYERS	MJC-100		1596	1 1/4" x 1"
3	JET PUMP #2	MYERS	MJC-100			
4	PRESSURE TANK #1		PMD 52		B 90685140	
5	PRESSURE TANK #2		PMD 52		B 89257660.	
6	WATER FILTER	AMETEK	1 1/2" BB			1 1/2 x 10"
7	WATER FILTER CART	"	JOIDP97			3 3/4" x 10"
8						
9						
10

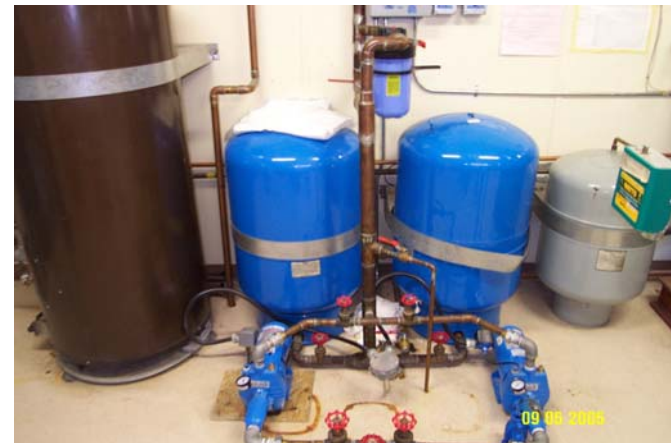
Photo 0086: 1322 Pressure Tanks and Filter
