**Phase I Environmental Site  
Assessment**

Lot 115, 29969 LTO YT, Ross River, YT

August 4, 2021

Stantec Consulting Ltd.

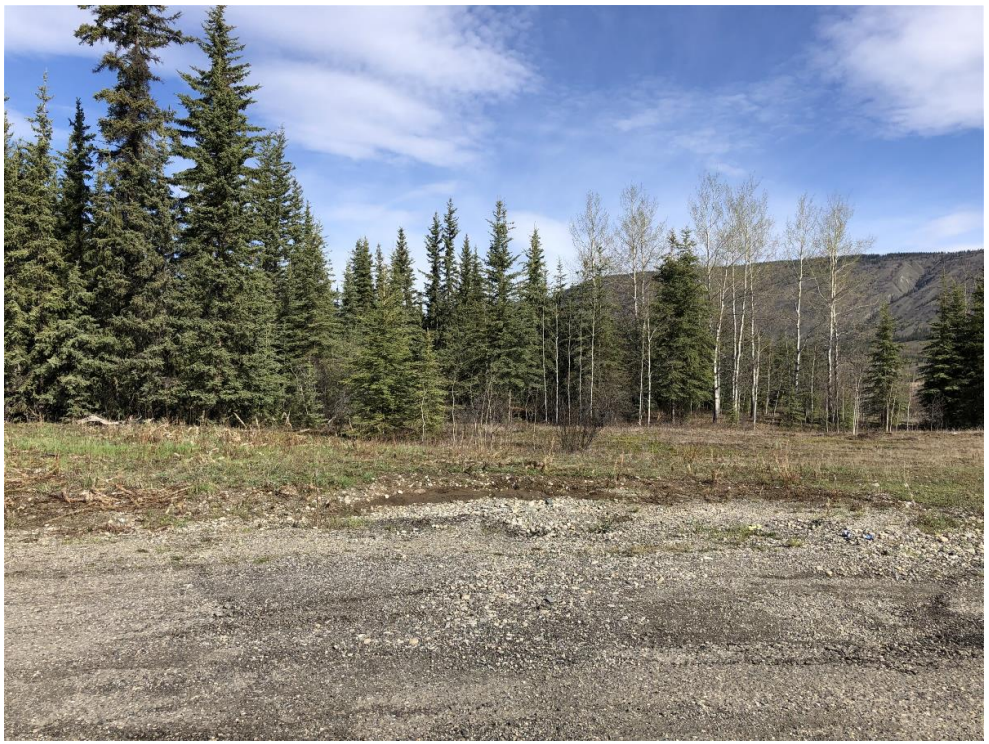
<b>Client:</b>		<b>Project:</b>	
<b>Site Name:</b>		<b>Site Location:</b>	
<b>Photograph ID: 1</b>

<b>Photo Location:</b> Lot 115			
<b>Direction:</b> North			
<b>Survey Date:</b> 5/27/2021			
<b>Comments:</b> Western cleared portion of Lot 115 looking north from Ketza Road			
<b>Photograph ID: 2</b>

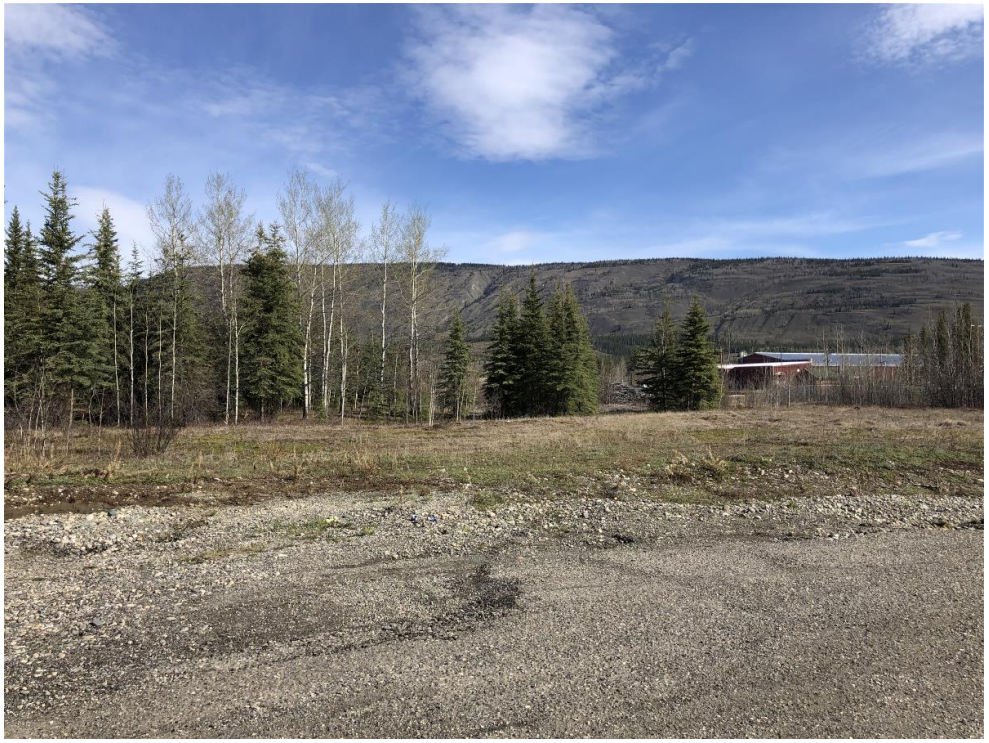
<b>Photo Location:</b> Lot 115			
<b>Direction:</b> North			
<b>Survey Date:</b> 5/27/2021			
<b>Comments:</b> Middle cleared portion of Lot 115 looking north from Ketza Road

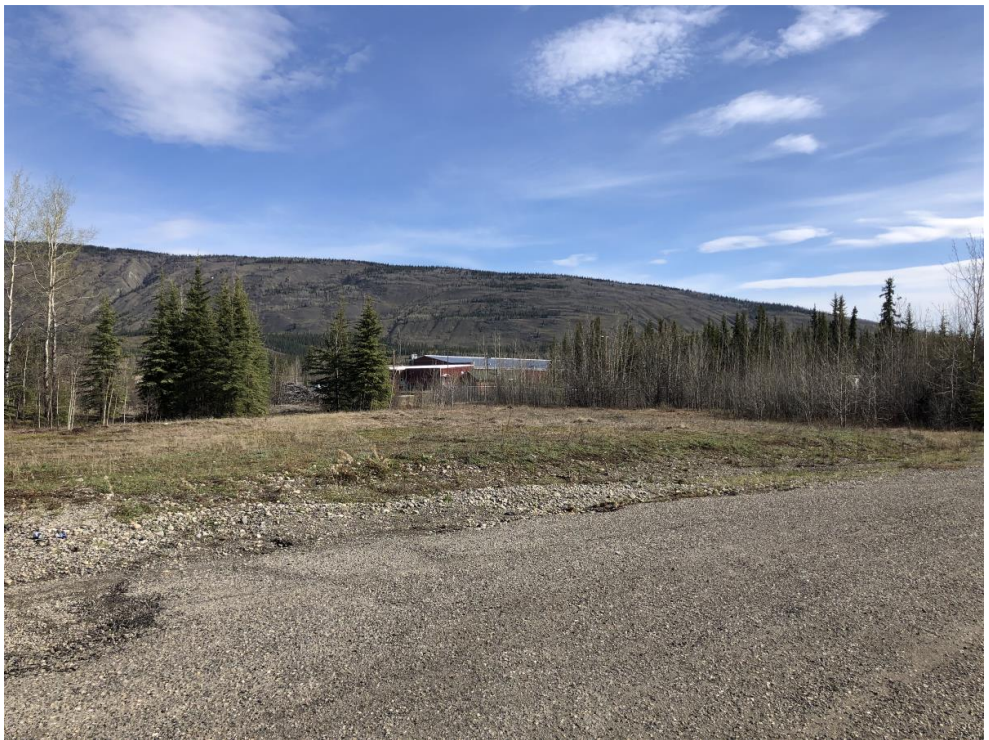
<b>Client:</b>		<b>Project:</b>	
<b>Site Name:</b>		<b>Site Location:</b>	
<b>Photograph ID:</b> 3

<b>Photo Location:</b> Lot 115			
<b>Direction:</b> North			
<b>Survey Date:</b> 5/27/2021			
<b>Comments:</b> Eastern cleared portion of Lot 115 looking north from Ketz Road			
<b>Photograph ID:</b> 4

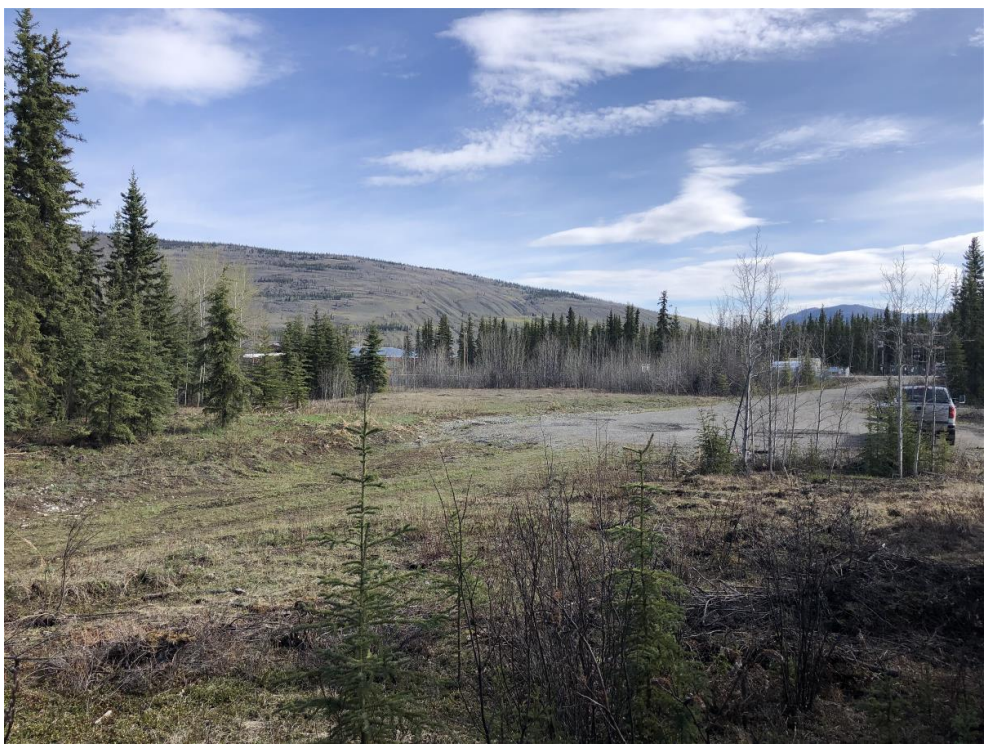
<b>Photo Location:</b> Lot 115			
<b>Direction:</b> Northeast			
<b>Survey Date:</b> 5/27/2021			
<b>Comments:</b> Lot 115 viewed from the southwest

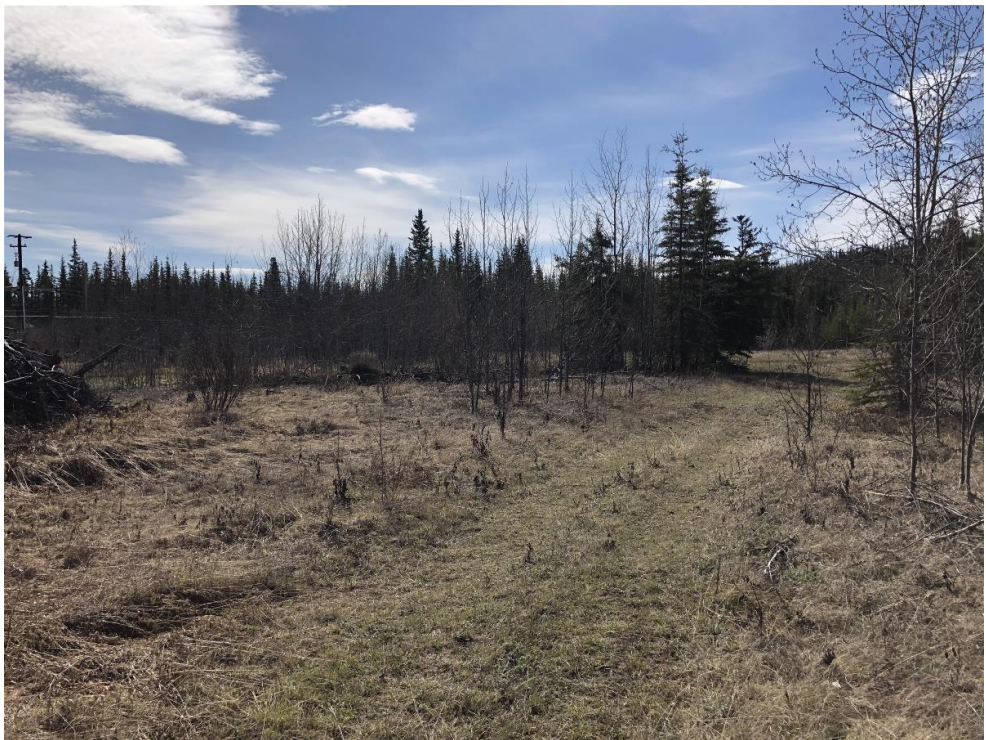
<b>Client:</b>		<b>Project:</b>	
<b>Site Name:</b>		<b>Site Location:</b>	
<b>Photograph ID:</b> 5

<b>Photo Location:</b> Lot 115			
<b>Direction:</b> South			
<b>Survey Date:</b> 5/27/2021			
<b>Comments:</b> Eastern edge of Lot 115 viewed from the north			
<b>Photograph ID:</b> 6

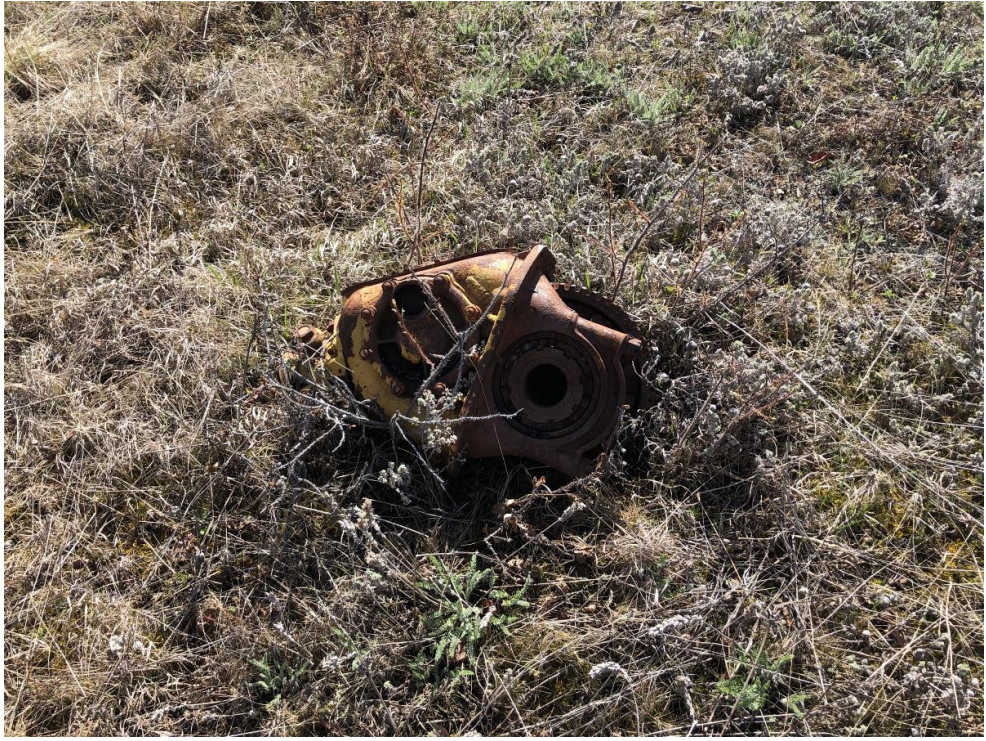
<b>Photo Location:</b> Lot 115			
<b>Direction:</b> N/A			
<b>Survey Date:</b> 5/27/2021			
<b>Comments:</b> Machinery debris on Lot 115

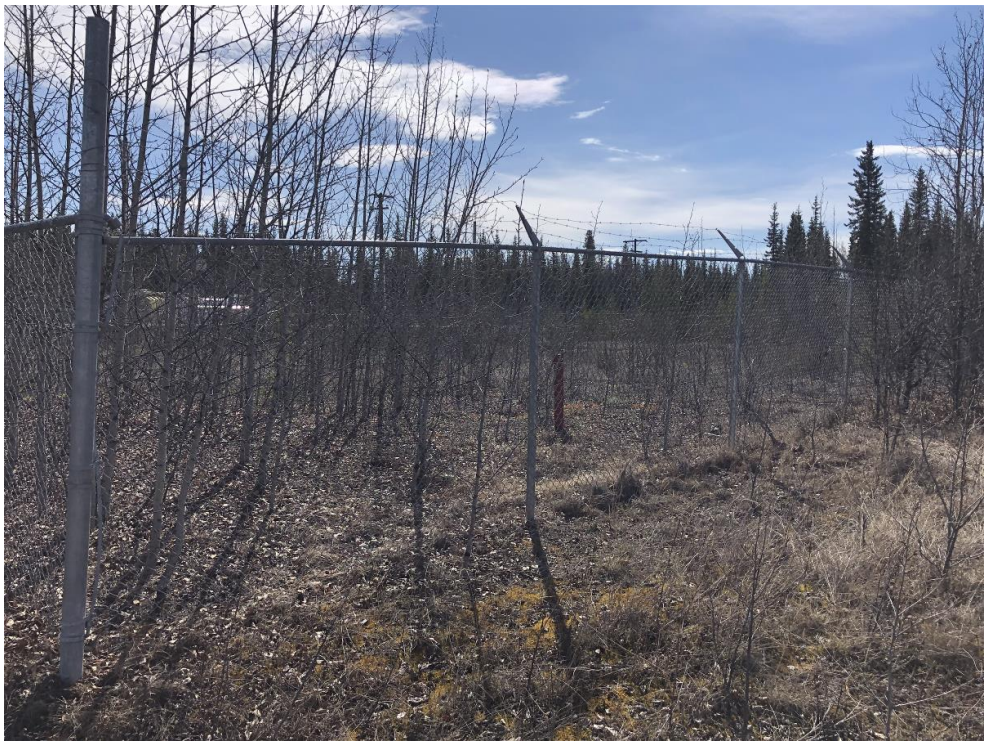
<b>Client:</b>		<b>Project:</b>	
<b>Site Name:</b>		<b>Site Location:</b>	
<b>Photograph ID:</b> 7

<b>Photo Location:</b> Lot 118			
<b>Direction:</b> Southeast			
<b>Survey Date:</b> 5/27/2021			
<b>Comments:</b> NW corner of Lot 118			
<b>Photograph ID:</b> 8

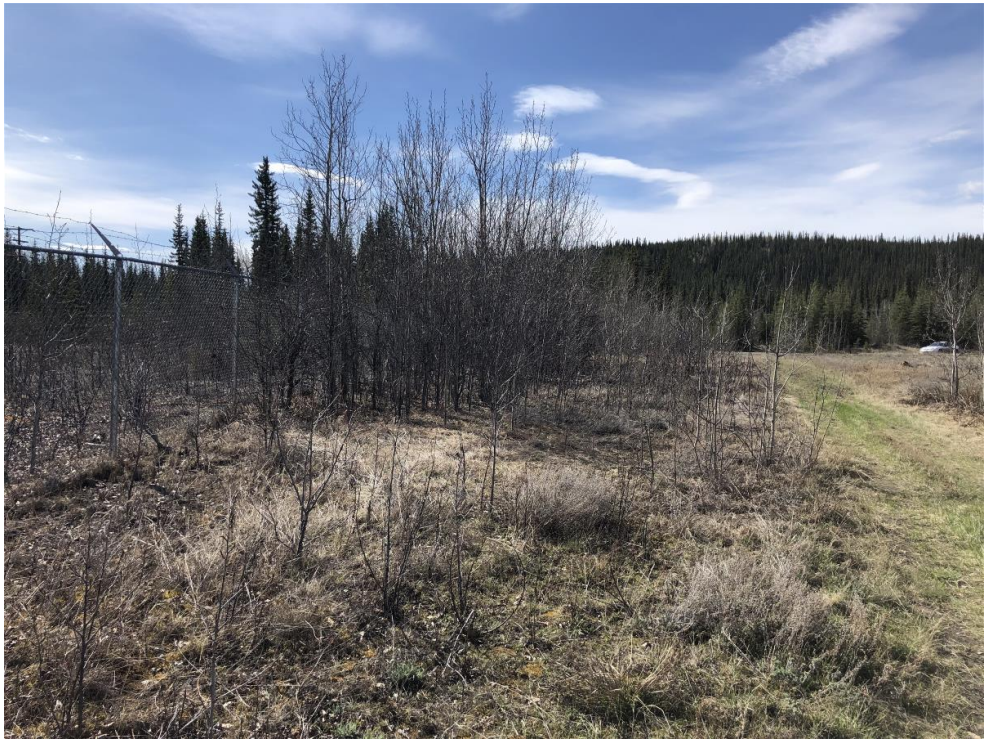
<b>Photo Location:</b> Lot 115 and Lot 118			
<b>Direction:</b> South			
<b>Survey Date:</b> 5/27/2021			
<b>Comments:</b> Fenceline along Lot 115 and Lot 118 property boundary

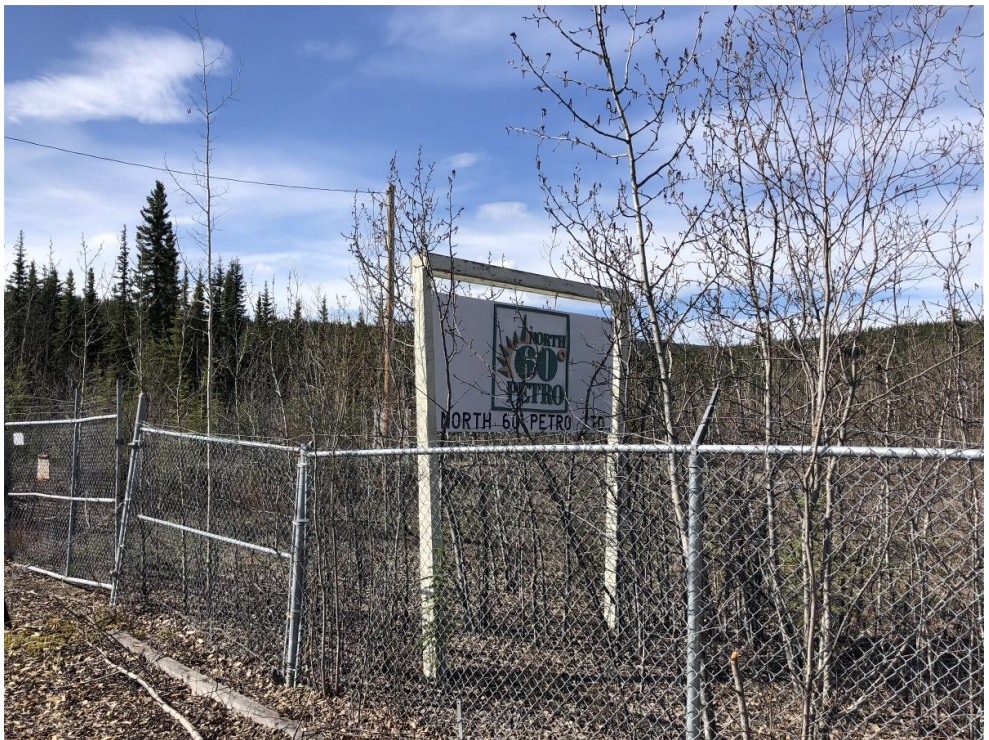
<b>Client:</b>		<b>Project:</b>	
<b>Site Name:</b>		<b>Site Location:</b>	
<b>Photograph ID:</b> 9

**Off-Site Former Petro Bulk Plant:** A former North 60 Petro Bulk Plant was located at Lot 118, located adjacent east of the Site, from at least the mid-1970s to the mid-1990s. This property is listed in the Contaminated Sites Inventory of the Yukon Government, which indicates that a drilling investigation was conducted on Lot 118 in June 2009 during a Phase II ESA. Available information indicates that reported concentrations of select petroleum hydrocarbon parameters in soil and groundwater samples collected at the property were greater than the applicable standards. No other information was provided on the property. Based on the proximity to the Site and the information provided, this property is considered a potential environmental concern to the Site.

<b>Photo Location:</b> Lot 118			
<b>Direction:</b> Southwest			
<b>Survey Date:</b> 5/27/2021			
<b>Comments:</b> Former North 60 Petro Bulk Plant			
<b>Photograph ID:</b> 10

Stantec recommends that a Phase II ESA consisting of the collection of soil and groundwater samples be completed to confirm the presence or absence of contamination associated with the APEC identified above.

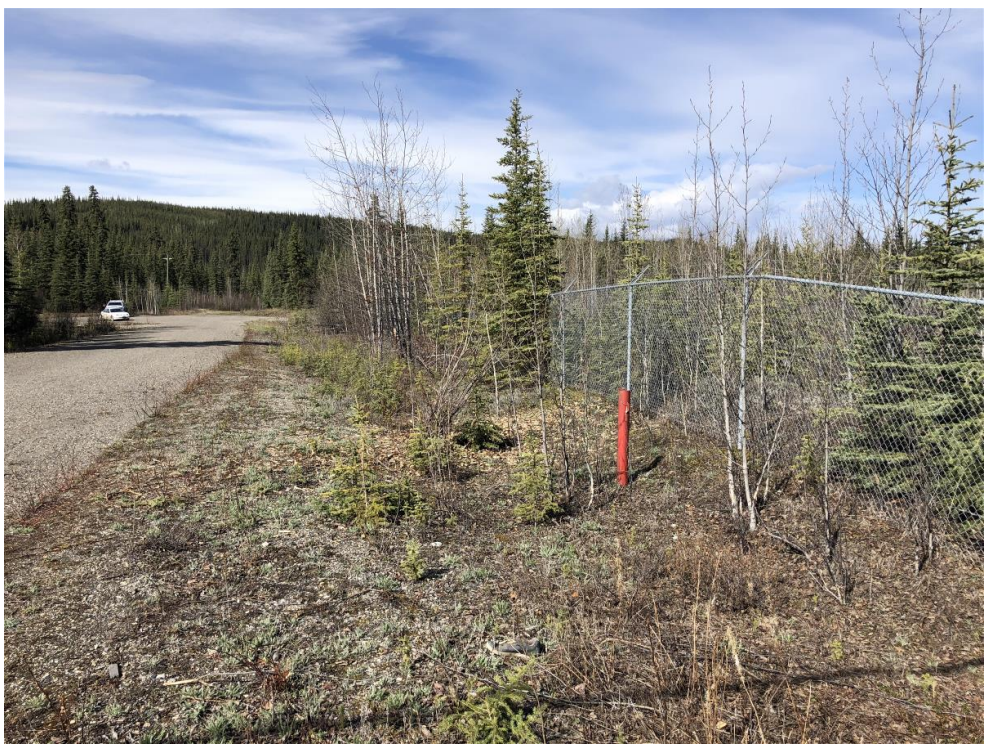
<b>Photo Location:</b> Lot 118			
<b>Direction:</b> West			
<b>Survey Date:</b> 5/27/2021			
<b>Comments:</b> Ketza Road and southern boundary of Lot 118

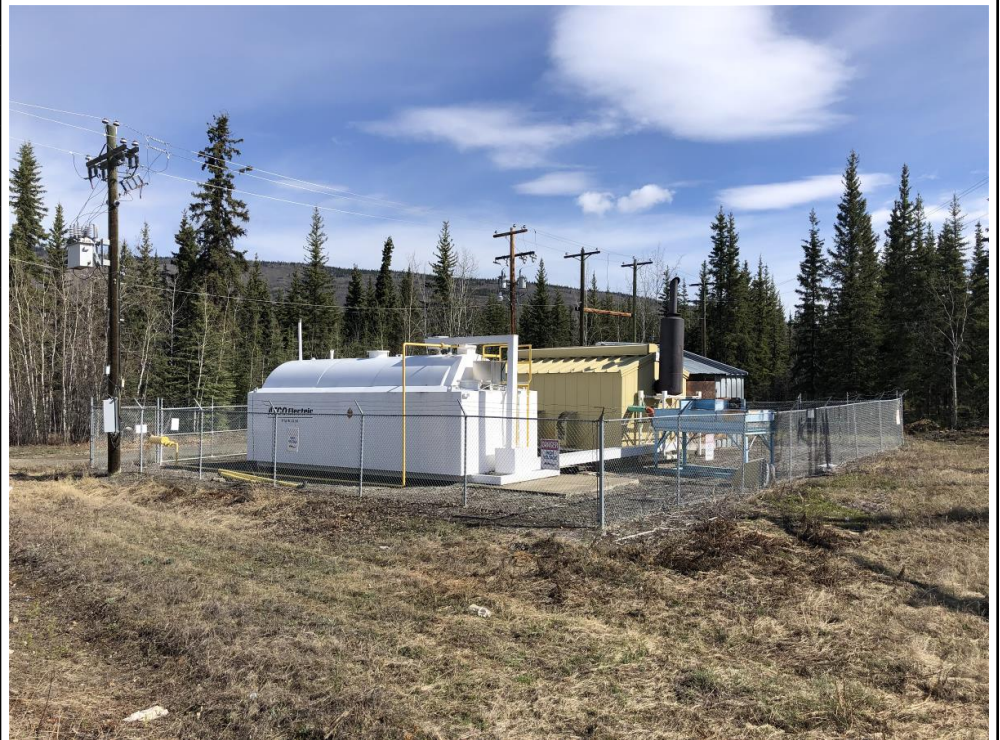
<b>Photograph ID:</b> 11
<b>Photo Location:</b> Lot 121
<b>Direction:</b> East
<b>Survey Date:</b> 5/27/2021
<b>Comments:</b> Current ATCO Electric diesel generator

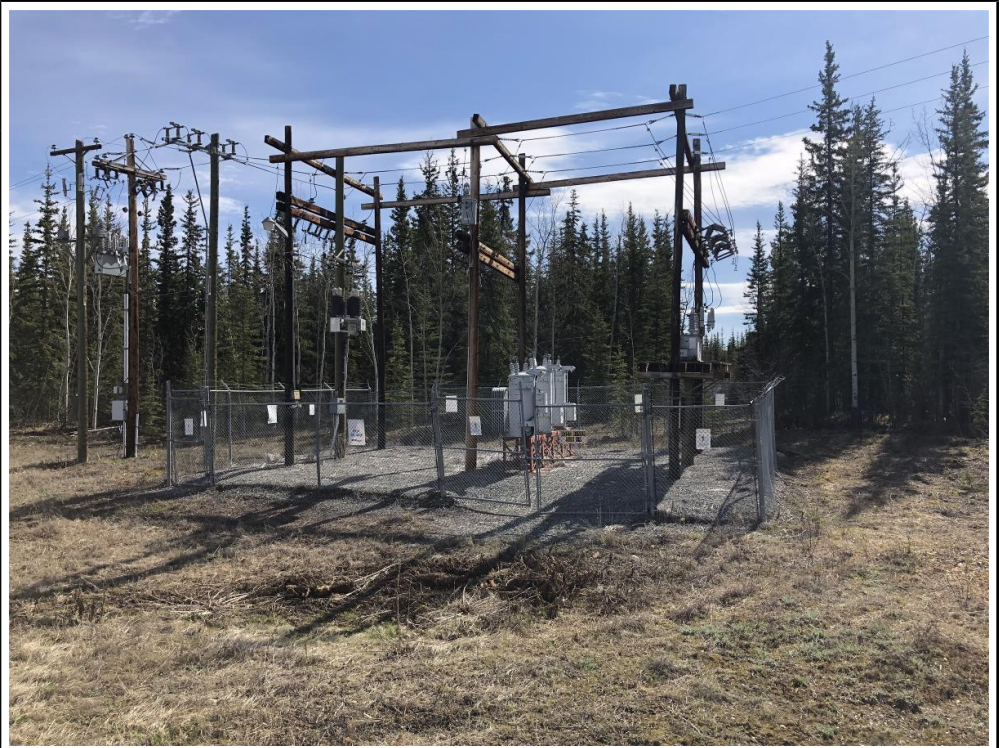
<b>Photograph ID:</b> 12
<b>Photo Location:</b> Lot 121
<b>Direction:</b> East
<b>Survey Date:</b> 5/27/2021
<b>Comments:</b> Current ATCO Electric transformer

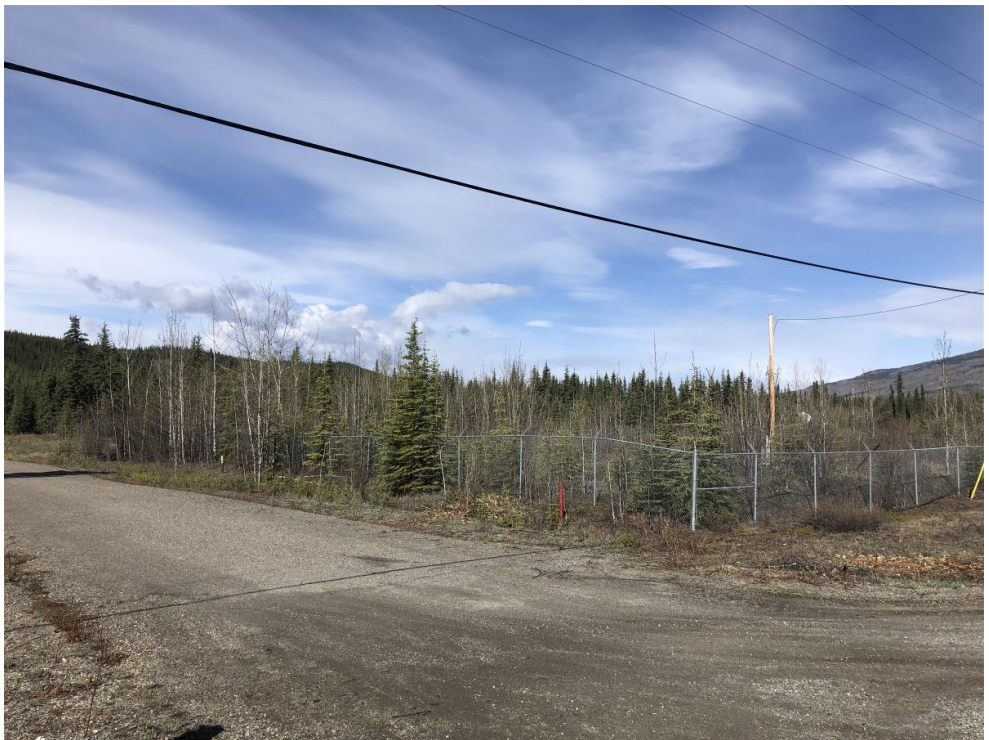
<b>Client:</b>		<b>Project:</b>	
<b>Site Name:</b>		<b>Site Location:</b>	
<b>Photograph ID:</b> 13

<b>Photo Location:</b> Lot 118			
<b>Direction:</b> Northwest			
<b>Survey Date:</b> 5/27/2021			
<b>Comments:</b> Southeast corner of Lot 118 and Lot 115 in background, viewed from Prospector Street			
<b>Photograph ID:</b> 14

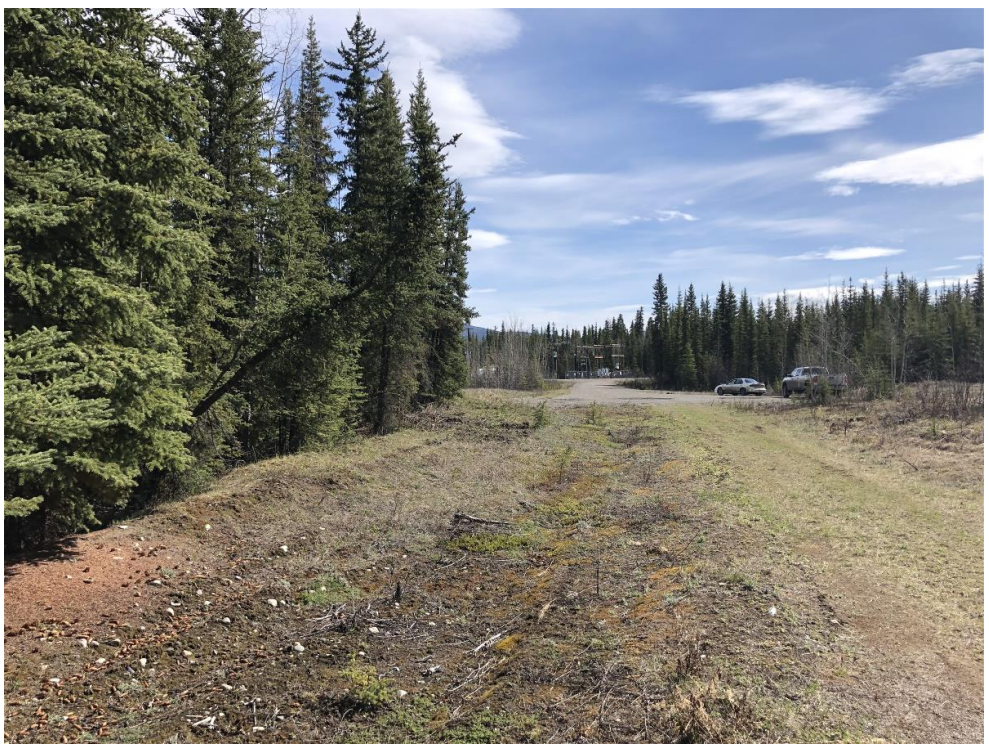
<b>Photo Location:</b> Lot 115			
<b>Direction:</b> East			
<b>Survey Date:</b> 5/27/2021			
<b>Comments:</b> Southwestern portion of Lot 115 and Ketz Road

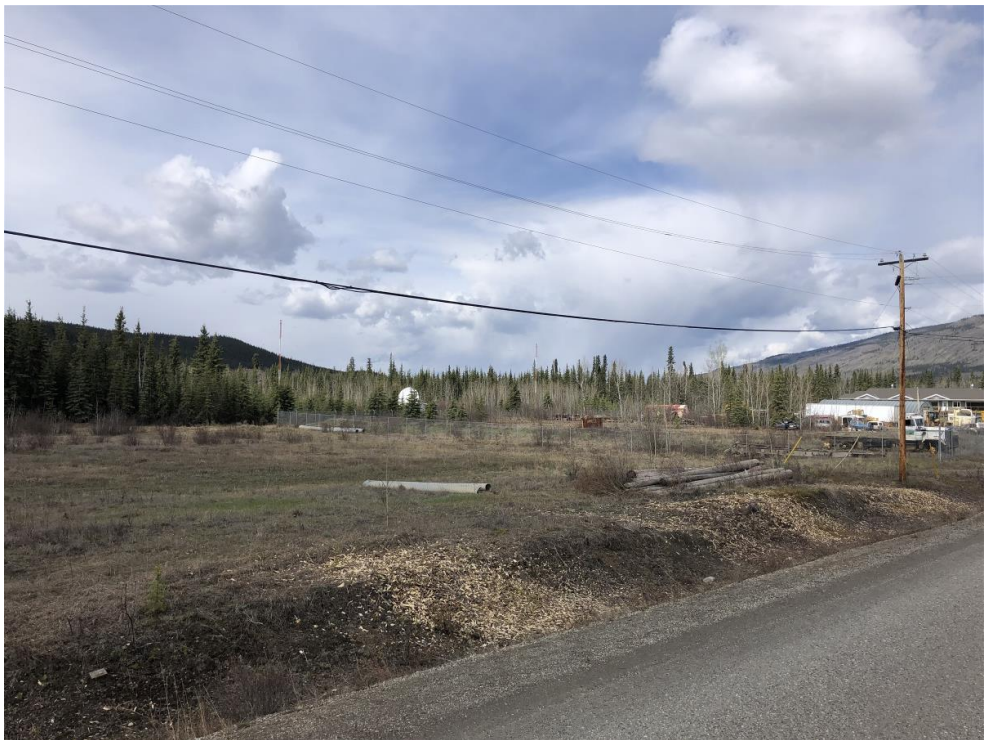
<b>Client:</b>		<b>Project:</b>	
<b>Site Name:</b>		<b>Site Location:</b>	
<b>Photograph ID:</b> 15

<b>Photo Location:</b> Lot 117 and Lot 119			
<b>Direction:</b> Northwest			
<b>Survey Date:</b> 5/27/2021			
<b>Comments:</b> Lots 117 and 119 viewed from the southeast on Prospector Street			
<b>Photograph ID:</b> 16

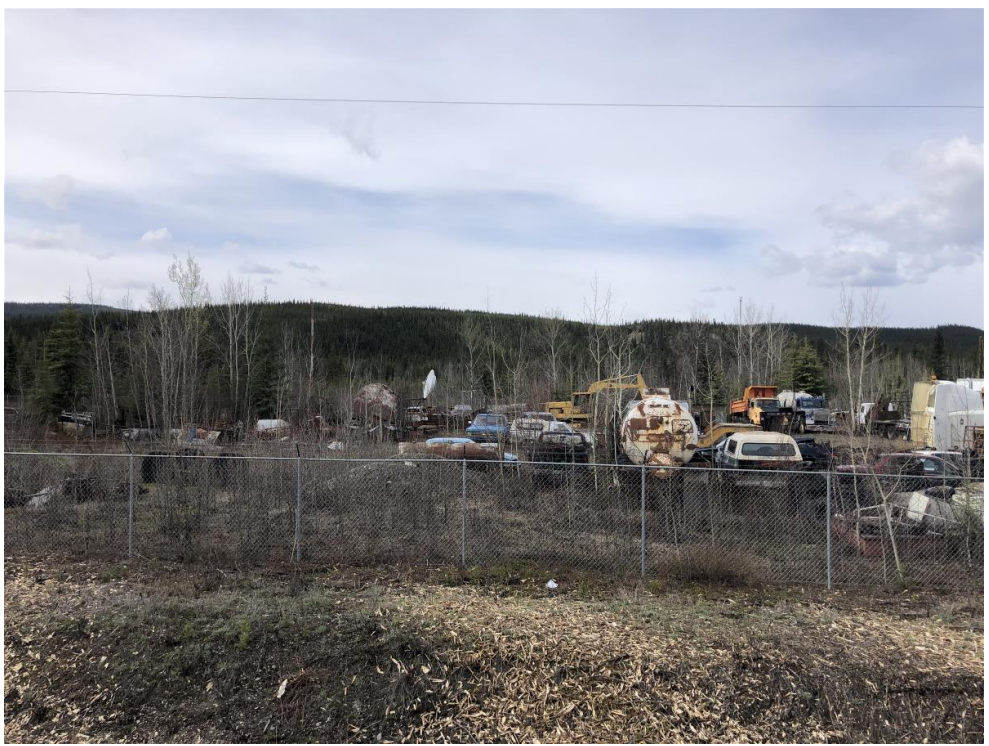
<b>Photo Location:</b> Lot 119			
<b>Direction:</b> West			
<b>Survey Date:</b> 5/27/2021			
<b>Comments:</b> Lot 119 viewed from Prospector Street
