## **2010 ANNUAL QUARTZ MINING LICENCE REPORT**

**Submitted to Yukon Government, Energy Mines and Resources  
Yukon Quartz Mining Licence QML-0007**

**March 2011**

## Carmacks Copper Project, Yukon Territory

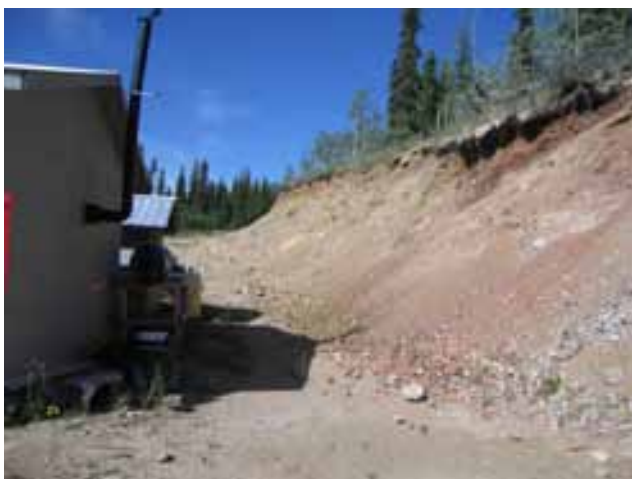
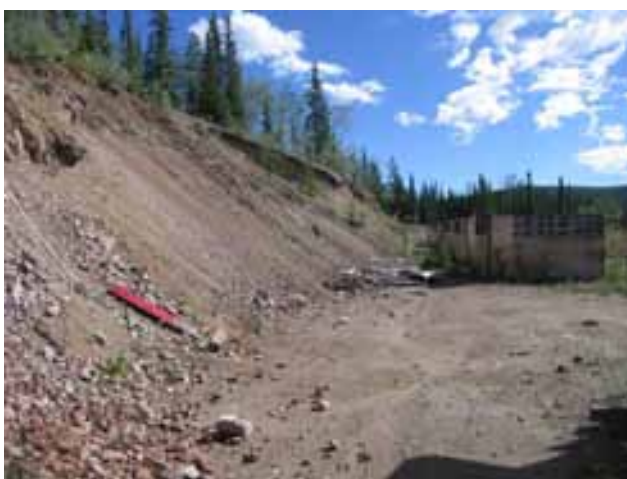
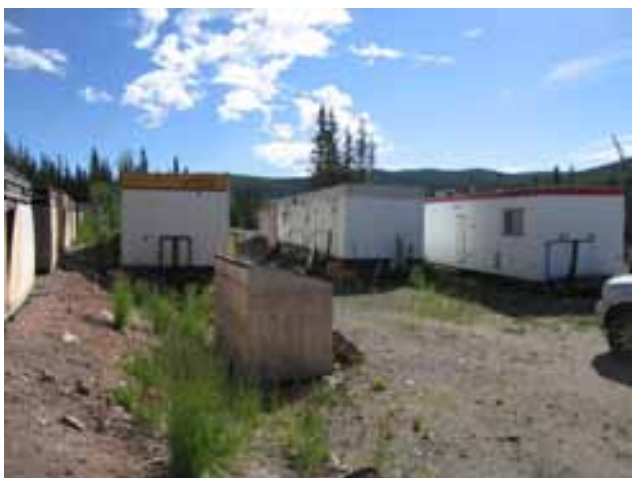
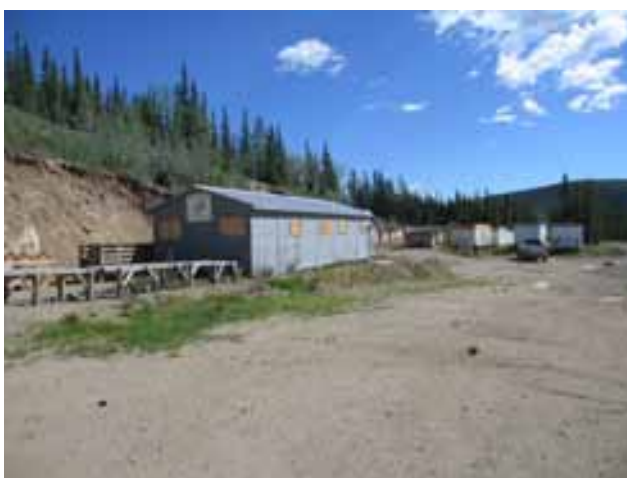
*Photographs 1 - 4: Carmacks Exploration Camp Infrastructure, which includes an office, core shack, equipment shed, temporary trailers for accommodations and kitchen facilities, and drill core storage area.*

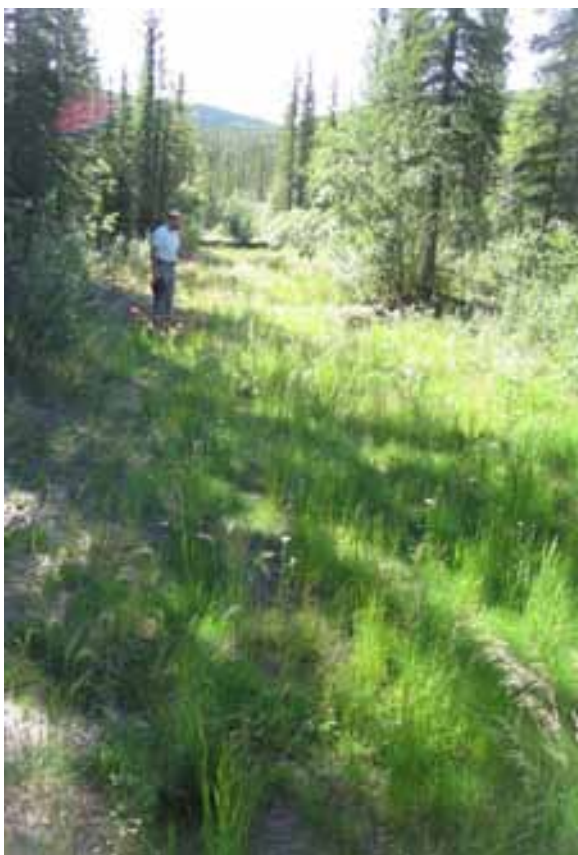
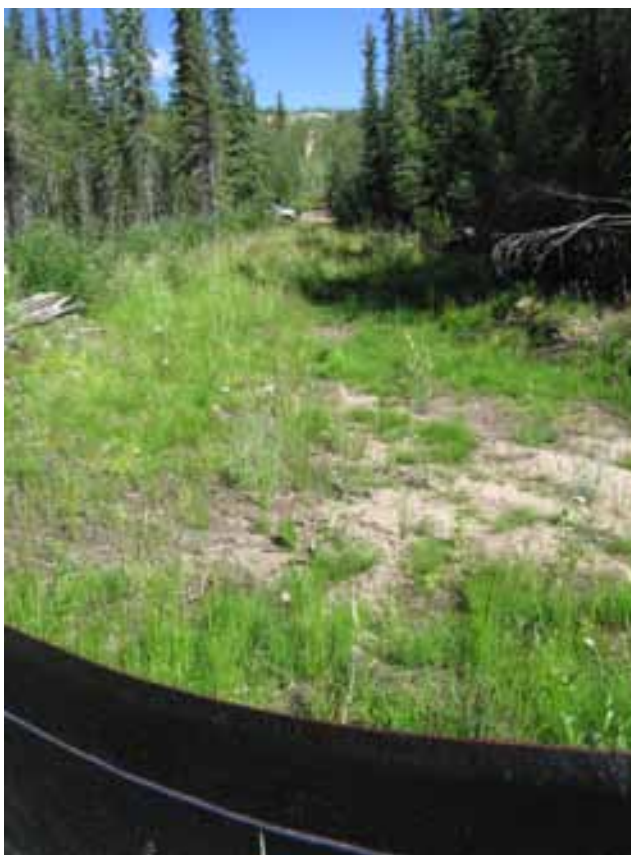
*Photographs 5 - 6: Drill pad access road located north of Williams Creek and downstream of the area of the proposed heap leach facility sediment pond. Photographs show vegetation re-growth which has occurred and is assisting in stabilizing previously transported sediments.*

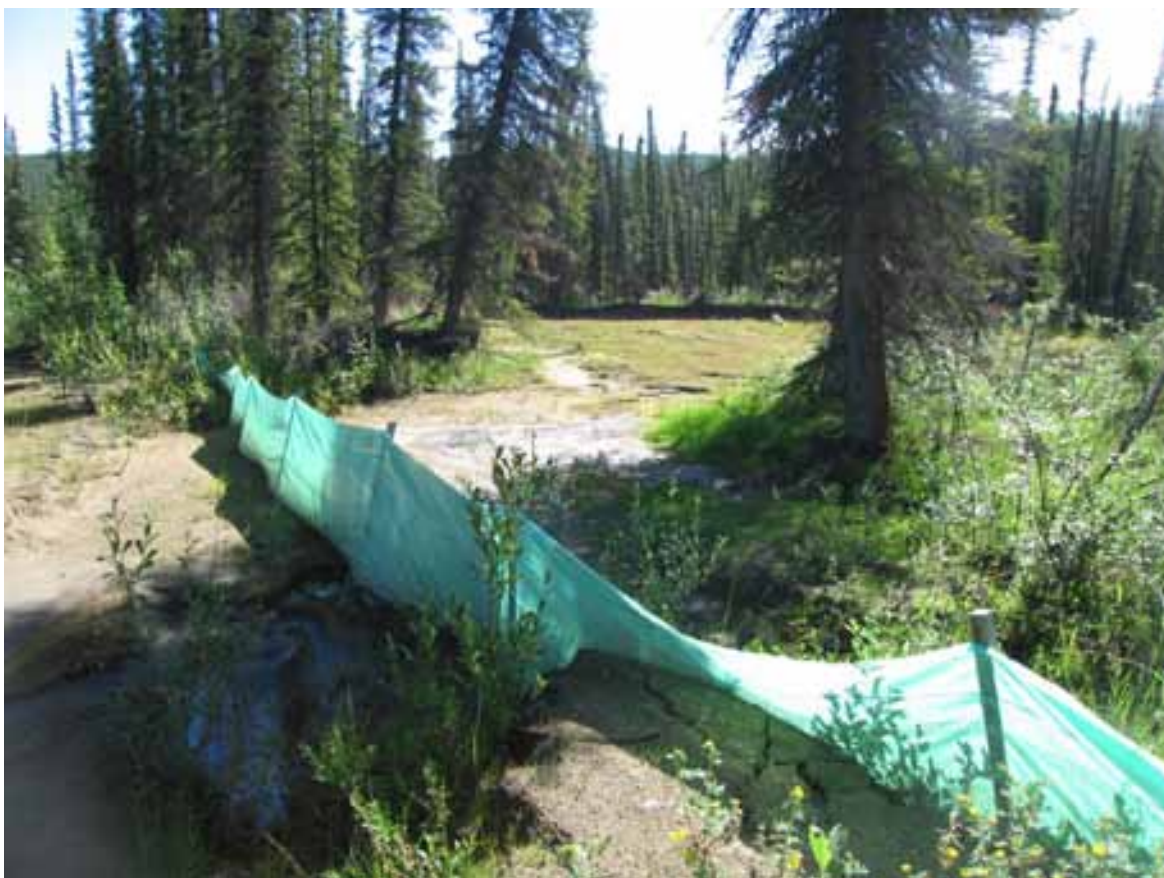
Further down slope, closer to Williams Creek, a series of silt fences have been installed and the area seeded. At the time of the inspection, re-growth in the area seeded in 2009 was observed to be occurring. Minor movement of sediment was observed beyond the lower silt fence. Sediment was observed to have entered a vegetated area beyond this silt fence, but there is no evidence that sediment has entered Williams Creek. On August 5, 2010, additional maintenance of the erosion control measures occurred. An additional silt fence was added to control further sediment movement beyond the existing fence. This work is deemed to be adequate at the current time. As with all temporary erosion control measures, annual inspection and ongoing minor maintenance activities should be anticipated.

*Photograph 7: Silt fences located between the area of the proposed heap leach facility sediment pond and Williams Creek were generally in good condition, however, some sediment was observed to have travelled beyond (bypassed) the silt fence in the foreground. However, no evidence of sediment entering Williams Creek was observed at the time of the inspection.*

*Photograph 8: An additional row of silt fencing was added beyond the green silt fence on August 5 to control further sediment movement towards Williams Creek.*

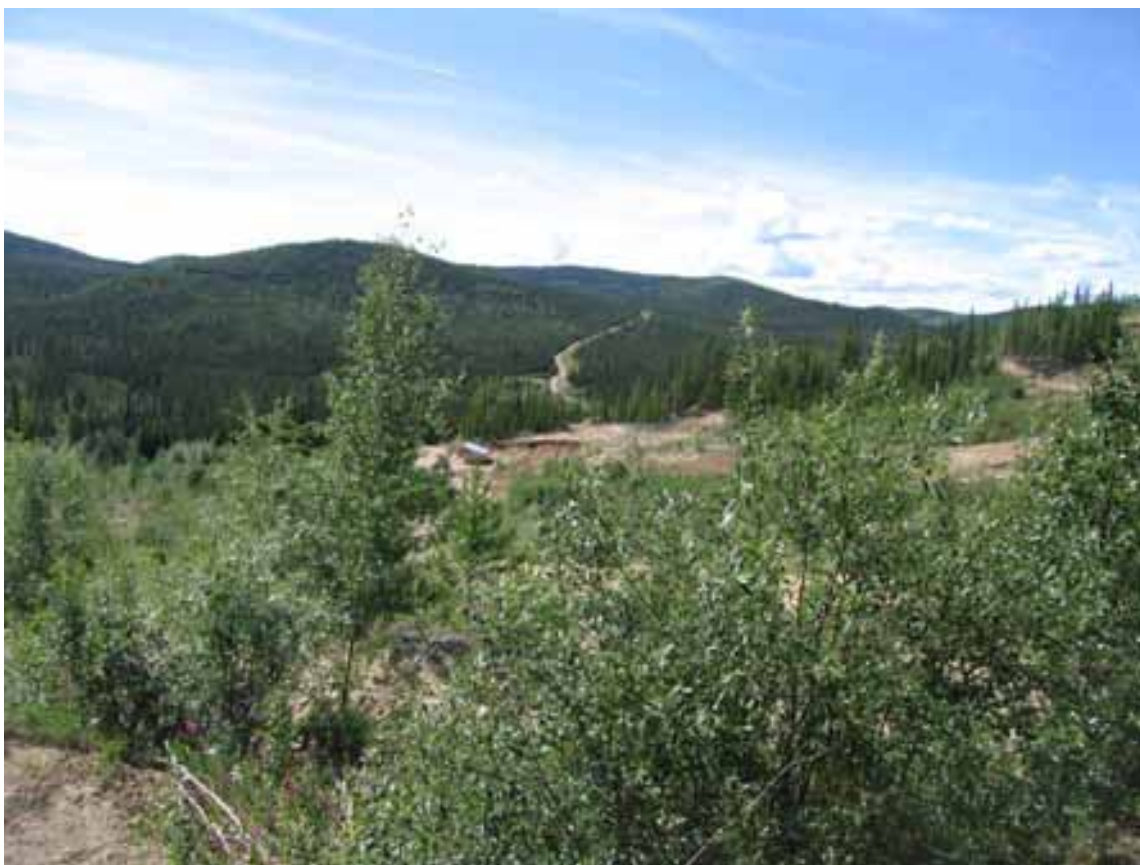
*Photograph 9: View of proposed heap leach facility and plant site area, taken from area of proposed open pit, looking southwest.*

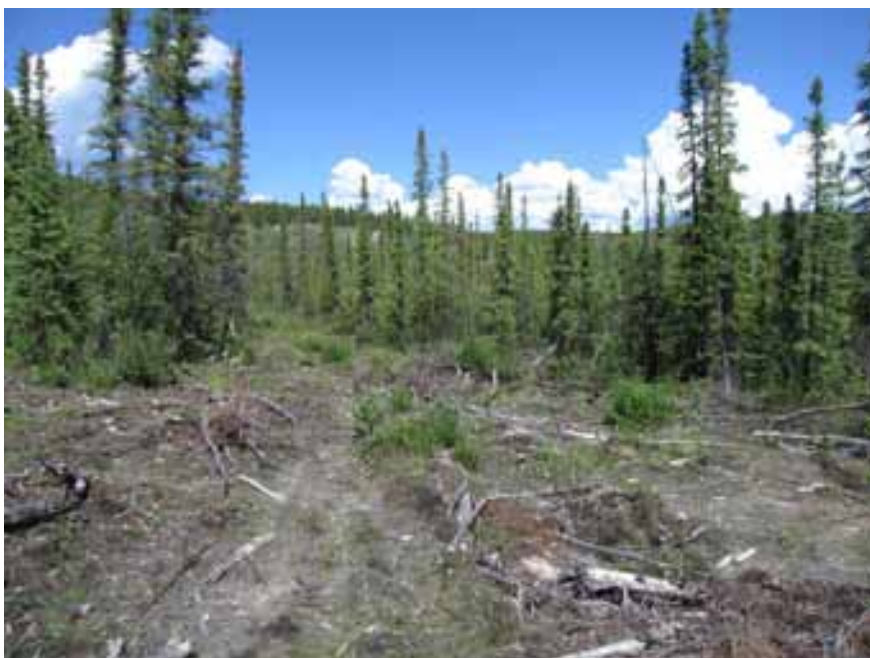
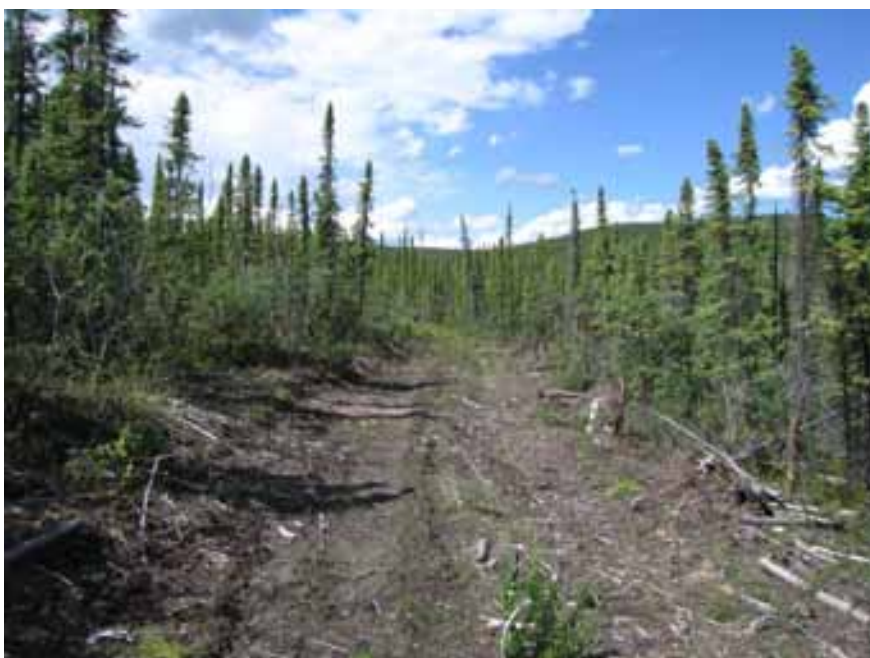
The area of the proposed waste rock storage area and the present access road crossing at North Williams Creek were inspected. The waste rock storage area is still tree covered and the drill pads in the area of the proposed waste rock storage area did not have any signs of sediment movement into the surrounding area. The small sediment catch basins at the drill pads still have capacity to manage more sediment, if required. Minor erosion along the ditches of the access road on the north side of North Williams Creek was observed. Small amounts of sediment had eroded and been trapped by the silt fences installed near the access road's crossing of North Williams Creek. The silt fences have reached their capacity to contain more sediment and require minor maintenance. On August 5, maintenance work was conducted in this area. A series of diversion ditches were created along the access road to divert water and sediment from the road area into adjacent vegetated areas. It is anticipated that this work will effectively reduce the movement of sediment towards North Williams Creek. Annual inspection and the requirement for minor maintenance of these sediment control measures should be anticipated.

*Photographs 10 - 11: Access roads within the proposed waste rock storage area.*

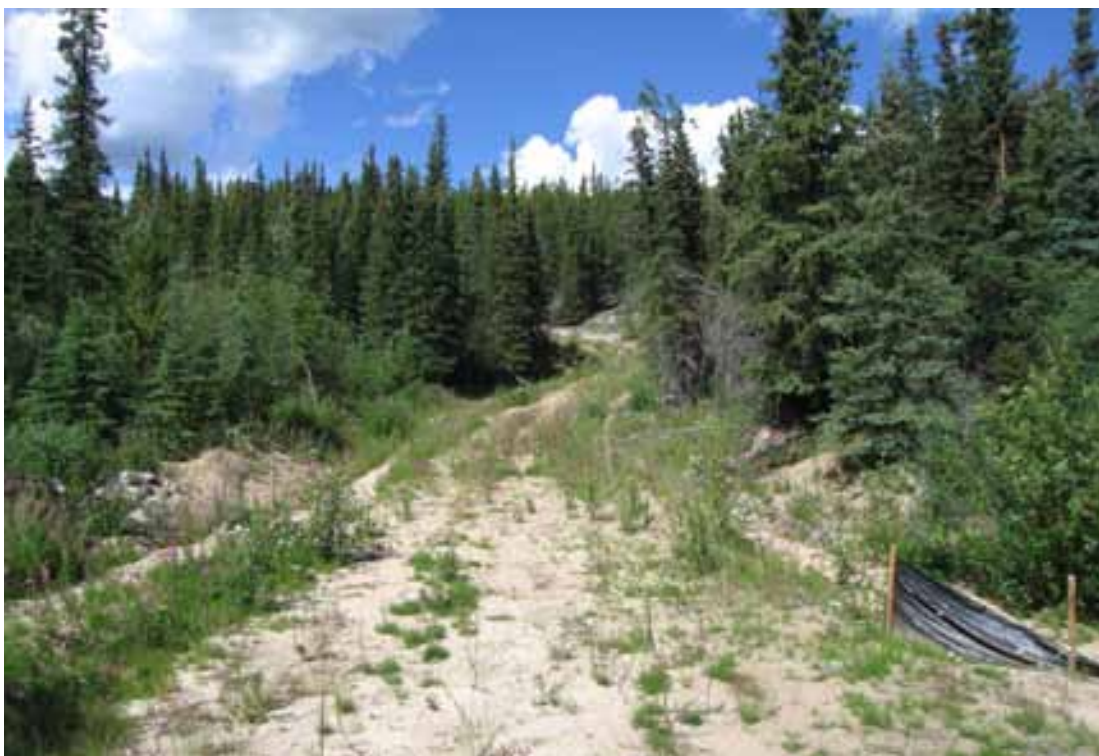
*Photograph 12: Access road east of North Williams Creek.*

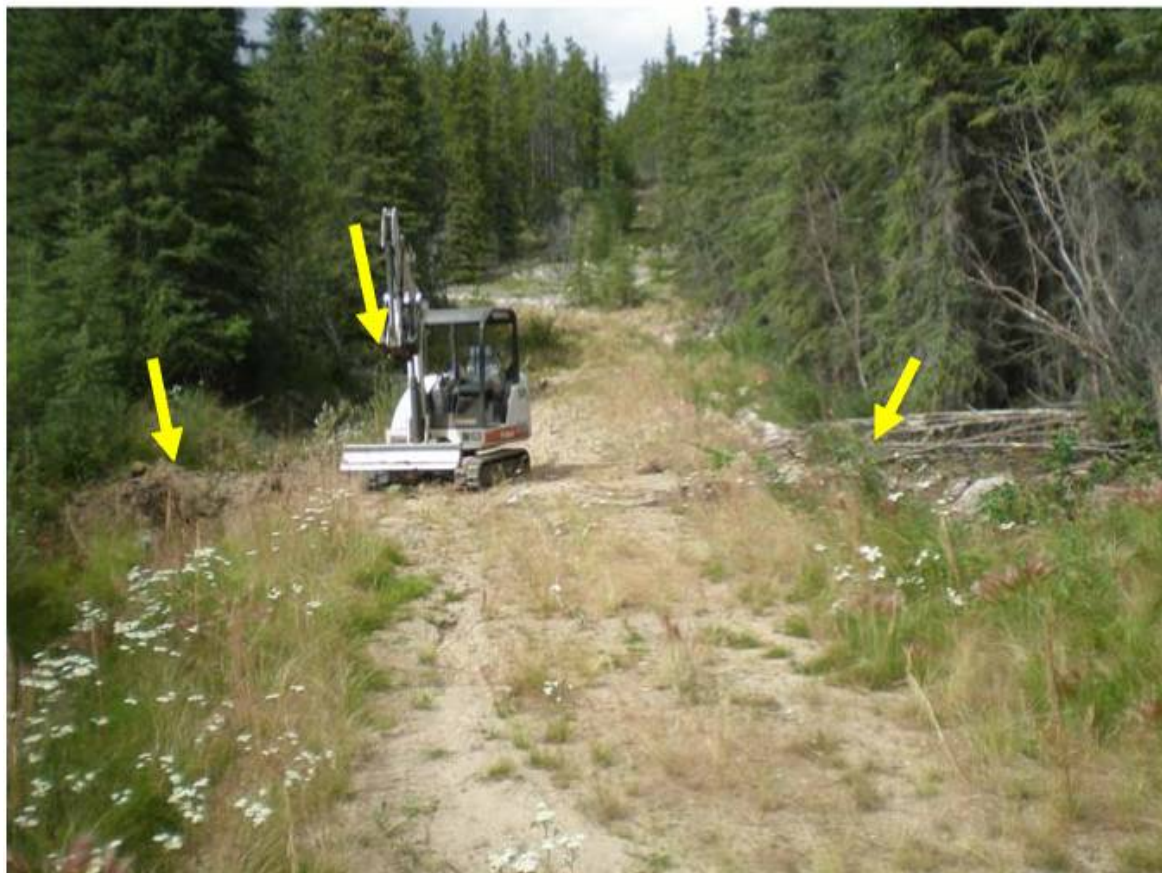
*Photograph 13: Yellow areas show where diversion ditches were excavated to redirect surface water runoff from the road side into the vegetated areas on either side of the access road.*

The general site development has not started yet. Therefore, there are no stability concerns associated with the undeveloped facilities and no maintenance required. No permanent water diversion structures are in place. There are however, temporary water management diversion structures (*i.e.*, ditches and sediment catch basins) in place that are appropriate for the exploration stage of the property. It is recommended that they continue to be inspected annually and that ongoing maintenance be conducted, as deemed necessary. All areas observed to require maintenance on July 8, 2010 have subsequently been adequately repaired.

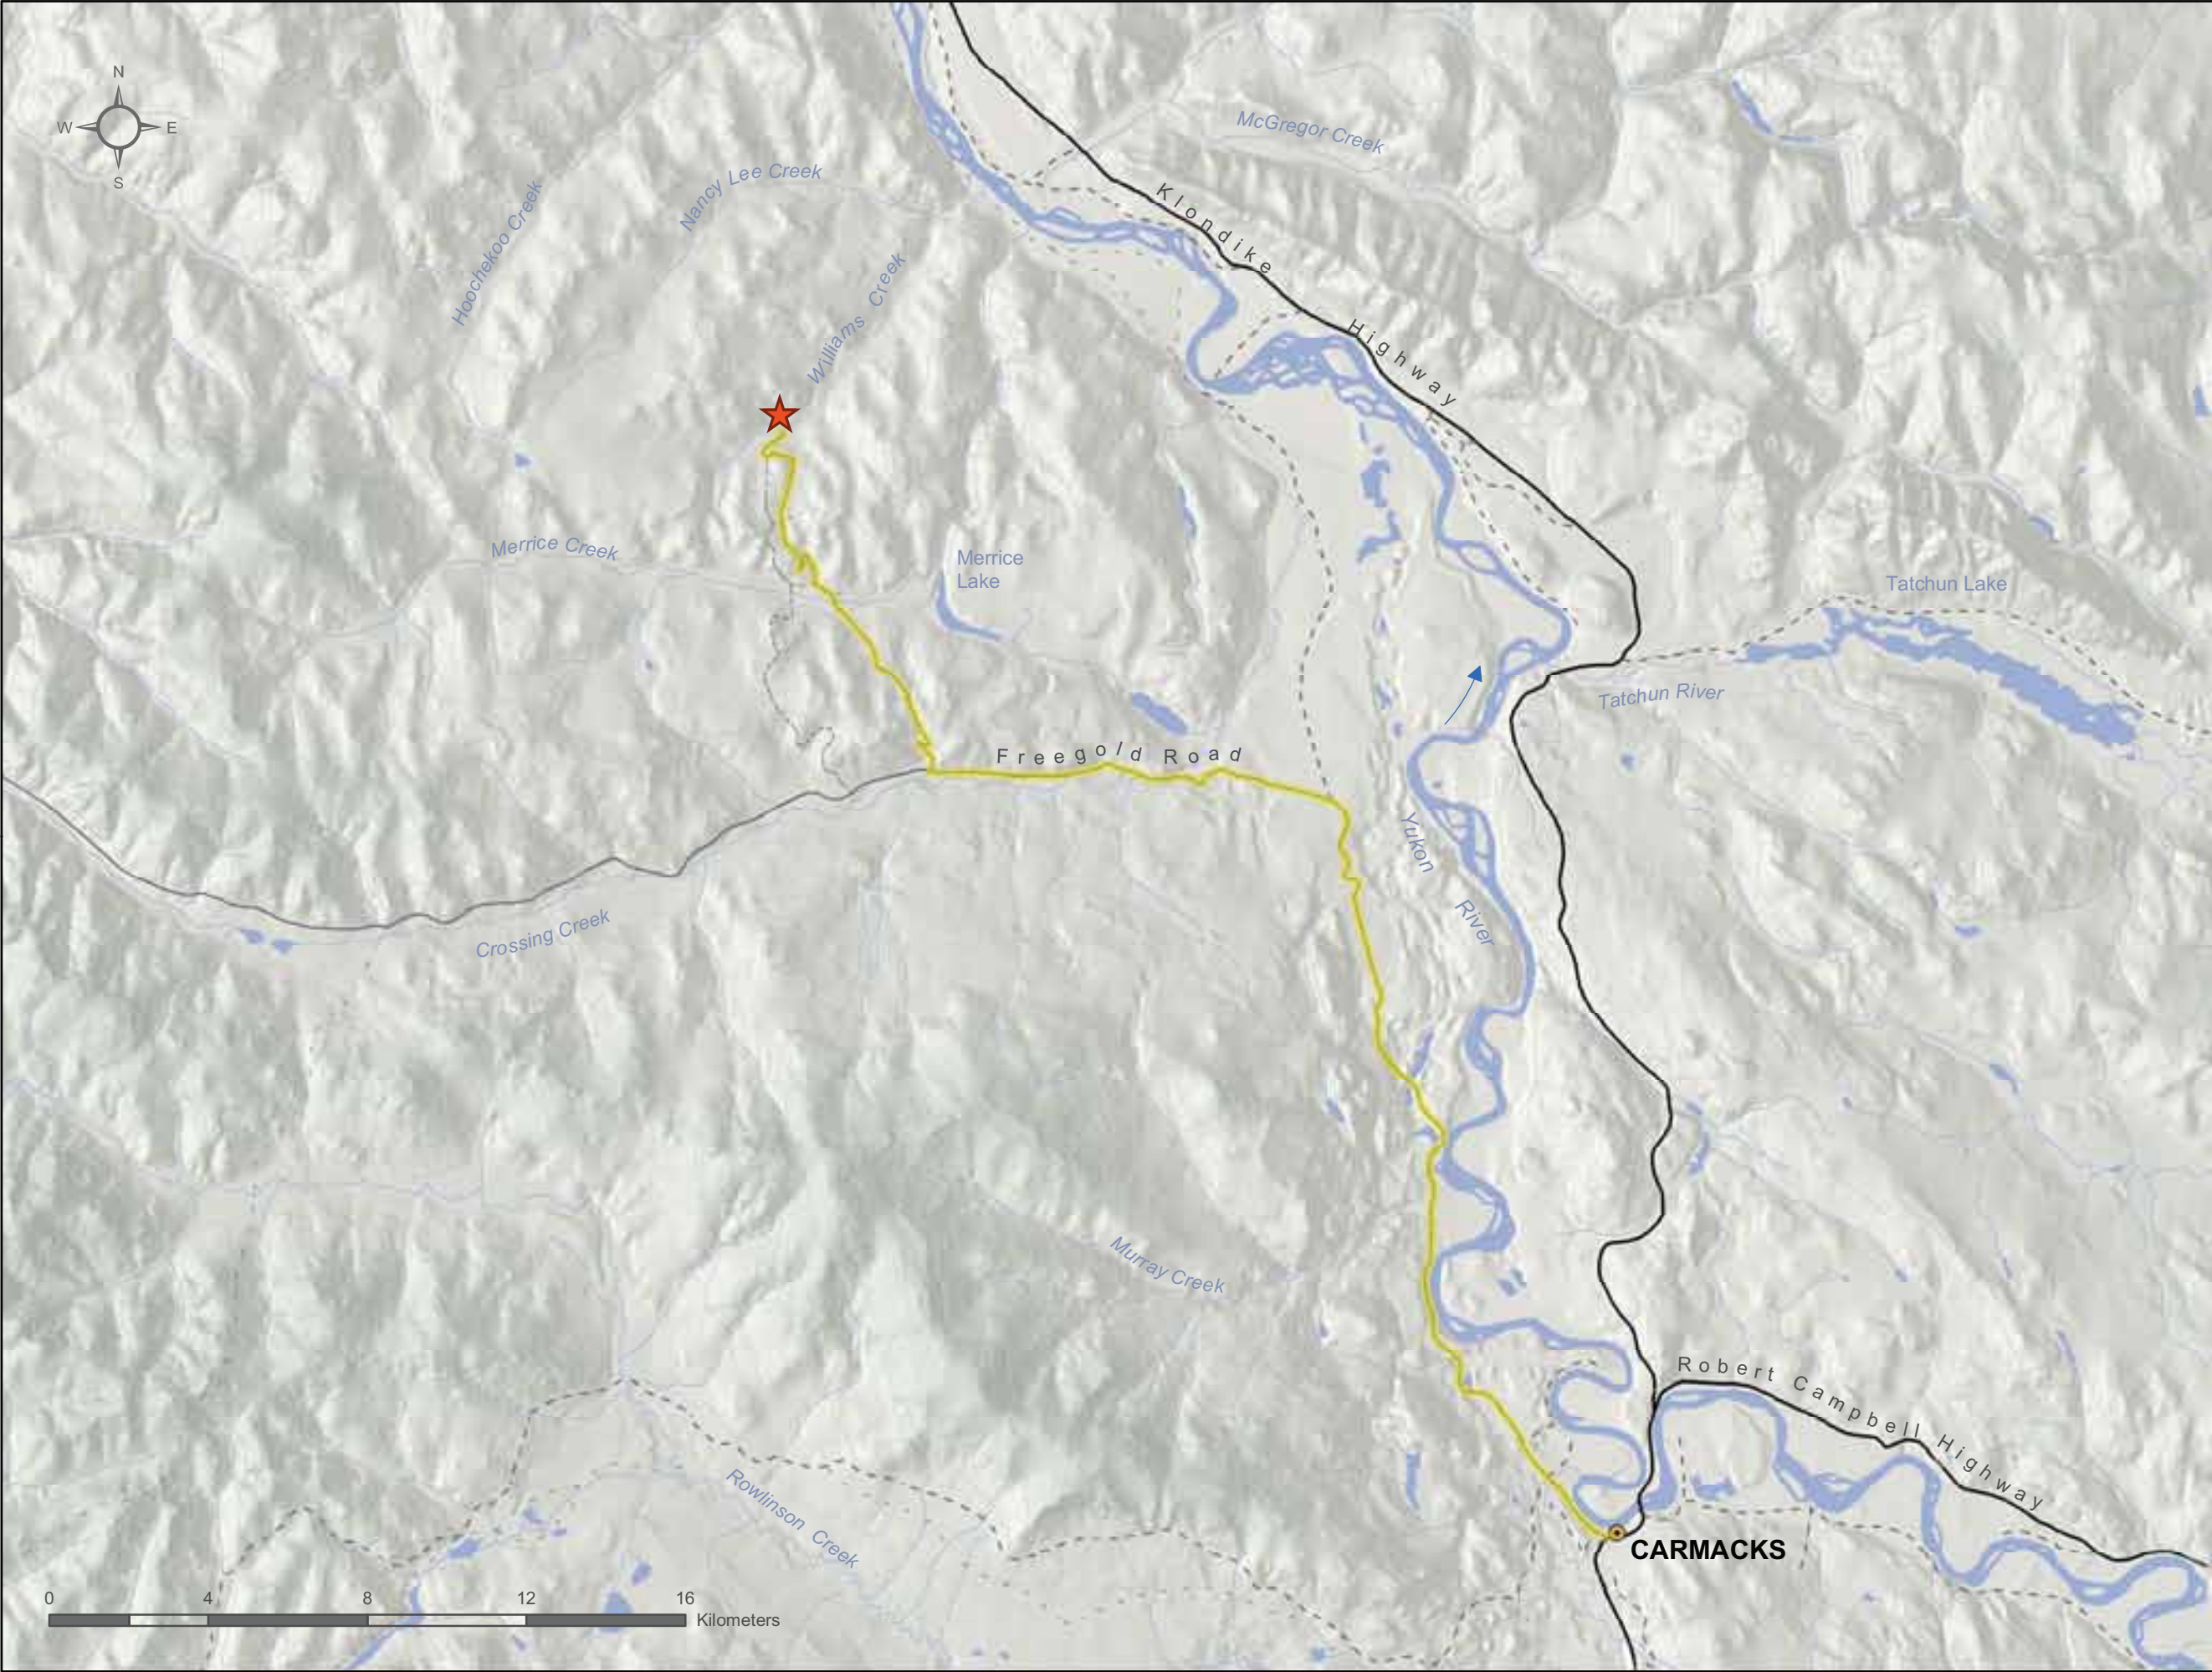
**FIGURE 1  
PROJECT LOCATION**

The Carmacks Copper project is a proposed open pit copper mine and solvent extraction and electrowinning processing facility being developed by Carmacks Copper Ltd., a wholly owned subsidiary of Western Copper Corporation (Western Copper) of Vancouver, British Columbia. The ore body is located in Yukon (Figure 1), about 38 km northwest of the Village of Carmacks, or 192 km northwest of Whitehorse (Figure 2). The project site is located in the upper reaches of Williams Creek, approximately 9 km upstream of the confluence with the Yukon River. Williams Creek is a small erosional creek originating in the Dawson Range and draining northeast into the Yukon River downstream of Carmacks.
