**APPENDIX 1**  
**RECLAMATION RESEARCH SUMMARY REPORTS**

**APPENDIX 1.1**  
**2012 DSTF INTERIM RECLAMATION AND COVER**  
**SUMMARY REPORT**

**Re:** 2012 Dry Stack Tailings Facility Cover Trial

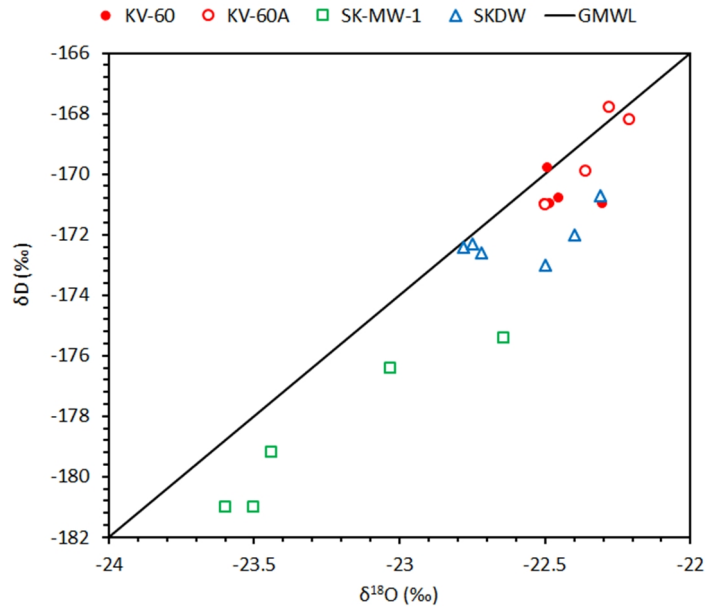
**Figure 2-9:  $\delta D$  versus  $\delta^{18}O$  plot of water samples from Galena Creek (KV-60 and KV-60A), the flooded SK mine workings (SKDW), and local groundwater (SK-MW-1).**

observed in the February and March, 2016 samples. Given the limited dataset available, it is unclear if this increase represents a seasonal trend.

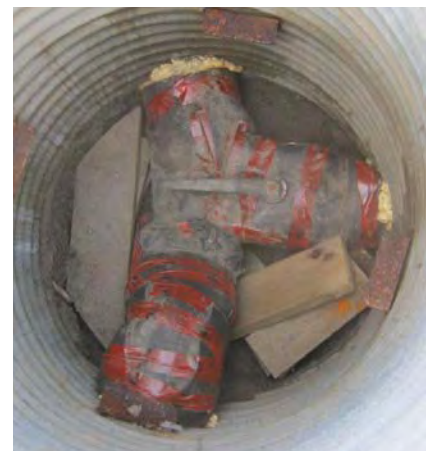
**Figure 2 - Inlet Valve**

Water is supplied to the bioreactor through an initial valve that when opened allows water to travel to the bioreactor's influent sump. Because of the harsh conditions in the Yukon, this valve, and all piping used in this setup was buried over 1 meter below surface, thereby reducing the possibility of freezing. Figure 2 shows the buried vertical pipe that contains this initial valve. In this figure, water travels downward from

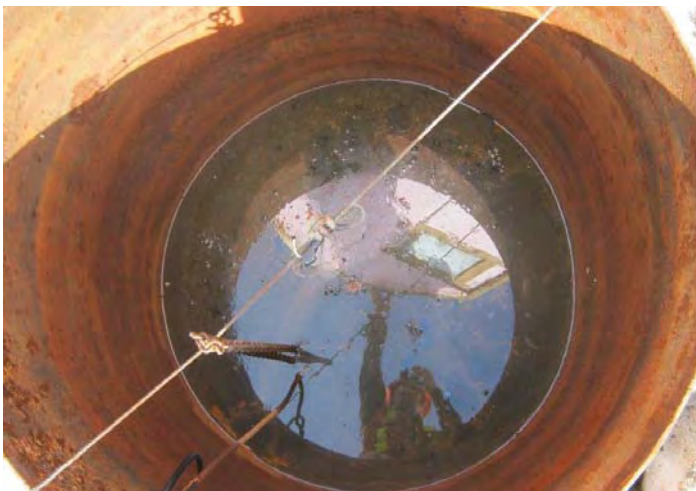
**Figure 3 - Bioreactor Influent Sump**

The bioreactor inlet sump, shown in Figure 3, has a 48 inch diameter and is also located below surface. It is accessed through a cover that allows for reagent addition and water sampling as needed. Normal operation of the bioreactor requires the frequent dosing (constant dosing up to as infrequently as every two weeks, depending on flow rates) of a carbon source such as sugar, ethanol, or methanol. These reagents are slowly added to this sump via a metering pump for the liquids, or as dry powder for the sugar. During initial start-up, and on a few other occasions, an addition of milk sugars/protein as dry milk powder was required to aid the growth of microbes in the bioreactor. These reagents were also added at this location.

Within in the bioreactor inlet sump is a 1-horsepower submersible pump. The cable seen in Figure 3, stretching from lower left to upper right, attaches to a chain allowing the pump to be removed from the mix tank for servicing and/or replacement. The discharge from this pump is shown in Figure 4.

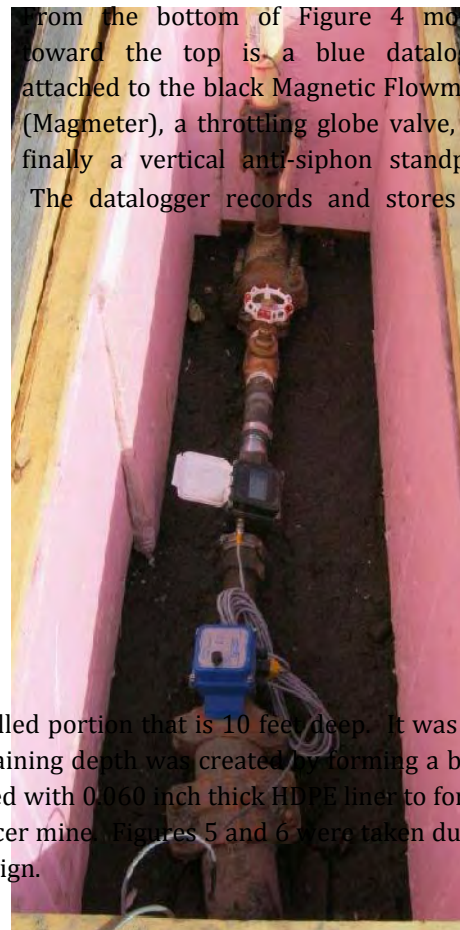
**Figure 4 - Bioreactor Inlet**

from the bottom of Figure 4 moving toward the top is a blue datalogger attached to the black Magnetic Flowmeter (Magmeter), a throttling globe valve, and finally a vertical anti-siphon standpipe. The datalogger records and stores the

flow rates from the magmeter, allowing the system's operation rate to be tracked and analyzed. The globe valve is used to adjust the flow rate into the bioreactor. The vertical anti-siphon standpipe is exposed to the atmosphere. The system is designed so that in the event of pump failure, air will be pulled into the pipe and breaks the siphon. This series of instruments and valves is also located below grade in an insulated box and can be accessed through a cover.

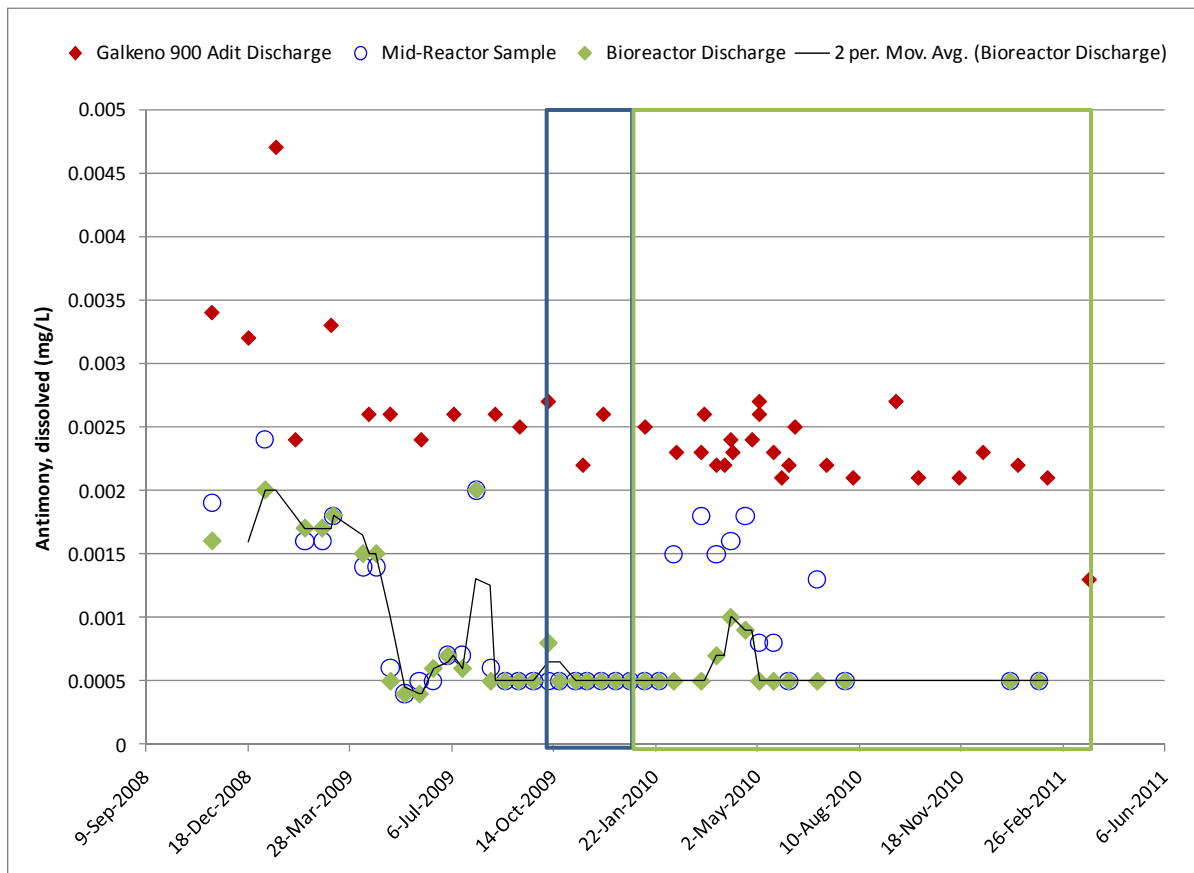
Figure 12 - Antimony Removal by the Galkeno 900 Bioreactor

Antimony concentrations declined approximately 80% during the test (0.0025 mg/L reduced to below the detection limit (0.0005 mg/L) for most of the phases of the test (See Figure 12). Antimony removal in an organic carbon-rich reducing system is typically attributed to an antimony sulphide phase, or by sorption to iron or manganese oxides, carbonates, or sulphides that are stable in reducing conditions.

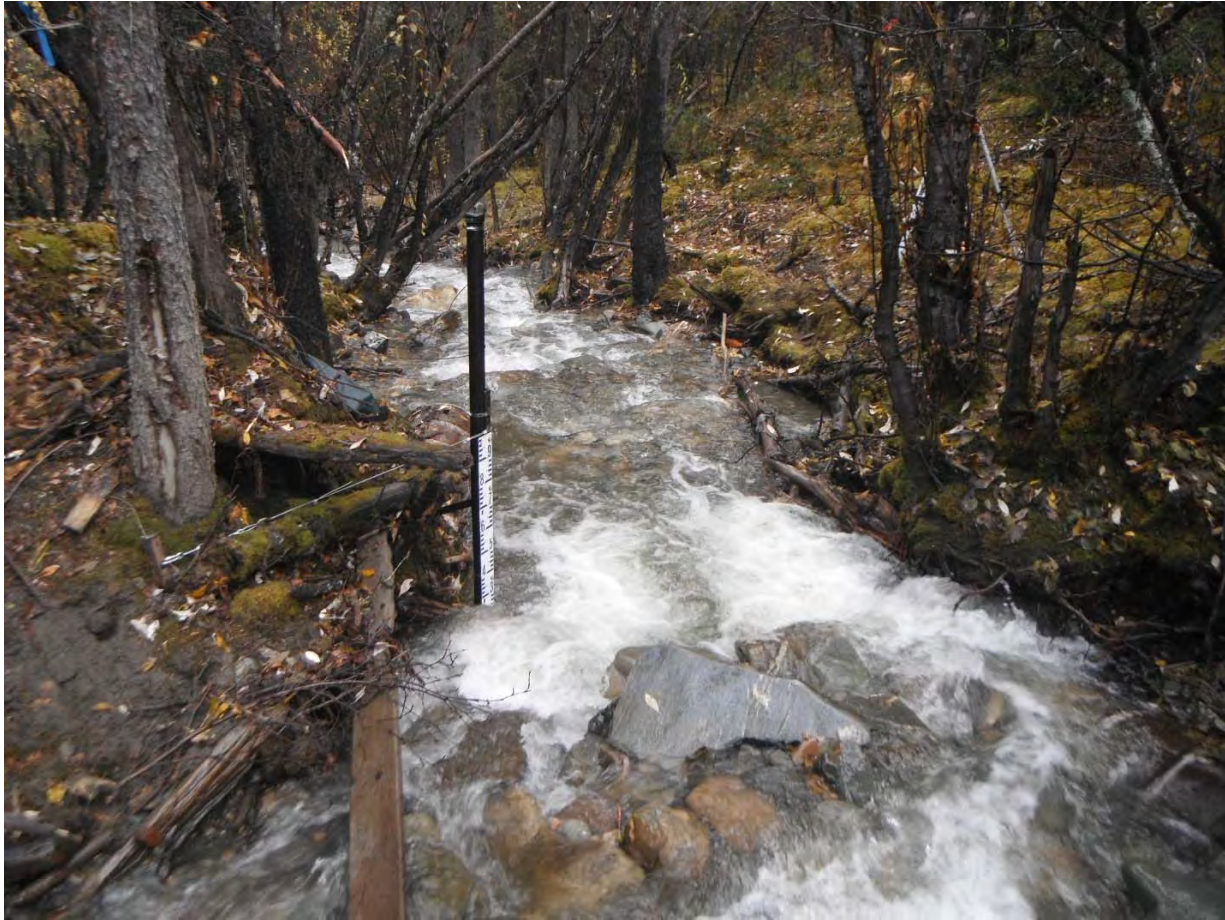
**Figure 2 – KV-64 hydrometric monitoring station, installed in September 2015, below the Silver Trail Highway**

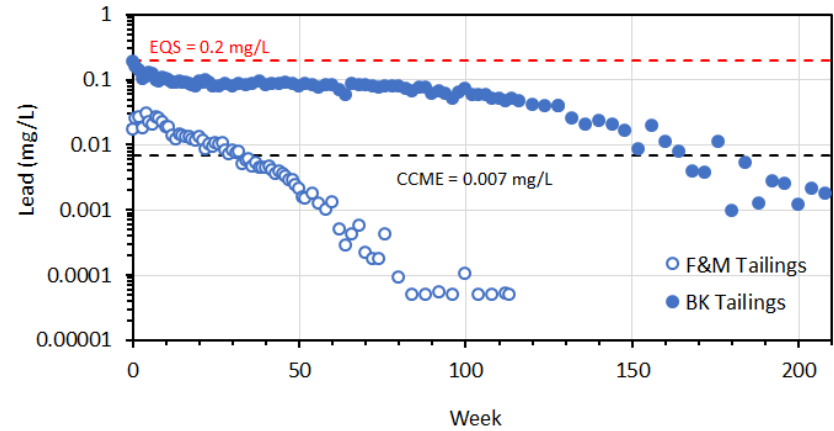
**Figure 5-12: Silver, Lead, Nickel, and Copper Trends within the Flame & Moth (F&M) and Bellekeno (BK) Tailings Humidity Cells**
