**Sä Dena Hes**  
**2002 Annual Report**  
**Yukon Production Licence QML - 0004**

## **RESULTS SUMMARY OF PHASE II REVEGETATION TEST PROGRAM 2002**

***RESULTS SUMMARY OF  
Phase II Revegetation Test Program - 2002***

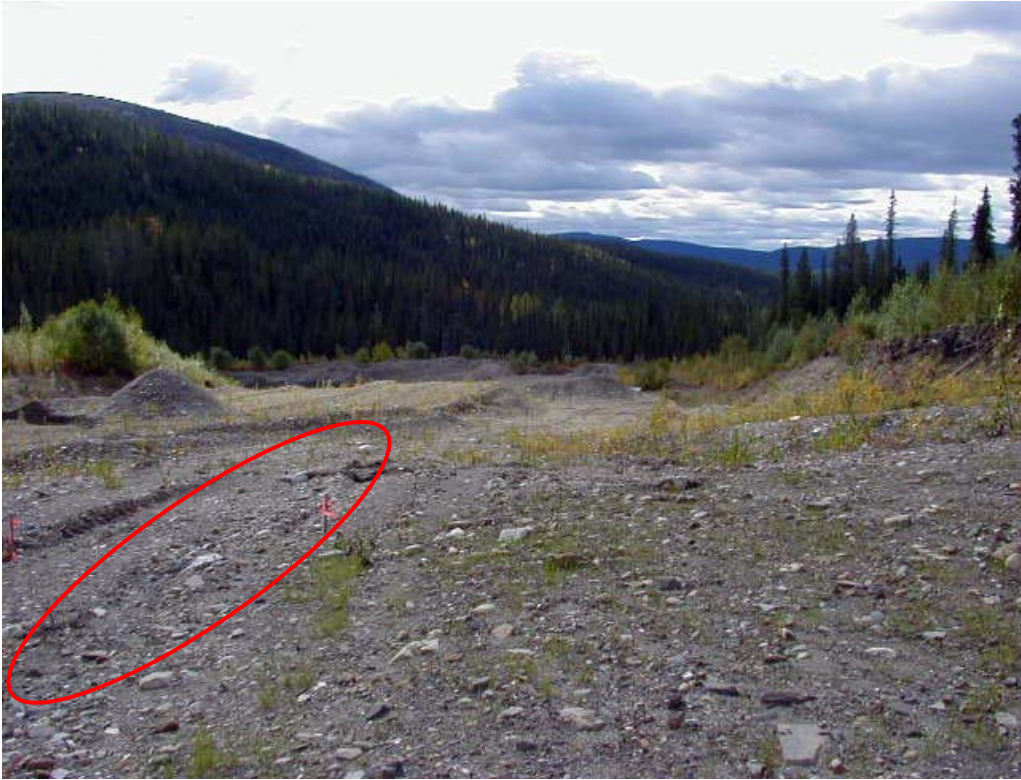
Evidence of Gullying/Rutting and Little Revegetation

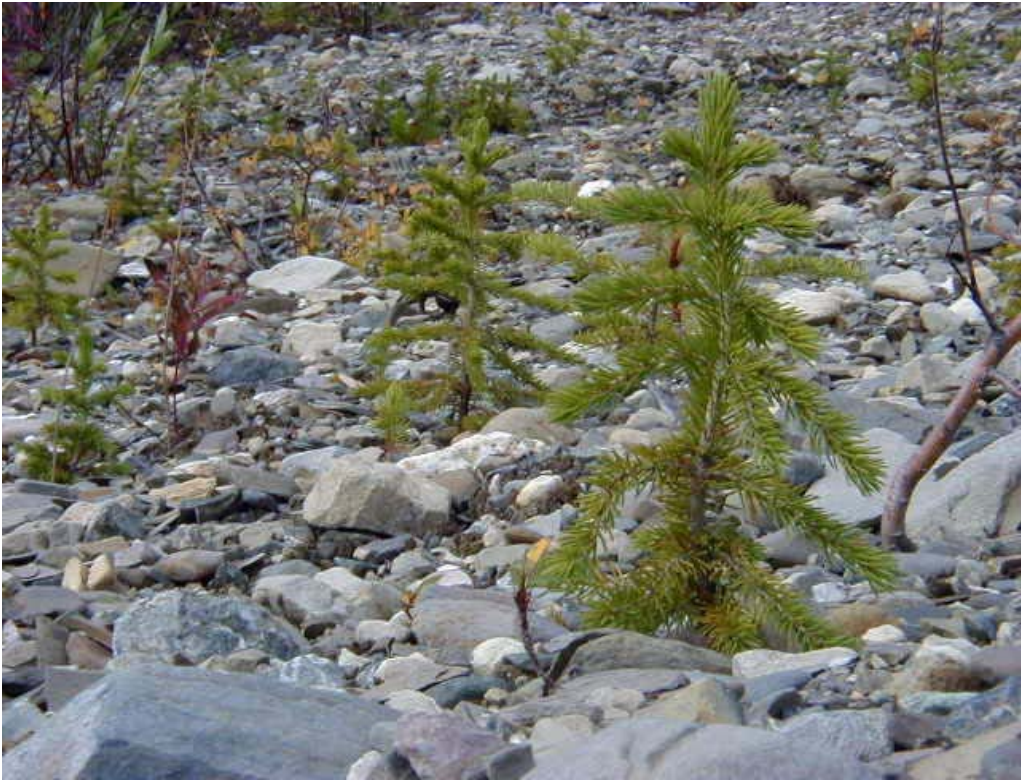
During the 2002 monitoring, it was noted that much of the previously disturbed land at the Sa Dena Hes Mine property was revegetating naturally. Native shrubs, forbs, and grasses appeared to be germinating on most disturbed sites. Alpine fir and white spruce have been particularly successful in colonizing these areas. These observations support the recommendations of the DDRP (Cominco, 2000) where it was stated that the preferred method of revegetating disturbed areas of the mine site (except the TMF) would include only recontouring and scarification.

Natural Revegetation of Coniferous Tree Species (white spruce) Access Road Fill Slope

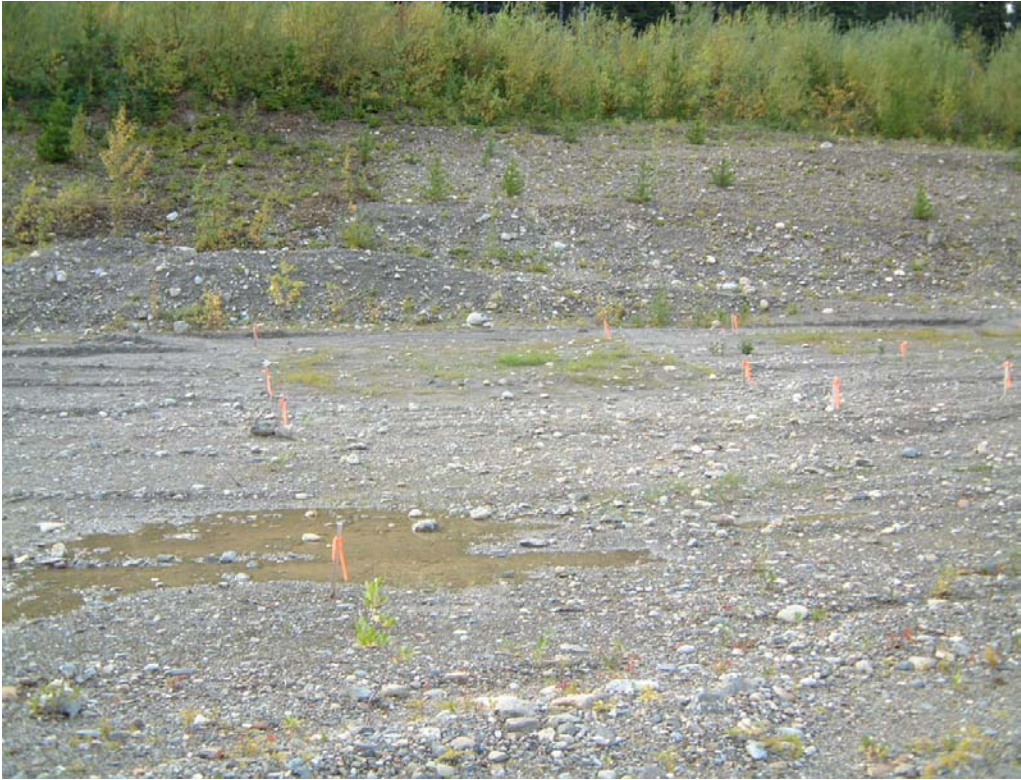
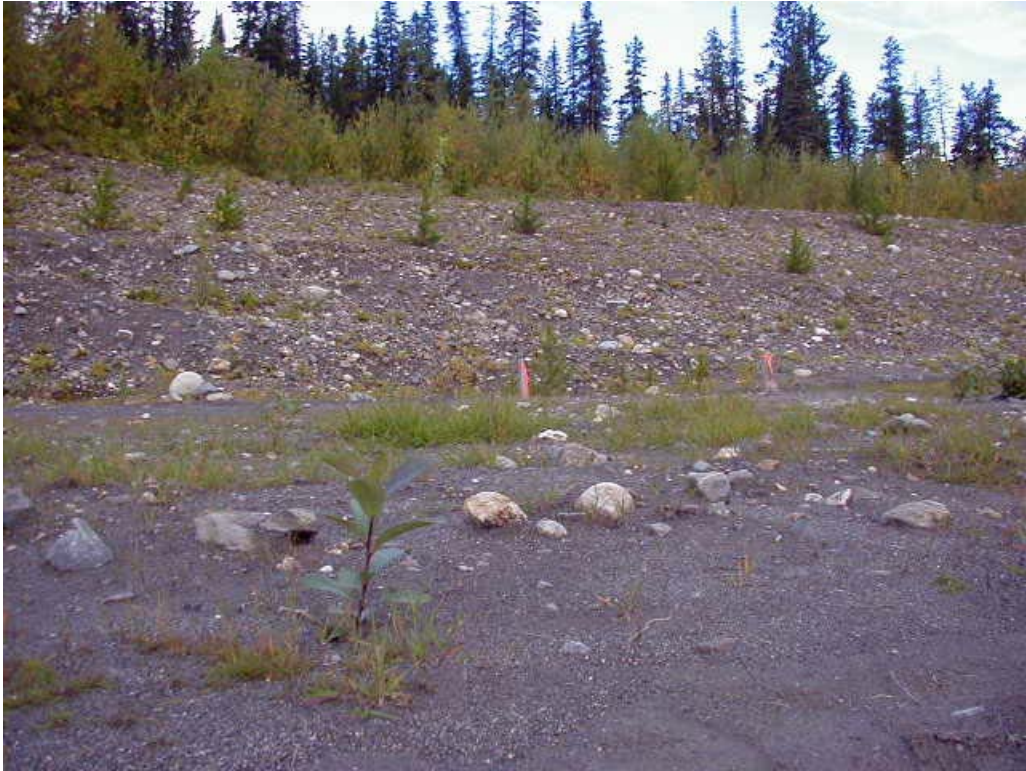
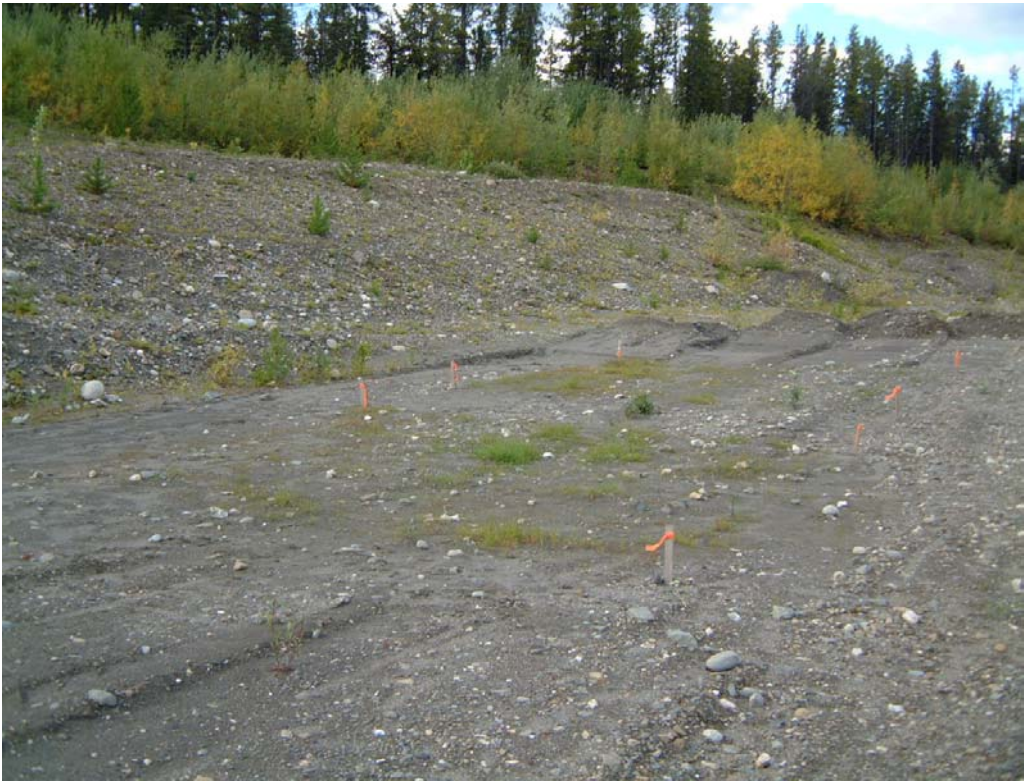
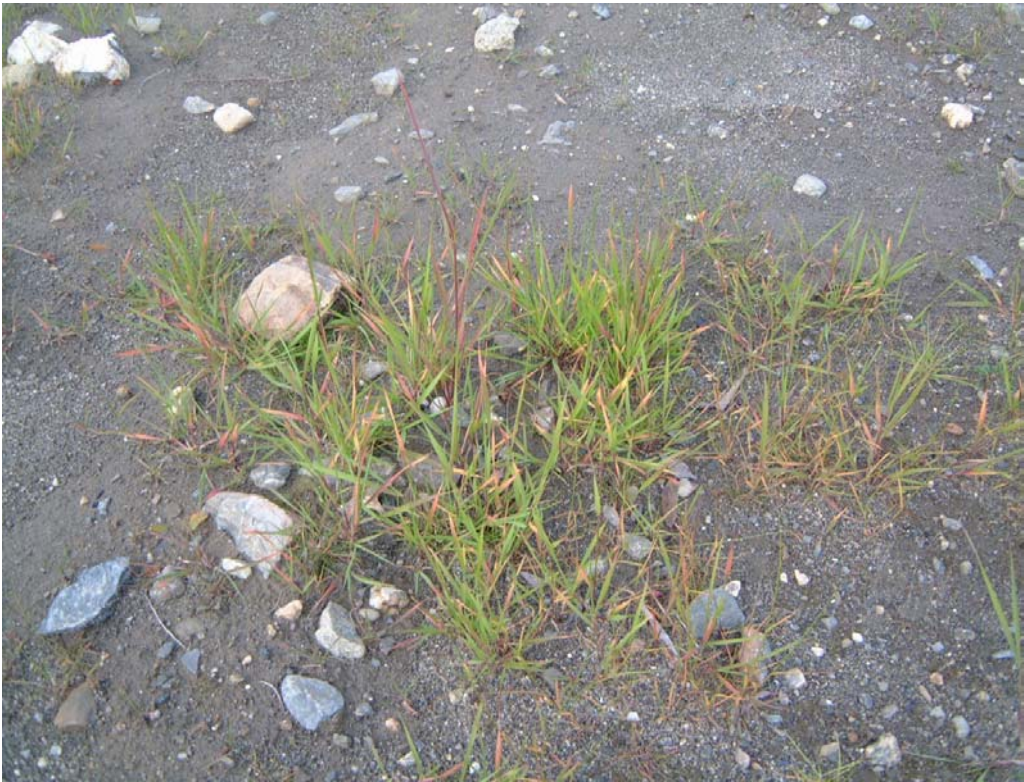
At all sites, the estimated cover was highest in the plot that was treated with a full application of seed and a full application of fertilizer (fertilizer application: 120 kg / ha, 24% nitrogen, 24% phosphorus, 24% potassium). The low vegetative cover on all plots suggests that a higher seeding rate may be required for this seed mix, although a second year of monitoring would be required to confirm this. Additional fertilizing may also be beneficial. It should be noted that below normal rainfall was reported for this area in May and June 2002. This is the critical season for the germination and early growth of these native species.

Adjacent to landfill - plot 1 in left background

Zoom - Adjacent to landfill - plot 1

Adjacent to landfill – plot 1 in left foreground

Adjacent to landfill - plot 1 (primarily violet wheatgrass)

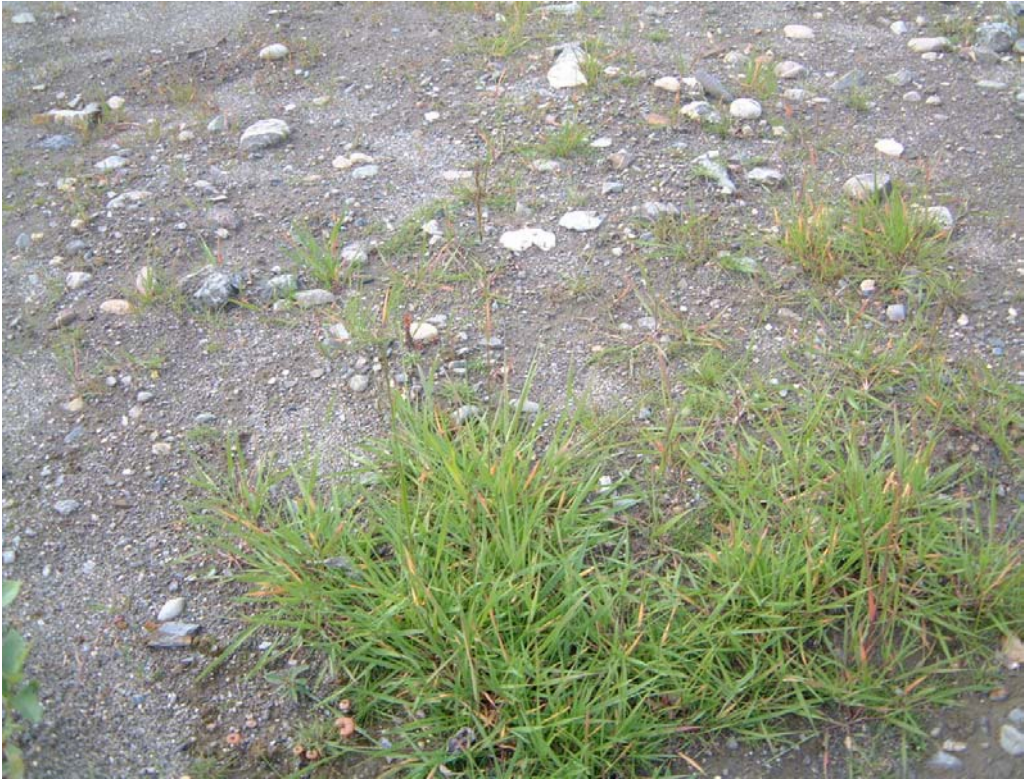
Adjacent to landfill – plot 2

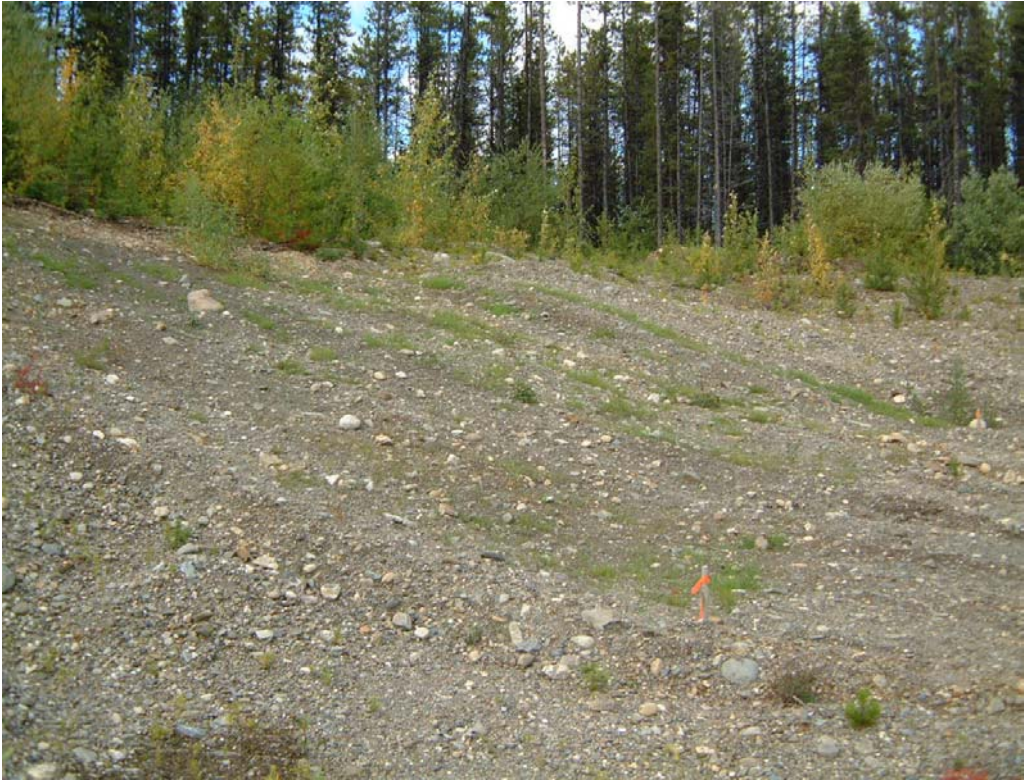
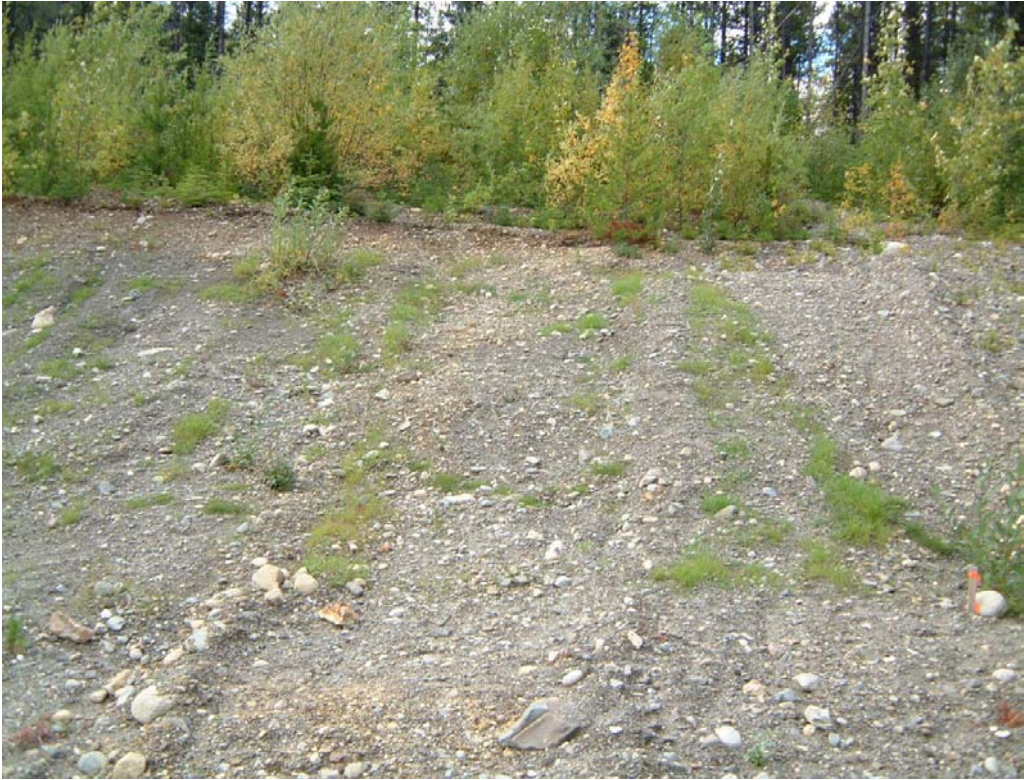
An estimated cover of about 15% was noted at the test plot seeded with only violet wheatgrass (the 0.1 ha plot established at the landfill site). The cover on this plot was very uneven, suggesting that ungerminated seed may have been washed downslope, fertilizer and/or seed had not been distributed evenly, or that soil nutrient conditions varied throughout the plot.

Adjacent to landfill – violet wheatgrass plot

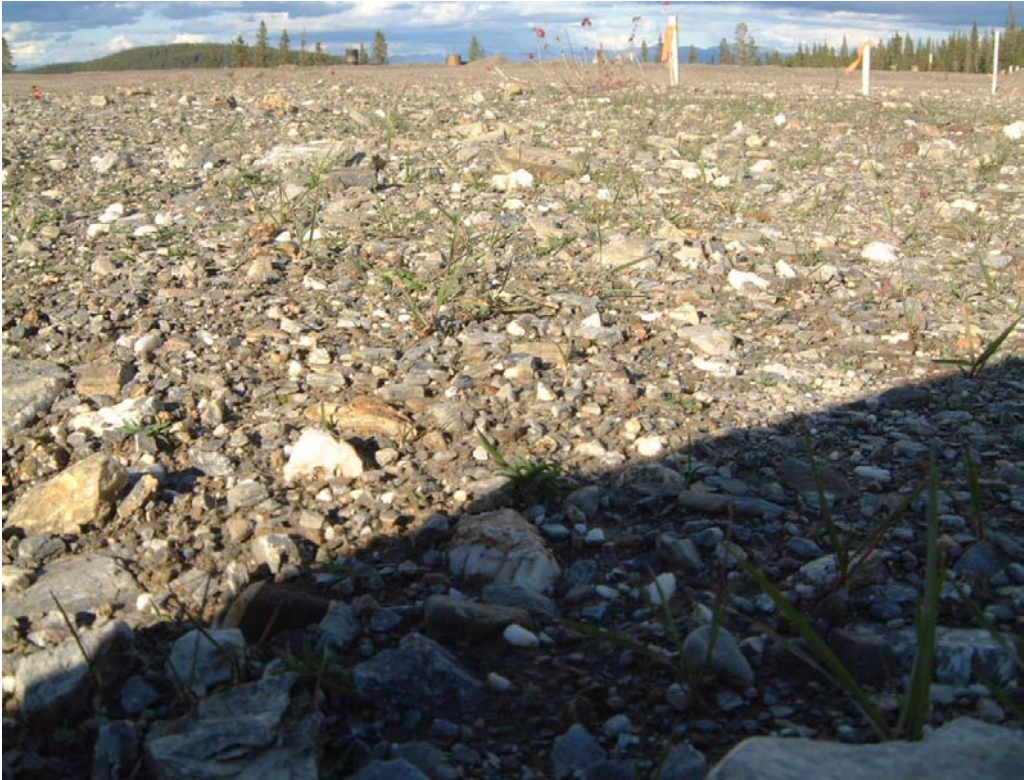
TMF with 200 mm soil – plot 1 (primarily violet wheatgrass)

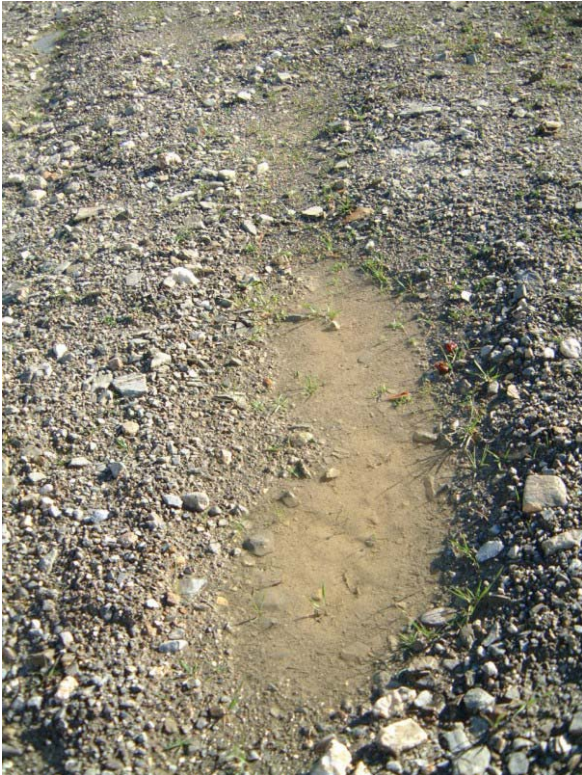
**TMF with 300 mm soil – plot 1**

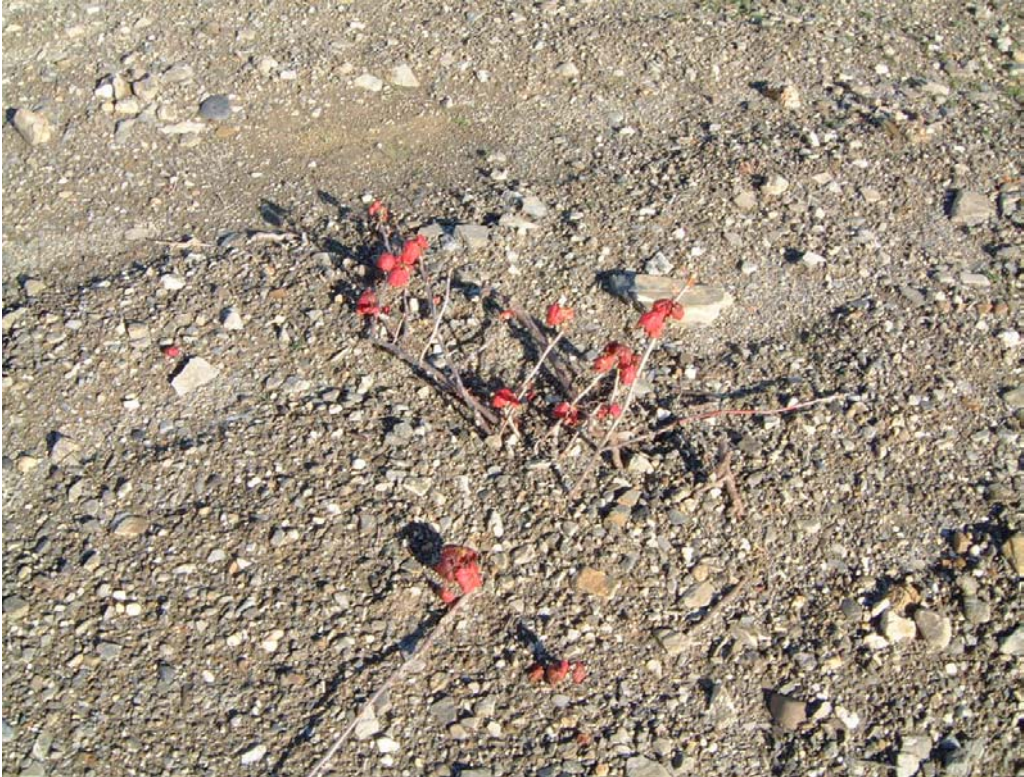
**TMF with 200 mm soil – black currant transplant**

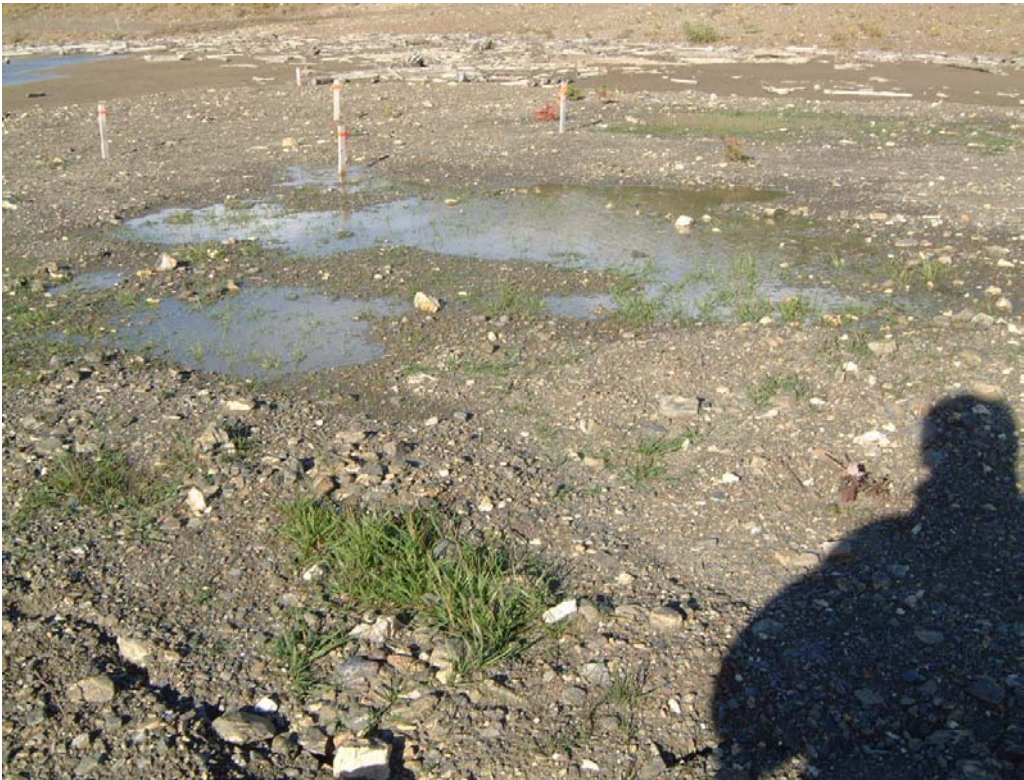
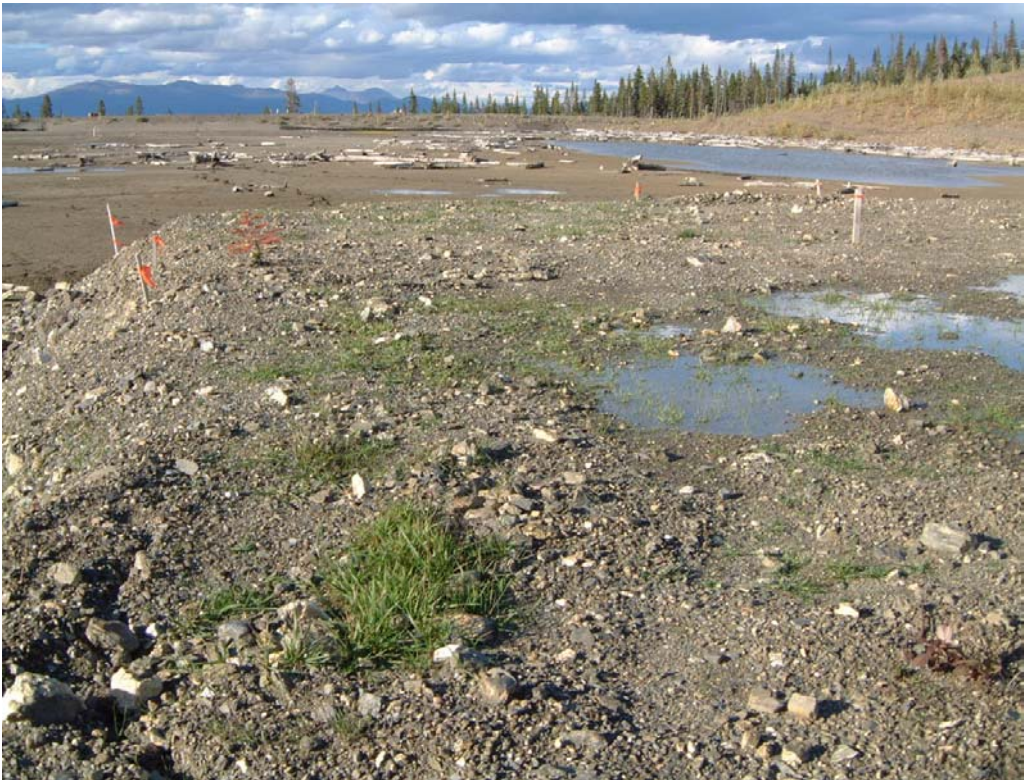
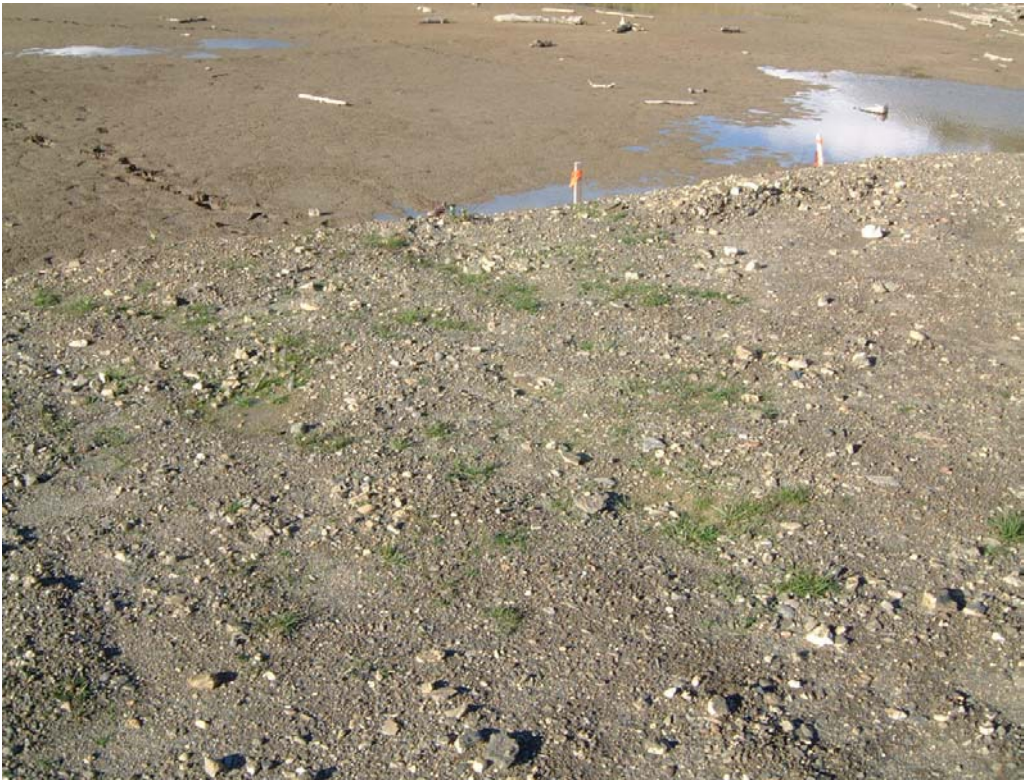
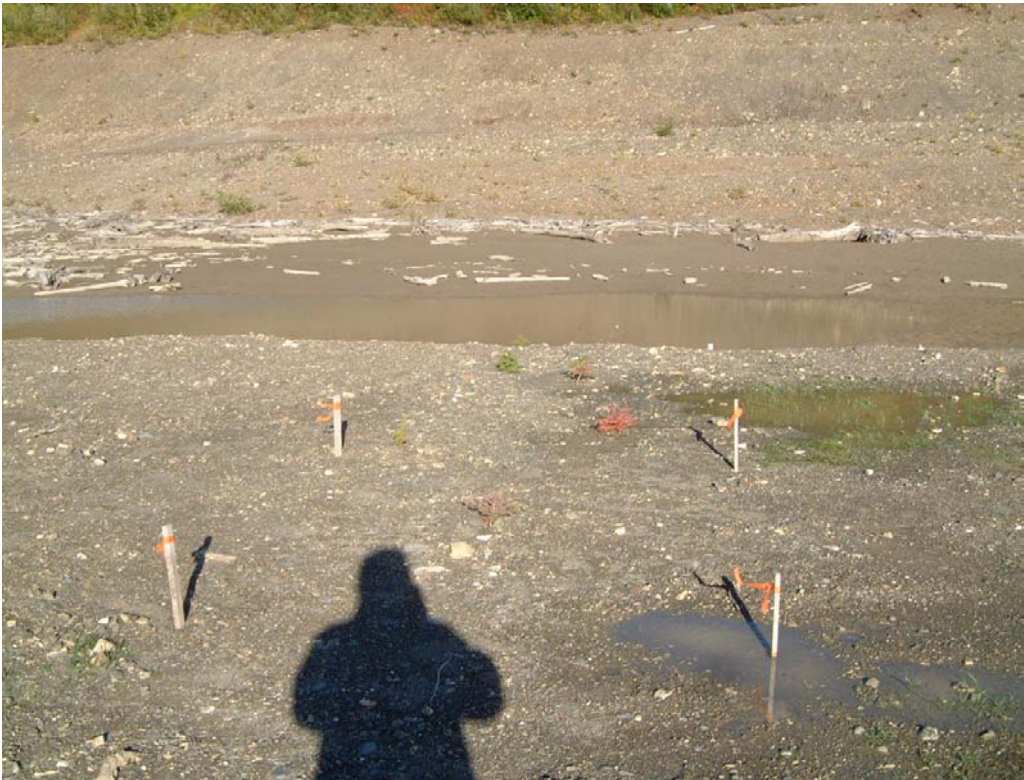
Of the three test sites on the Tailings Management Facility (TMF), the one with 500 mm of rock capped with 300 mm of soil had a higher vegetative cover. This site was slightly more sheltered from the wind than the other two test sites established on the TMF and this factor may be attributable to the greater cover seen here.

TMF with 500 mm rock and 300 mm soil – plot 1 in foreground

TMF with 500 mm rock and 300 mm soil – plot 1 in left foreground

**TMF with 500 mm rock and 300 mm soil – plot 2 in left foreground**

**TMF with 500 mm rock and 300 mm soil – plot 3 in right foreground**

For the TMF plots it is recommended to add 5 kg/ha creeping red fescue (*Festuca rubra*) or Kentucky bluegrass (*Poa pratensis*), and 2 kg/ha alsike clover (*Trifolium hybridum*) to the mix. These are commonly used agronomic species that would hasten the “greening up” of the plots.

The sites where the additional seeding effort should most appropriately be concentrated include the test plots at the TMF.

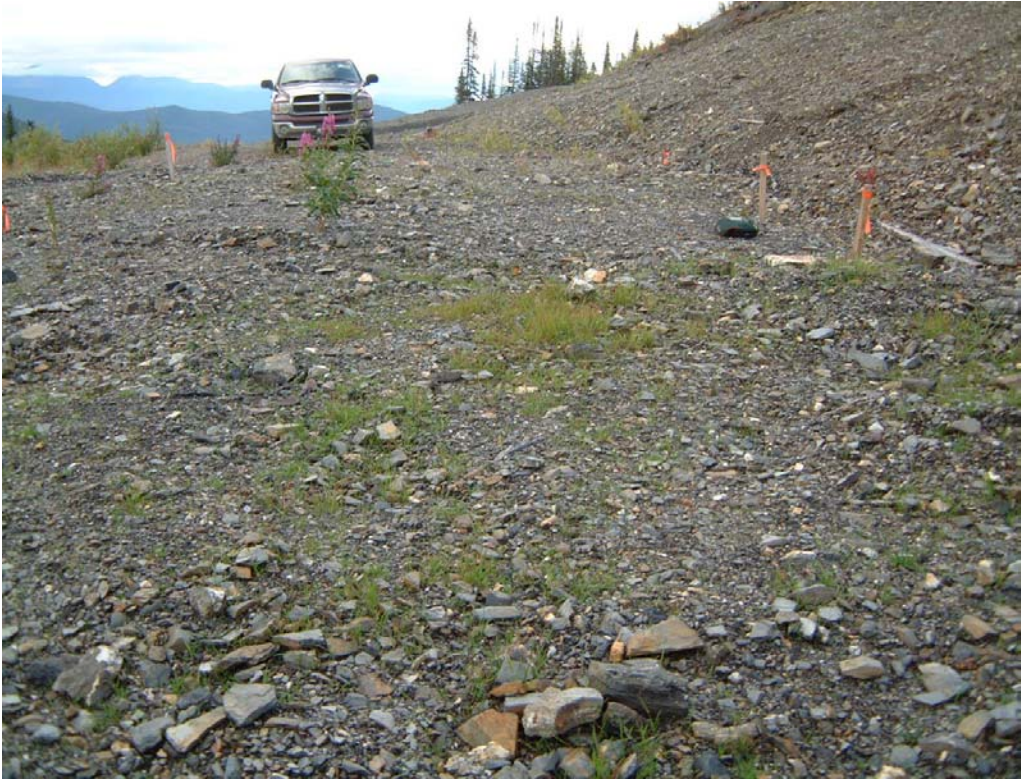
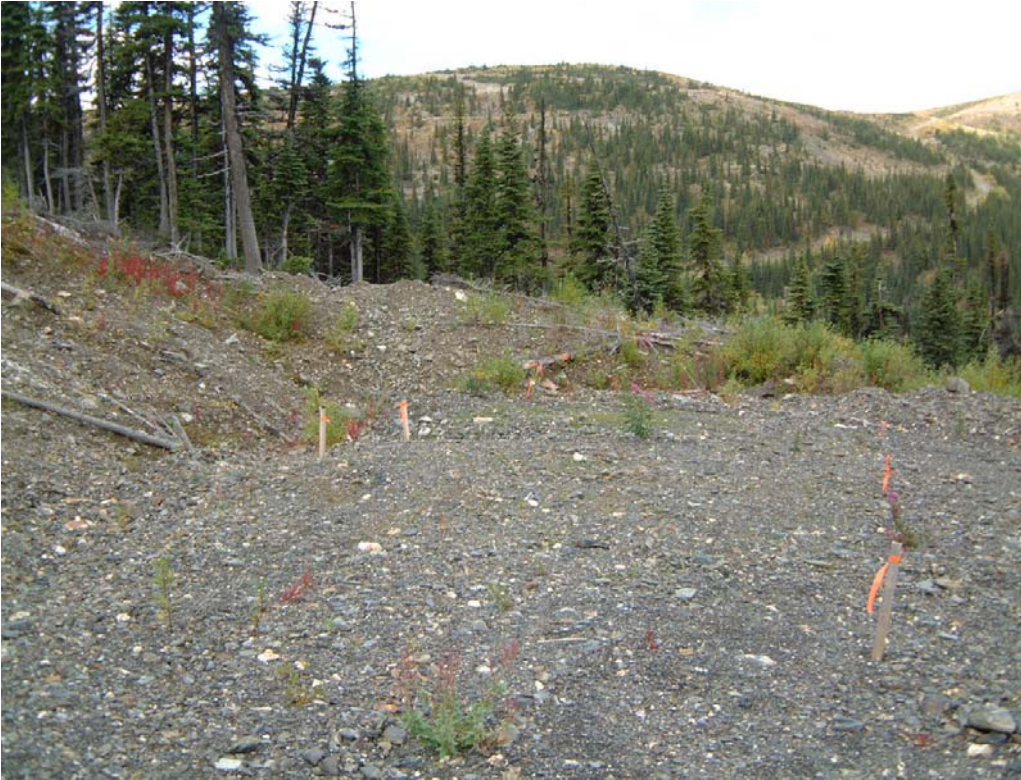
Jewel Box haul road – plot 1 in right foreground

Jewel Box haul road – plot 1 in left background

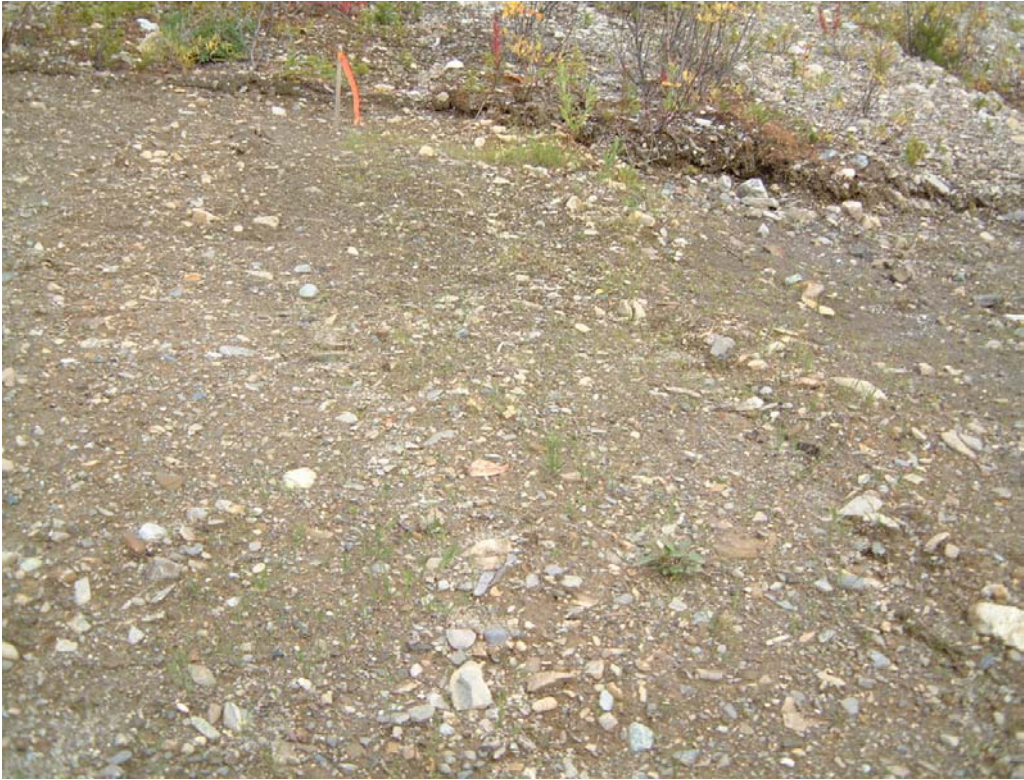
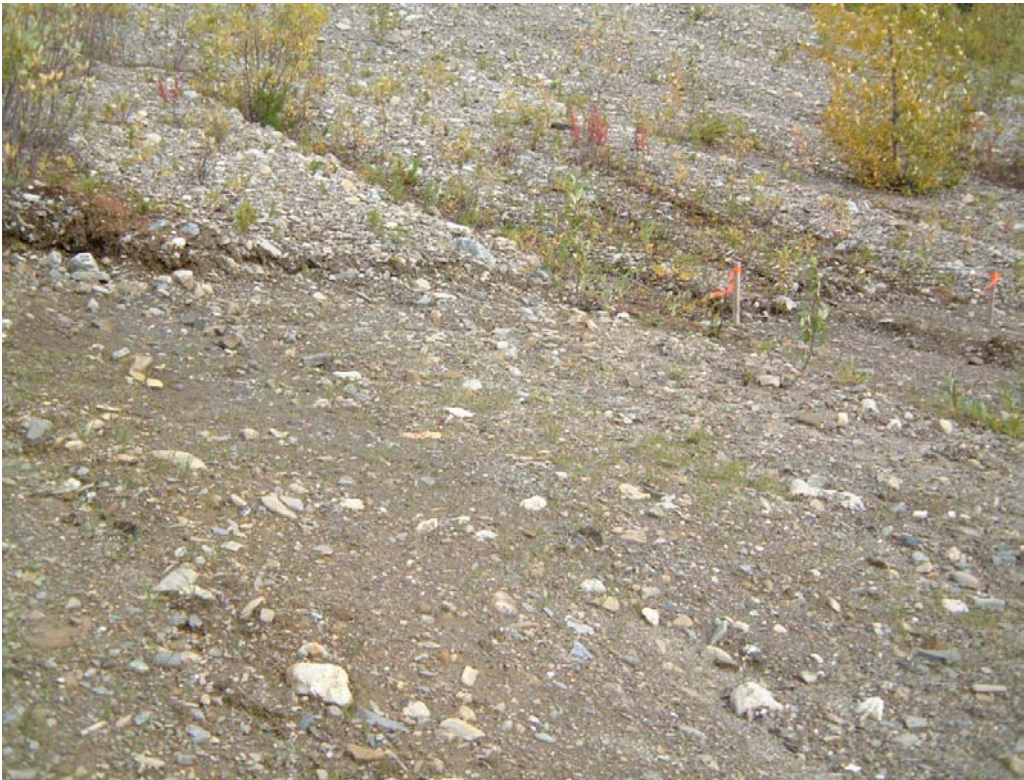
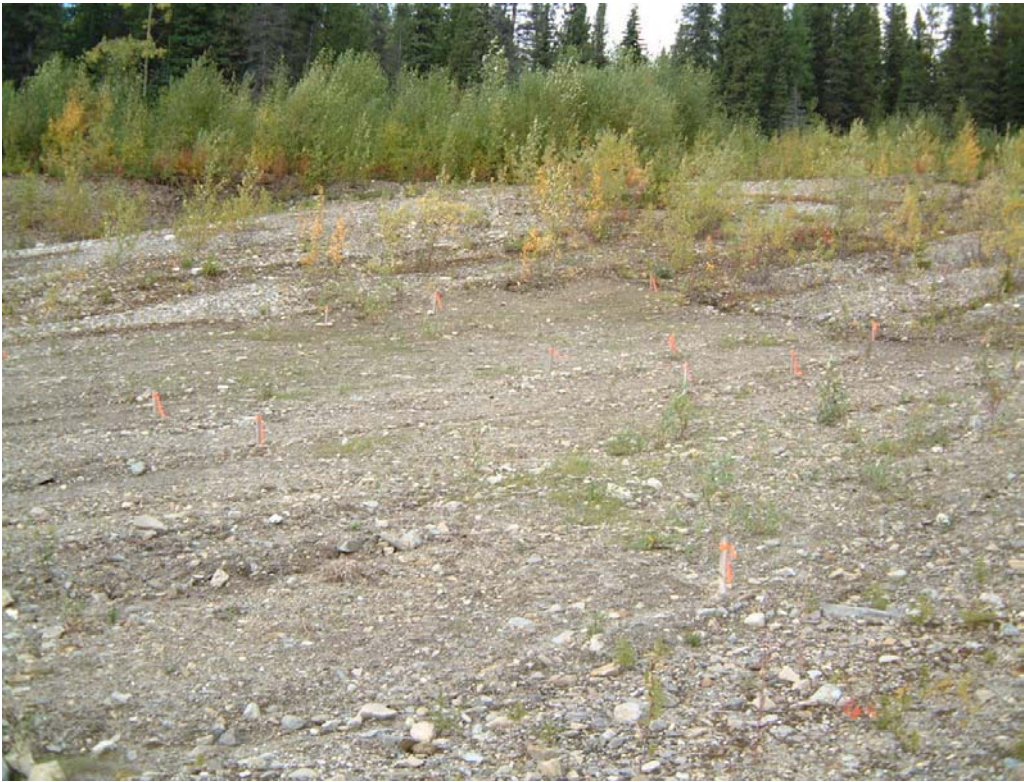
**Km 22 main access road – plot 1 in right foreground**

**Km 22 main access road – plot 1**

Km 22 main access road – plot 1 in centre background

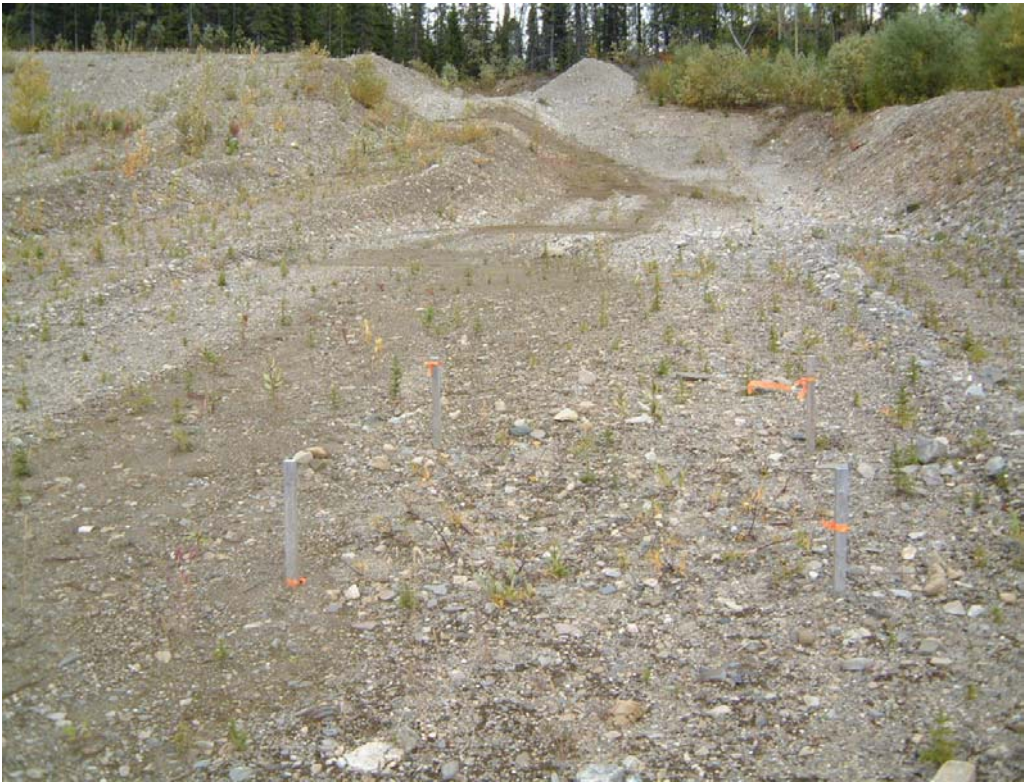
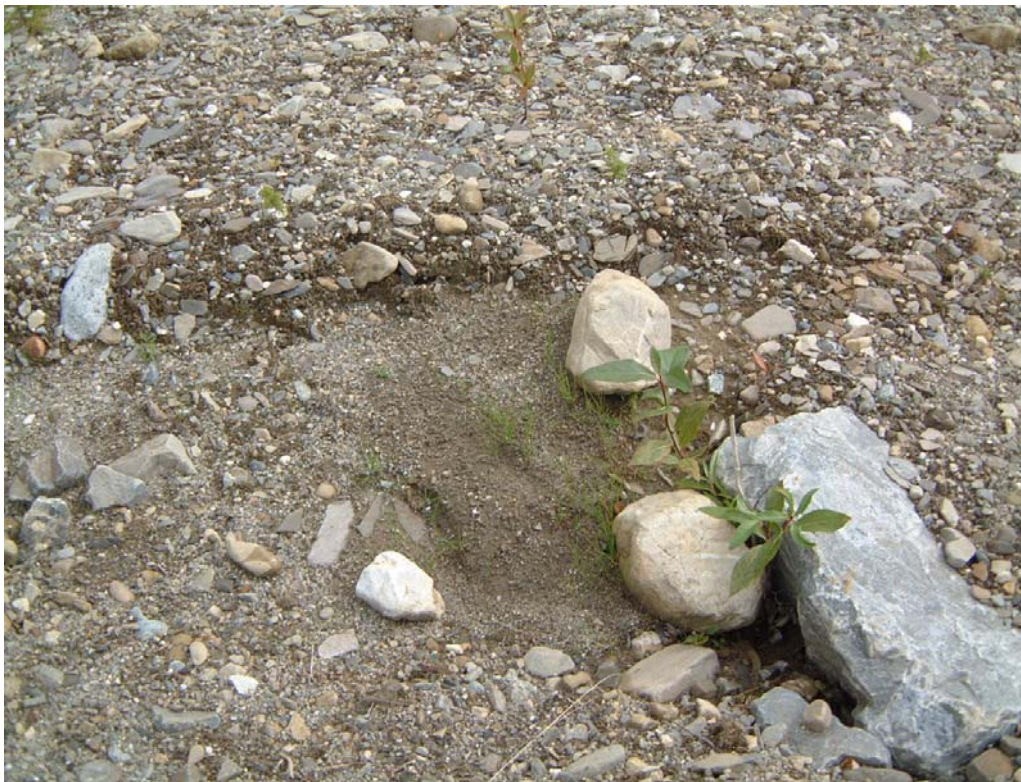
Although the survival rates of these shrubs are quite high, the growth rate at both sites is low. This probably results from the compacted, well-drained nature of the coarse textured substrate. Willows that are naturally colonizing areas adjacent to the test plots also have slow growth rates. Decompaction of the soil at these sites would undoubtedly hasten plant growth. It is notable that conifers (alpine fir and white spruce) appear to be quite successful in colonizing these compacted soils.

Km 22 main access road – willow cutting test plot

**Km 22 main access road – willow cutting test plot**

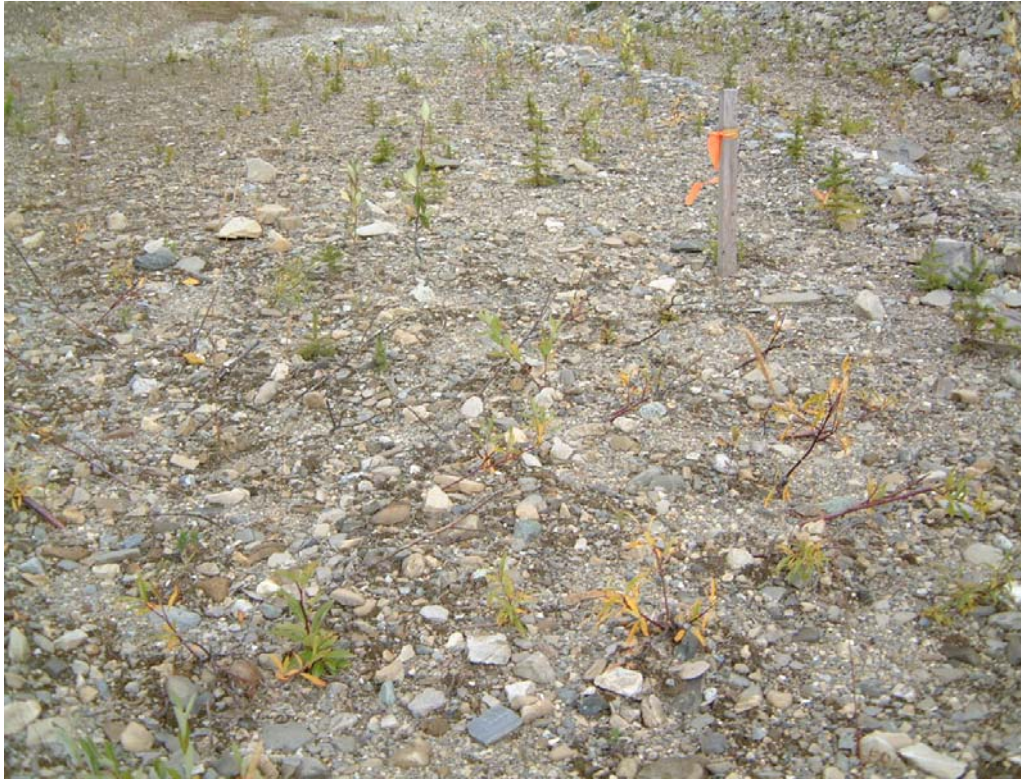
The vegetative cover was found to be densest in small depressions on each plot. This could be the result of the higher moisture retention occurring in these depressions and/or seed being concentrated (from initial broadcasting, wind, and/or water movement) in the depressions prior to germination. These observations, of what are termed 'microclimate effects', most often occur

at sites of revegetation on side slopes where seed movement is more easily facilitated, and have been previously characterized and documented at other hard rock mine operations in the Yukon by C. Mougeot (1996). At the test site located at km 22 of the main access road, growth was noted in depressions found down-slope from the plot, suggesting that seed was washed down-slope prior to germination.

**Km 22 main access road – grass seed germinating in depression downhill from test plots**

It appears that microclimate effects (moisture concentration and elevated seed retention in seed plot depressions) may be playing a part in the more successful germination of the seeded vegetation species at some locations. The positive benefits of these effects, particularly moisture concentration and seed retention in depressions, can be recreated by scarification of the ground surface at the time of closure.
