## **Wolverine Project**

**QUARTZ MINING LICENSE QML-0006**

**2007 ANNUAL REPORT**

**Prepared by:  
Yukon Zinc Corporation  
Vancouver, British Columbia**

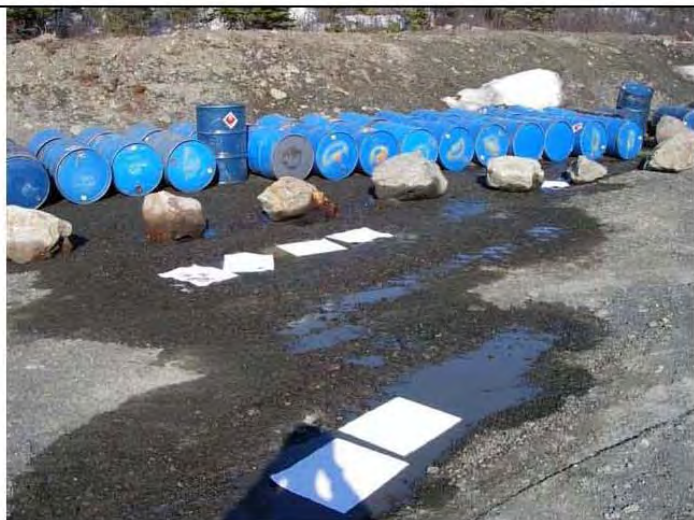
**Photo 3.** Area of spill (Cache A) with righted drums that had leaked. Note: Wetted area is from seeping surface water. No product was observed in puddles. Taken May 23, 2007.

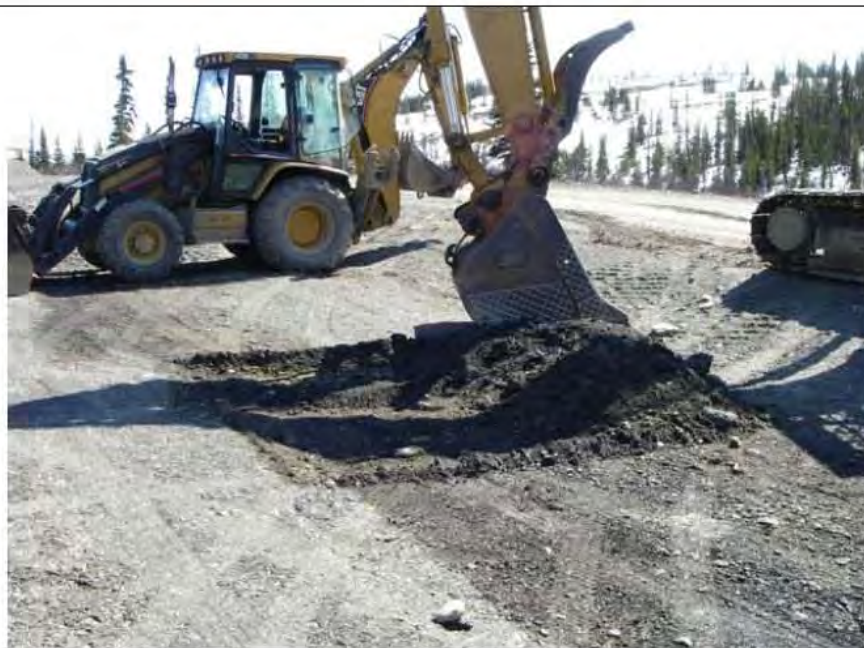
**Photo 4.** Start of contaminated soil excavation (approx. 30 cm deep). Taken May 23, 2007

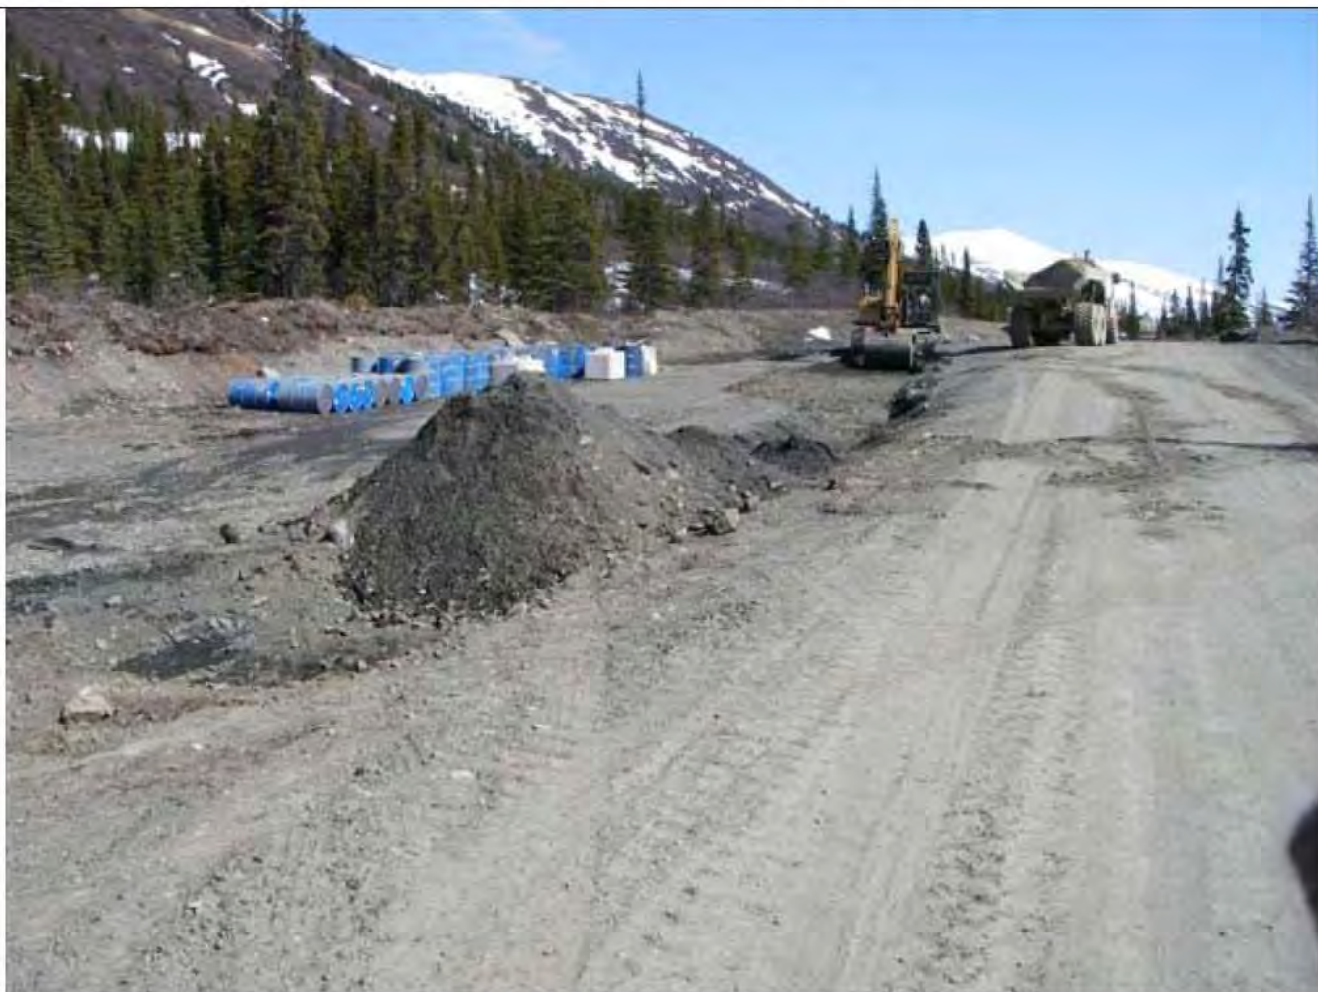
**Photo 5.** After the drums were moved from Cache A north to Cache B; midway through excavation of the contaminated soil. The red line outlines the contaminated area viewed from the north-west, looking down the site road towards the portal area. Taken May 23, 2007.

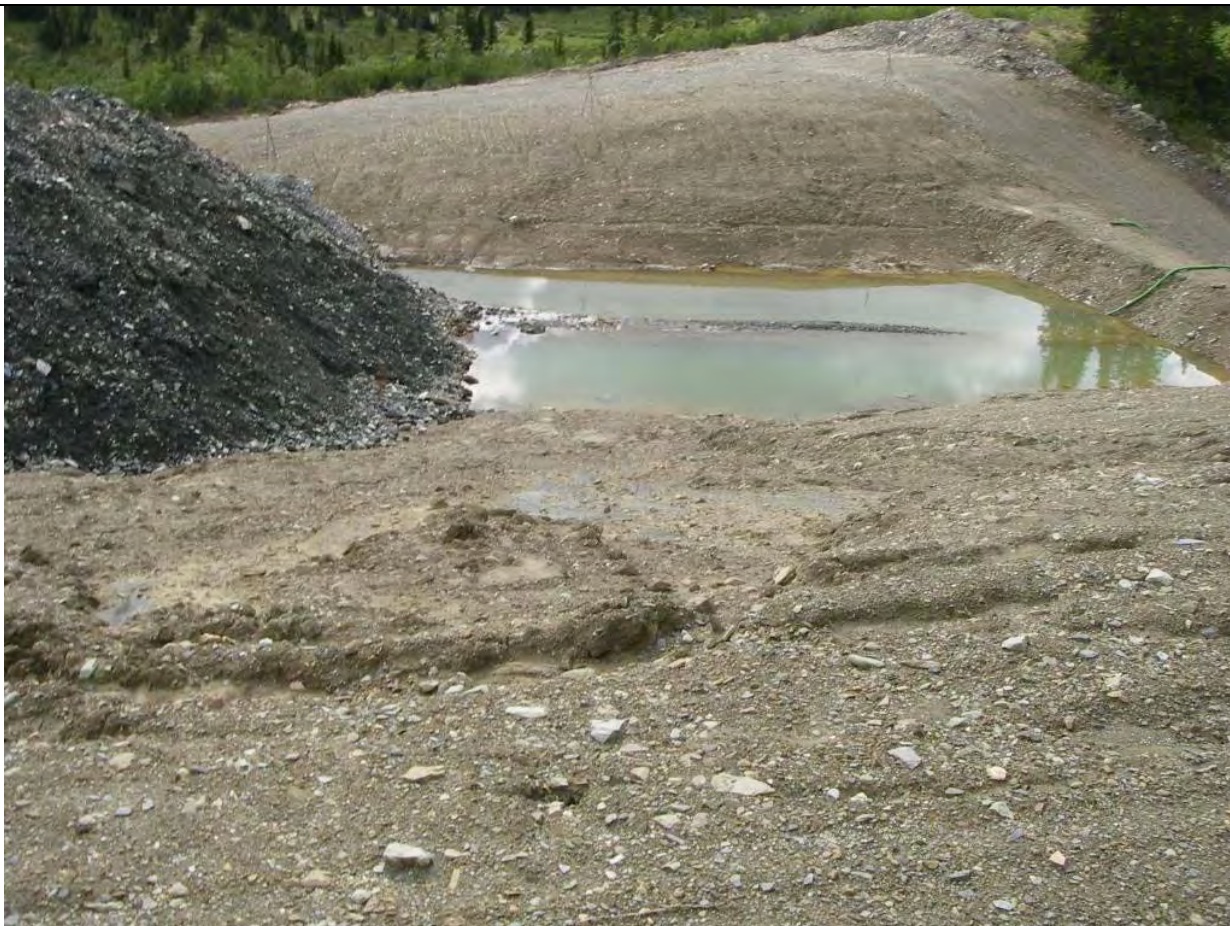
**07/07/07 Slumping of clay liner on East side of WRP (facing W)**

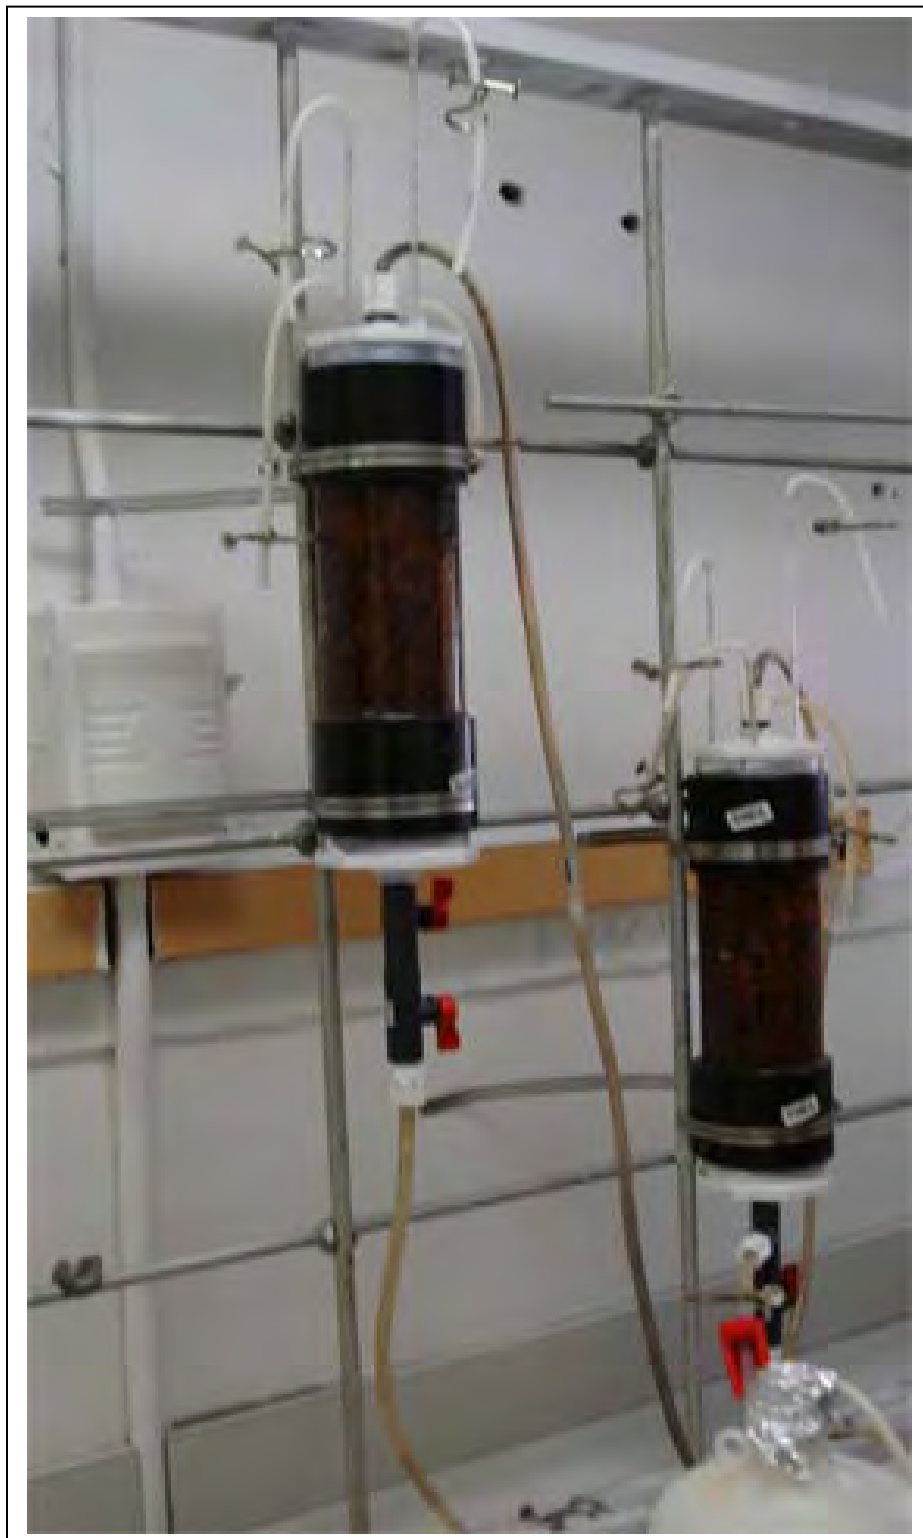
*Figure 6.* Two BEMR in series using a retention time of twenty-two hour each for a total retention time of forty-four hours.
