**Wolverine Mine**  
**Waste Rock Storage Pad**

This report presents the construction record of the Rock Pad Storage Facility for the above project. The rock pad will be used to temporarily store mine rock prior to use as backfill for the underground workings. The rock pad is lined with an impervious geomembrane and will store up to 170,000 tonnes of potentially acid generating mine waste rock. Runoff from the rock pad will be collected in a sump and directed to the tailings storage facility where it will be reclaimed for use in the mill, or treated and discharged to the environment.

| D-WR-001 | Waste Rock Storage Area, General Arrangement - Plan |
| D-WR-002 | Waste Rock Storage Area, Details |

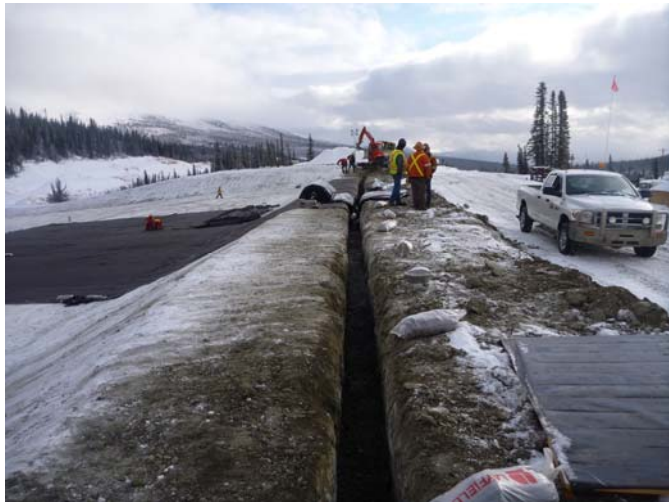
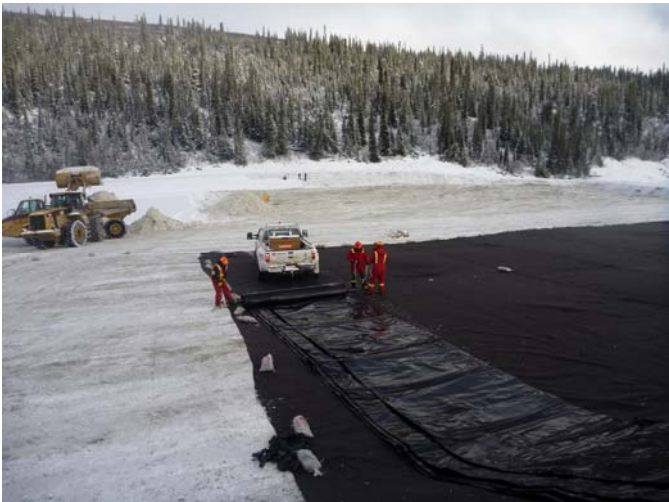
| <b>Photo 1 (11/10/30):</b> Looking southeast – 1 <sup>st</sup> geo-membrane protective cloth laid with the ends tugged in and over the anchor trench along the southwest berm. | <b>Photo 2 (11/10/30):</b> Looking east - G-panel liner rolled over the 1 <sup>st</sup> layer of geo-membrane cloth. |

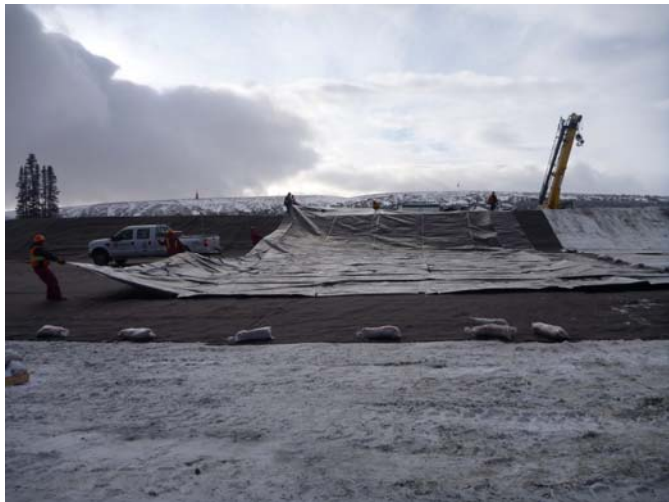
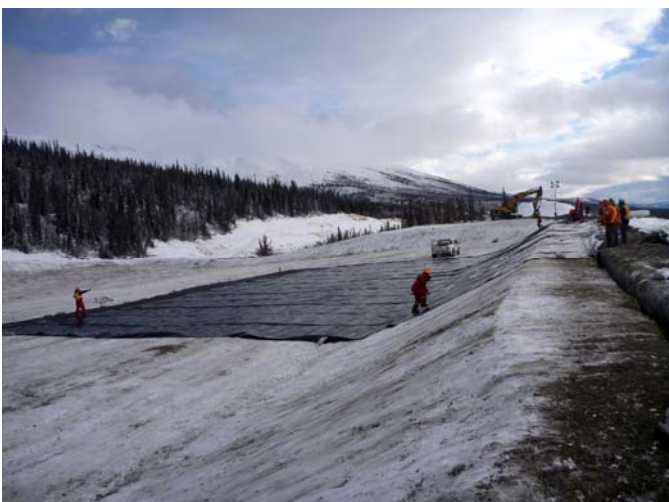
| <b>Photo 3 (11/10/30):</b> Looking southwest – Spreading the G-panel liner over the 1 <sup>st</sup> geo-membrane cloth. Bags of sand used to hold the cloth in place. | <b>Photo 4 (11/10/30):</b> Looking southeast – G-panel fully spread over the 1 <sup>st</sup> geo-membrane cloth. |

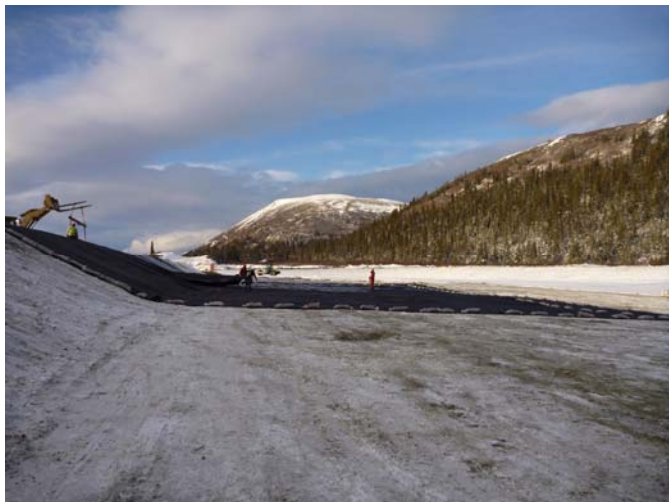
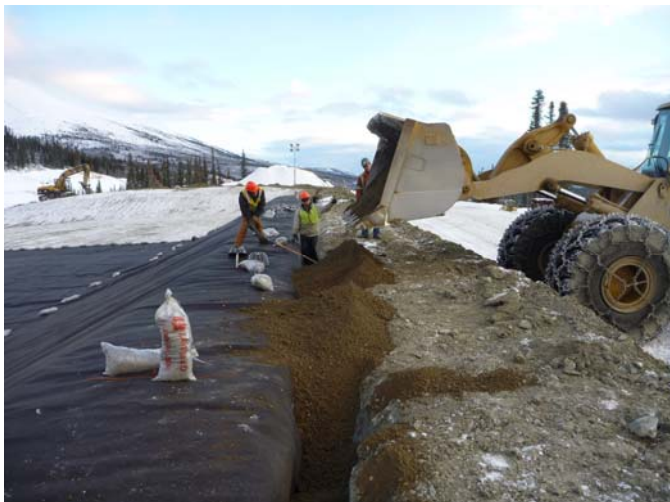
| <b>Photo 5 (11/10/30):</b> Looking north – laying 2 <sup>nd</sup> LP16 geo-membrane cloth over the G-panel. | <b>Photo 6 (11/10/30):</b> .Looking southeast – G-panel completed. Anchor trench backfilled with materials. |

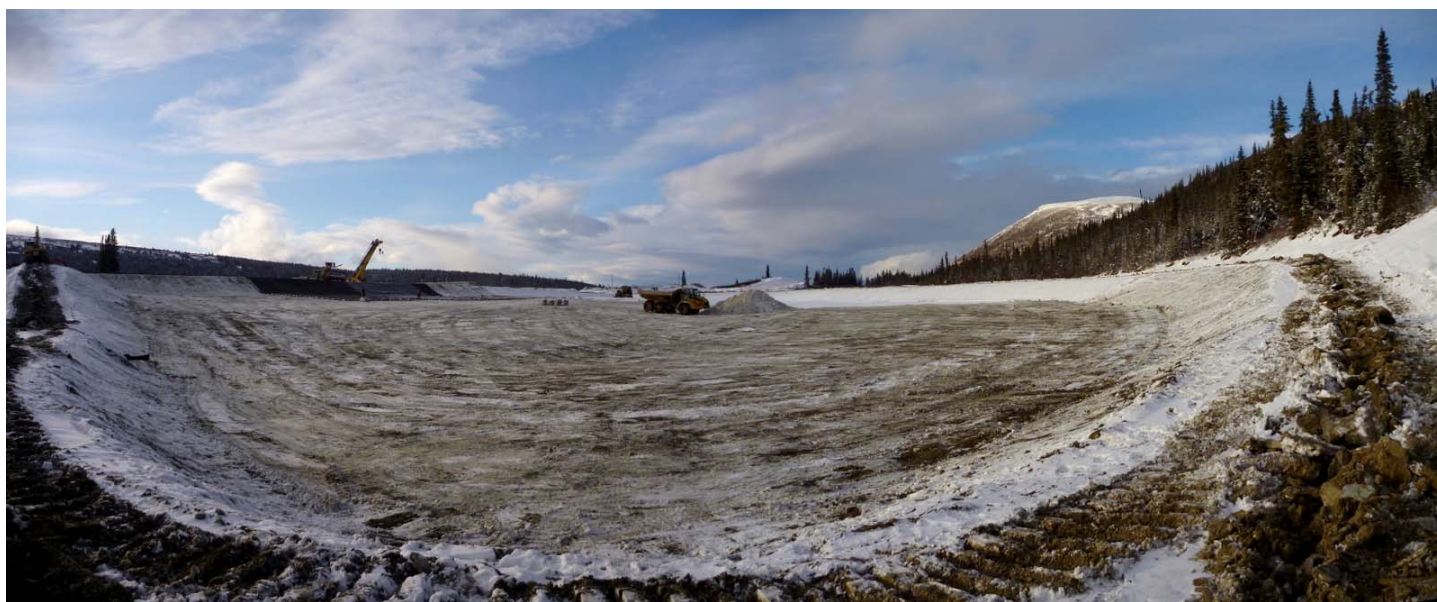
**Photo 7 (11/10/30):** .Looking west – installing geo-membrane cloth and G-panel liner along the southwest wall; snow removal within the pad and trenching the anchor trench along the perimeter of the pad.

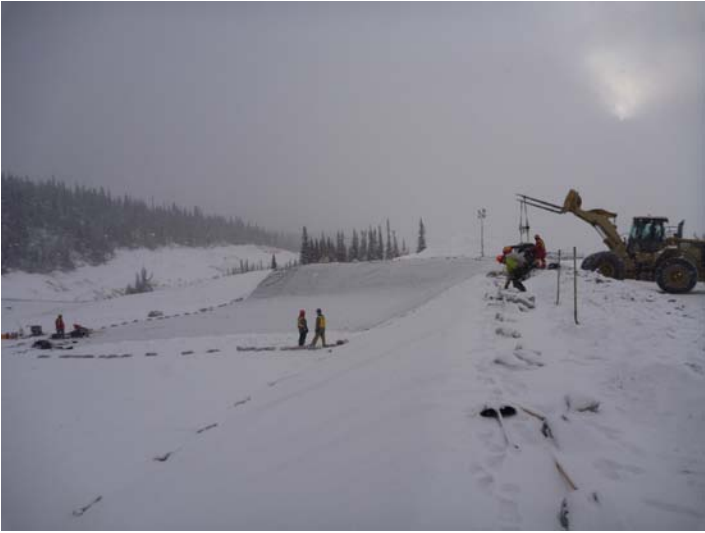
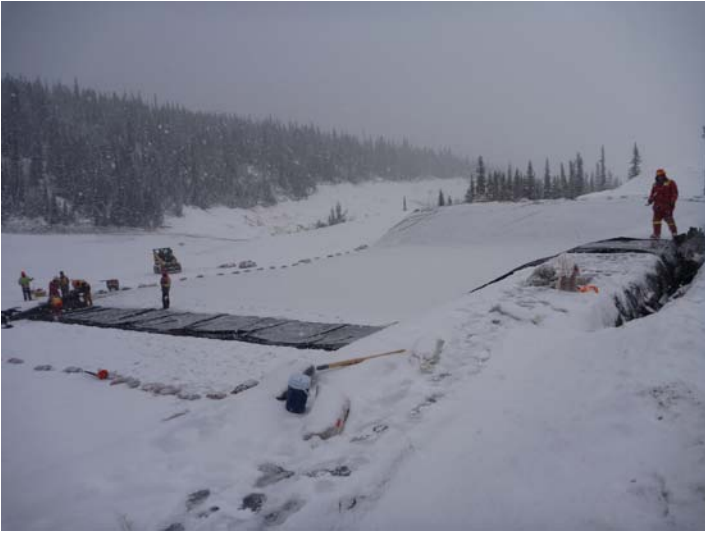
| <b>Photo 1 (11/10/31):</b> Looking southeast – 1 <sup>st</sup> geo-membrane protective cloth laid with the ends tugged in and over the anchor trench along the southwest berm. | <b>Photo 2 (11/10/31):</b> Looking east - A-panel liner rolled over the 1 <sup>st</sup> layer of geo-membrane cloth. |

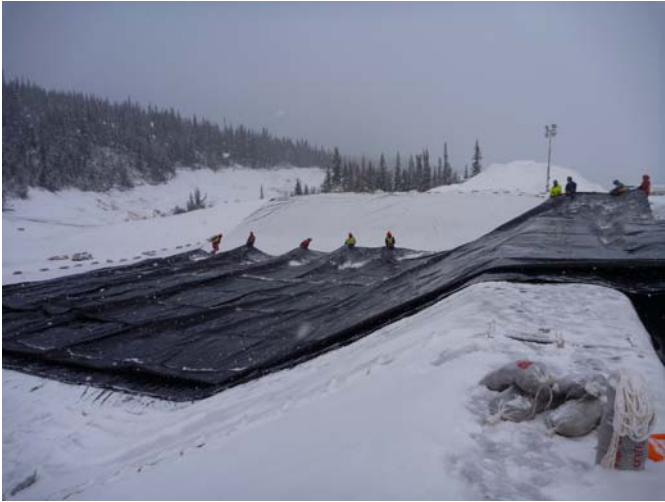
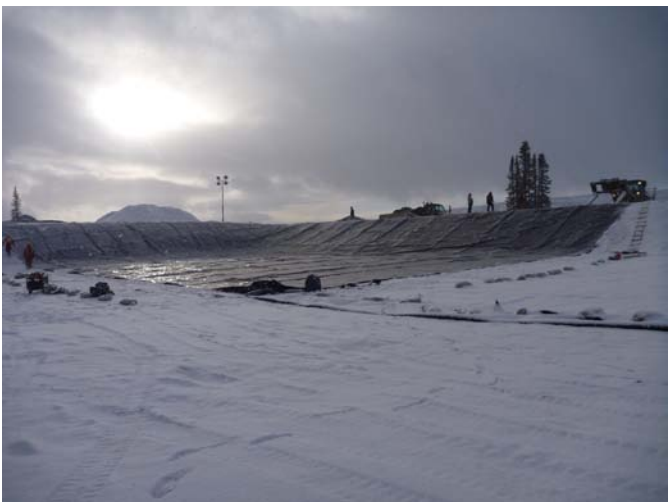
| <b>Photo 3 (11/10/31):</b> Looking southwest – Spreading the A-panel liner over the 1 <sup>st</sup> geo-membrane cloth. | <b>Photo 4 (11/10/31):</b> Looking southeast – G-panel fully spread over the 1 <sup>st</sup> geo-membrane cloth. |

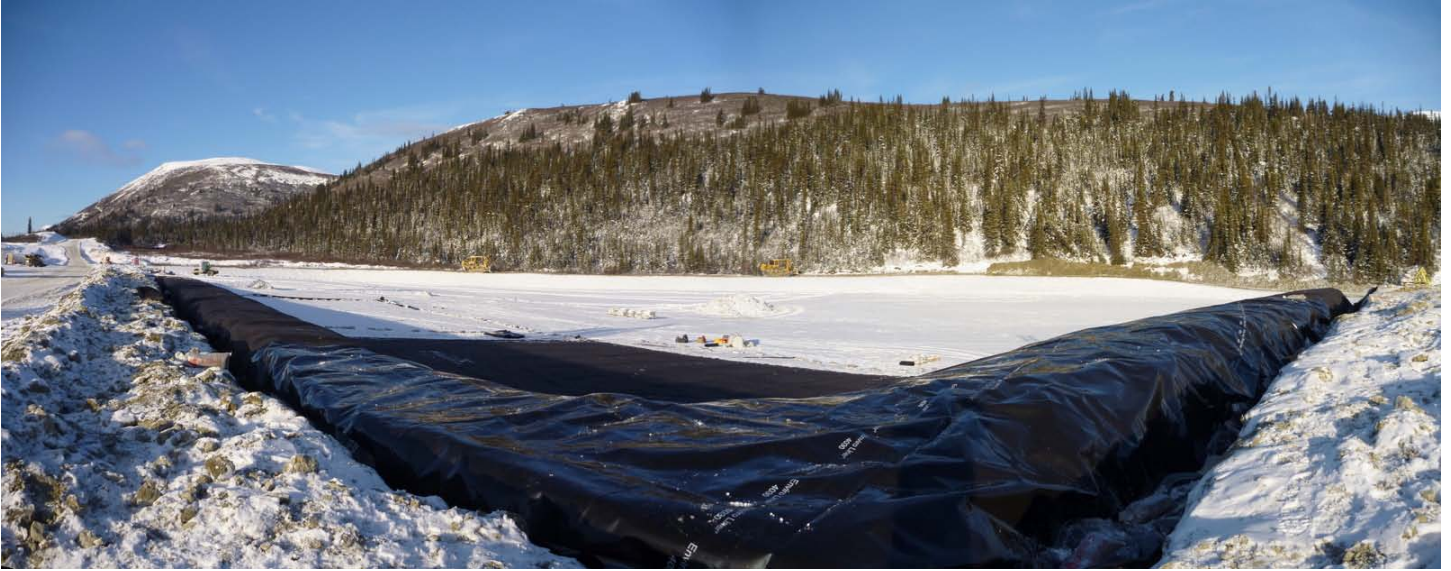
**Photo 5 (11/10/31):** Looking north – installing A-panel liner along the southeast wall.

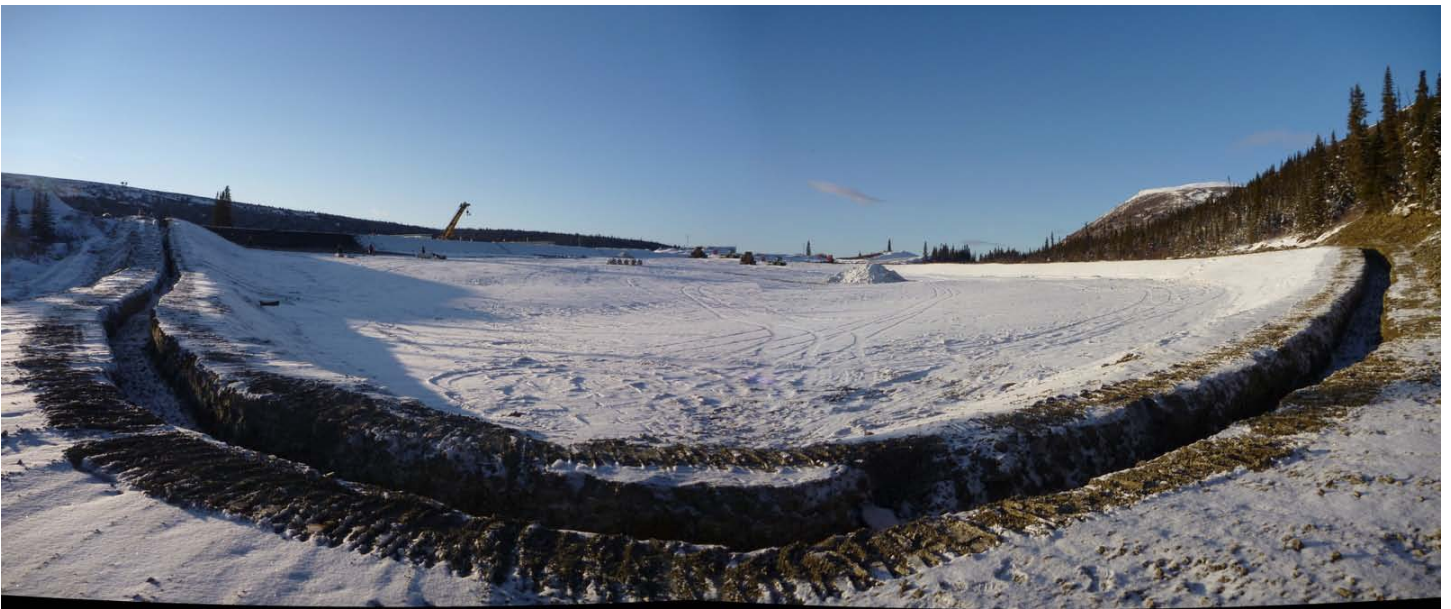
**Photo 6 (11/10/31):** Looking west – installing geo-membrane cloth and A-panel liner along the southwest wall; completed trenching of anchor trench along the southeast and northeast perimeter of the pad.

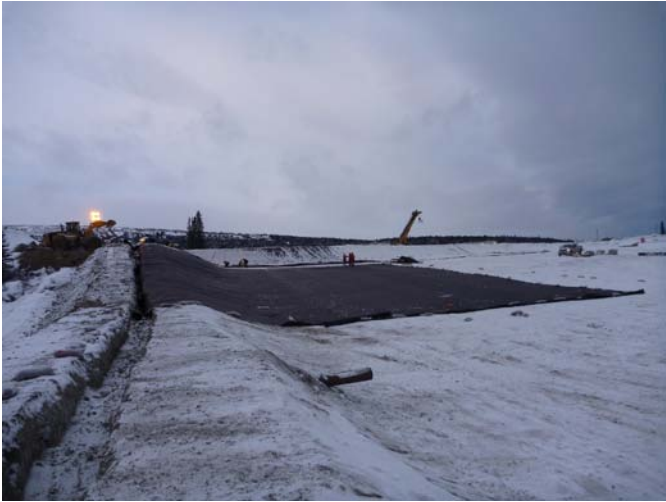
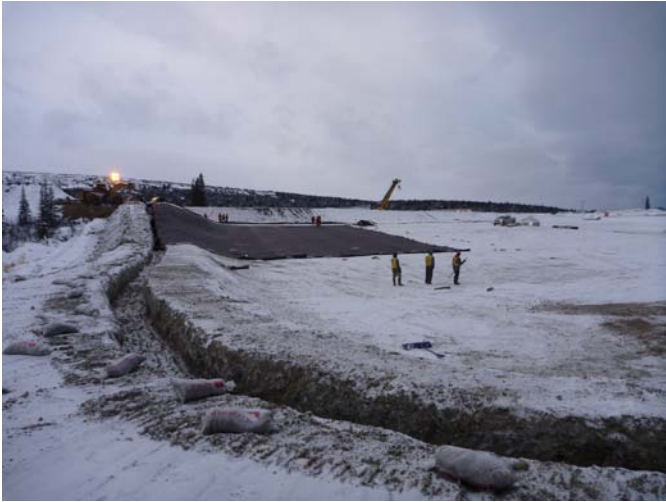
| <b>Photo 1 (11/11/01):</b> Looking west – midmorning 3 <sup>rd</sup> liner panel and geomembrane protective cloth laid with the ends tugged in and over the anchor trench along the southeast berm. | <b>Photo 2 (11/11/01):</b> Looking west – midmorning 3 <sup>rd</sup> liner panel anchored with sand bags. |

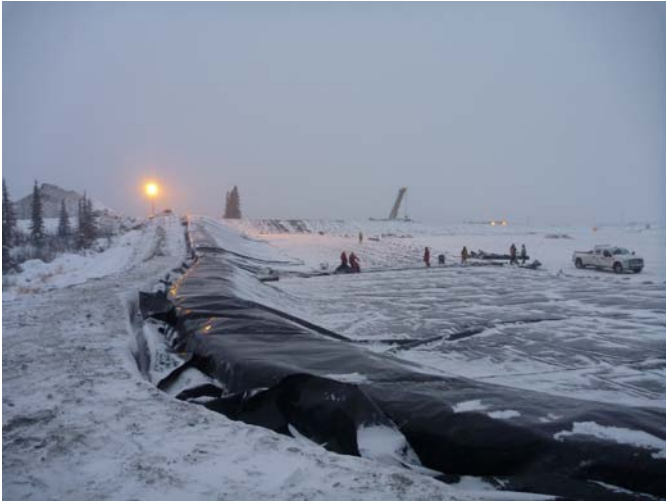
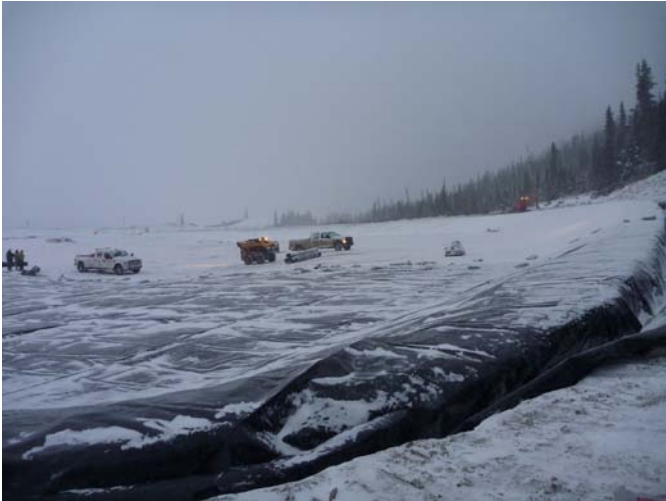
| <b>Photo 3 (11/11/01):</b> mid afternoon - looking west – 4 <sup>th</sup> liner panel installed. Steady southeast winds & snow. | <b>Photo 4 (11/11/01):</b> mid afternoon - looking west – 5 <sup>th</sup> liner panel installed. Steady southeast winds & snow. |

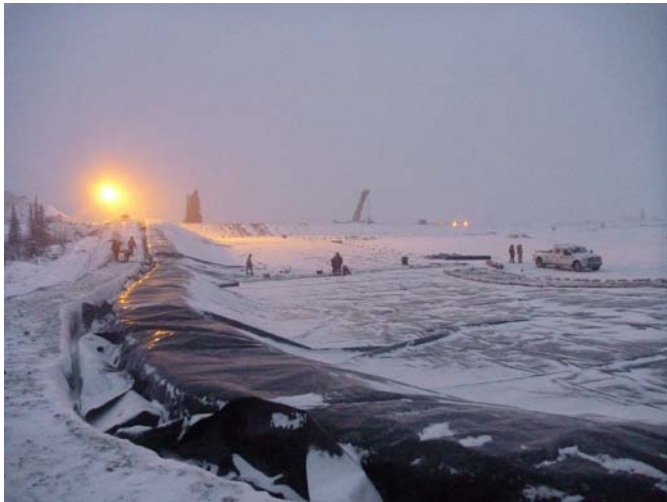
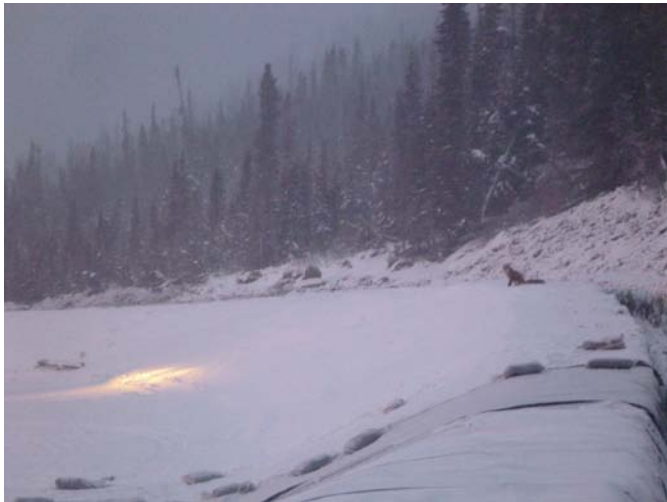
| Site Name: Waste Rock Pad – Day 4 | Date: November 1, 2011 |
|---|---|
| <p><b>Photo 5 (11/11/01):</b> mid afternoon - looking west – 4<sup>th</sup> liner panel installed. Steady southeast winds &amp; snow.</p> | <p><b>Photo 6 (11/11/01):</b> Looking north – 5<sup>th</sup> liner panel installed. Lone spectator on the northeast berm.</p> |

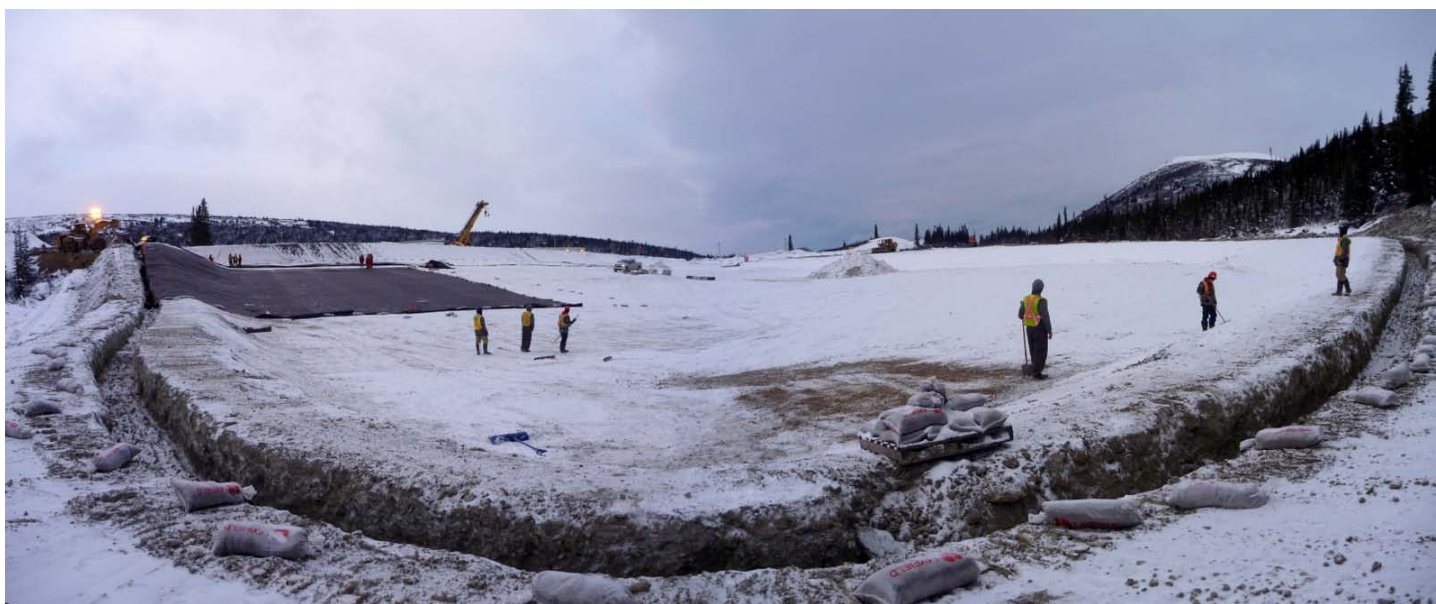
**Photo 7 (11/11/01):** .Looking west – Midmorning 3<sup>rd</sup> liner panel installed along the southwest wall; snow removal within the pad and trenching the anchor trench along the perimeter of the pad.

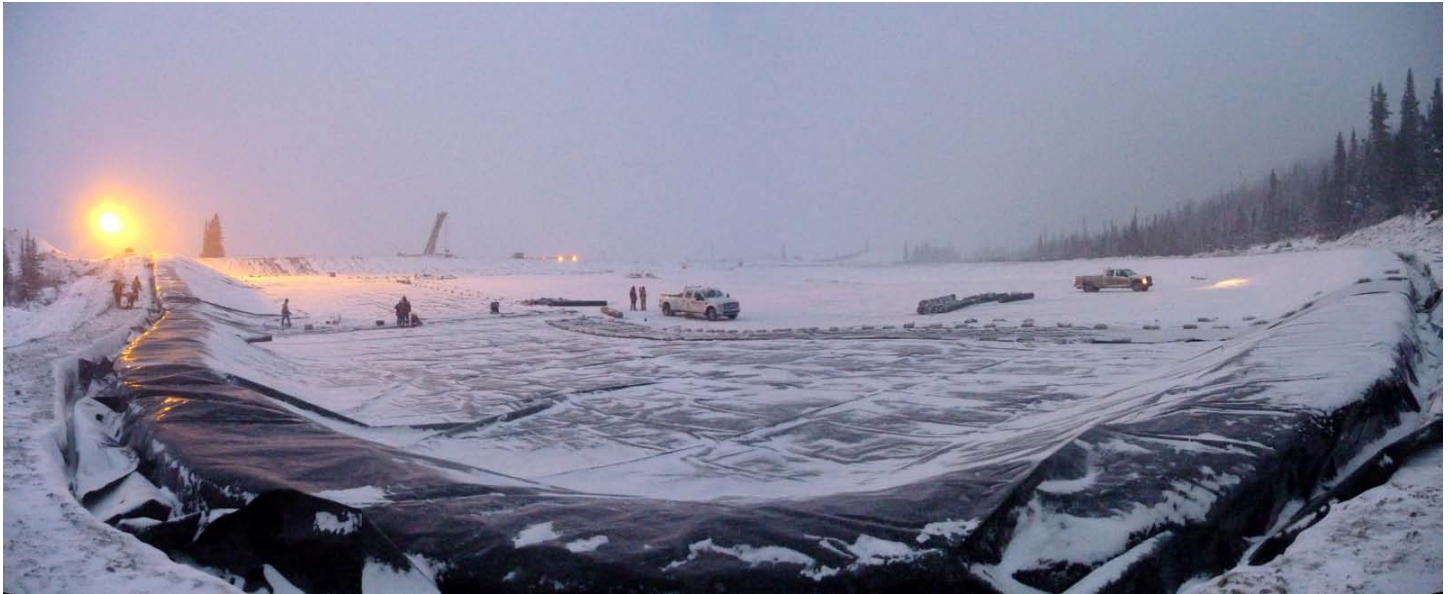
**Photo 7 (11/11/01):** Mid afternoon - looking west – 4<sup>th</sup> & 5<sup>th</sup> liner panels installed. The 2<sup>nd</sup> geomembrane cloth cover is yet to be placed over the main liner. Steady southeast winds and snow. Sand bags placed onto the liner.
