MPERG Report 2010-6

An evaluation of factors influencing spontaneous vegetation succession in northern latitude disturbances: Assessment of natural recolonization of disturbances in Yukon

AN EVALUATION OF FACTORS INFLUENCING SPONTANEOUS VEGETATION SUCCESSION IN NORTHERN LATITUDE DISTURBANCES: ASSESSMENT OF NATURAL RECOLONIZATION OF DISTURBANCES IN YUKON¹

Assessment of Natural Recolonization of Historic Decommissioned Borrow Pit and Highway Sections in Yukon

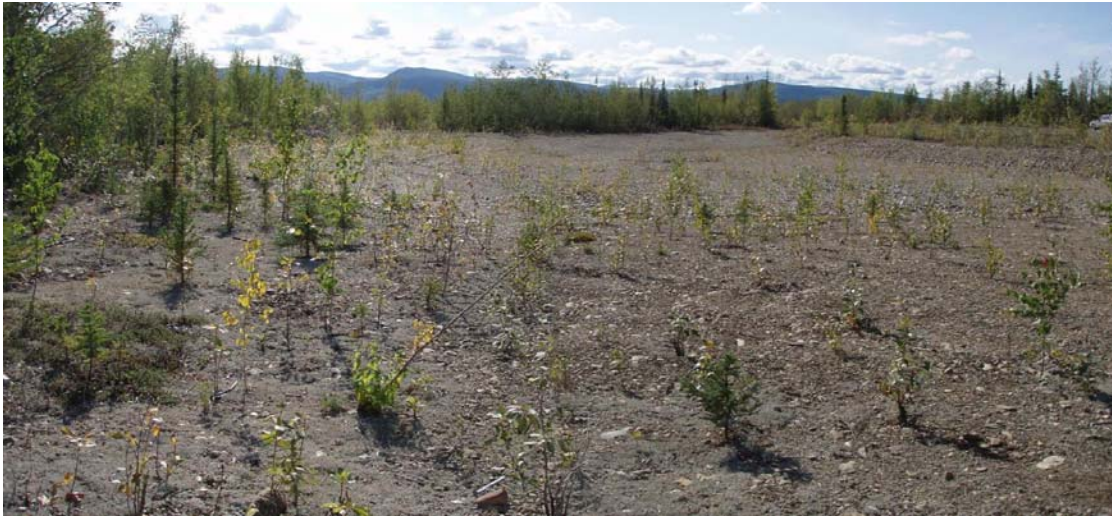
Figure 1. Sparse recolonization at site KV-07, an approximately 50-year old decommissioned borrow pit located in central Yukon. At the clearing centre, all growth is less than 2m high with less than 5 percent cover. The primary filter to natural recolonization at this site appears to be low moisture availability as influenced by: i) low precipitation (325mm annually), ii) a low proportion of silt to clay-sized particles (7 percent), iii) location at least 10m above local water table, and iv) pebble ‘armouring’ of the smooth surface.

The various aspects of moisture availability filters are best illustrated through examples from some of the sites. Figures 1 and 2 show two sites within 14 km of each other in the Klondike valley area of central Yukon. Although the disturbances differ in age by almost 40 years, the younger disturbance shows areas of abundant natural recolonization which appear to be largely due to slope aspect and a higher proportion of silt to clay-sized particles in the substrate.

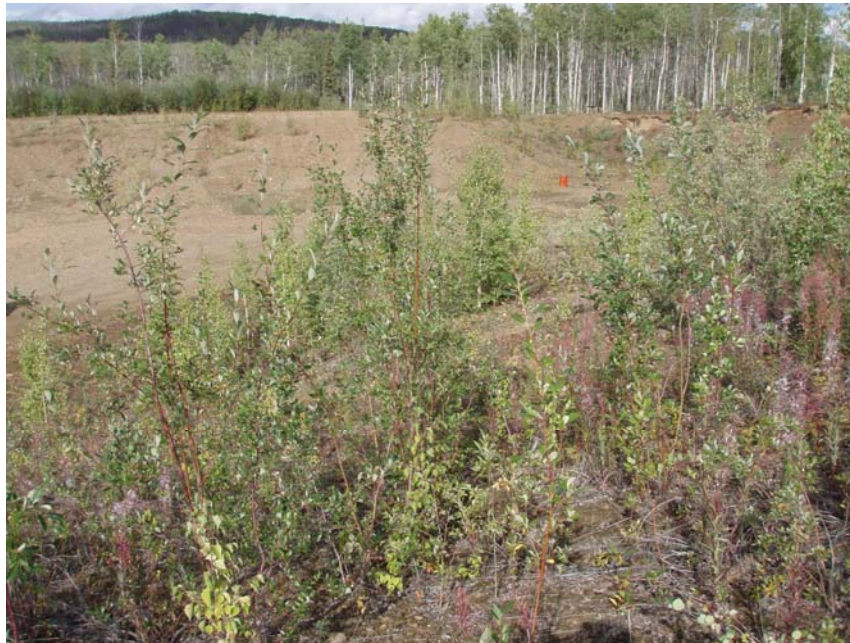
Figure 2. Abundant natural recolonization on a gentle north-facing slope at site KV-03, a decommissioned borrow pit (13 years previous) near the closed Brewery Creek Mine. This site is approximately 14 km from and 120m higher than site KV-07 shown in Figure 1, and has similar precipitation. However, the substrate at this site is relatively high in silt to clay-sized particles (estimated at greater than 20 percent), and the north-facing aspect serves to enhance moisture availability. On the other hand, the south-facing and flat sectors in the background show much lower natural colonization.

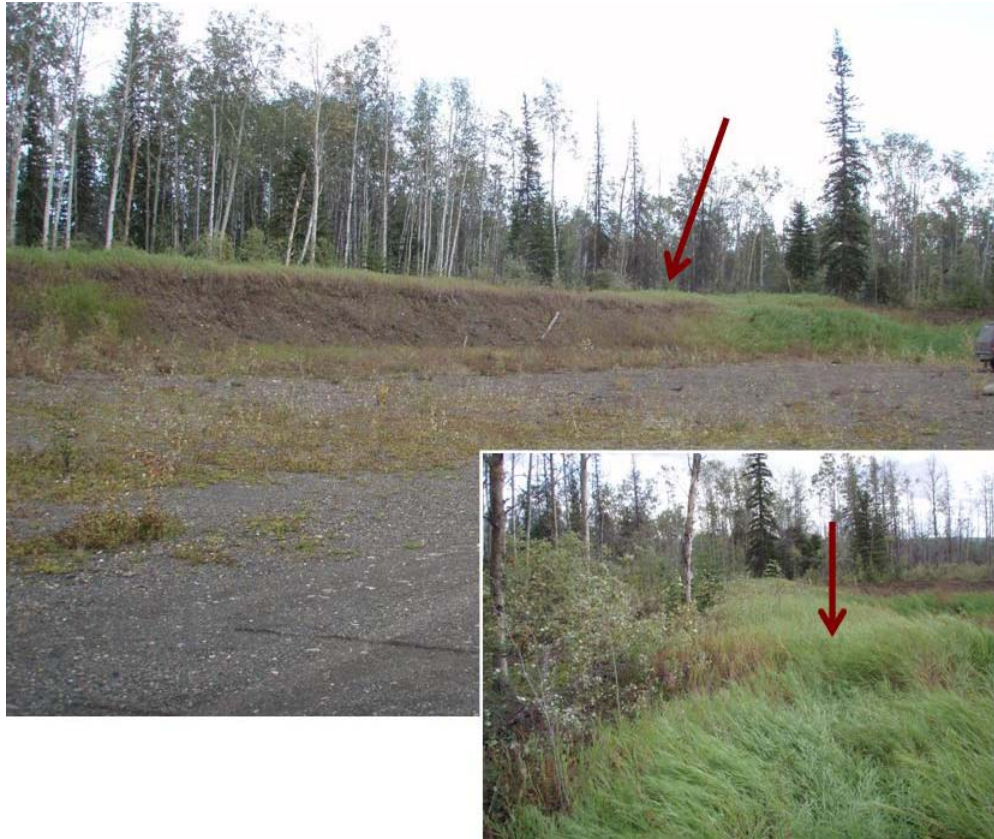
Figure 3. Site KV-04, central Yukon, seeded in 1998. Along the clearing edge (arrows in main and inset photos), a thick cover of seeded smooth brome (*Bromus inermis*) is impeding natural encroachment of the surrounding tree and shrub species.

On a qualitative level, it could be seen that at some seeded sites, certain of the initial seeded cover species were still the dominant species some 10 to 20 years following seeding, and in some cases, that the seeded species were impeding the expected natural colonization. This was particularly evident where brome species (*Bromus spp.*) were included in the original seed mix and where the original seed application had taken well. One example is shown in Figure 3, a small borrow pit seeded in 1998. At this location smooth brome (*Bromus inermis*) became well-established along the clearing edge, a location where typically one would see the most rapid recolonization by local deciduous trees and shrubs. As a result, a thick grass fringe with very sparse colonization by trembling aspen and willow (*Populus tremuloides* and *Salix spp.*) has instead developed. Some sites with a heavy seeded cover also showed a heavy thatch development of dead material. While this thatch appeared to impede colonization of native forbs as well as shrubs and trees, it did serve to foster development of certain moss and lichen species in the moist environment at the underlying soil level.

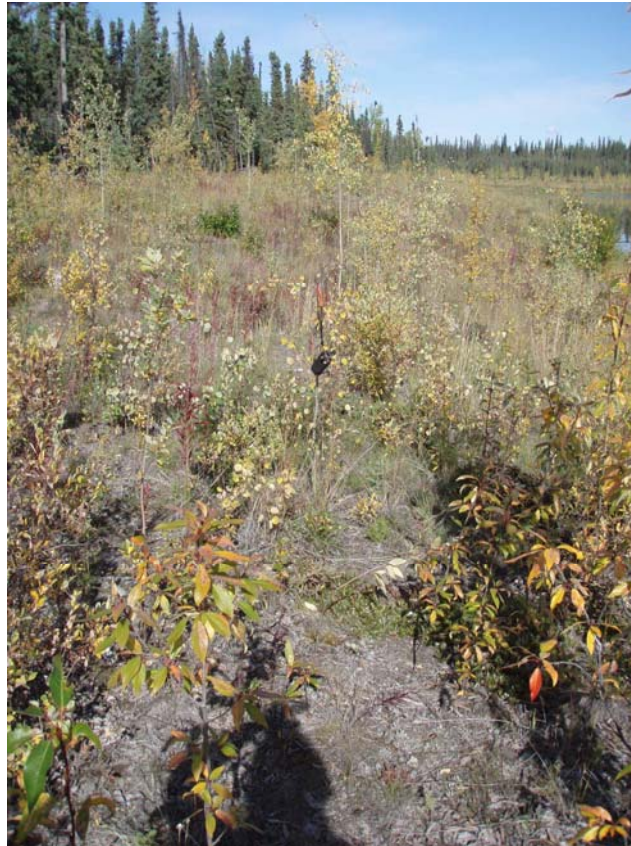
Figure 4. Site KL 02 in the Beaver Creek region of central-west Yukon, with integration of both seeded cover and spontaneous revegetation growth. This site receives just over 400mm of precipitation annually, approximately 25 percent greater than many sites in central and south-central Yukon.

Some seeded sites show good balance between seeded and naturally colonizing species, such as is observed at site KL-02 in the Beaver Creek region of central-west Yukon (Figure 4). This site was decommissioned and seeded in the late 1990's, and has formed a moderate to sparse cover of grass and legumes (no brome species evident) that does not appear to impede the colonization of native species.

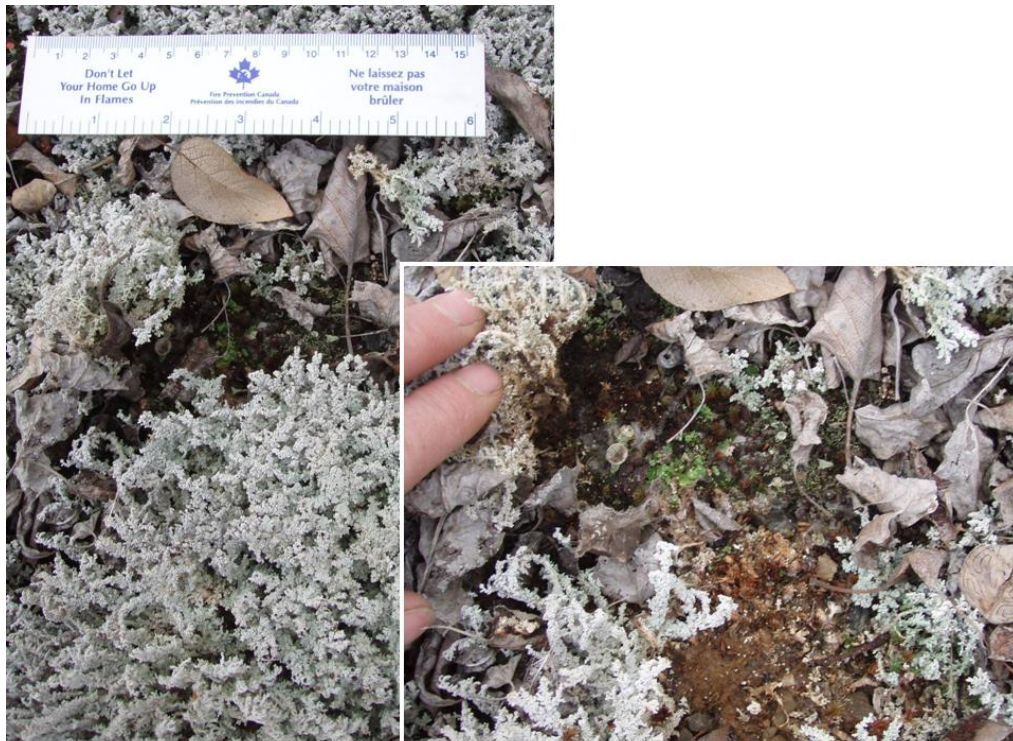
Figure 5. *Stereocaulon* sp. lichen colonization (left) and underlying moss and lichen community (right) at site KV-06, central Yukon.

The *Stereocaulon* species was observed at several sites (KV-06, KV-07, KV-08, other undocumented sites along the North Klondike Highway, and at HR-01 on the Haines Highway). Closer examination of one of these zones at site KV-06 is shown in Figure 5 and reveals the development of a diverse moss and lichen community under the cover of the *Stereocaulon* lichen.

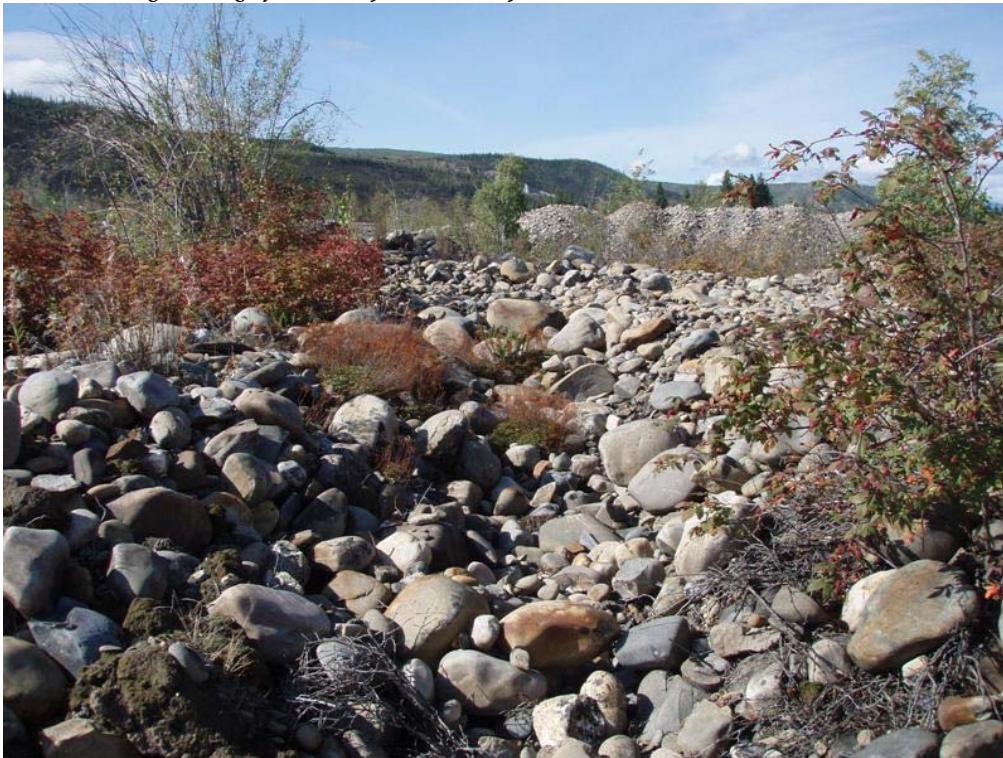
Figure 3-1 Dredge tailings pile, 80+ years' recovery

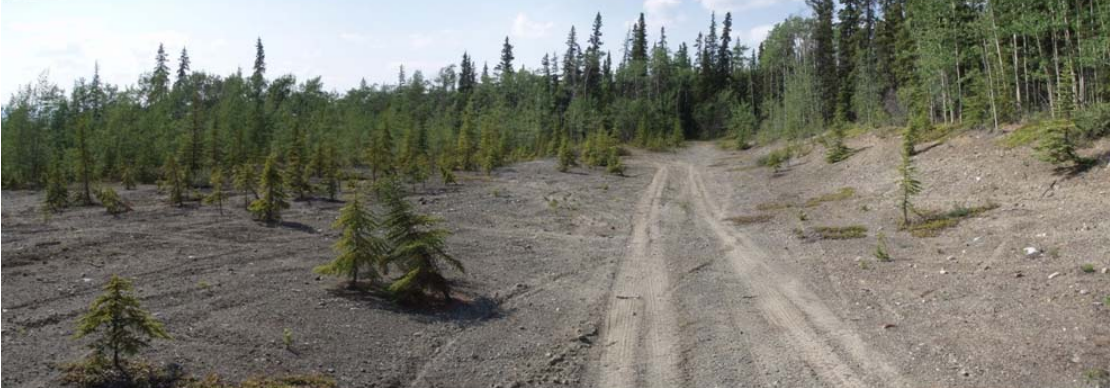
Figure 3-2 Site SL-01, Southern Lakes region approximately 25-35 years' recovery

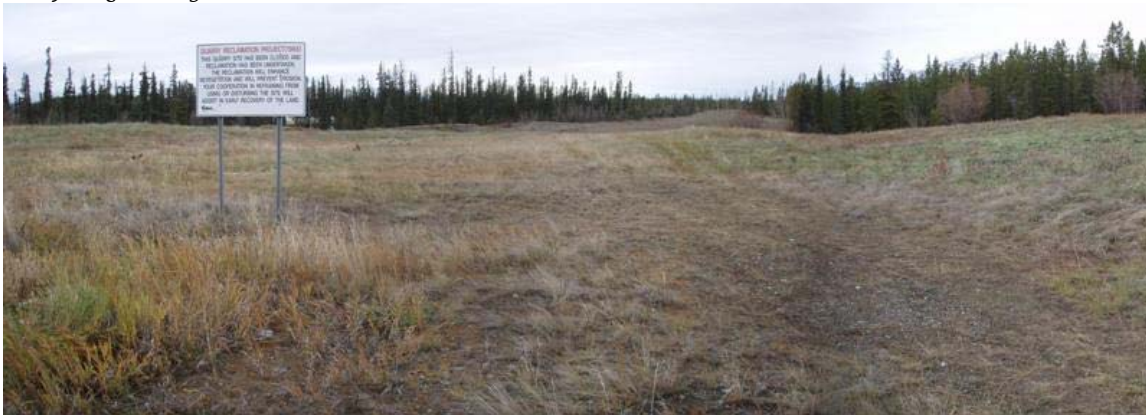
Figure 3-3 Site SL-04, recovering for 20+ years, showing extensive seeded grass and legume cover but virtually no growth of trees.

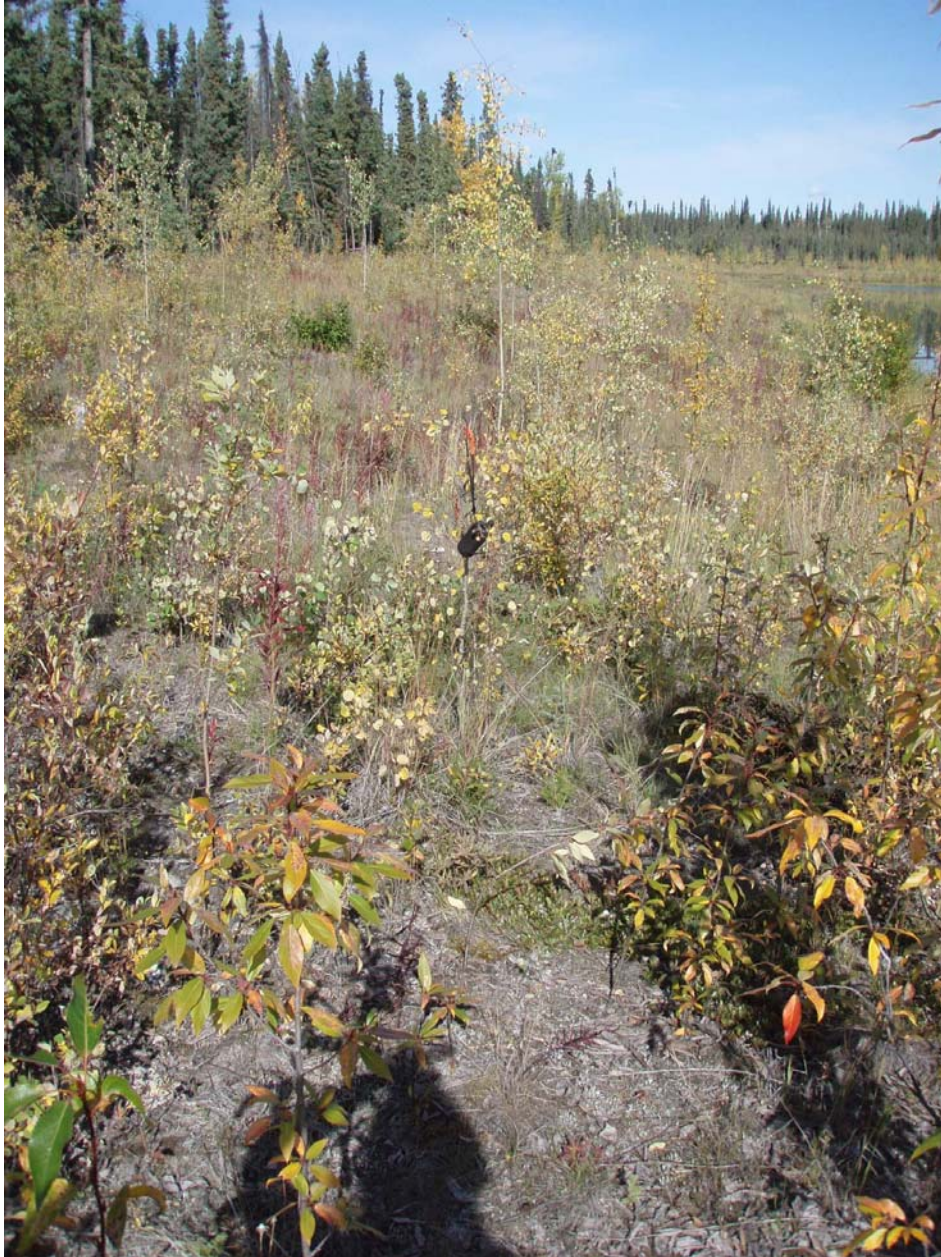
Figure 3-4 Site KL-03, recovering for less than 10 years, showing extensive recolonization. See also Figure 3-11, section 3.4.

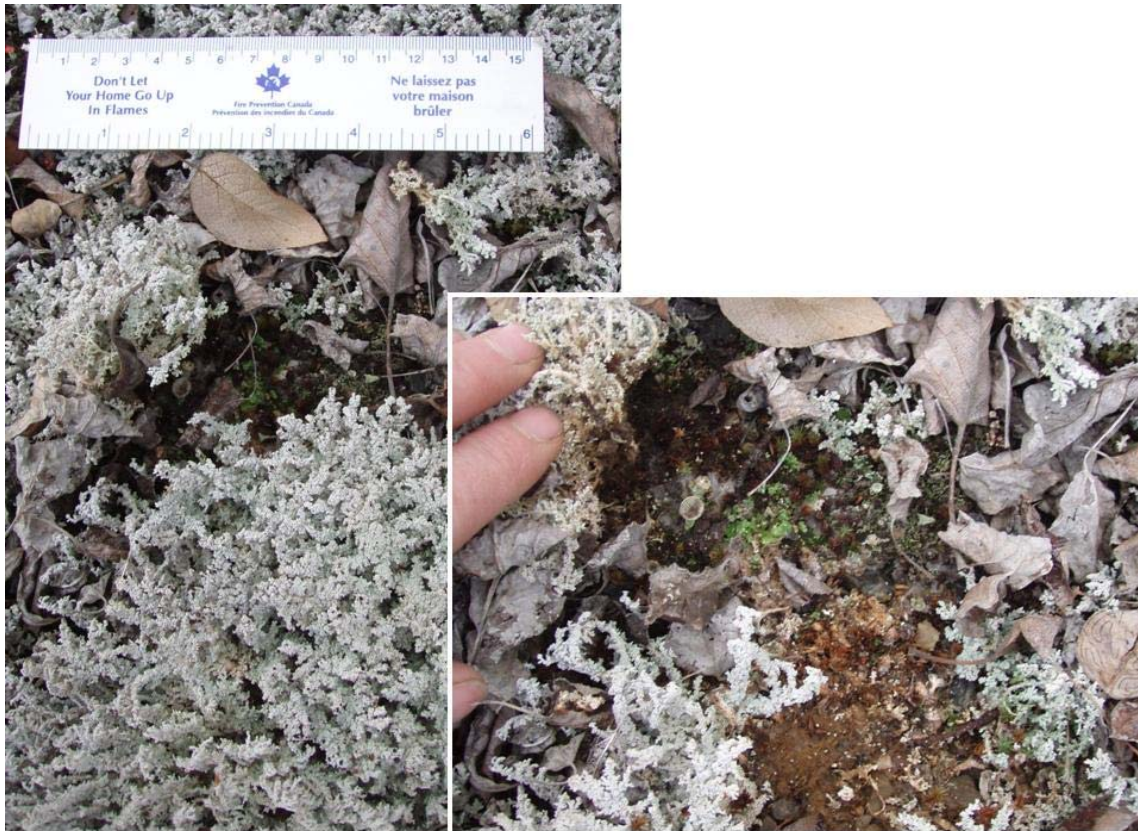
Figure 3-6 *Stereocaulon* sp. lichen colonization (left) and underlying moss and lichen community (right) at site KV-06, central Yukon.

The *Stereocaulon* species was observed at several sites (KV-06, KV-07, KV-08, other un-documented sites along the North Klondike Highway, and at HR-01 on the Haines Highway). Closer examination of one of these zones at site KV-06 is shown in Figure 3-6 and reveals the development of a diverse moss and lichen community under the cover of the *Stereocaulon* lichen. The occurrence of *Stereocaulon* as a

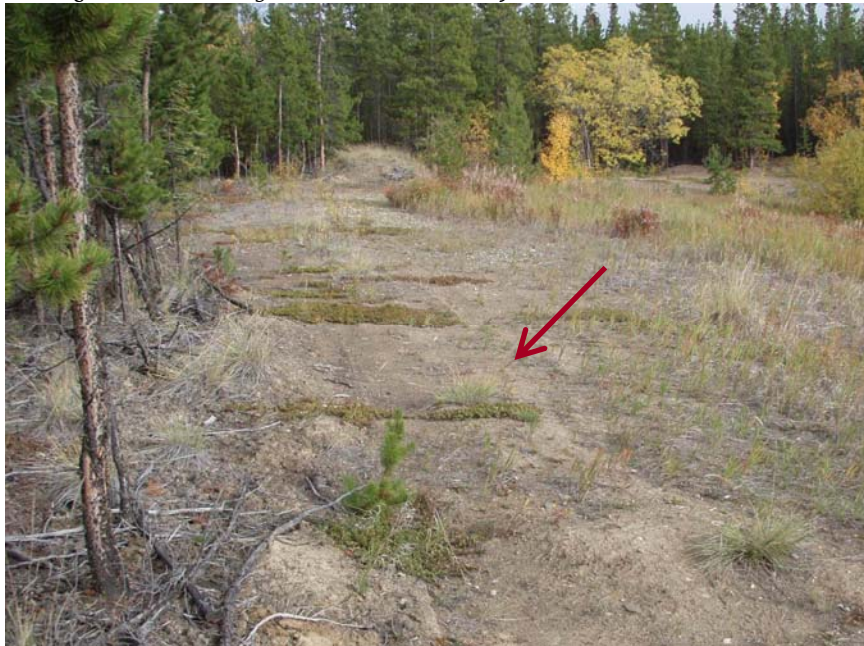
Figure 3-7 *Edge encroachment of kinnikinnick (shown by red arrow) at site SL-02 near Whitehorse.*

Certain regional tendencies are suggested in the data as well: in the Klondike River basin region, adjacent stands of trembling aspen, black spruce, Alaska paper birch and willow are suggested as likely seed sources for disturbance colonization of these species. In the Southern Lakes and Kluane areas, white spruce colonization is similarly linked to occurrences of this species in adjacent stands. The data indicates that kinnikinnick also colonizes from adjacent undisturbed sources, and field observations indicate that encroachment from the disturbance edges, rather than seed dispersal, is the primary colonization route for this species (Figure 3-7).

Of note is that kinnikinnick is also highlighted above in Table 3-3 as a key species that potentially colonizes from adjacent natural vegetation. Due to the 'encroachment' style colonization of this species, possibly this split in data indicates that we are seeing an opportunistic-based tendency of the species to, over time, creep into the disturbance under the right conditions (for example, where natural kinnikinnick vegetation is directly exposed along the disturbance edge, as shown in Figure 3-7.

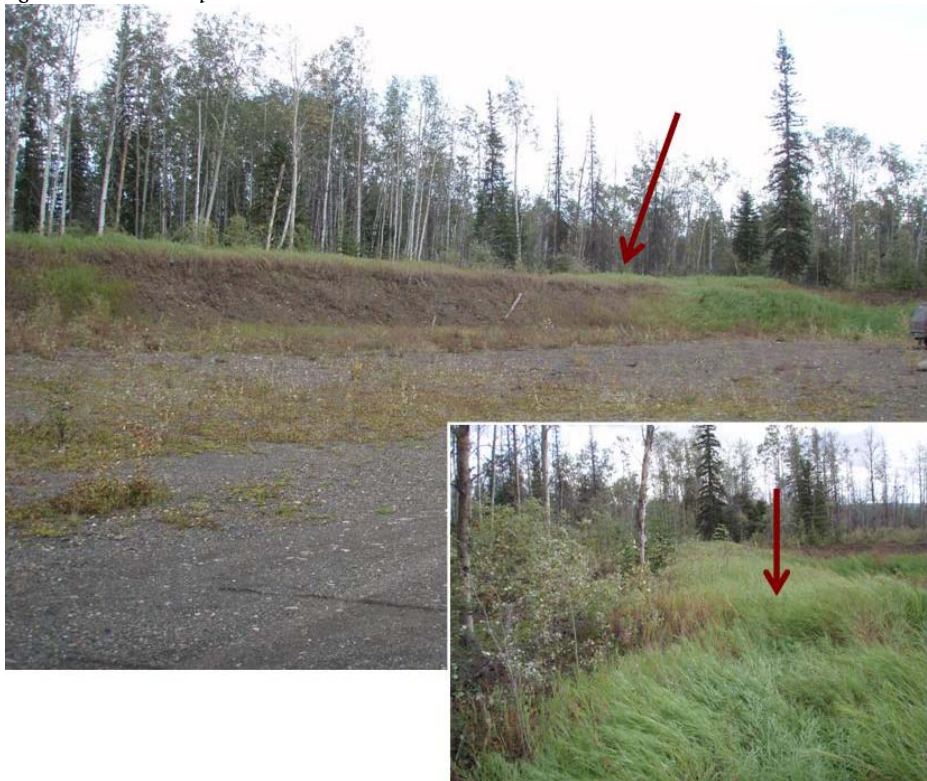
Figure 3-8 Site KV-04, Klondike River basin region, seeded in 1998. Along the clearing edge (arrows in main and inset photos), a thick cover of seeded smooth brome (*Bromus inermis*) is impeding natural encroachment of the surrounding tree and shrub species.

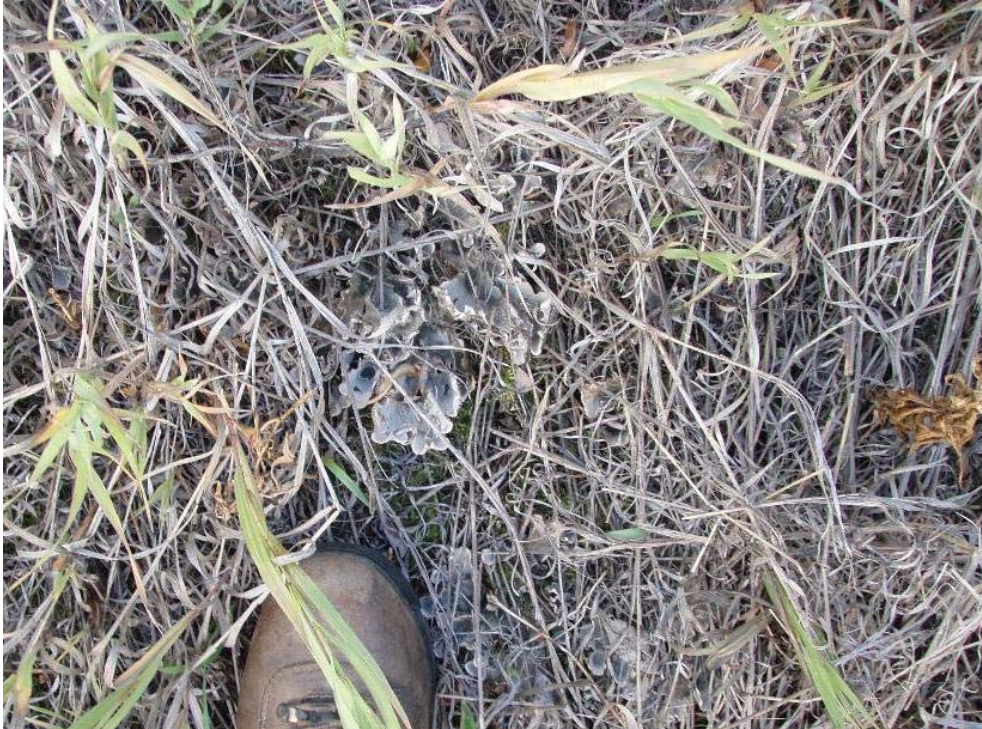
Figure 3-9 Site SL-02, agronomic cover seeded in 1988 showing substantial thatch of dead grass, as well as moss/lichen/liverwort colonization.

Some sites with a heavy seeded cover also showed a heavy thatch development of dead material. While this thatch appeared to impede colonization of native forbs as well as shrubs and trees, it did serve to foster development of certain moss and lichen species in the moist environment at the underlying soil level, and in some cases, development of organic-rich soil (Figures 3-9 and 3-10).

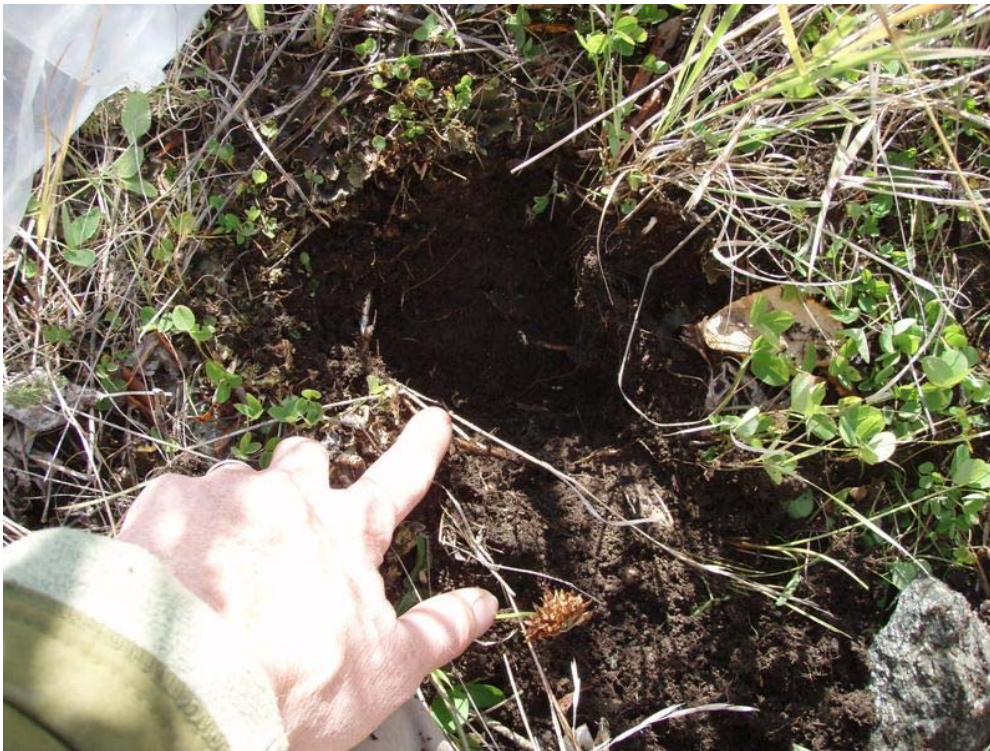
Figure 3-10 Site KL-02, seeded approximately 1997, showing soil development below the clover-dominated cover.

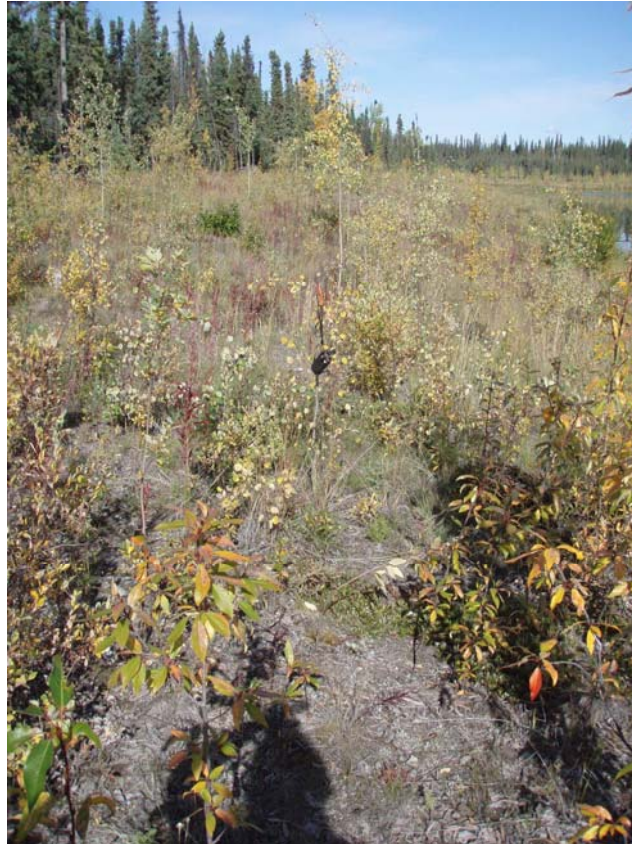
Figure 3-11 Site KL 03 in the Beaver Creek region of central-west Yukon, with integration of both seeded cover and spontaneous revegetation growth. This site receives just over 400mm of precipitation annually, approximately 25 percent greater than many sites in central and south-central Yukon.

Some seeded sites show good balance between seeded and naturally colonizing species, such as is observed at site KL 02 in the Beaver Creek region of central-west Yukon (Figure 3-11). This site was decommissioned and seeded in the late 1990's, and has formed a moderate to sparse cover of grass and legumes (no brome species evident) that does not appear to impede the colonization of native species.

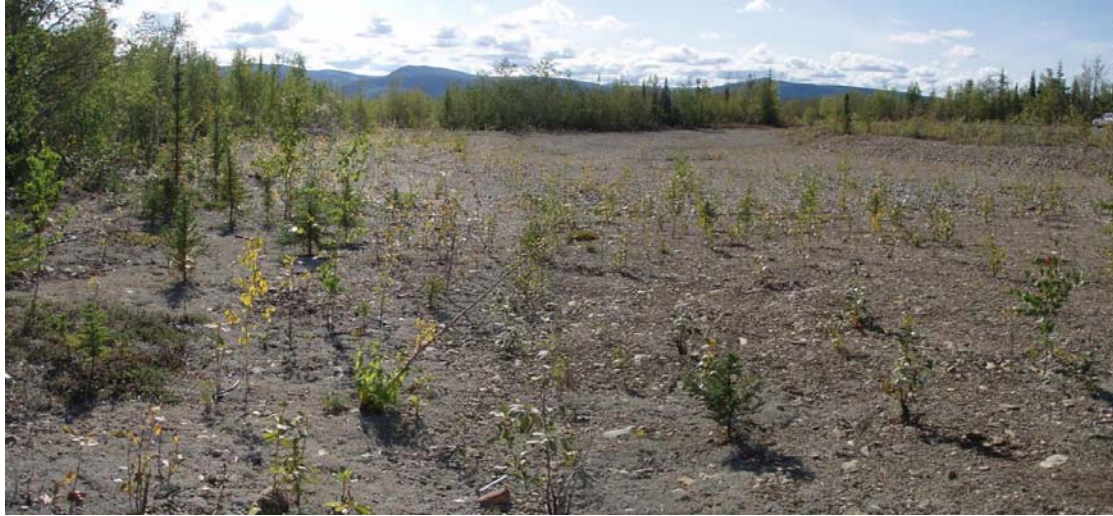
Figure 3-13 Sparse recolonization at site KV-07, an approximately 50-year old decommissioned borrow pit located in central Yukon. At the clearing centre, all growth is less than 2m high with less than 5 percent cover. The primary filter to natural recolonization at this site appears to be low moisture availability as influenced by: i) low precipitation (325mm annually), ii) a low proportion of silt to clay-sized particles (7 percent), iii) location at least 10m above local water table, and iv) pebble 'armouring' of the smooth surface.

On completion of the field surveys, there was the general sense that most sites that showed exceedingly slow rates of colonization were confronted with at least two potentially negative filters. In particular, sites with filters affecting plant moisture availability seemed to be progressing the slowest, and in some cases stagnating. While the most direct controls of plant-available moisture are precipitation and proximity of water table, other factors such as substrate texture, lack of micro-sites, and aspect appear to clearly influence the rate and success of natural recolonization. Although there are too few sites in this study to effectively demonstrate through graphical or statistical methods, this point can be illustrated by comparison of two sites within 14km of each other, KV-03 and KV-07. As shown in Figures 3-13 and 3-14, although the disturbances differ in age by almost 40 years, the younger disturbance shows areas of abundant natural recolonization which appear to be largely due to slope aspect and a higher proportion of silt to clay-sized particles in the substrate.

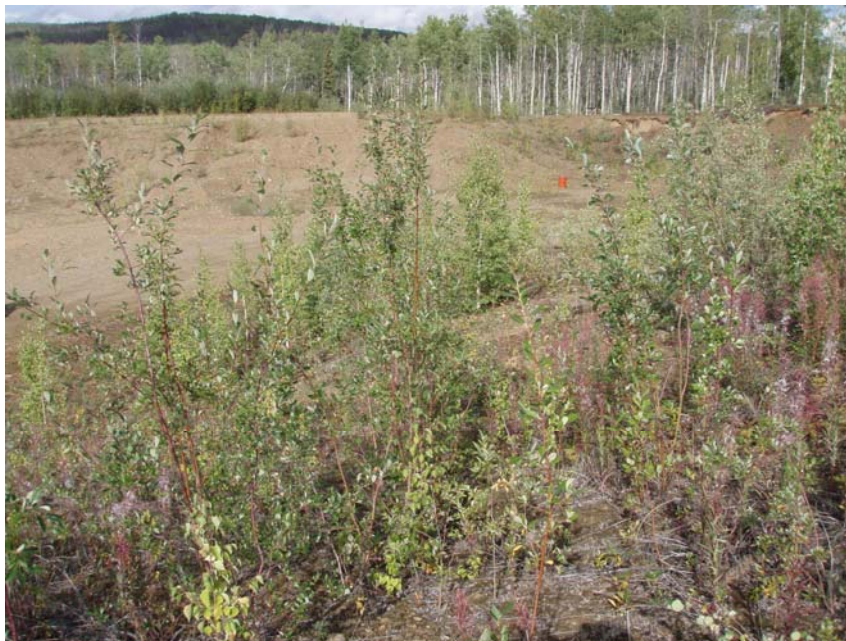
Figure 3-14 Abundant natural recolonization on a gentle north-facing slope at site KV-03, a decommissioned borrow pit (13 years previous) near the closed Brewery Creek Mine. This site is approximately 14 km from and 120m higher than site KV-07 shown in Figure 1, and has similar precipitation. However, the substrate at this site is relatively high in silt to clay-sized particles (estimated at greater than 20 percent), and the north-facing aspect serves to enhance moisture availability. On the other hand, the south-facing and flat sectors in the background show much lower natural colonization.
