**YEIP
2007
-042**

**Report of 2007 Field Activities
Funded under YMIP Grant #07-042**

NAME OF PROJECTS AREAS

**ALAN DENDYS
PROSPECTOR / PLACER MINER
BOX 31450
WHITEHORSE, YUKON
Y1A 3T5**

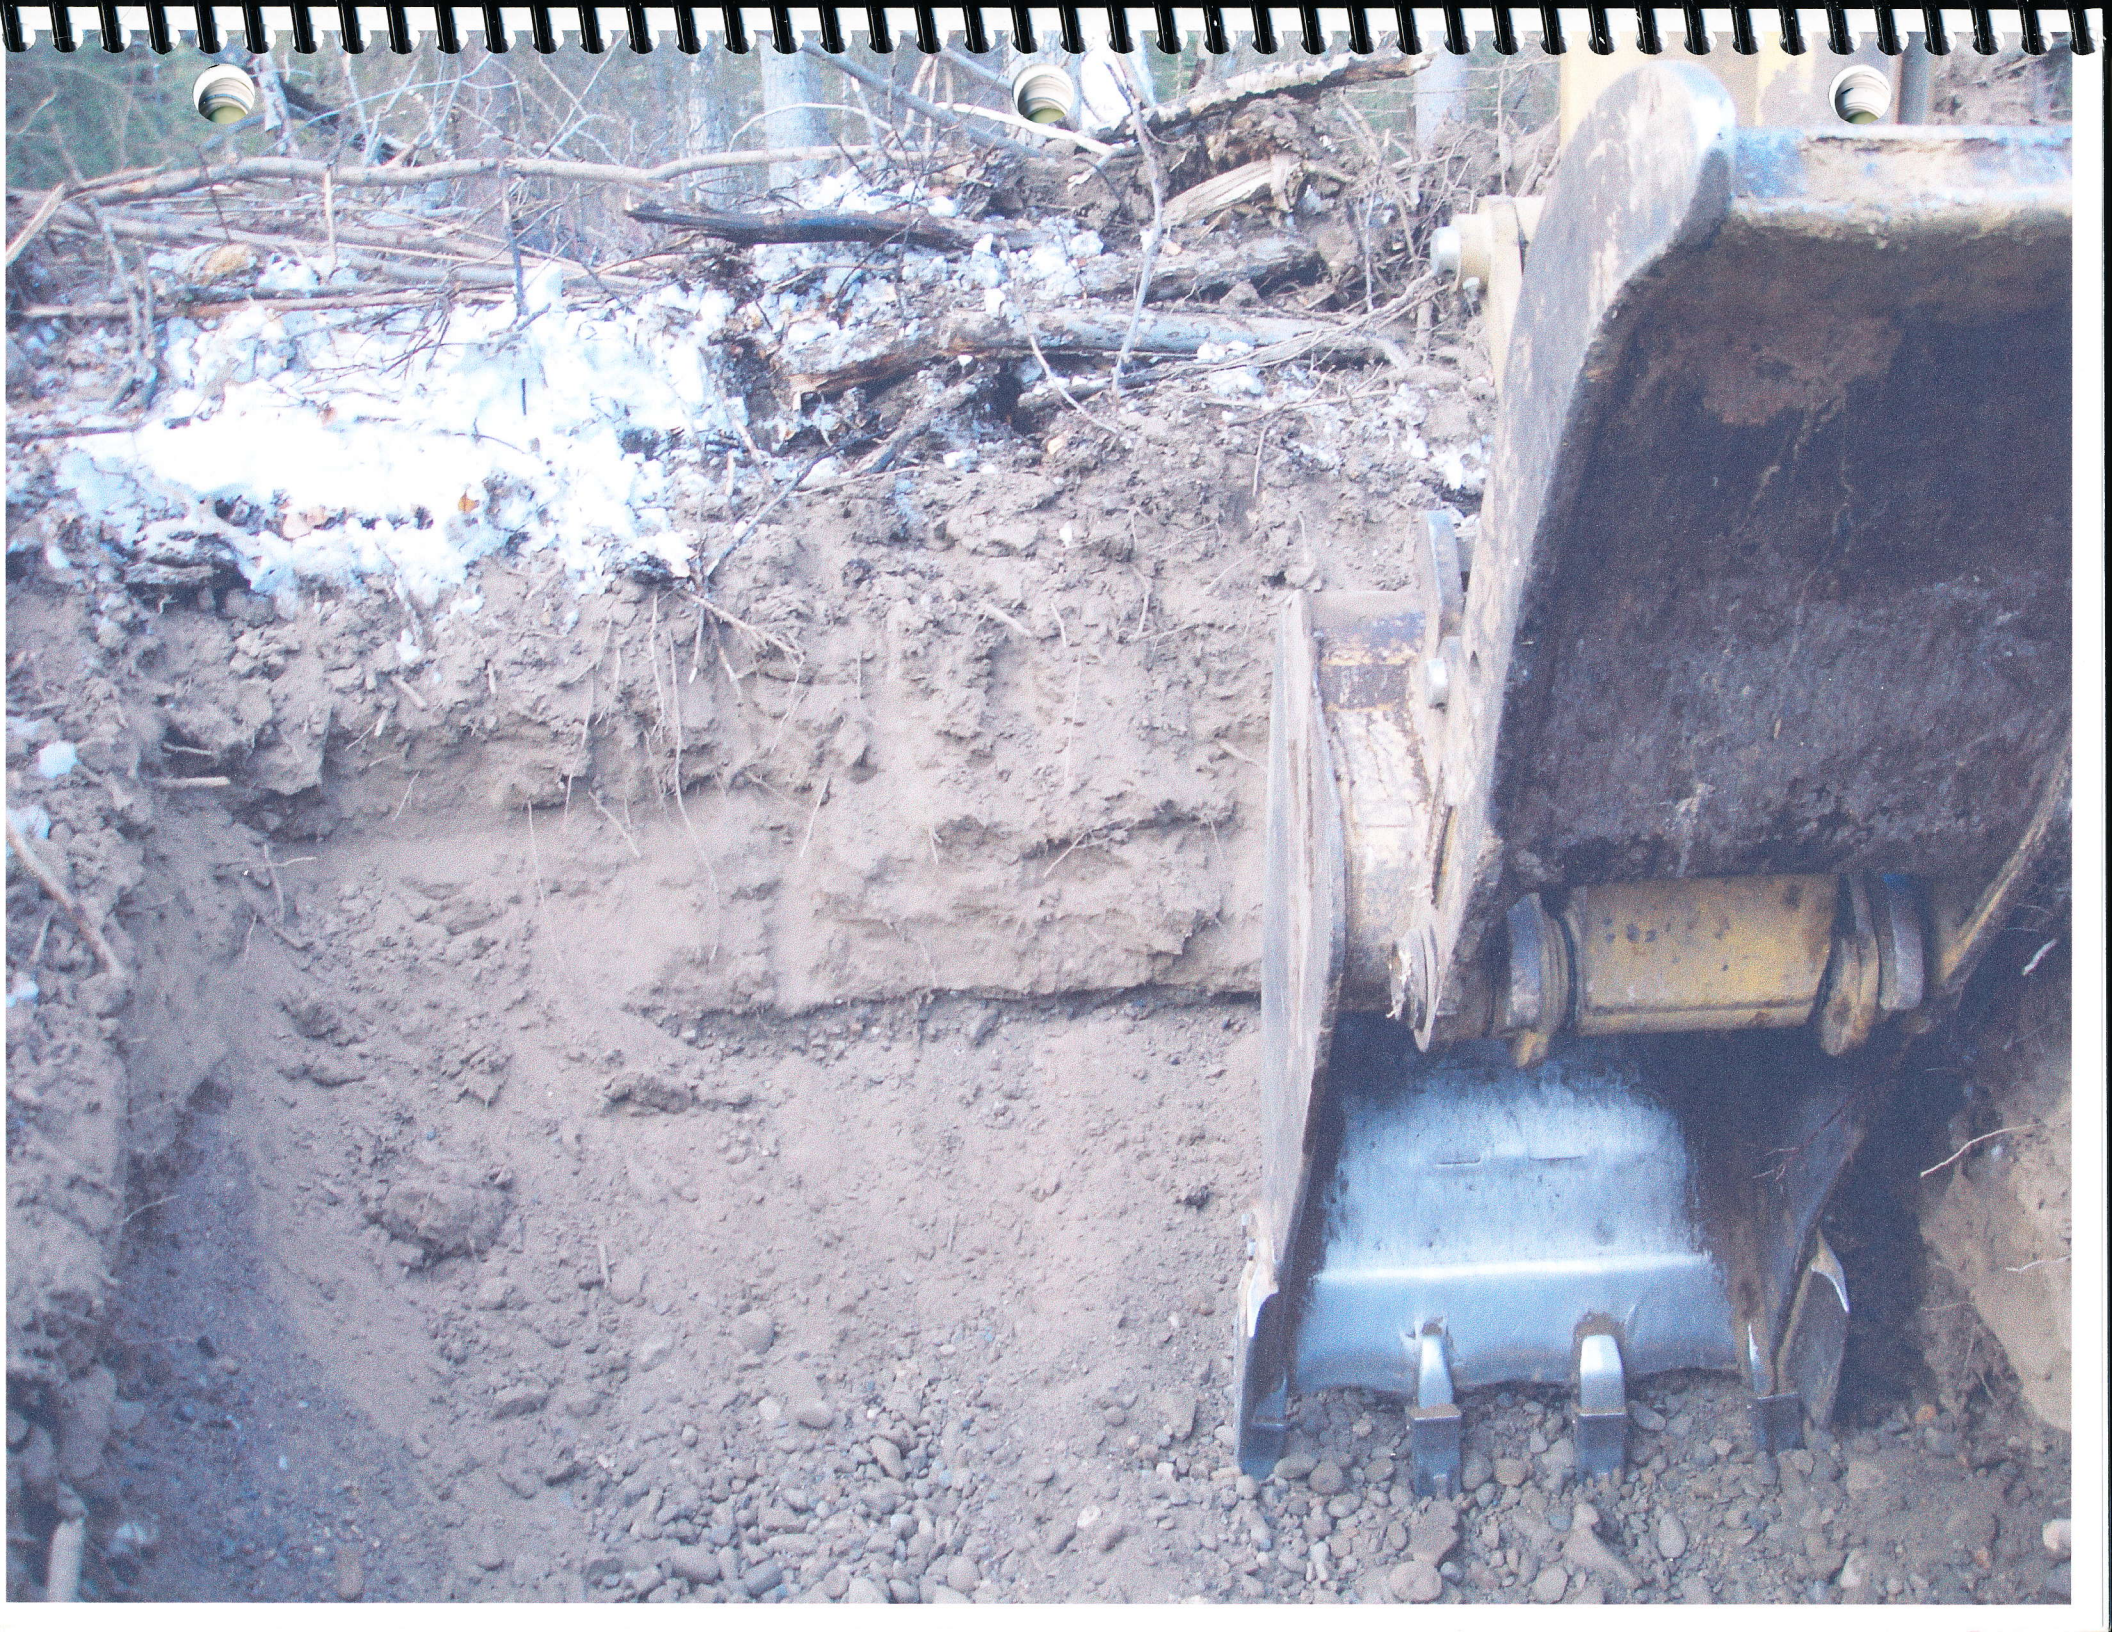
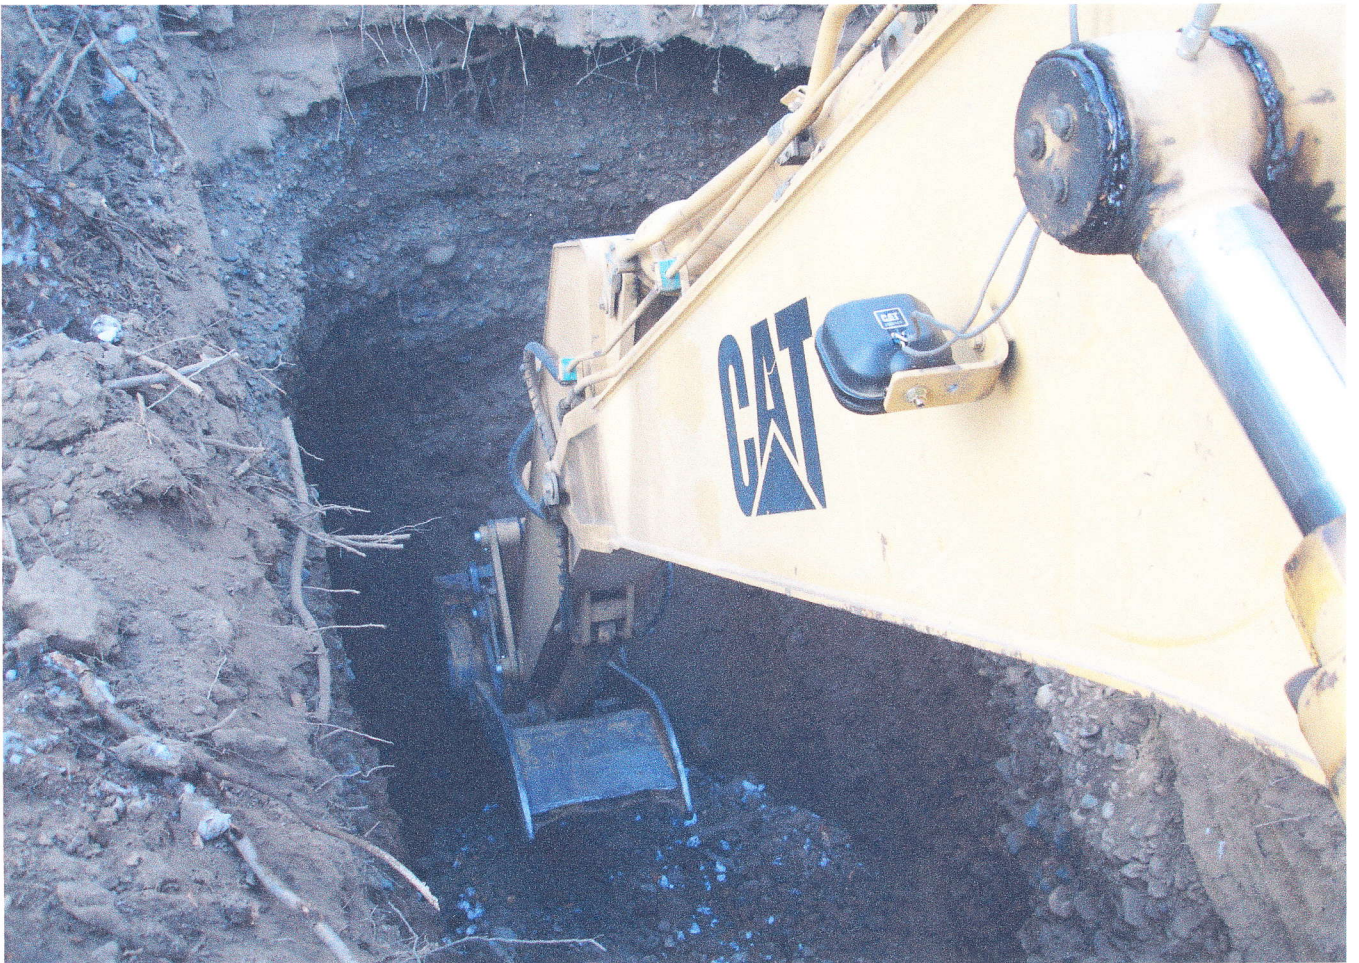
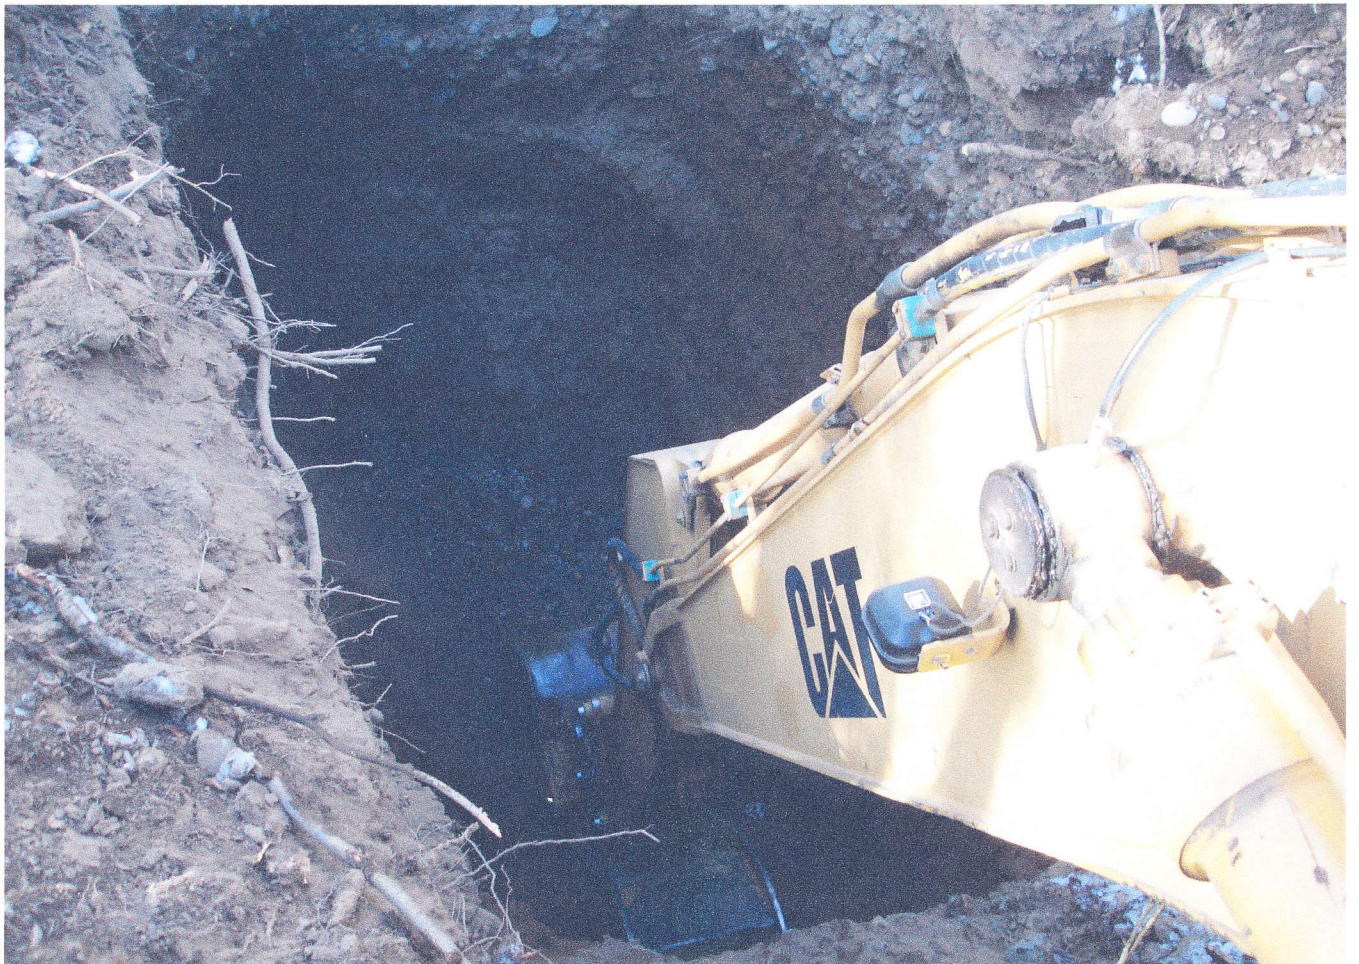
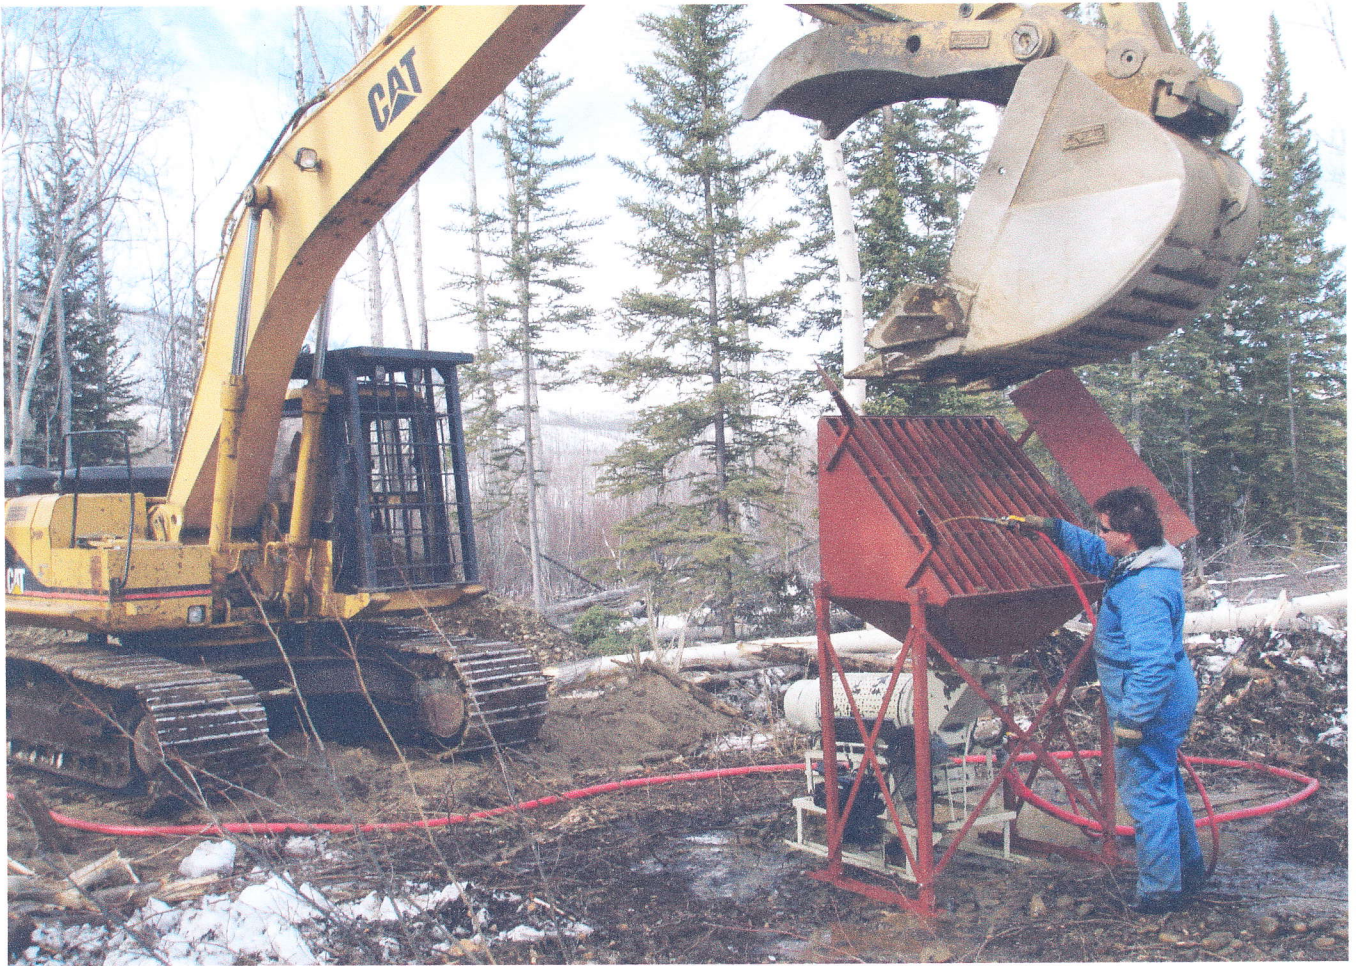
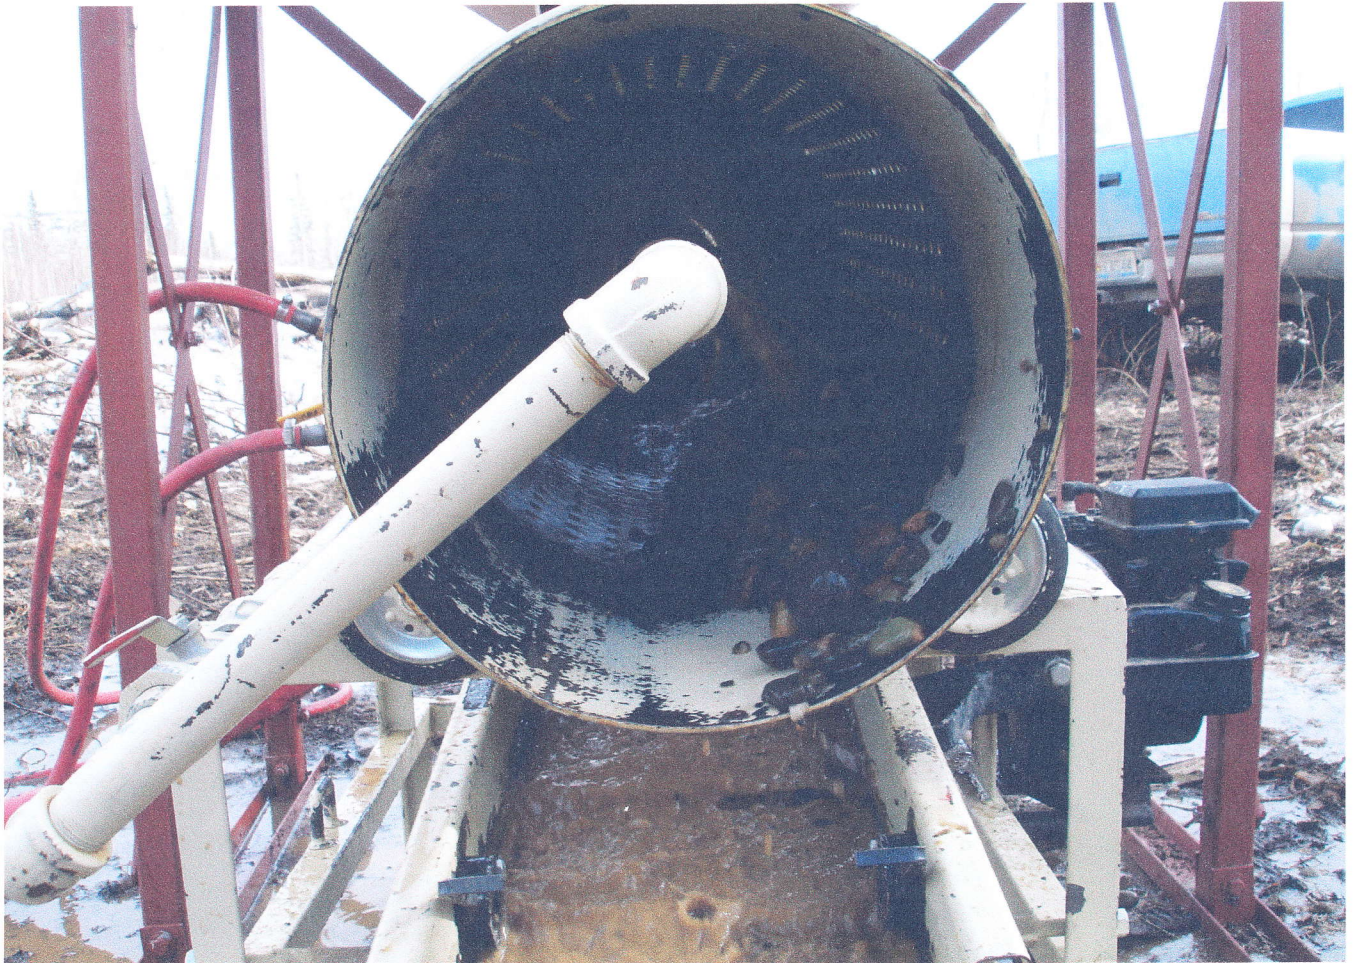
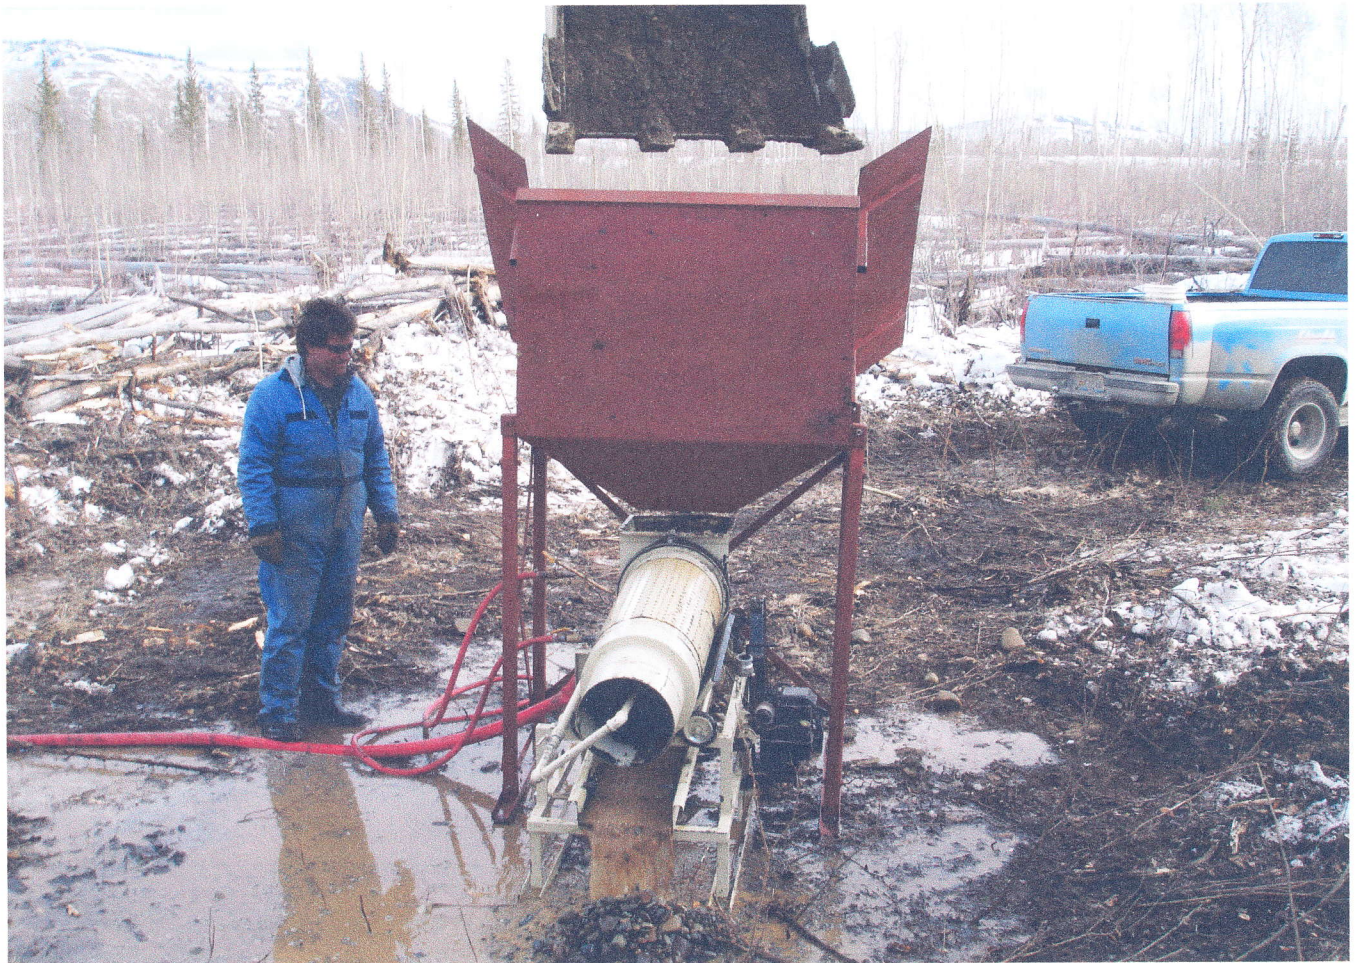
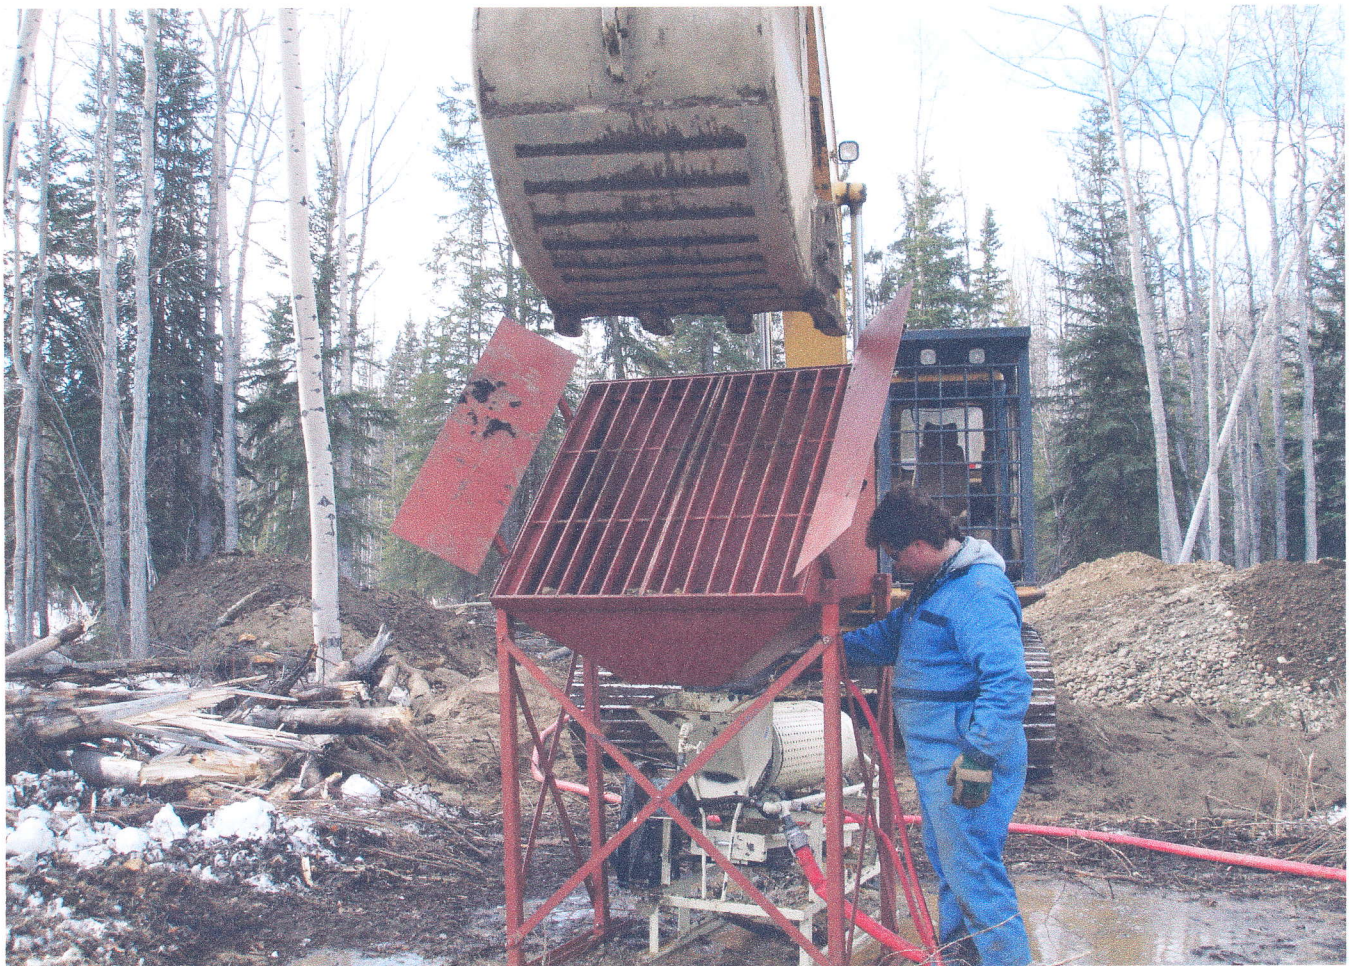
Test Site Located at

1 yard test

Material Screened to $\frac{1}{4}$ inch minus

Area 1 in the vicinity of Big Creek three holes were excavated to depths of 25 ft and no bedrock was encountered. Only one hole had water seepage. All holes had gravel in which we could pan 1 to 2 colours per pan. A one yard bulk sample was processed from from the test pit that had water. .1 gram of gold was recovered. See pictures for material type.

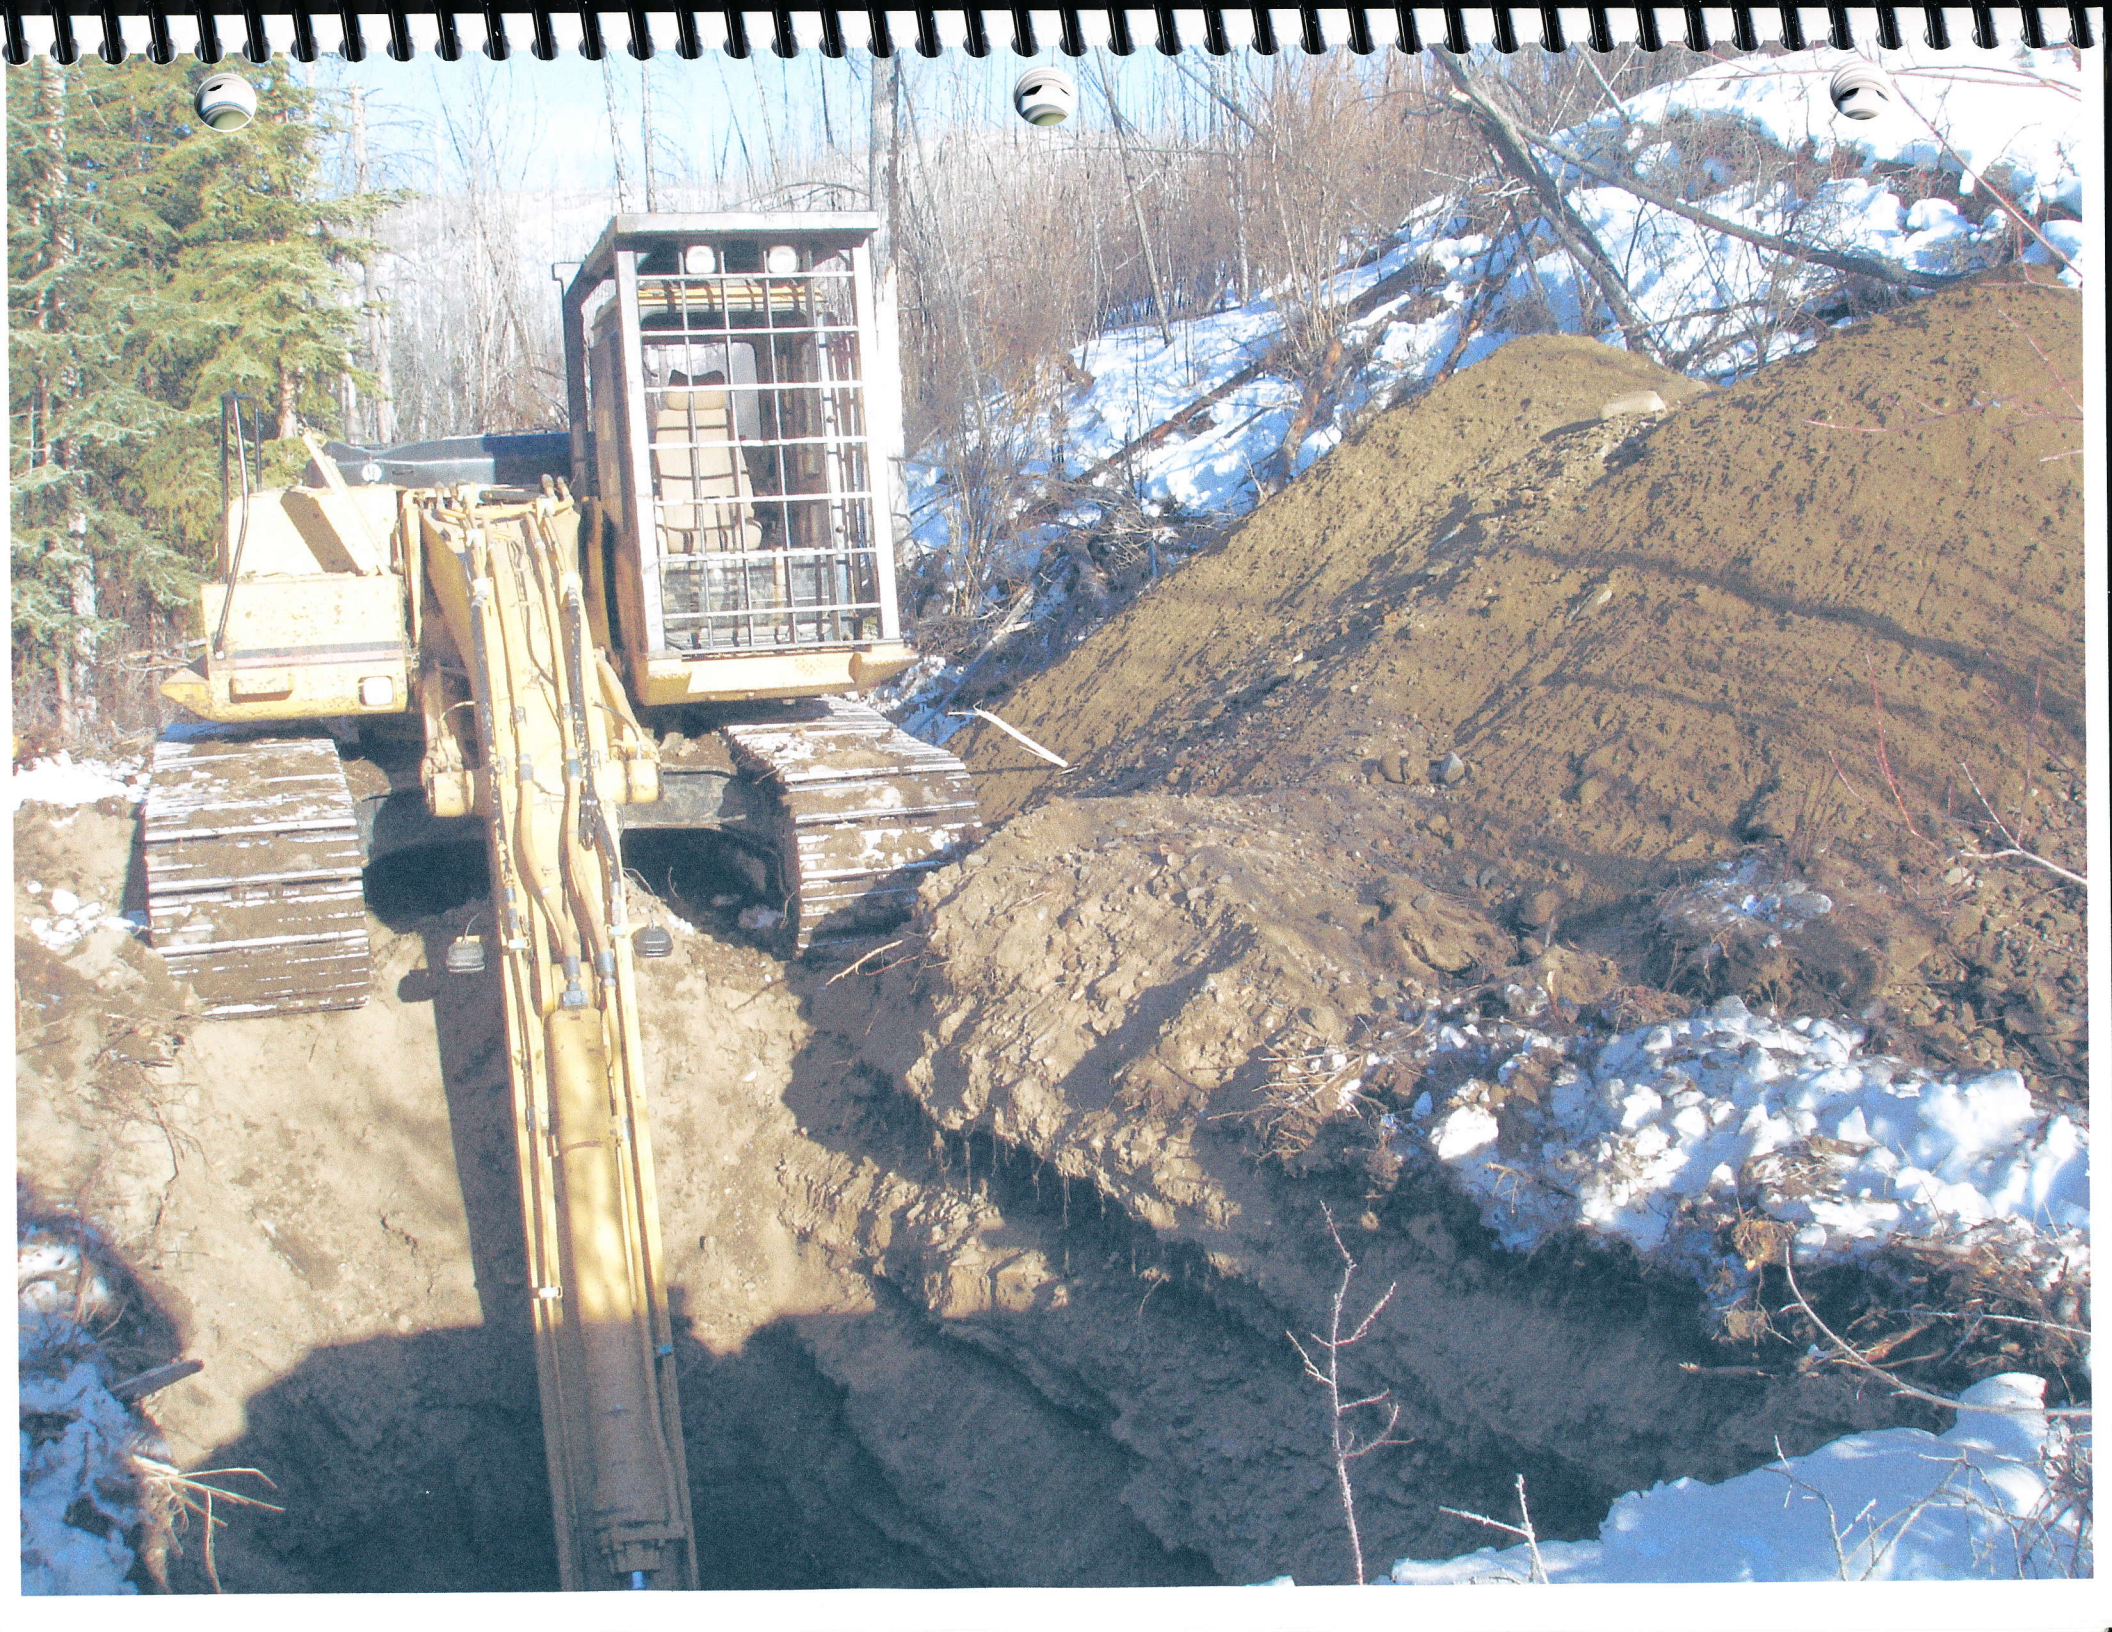
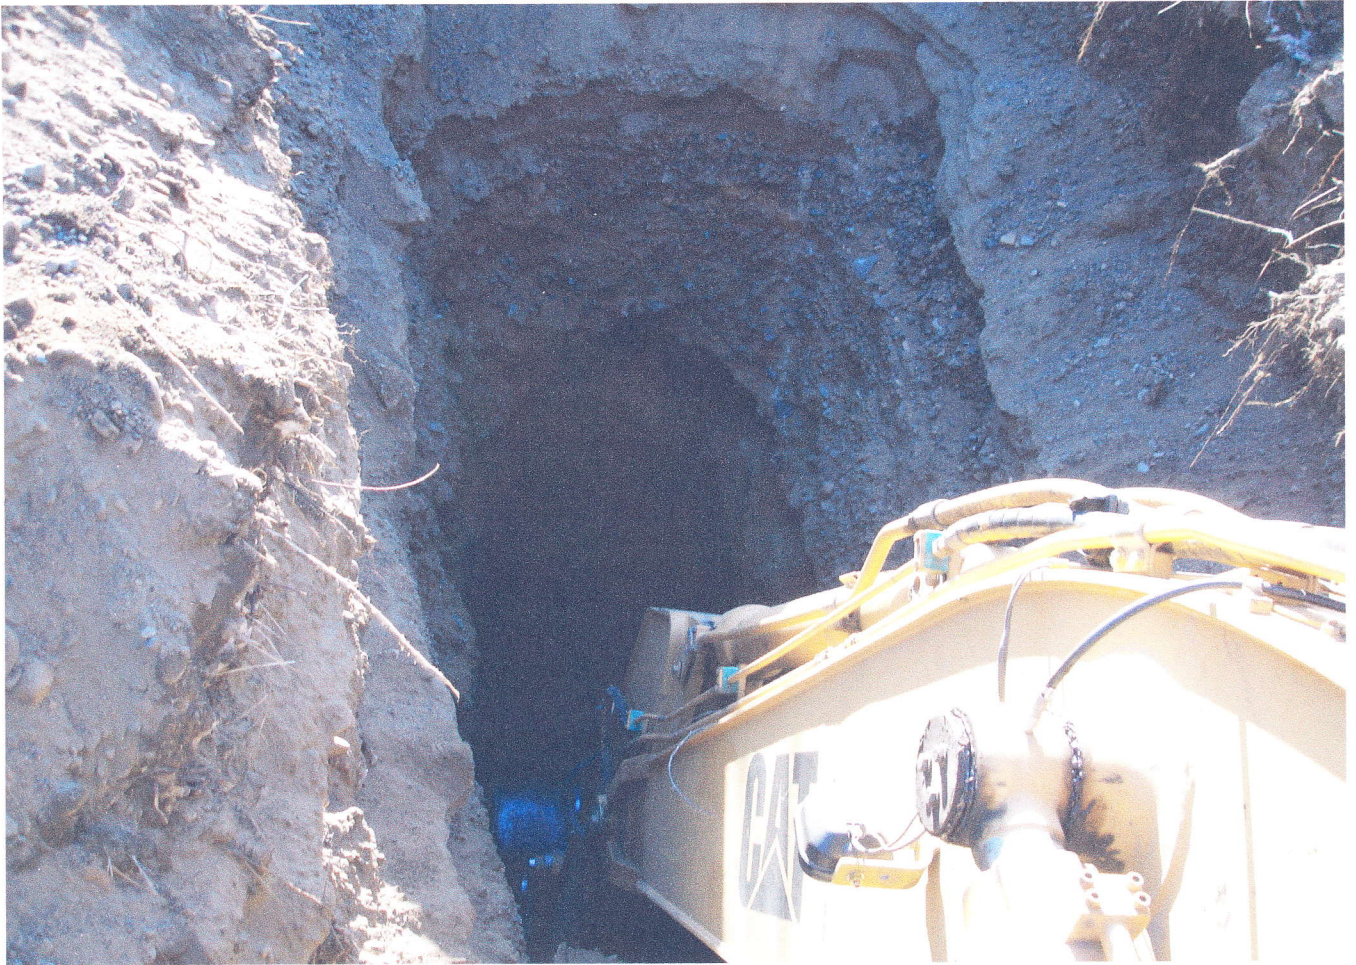
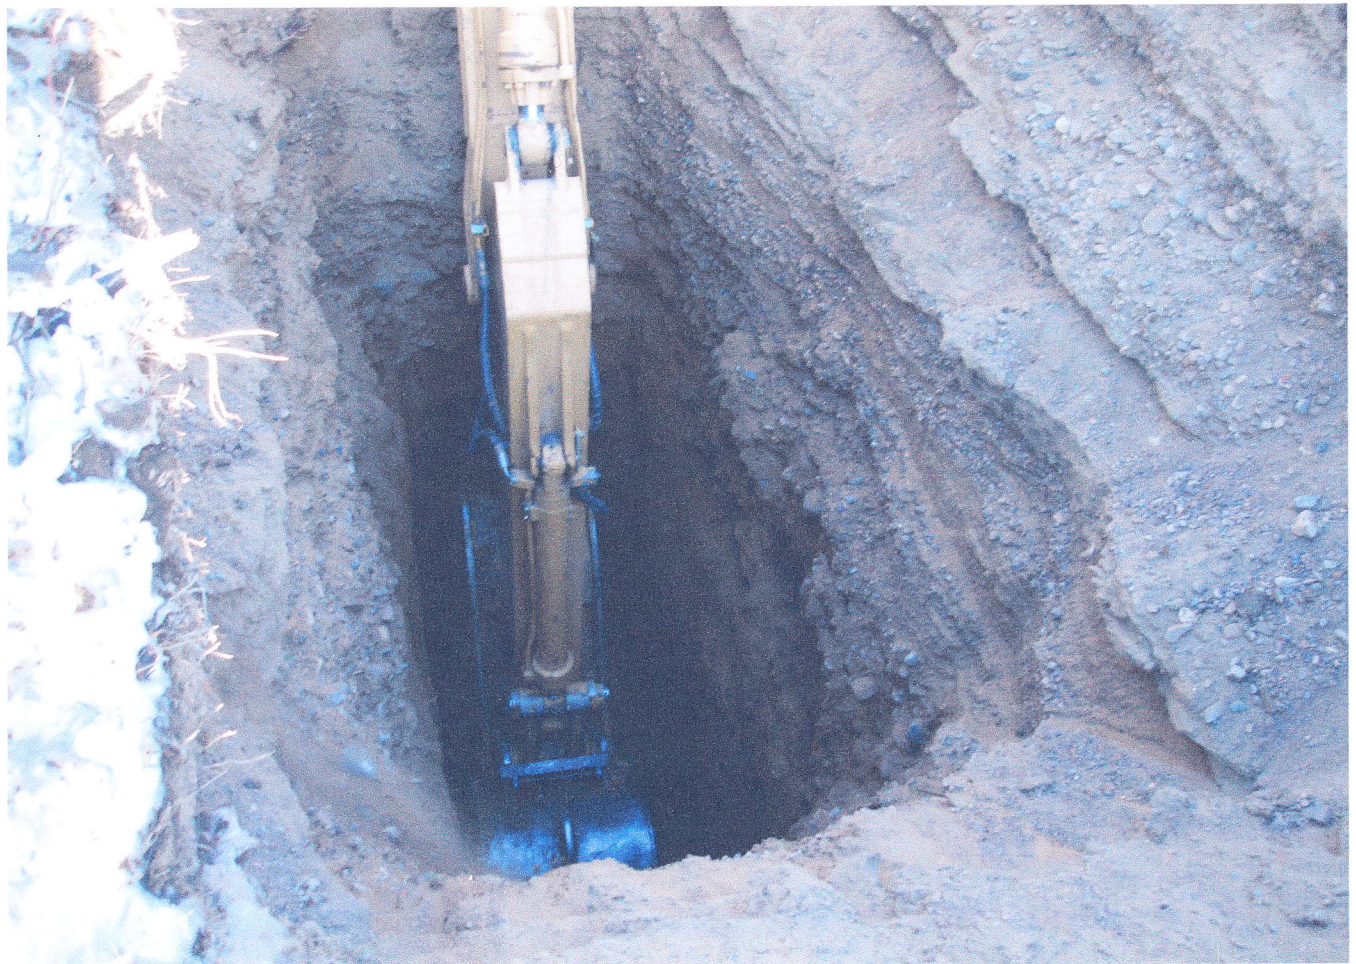
Test Site Located

25 feet No water
1 to 2 fines to a pan
