**YEIP
2007
-042**

**Report of 2007 Field Activities
Funded under YMIP Grant #07-042**

NAME OF PROJECTS AREAS

**ALAN DENDYS
PROSPECTOR / PLACER MINER
BOX 31450
WHITEHORSE, YUKON
Y1A 3T5**

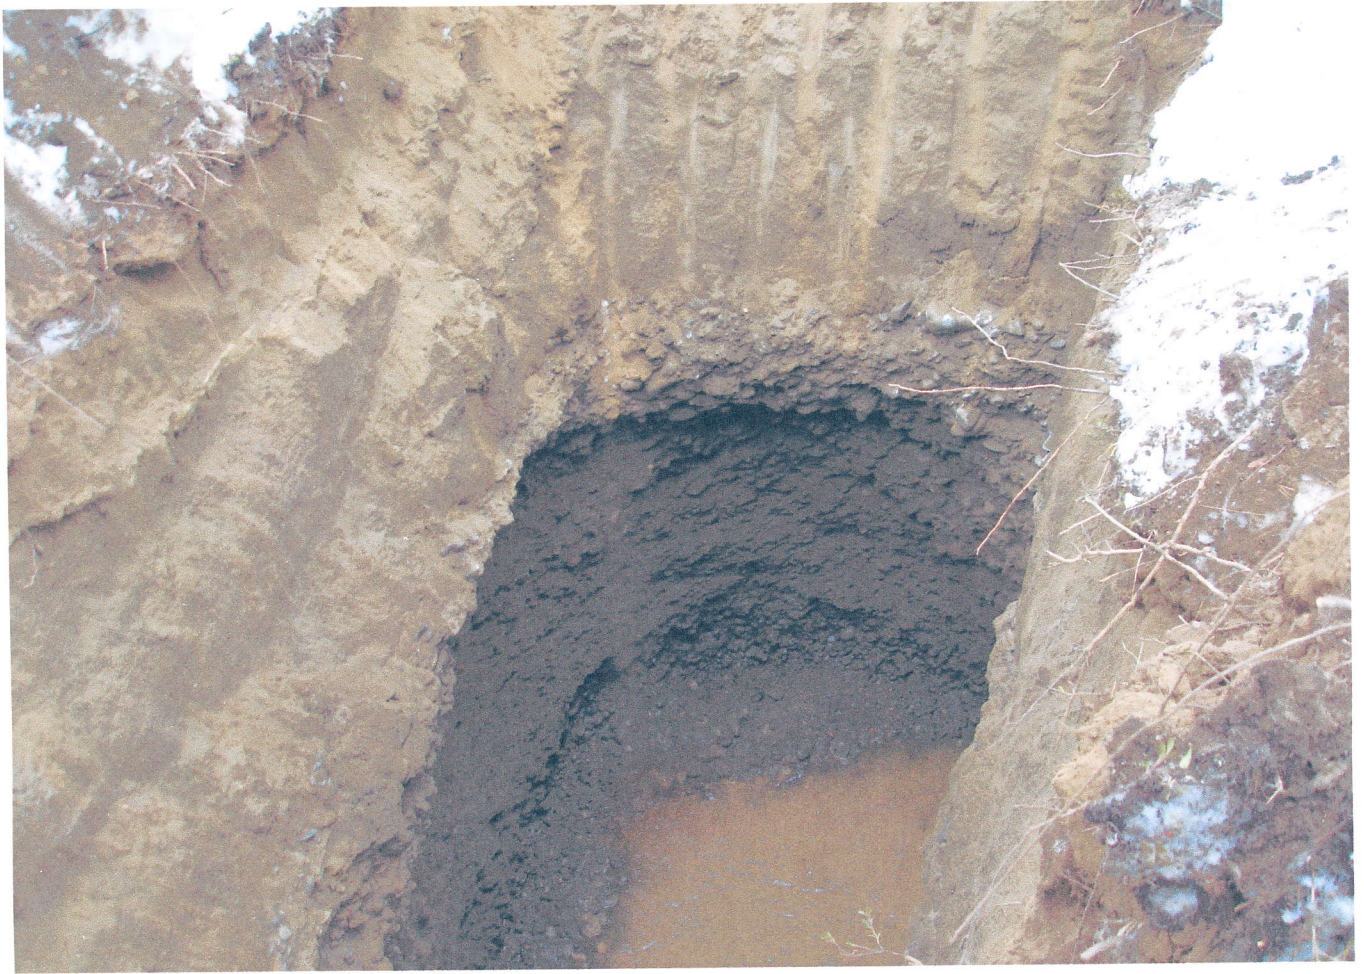
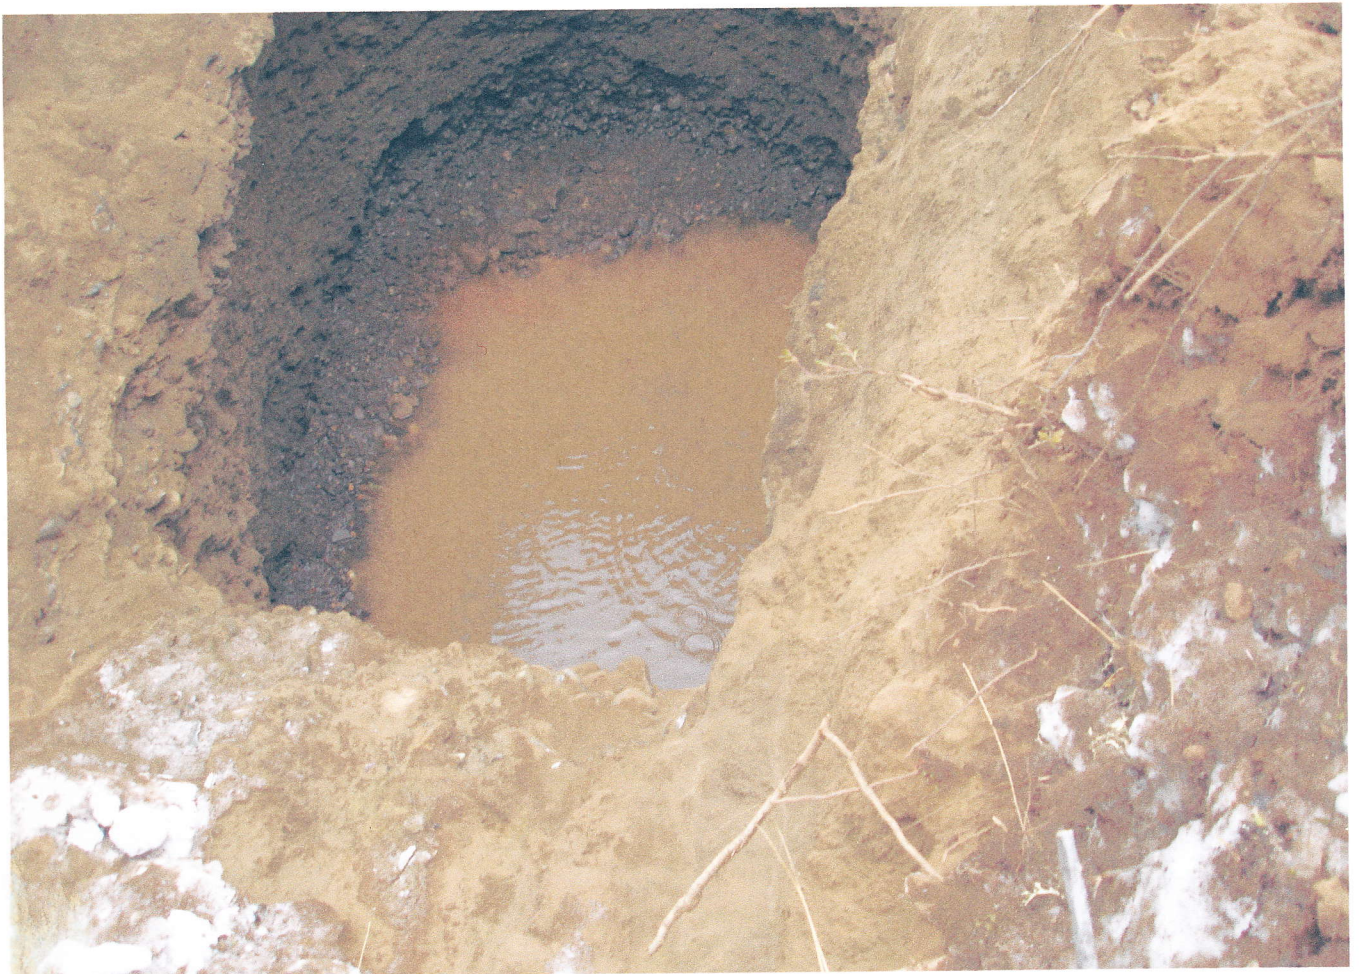
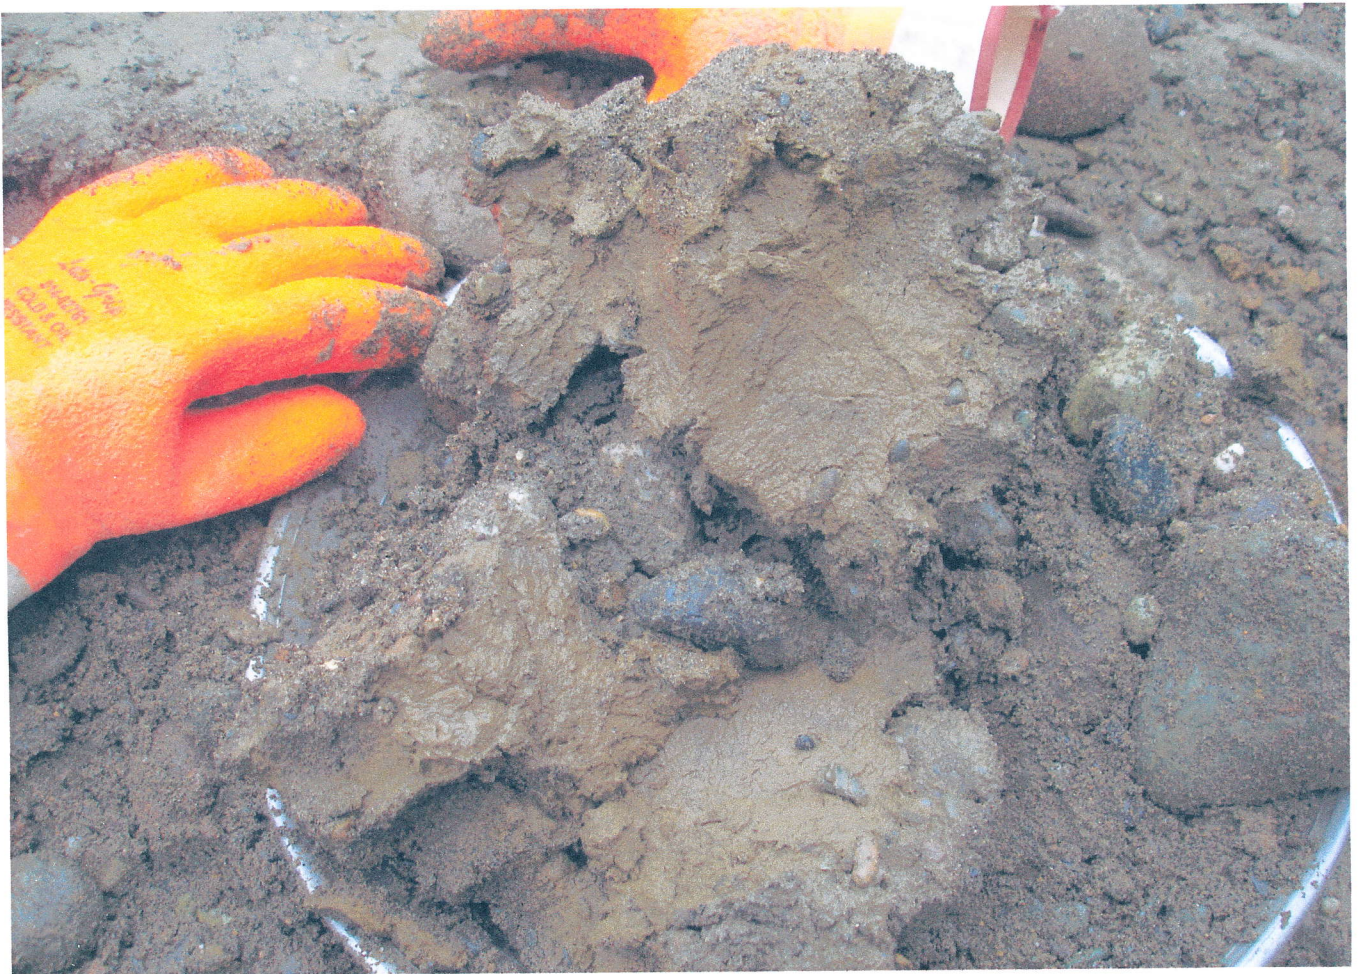
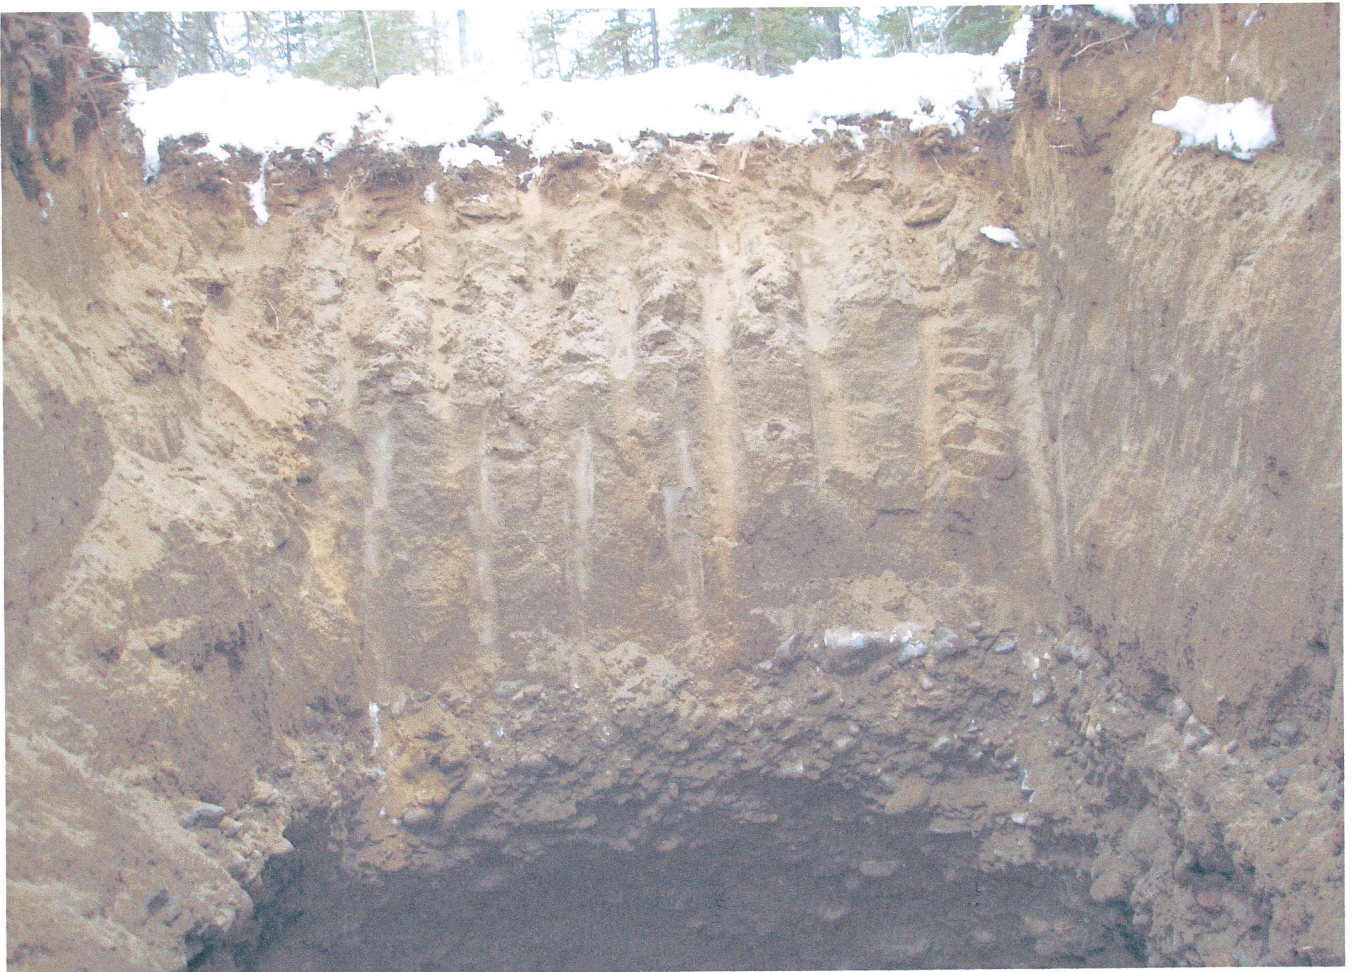
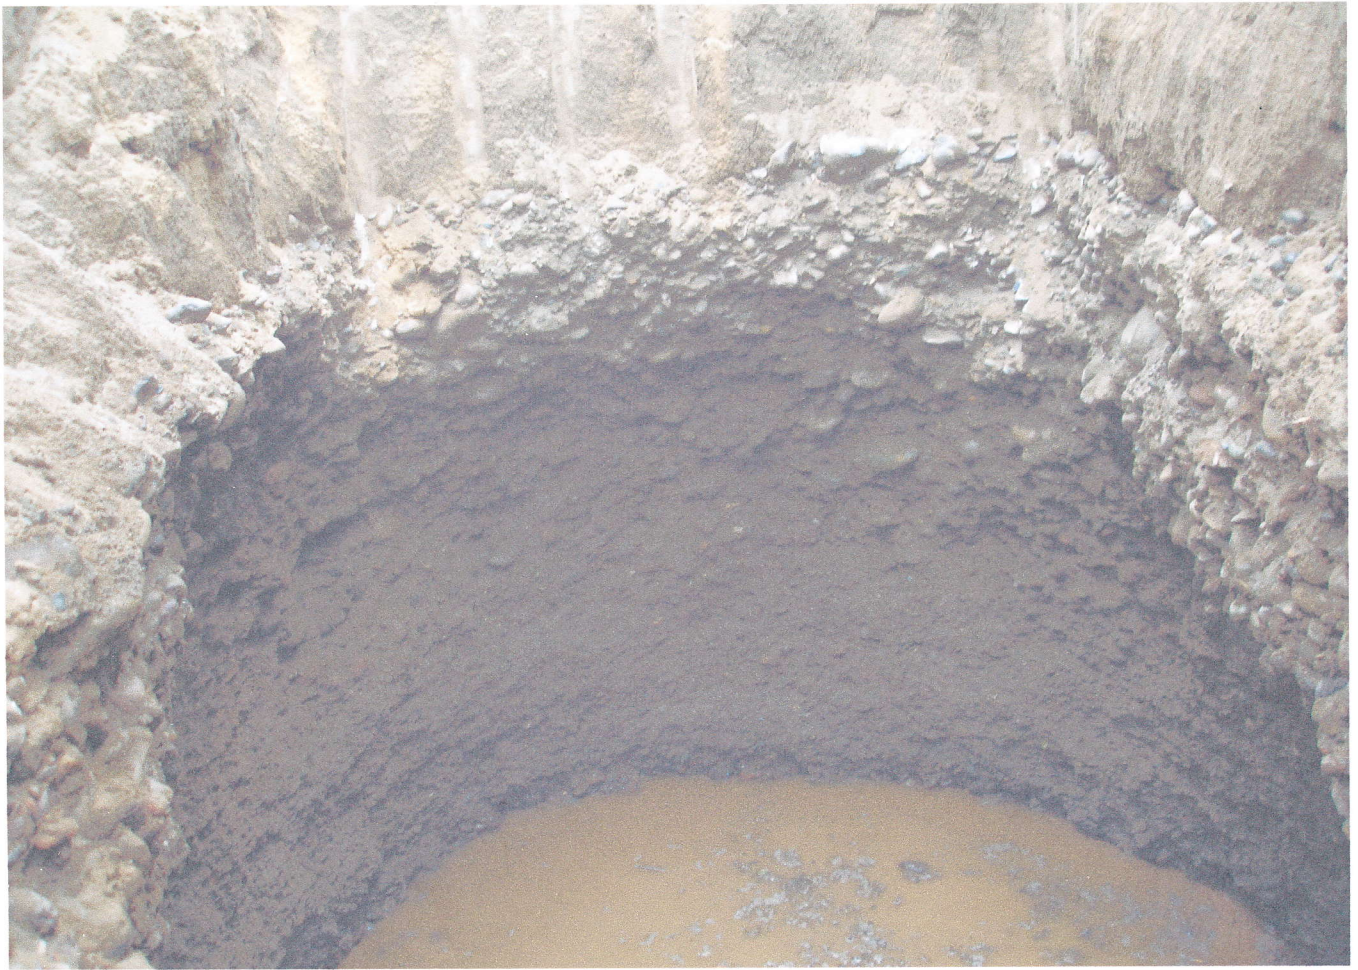
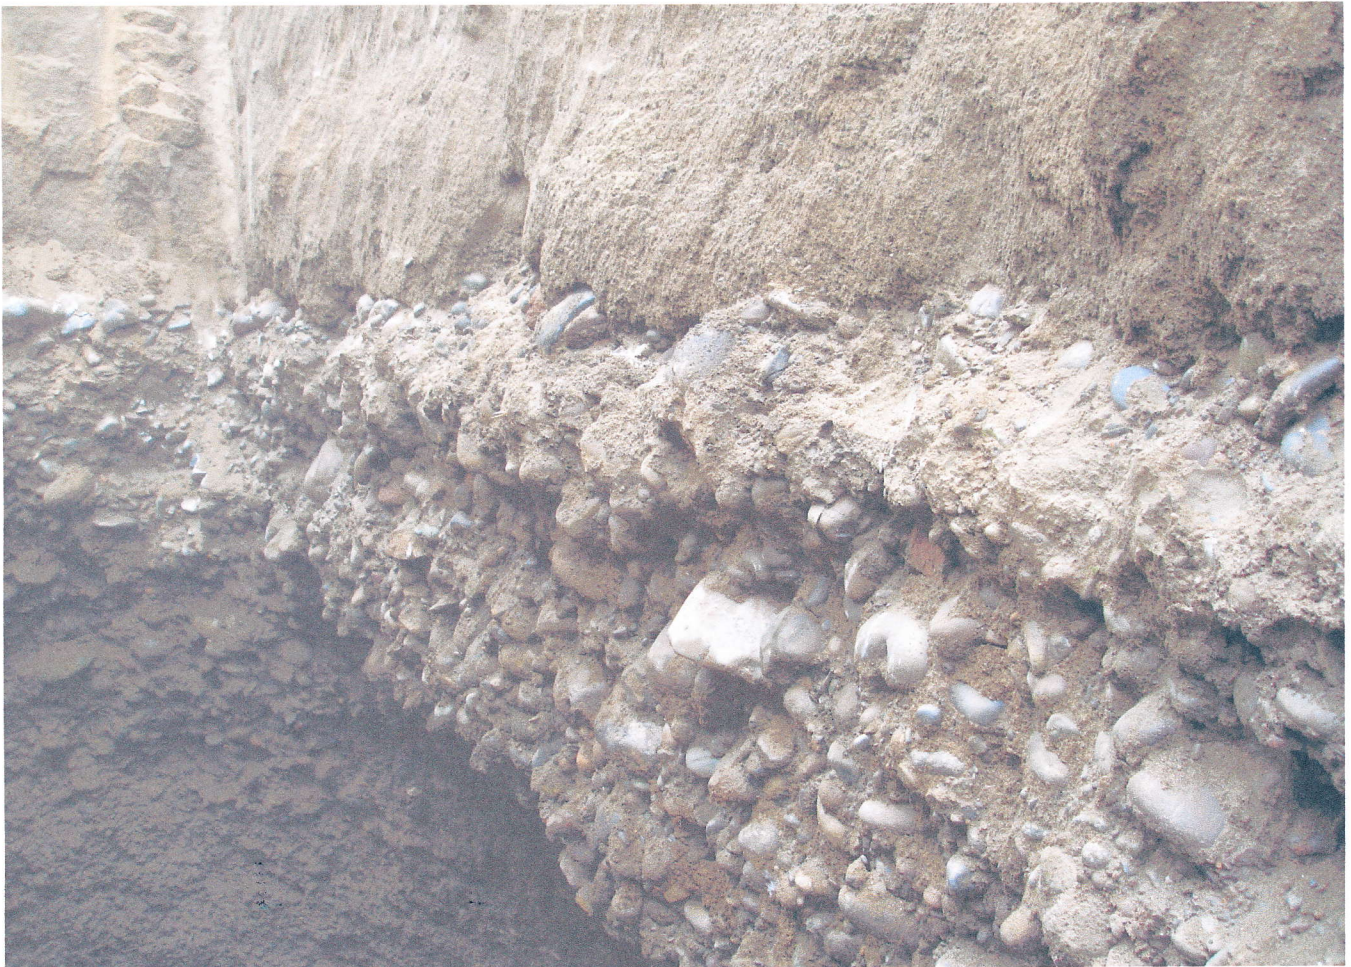
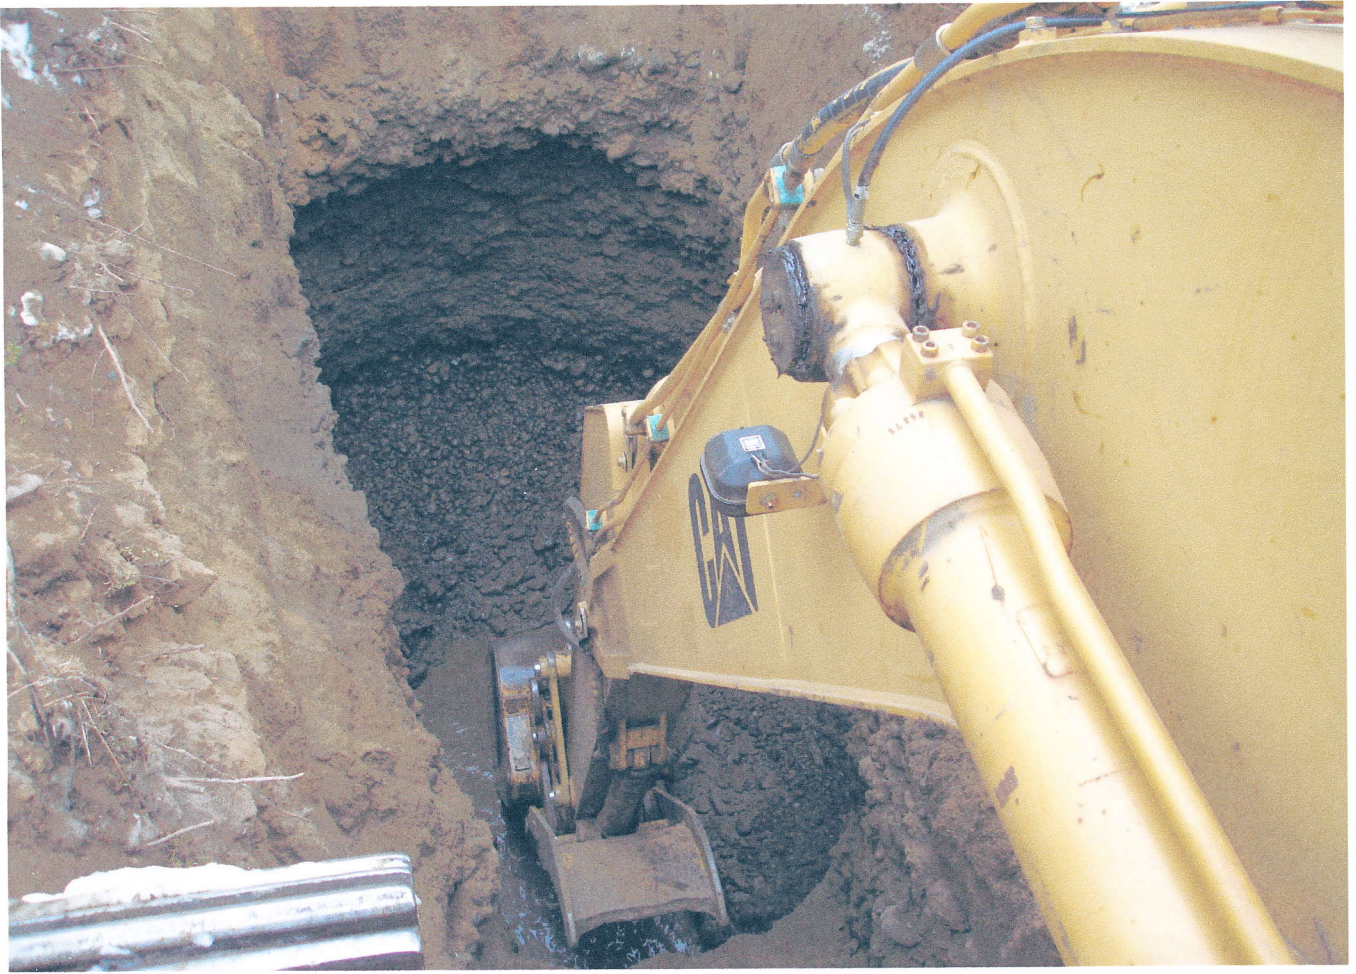
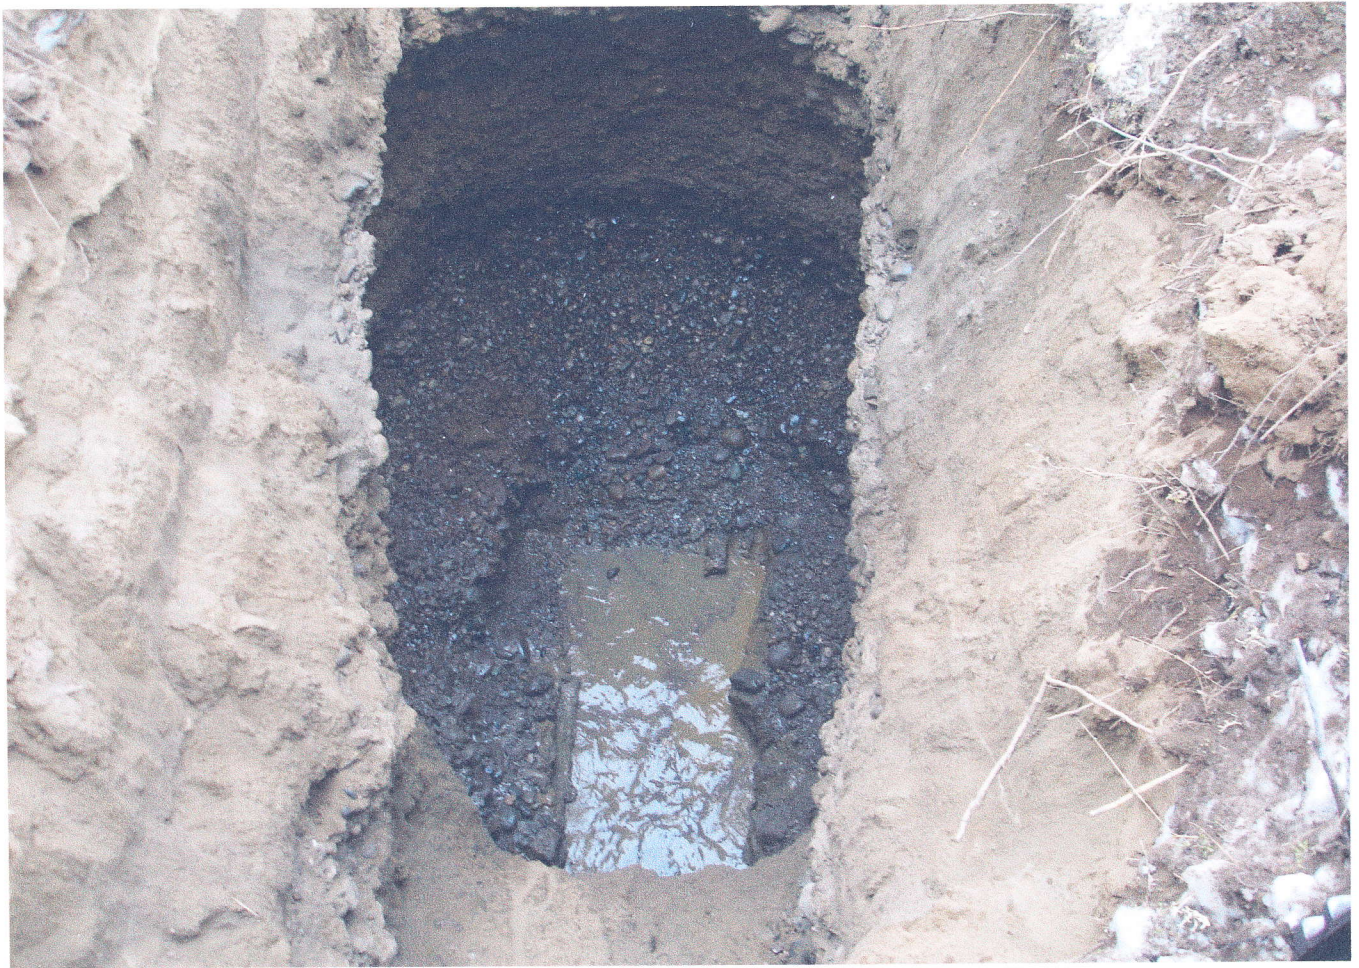
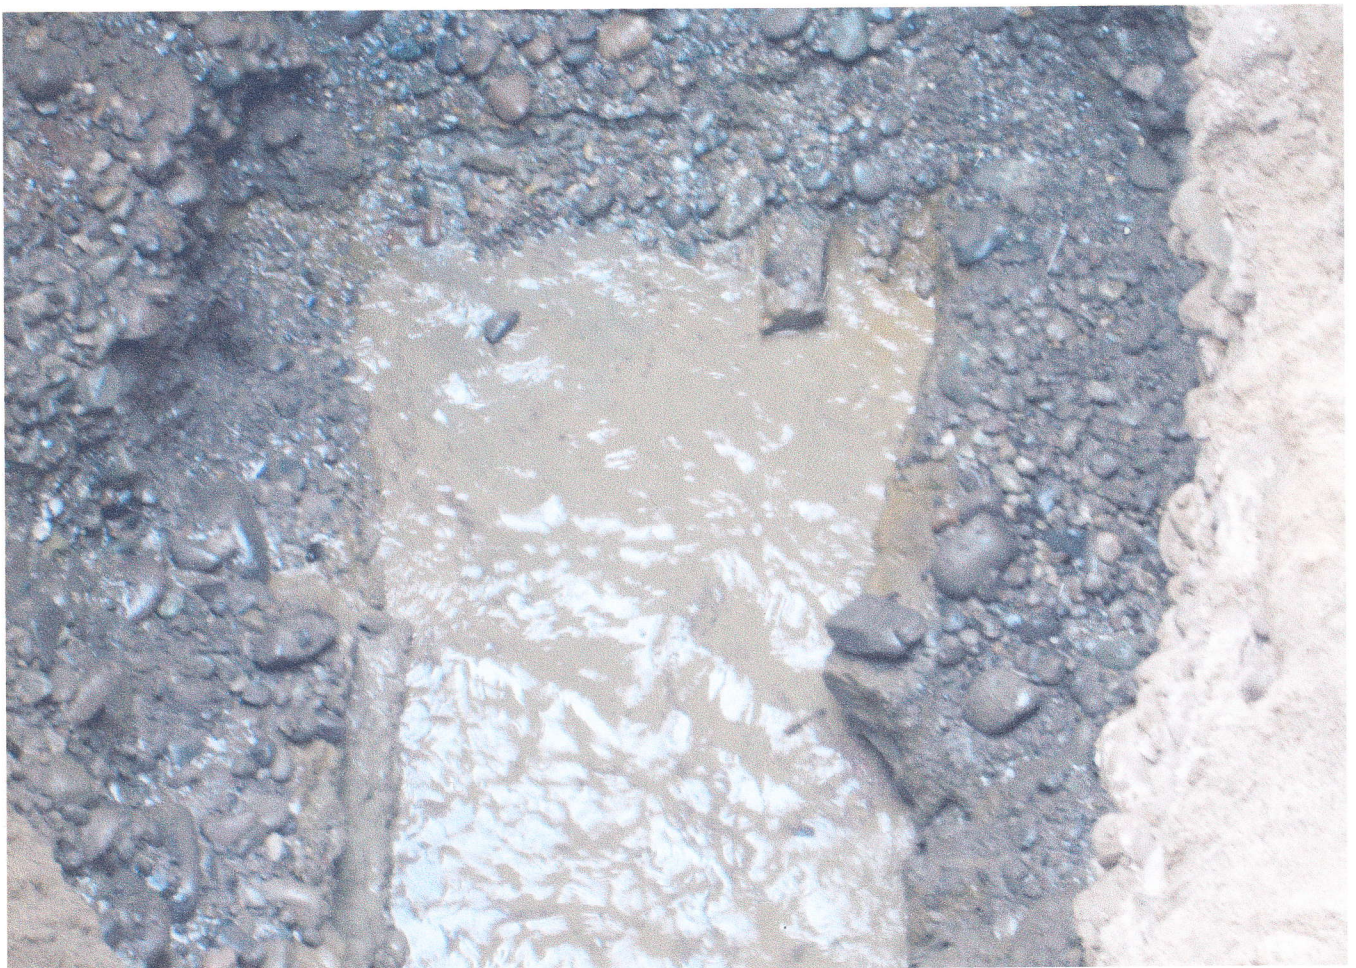
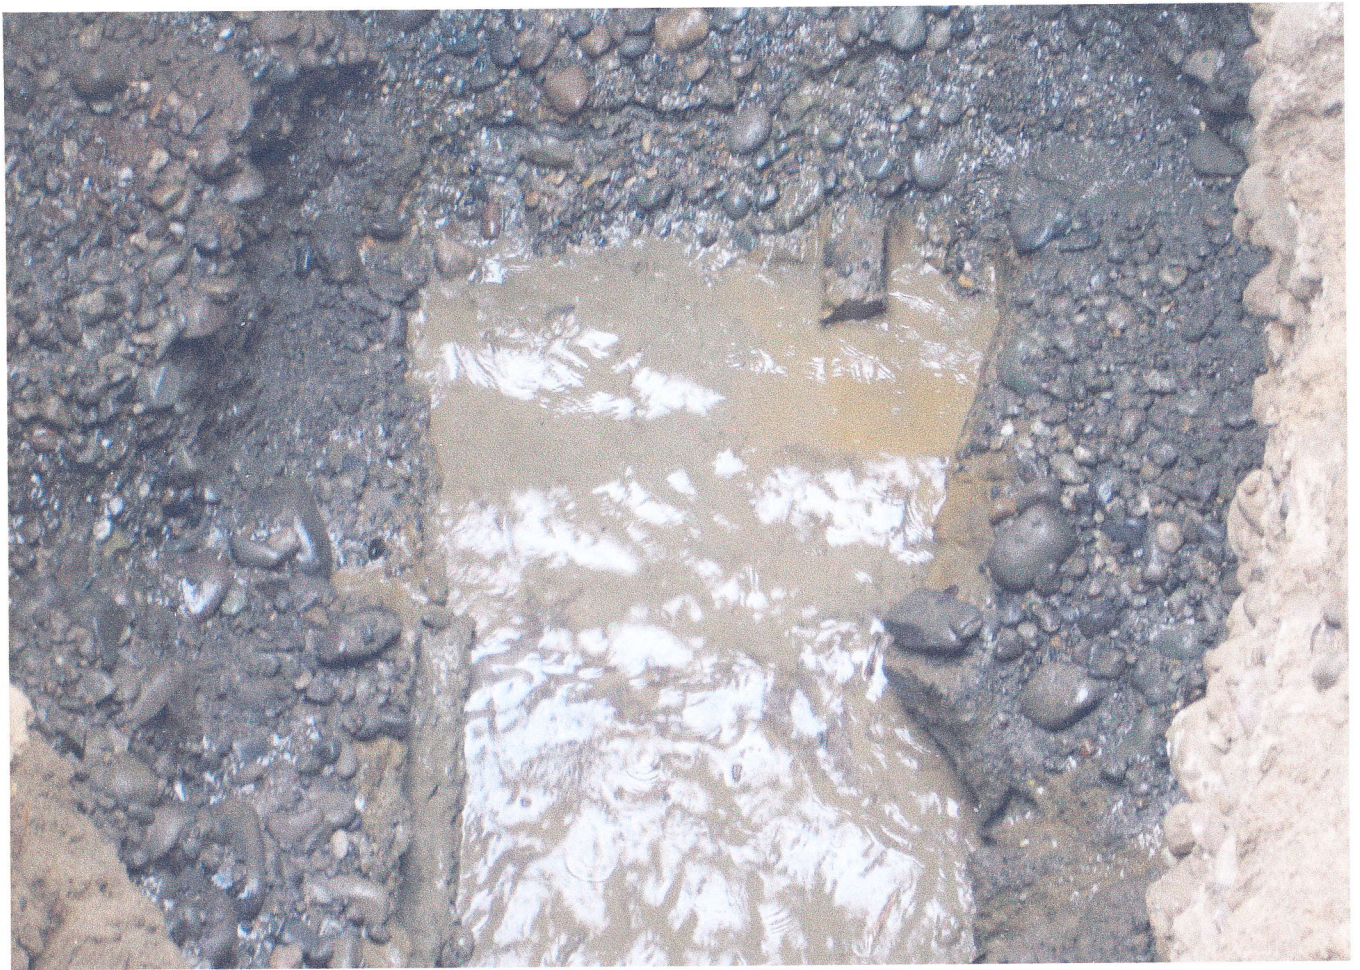
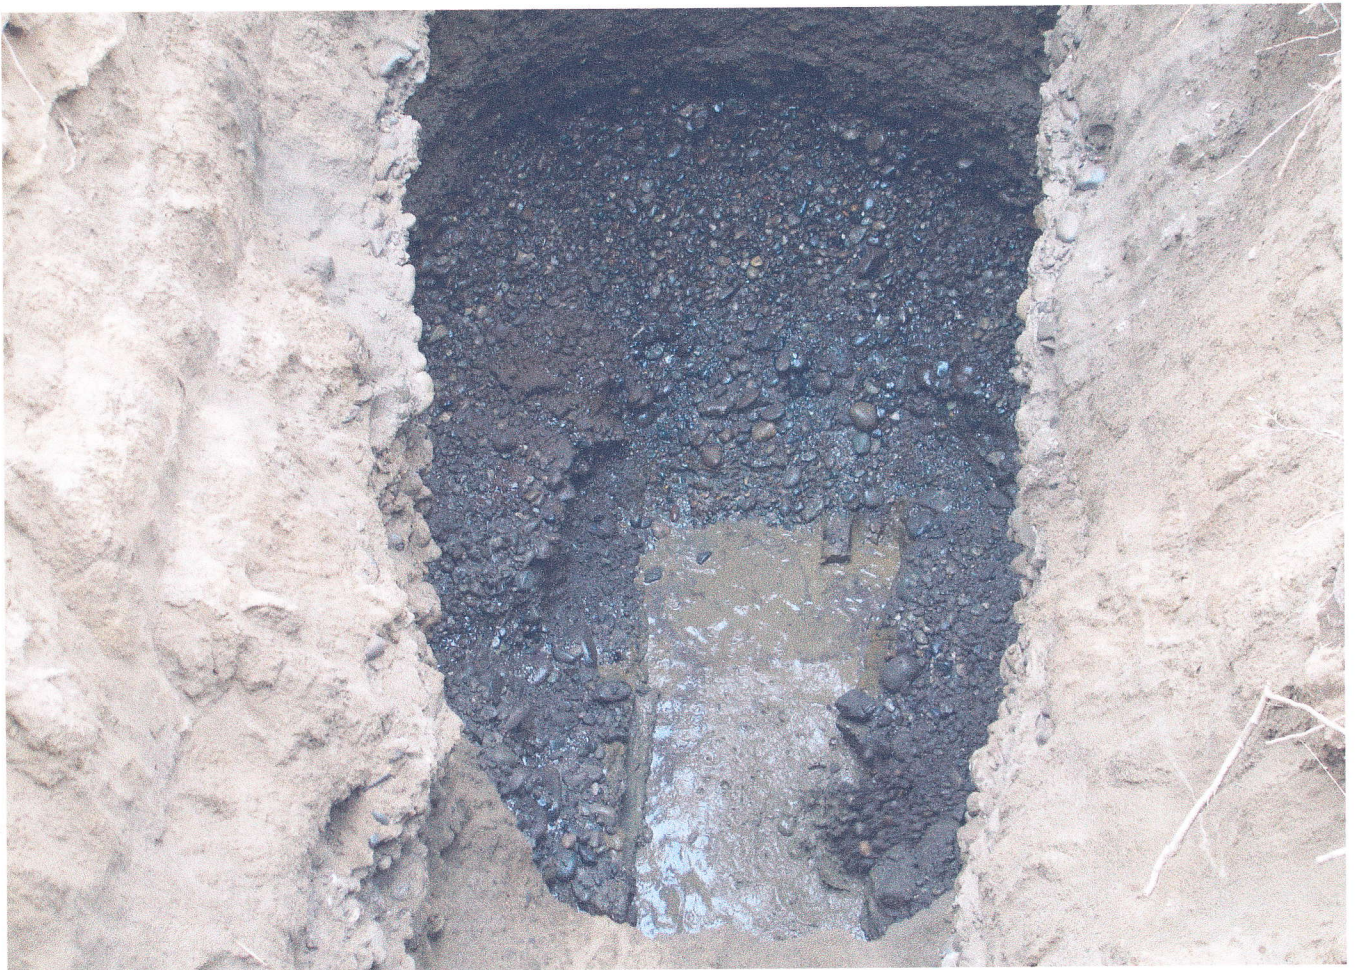
Test site located

Yukon River Clay

Bottom and Water

3 feet top soil

12 feet gravel to clay

Five pits were excavated at various locations along the Yukon River bench to the depth of 25 feet. One excavation only had vegetation on top of bedrock. The pan samples from bedrock produced 2 to 3 colours to the pan. Another test pit had gravel down to 15 feet where water and a clay layer were reached. From this area a one yard bulk sample was processed. The sample had .1 gram gold. Of the .1 gram gold recovered .069 gram was one piece indicating possible course gold in the area. Other samples that were panned produced 100 mesh gold.

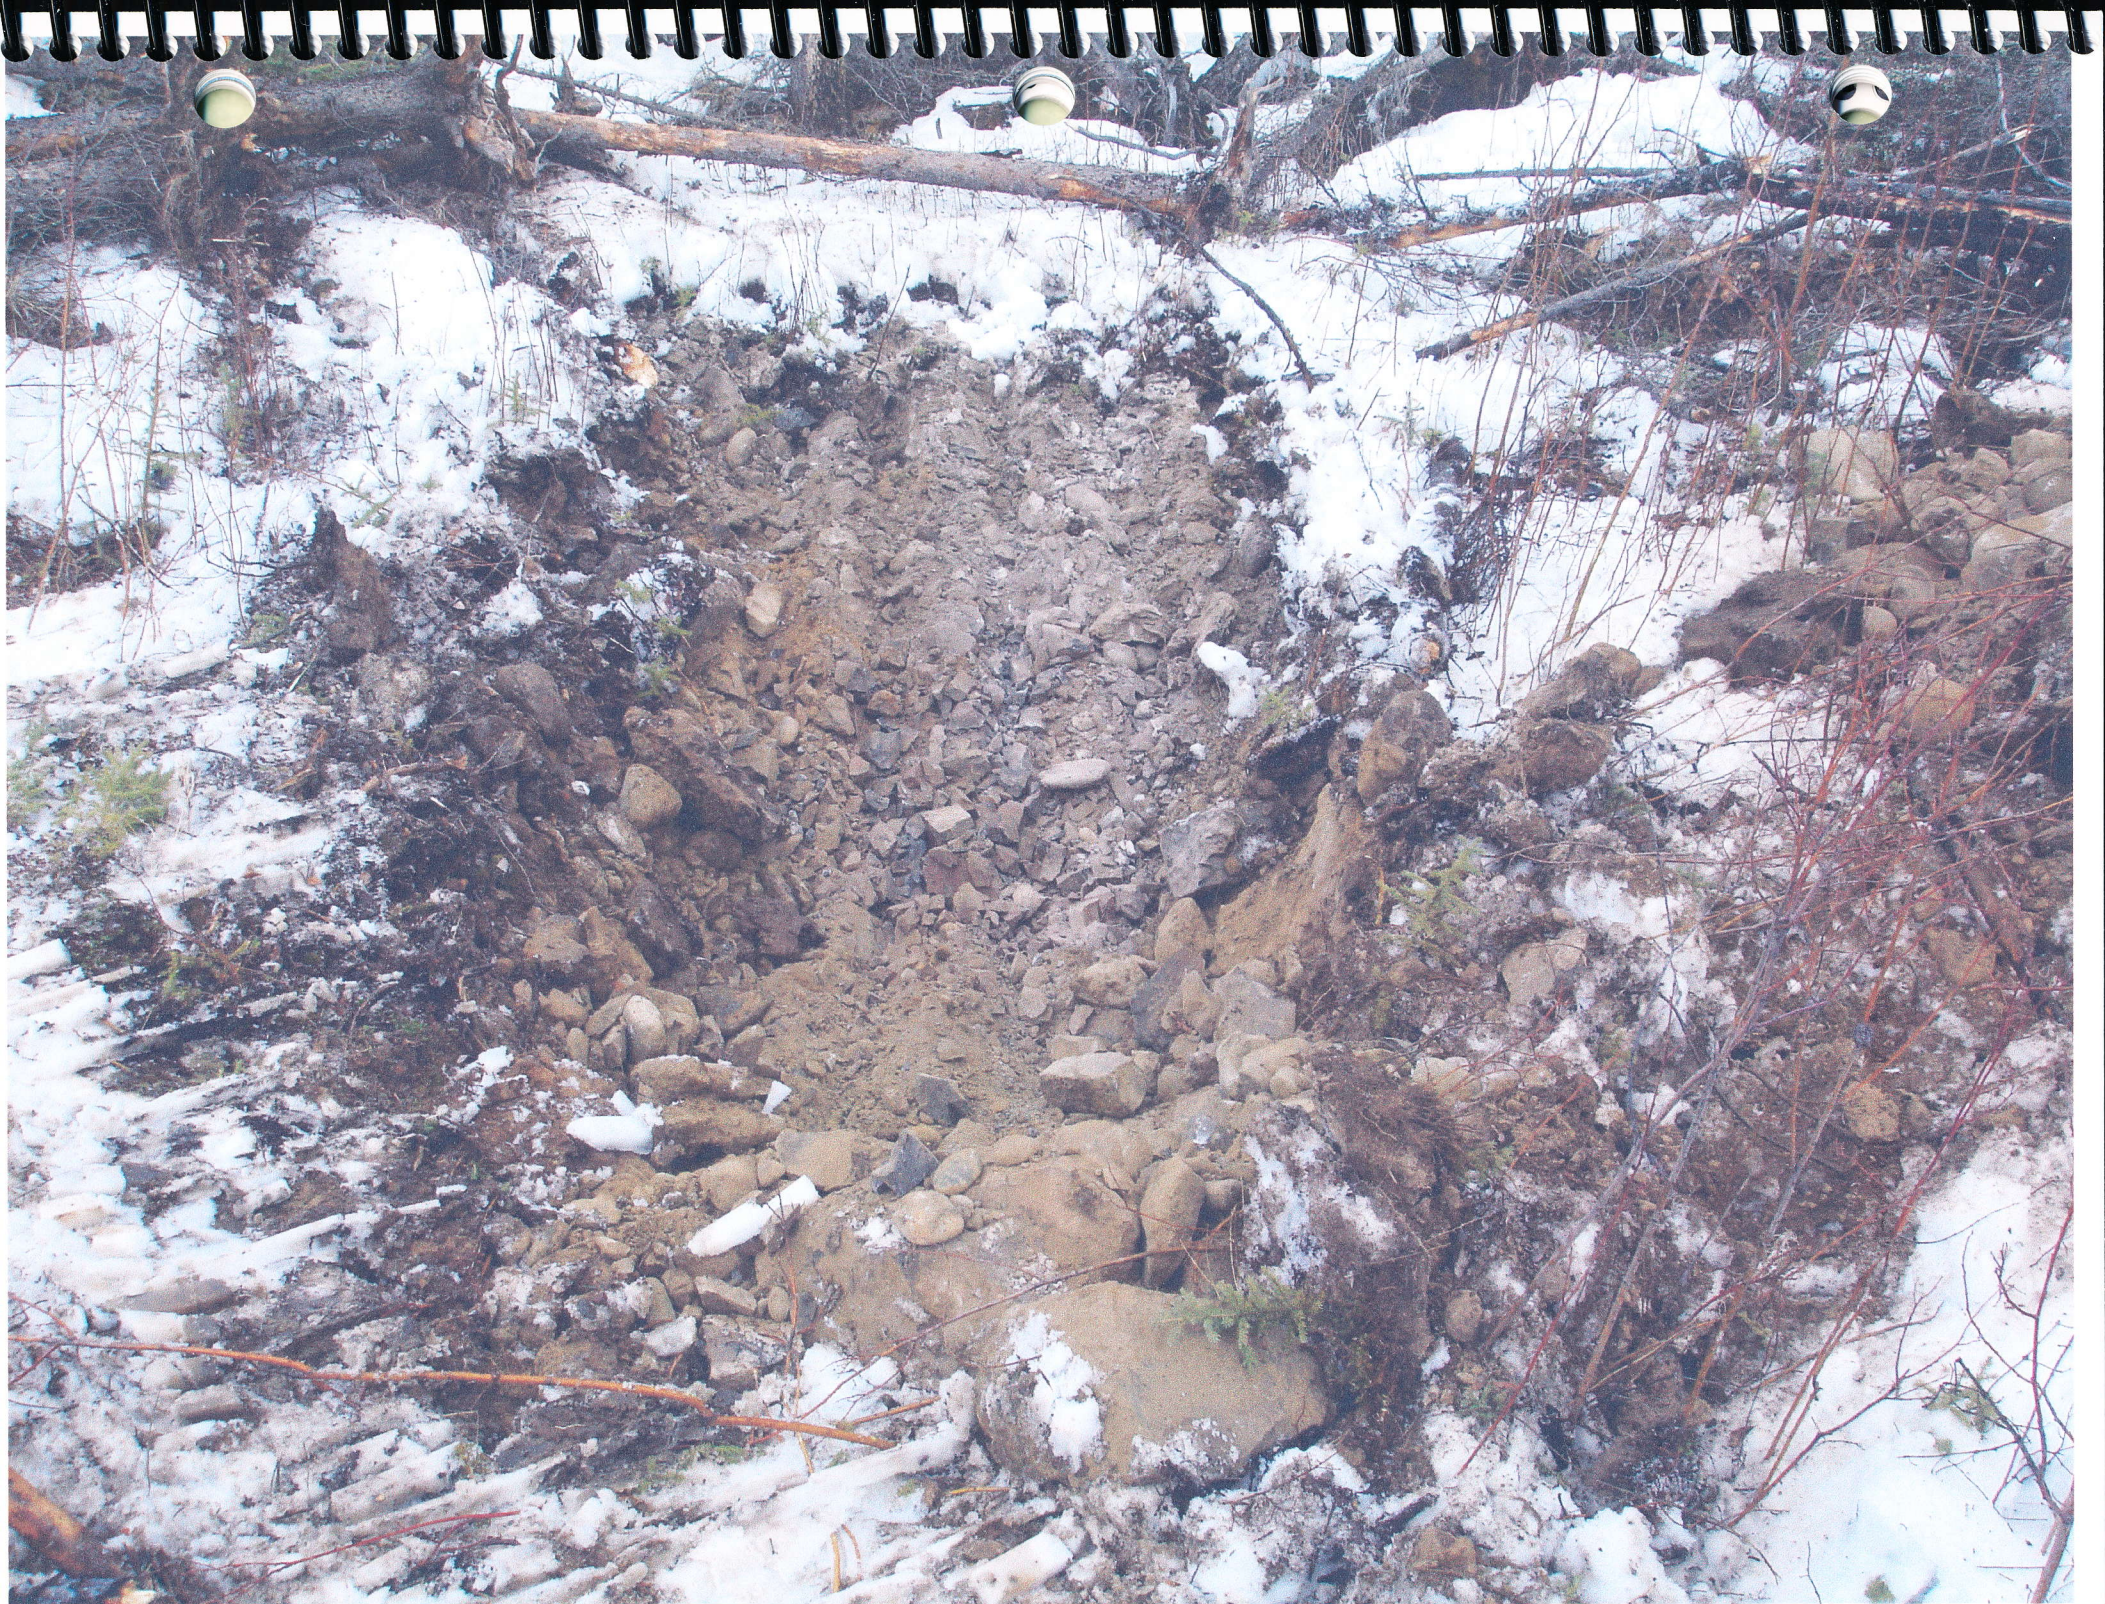
Test Site Located

Bedrock pit

3 feet in bedrock

3 to 4 colours

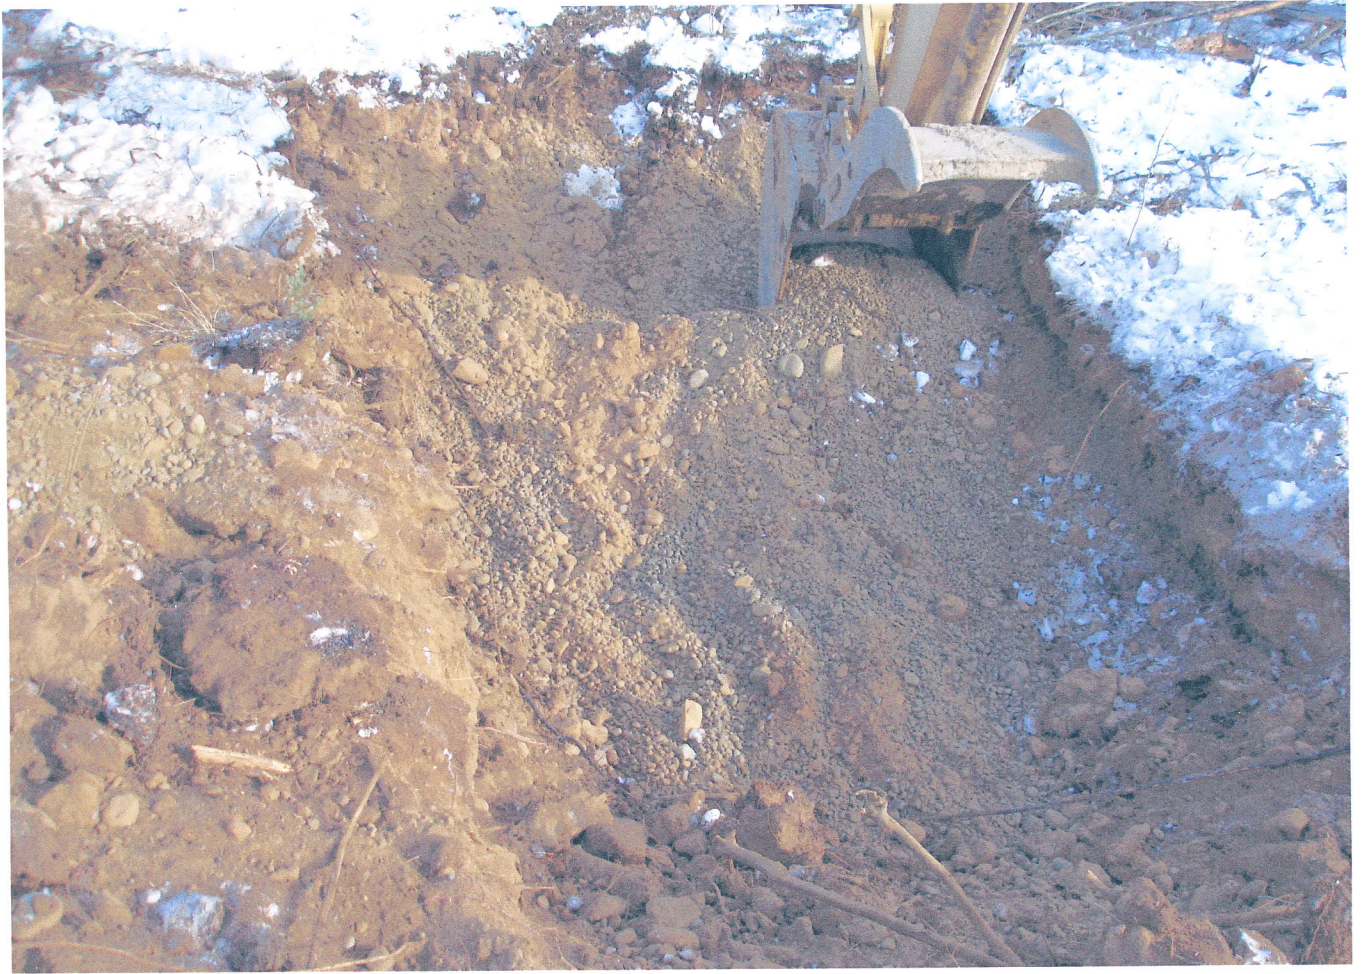
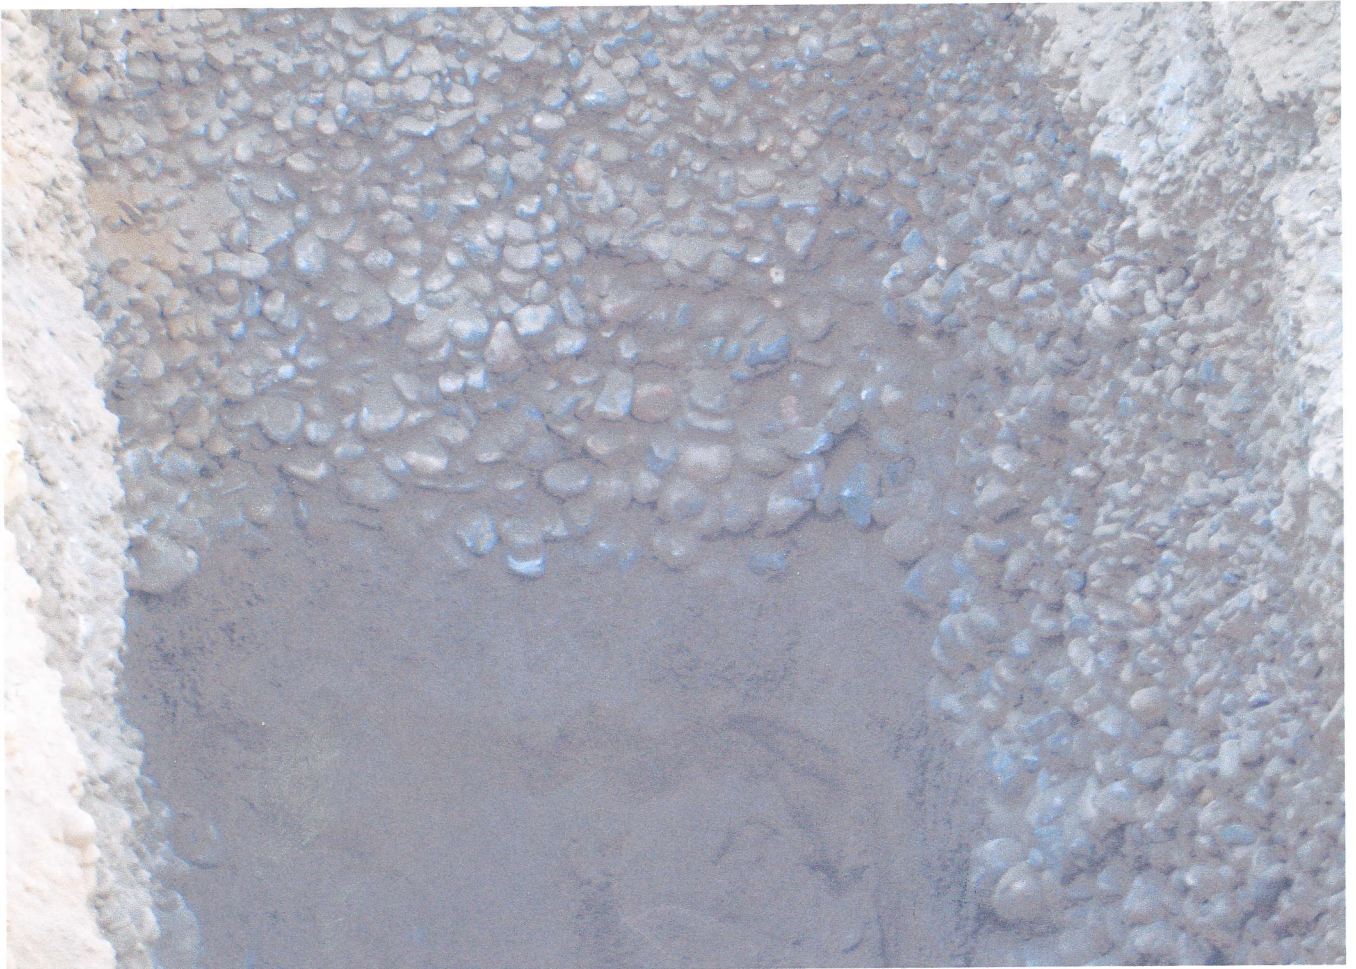
Location of test site

6 feet of cobble silty sand down 25 feet
Full depth of machine reach
Very dry and dusty material
