**YEIP
2007
-042**

**Report of 2007 Field Activities
Funded under YMIP Grant #07-042**

NAME OF PROJECTS AREAS

**ALAN DENDYS
PROSPECTOR / PLACER MINER
BOX 31450
WHITEHORSE, YUKON
Y1A 3T5**

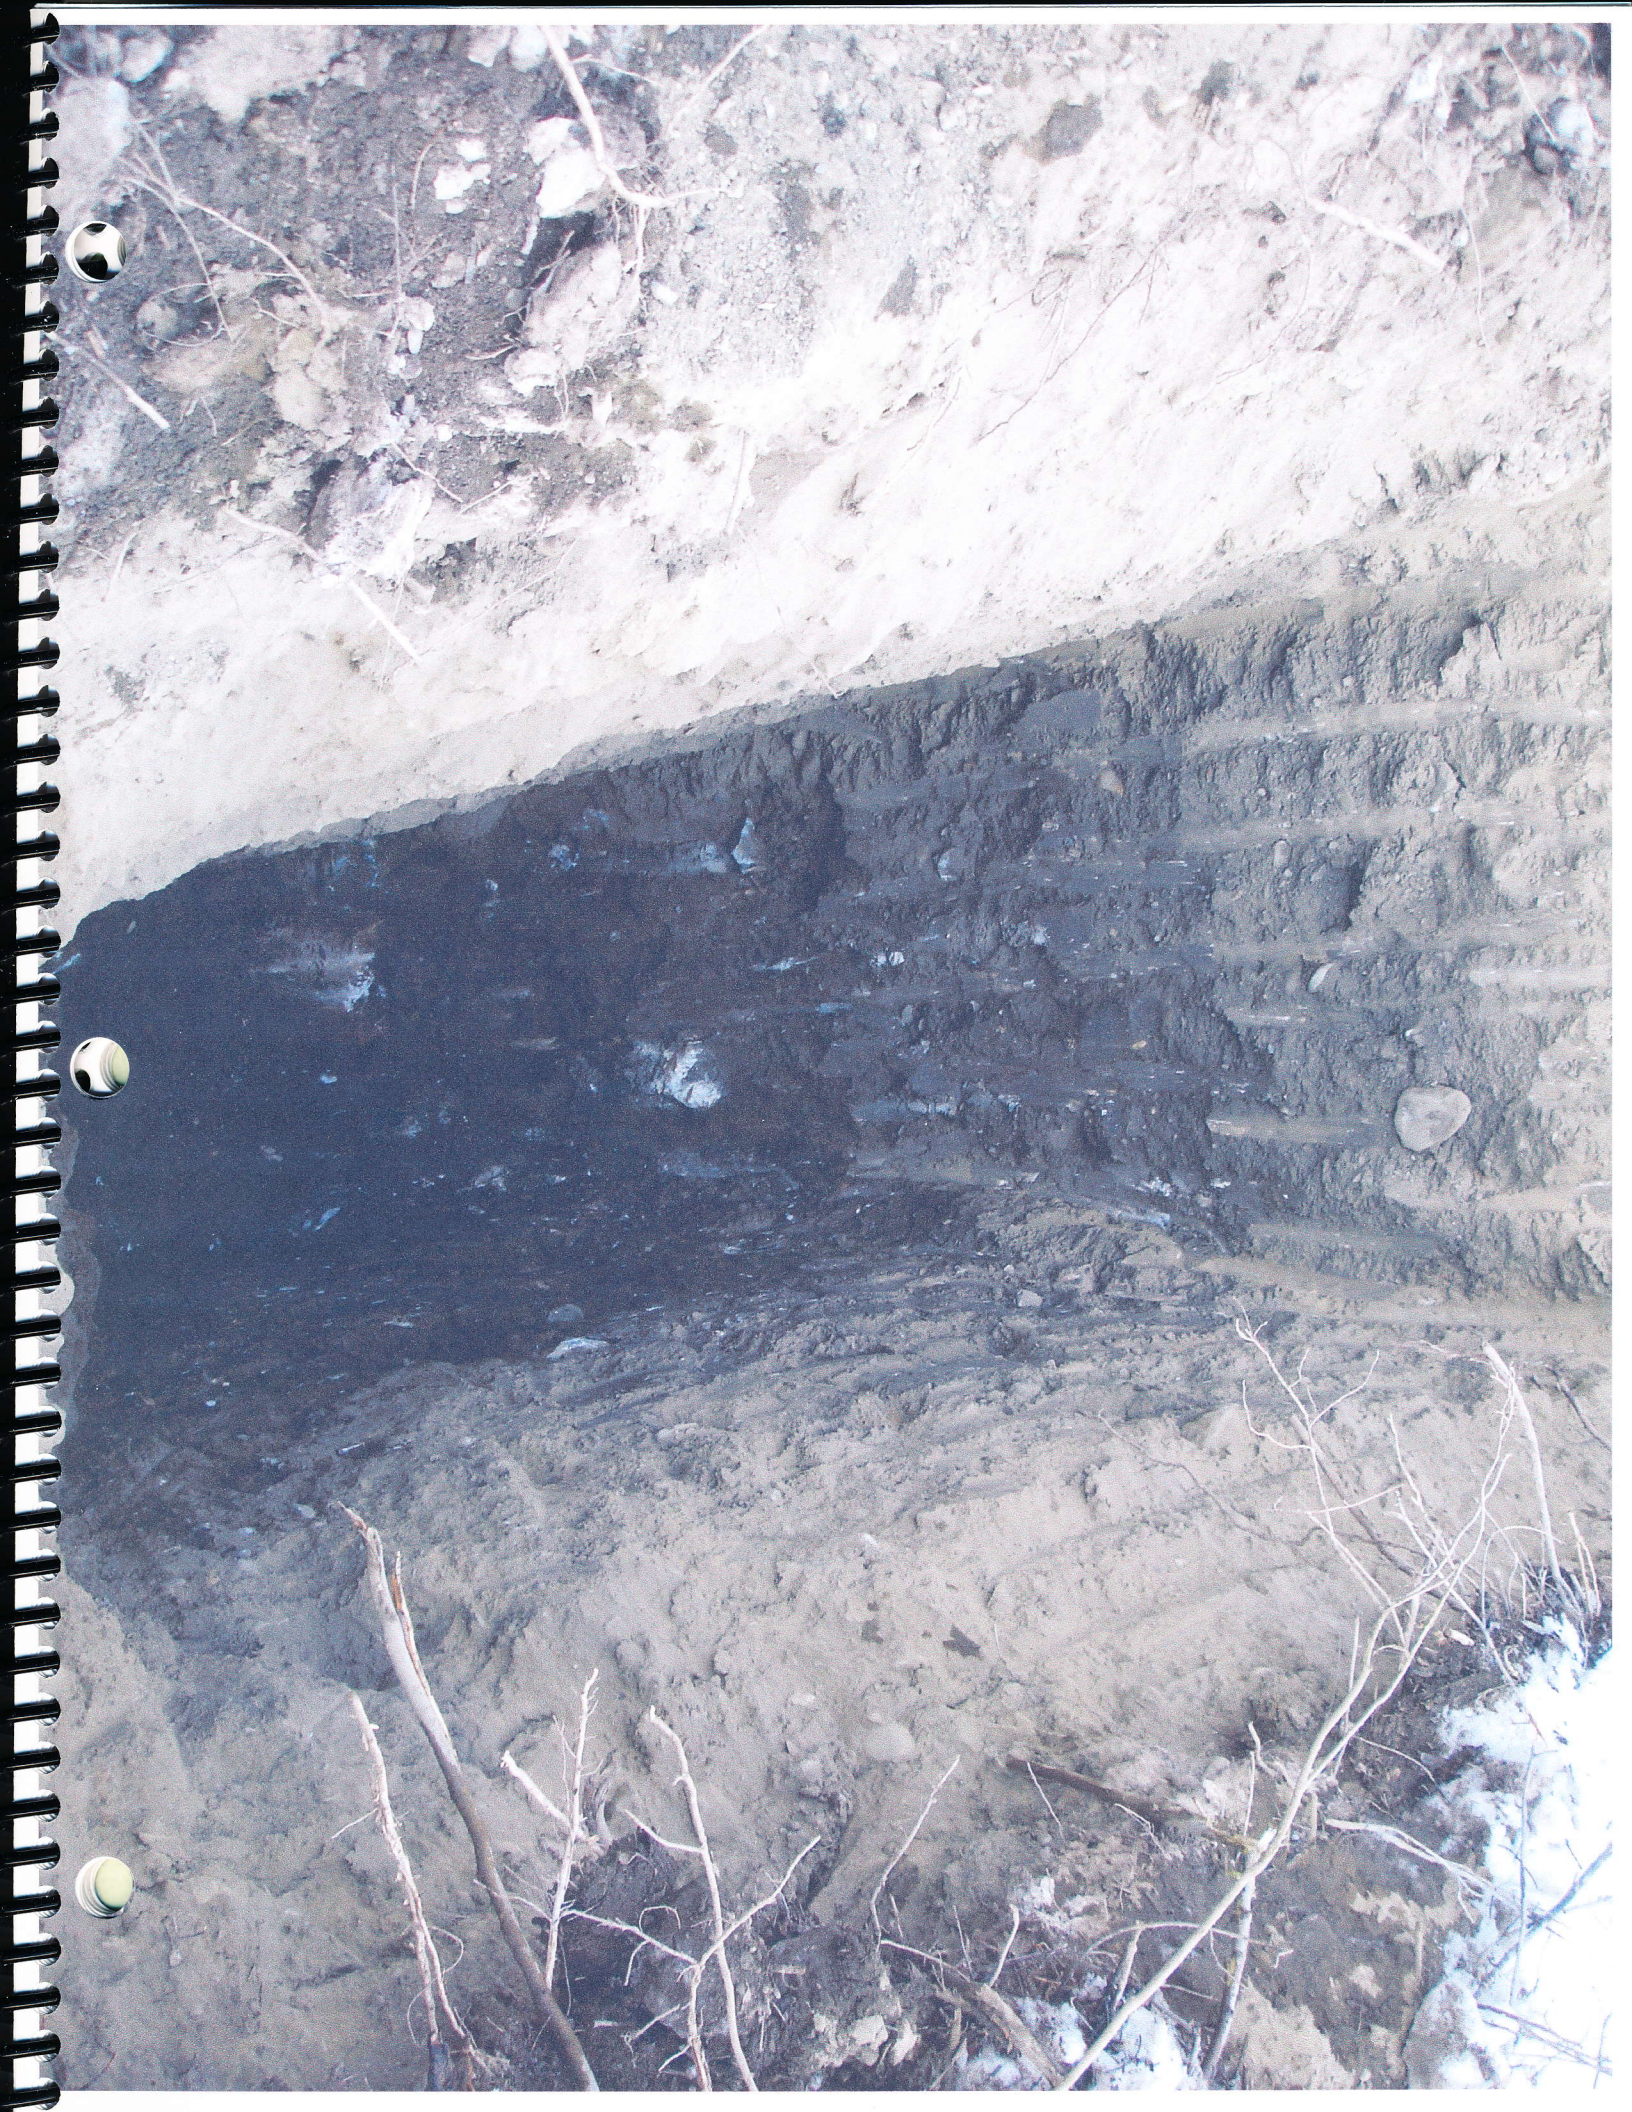
Test site location

Hole by Camp
All clay with gravel
Full reach of excavator

Access to test area was by turning off the Campbell Highway at km 36 and traveling down 3 miles drainage lease. Three test pits were excavated on 3 mile lease. Holes were excavated to 25 feet. First hole dug was in a clay layer with little gravel. No colours indicated in the pan.

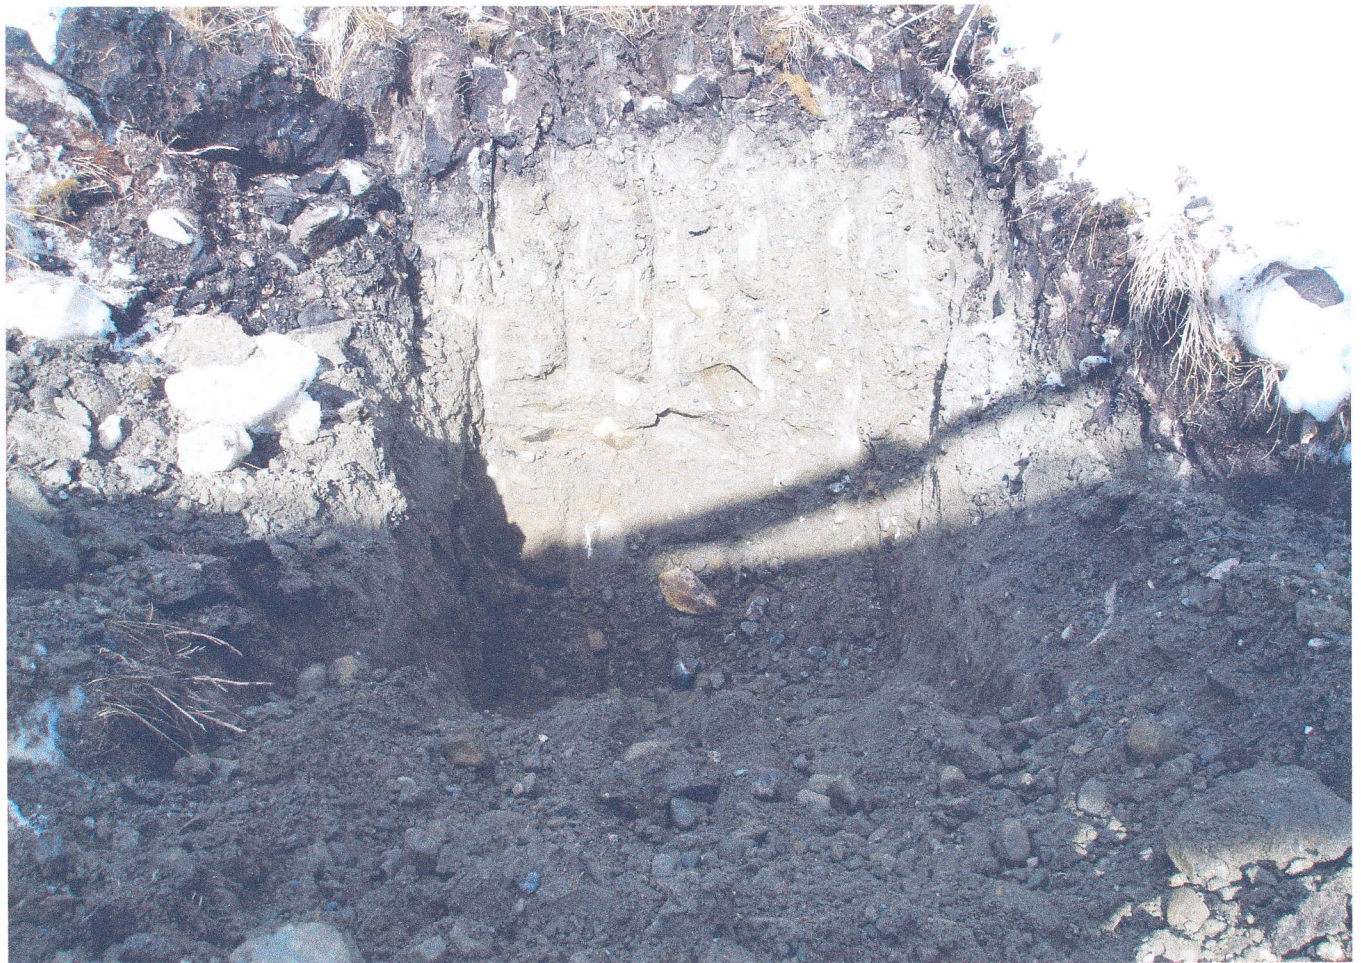
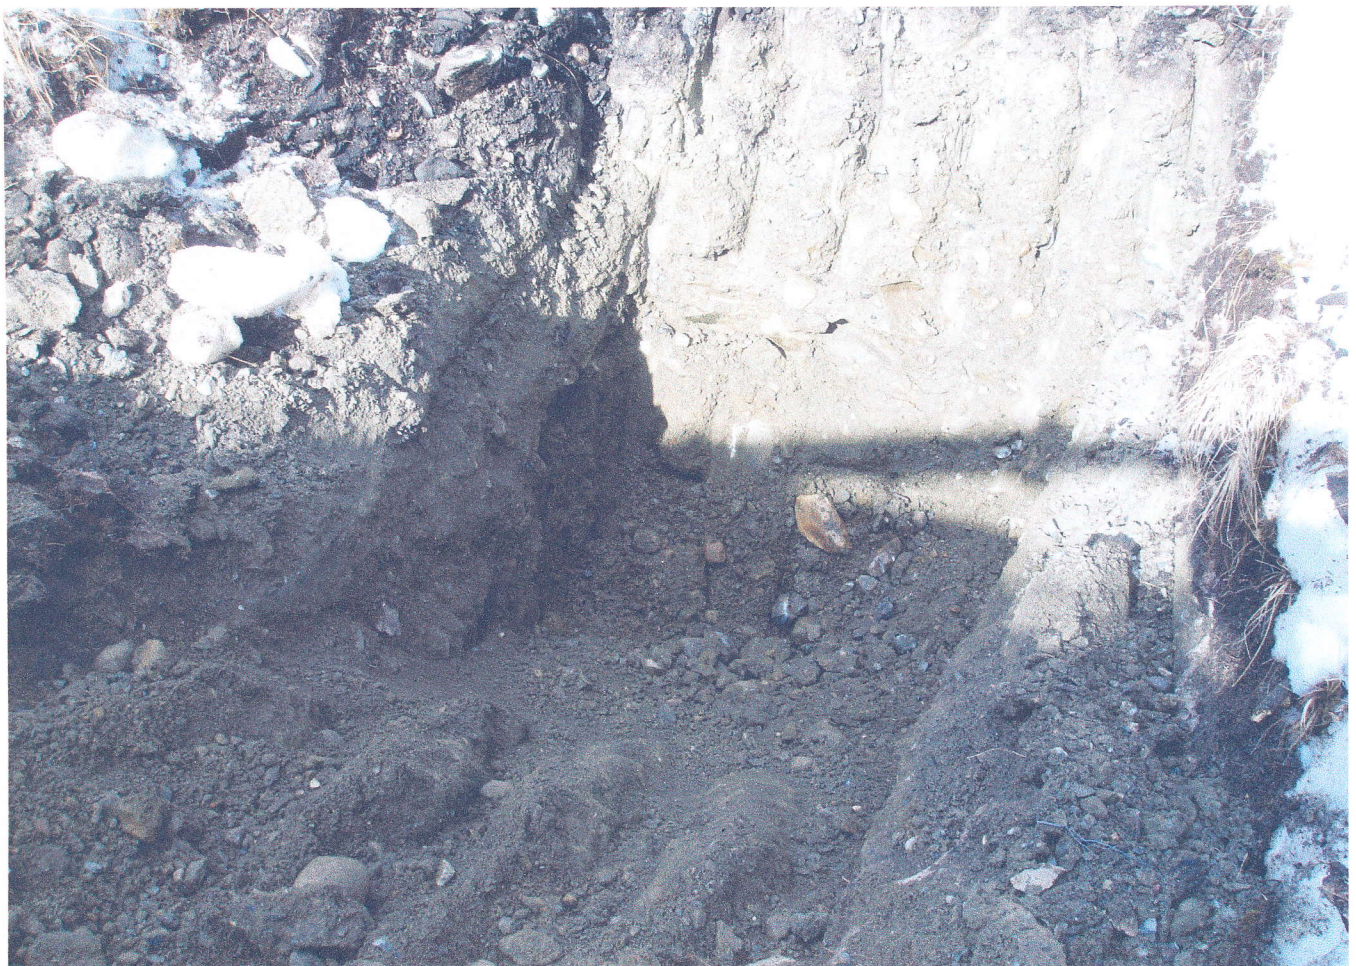
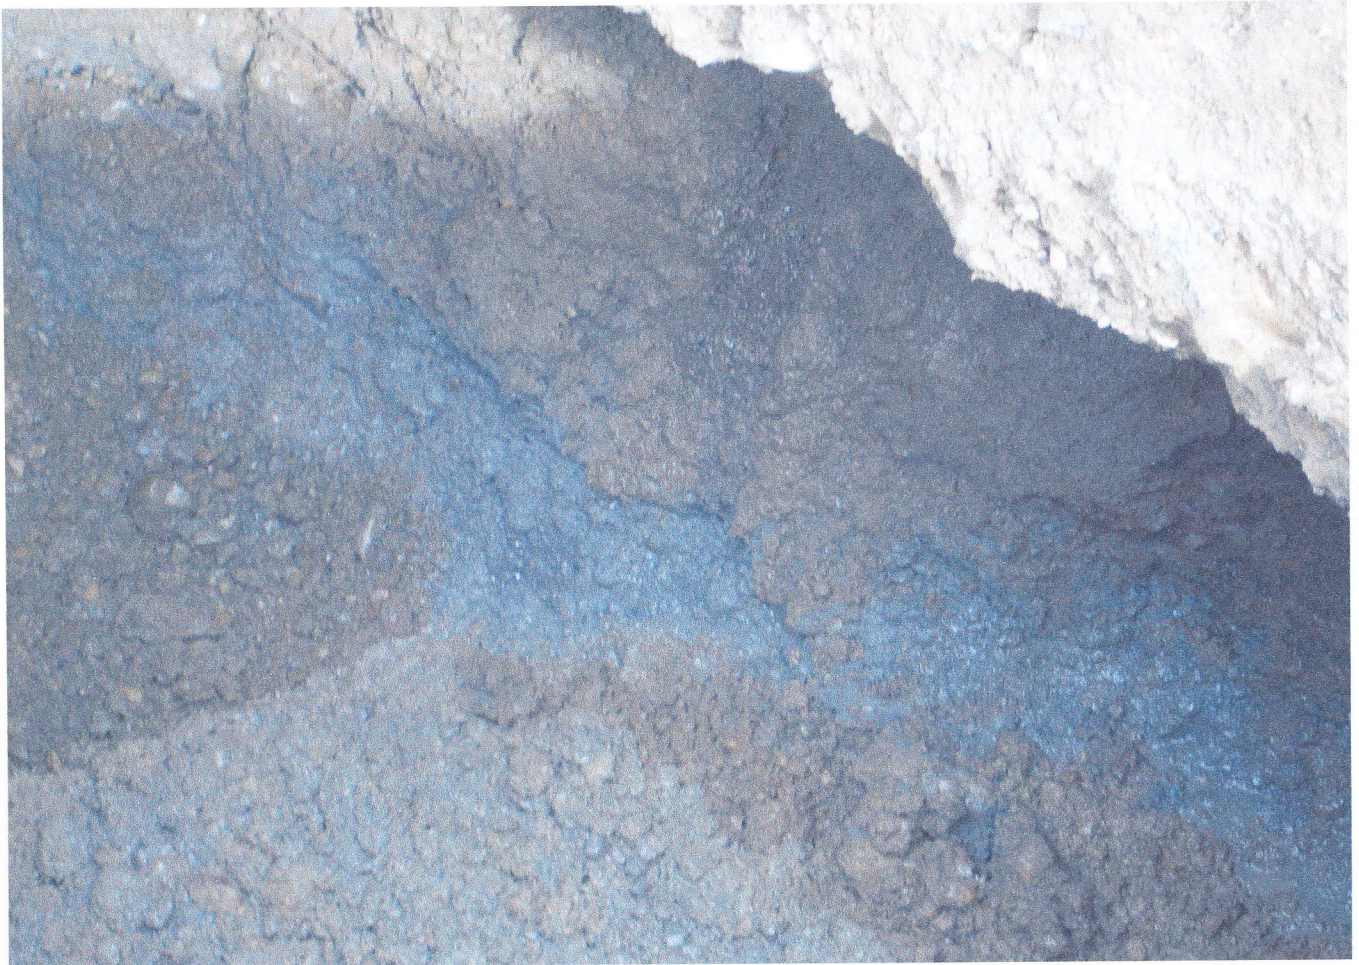
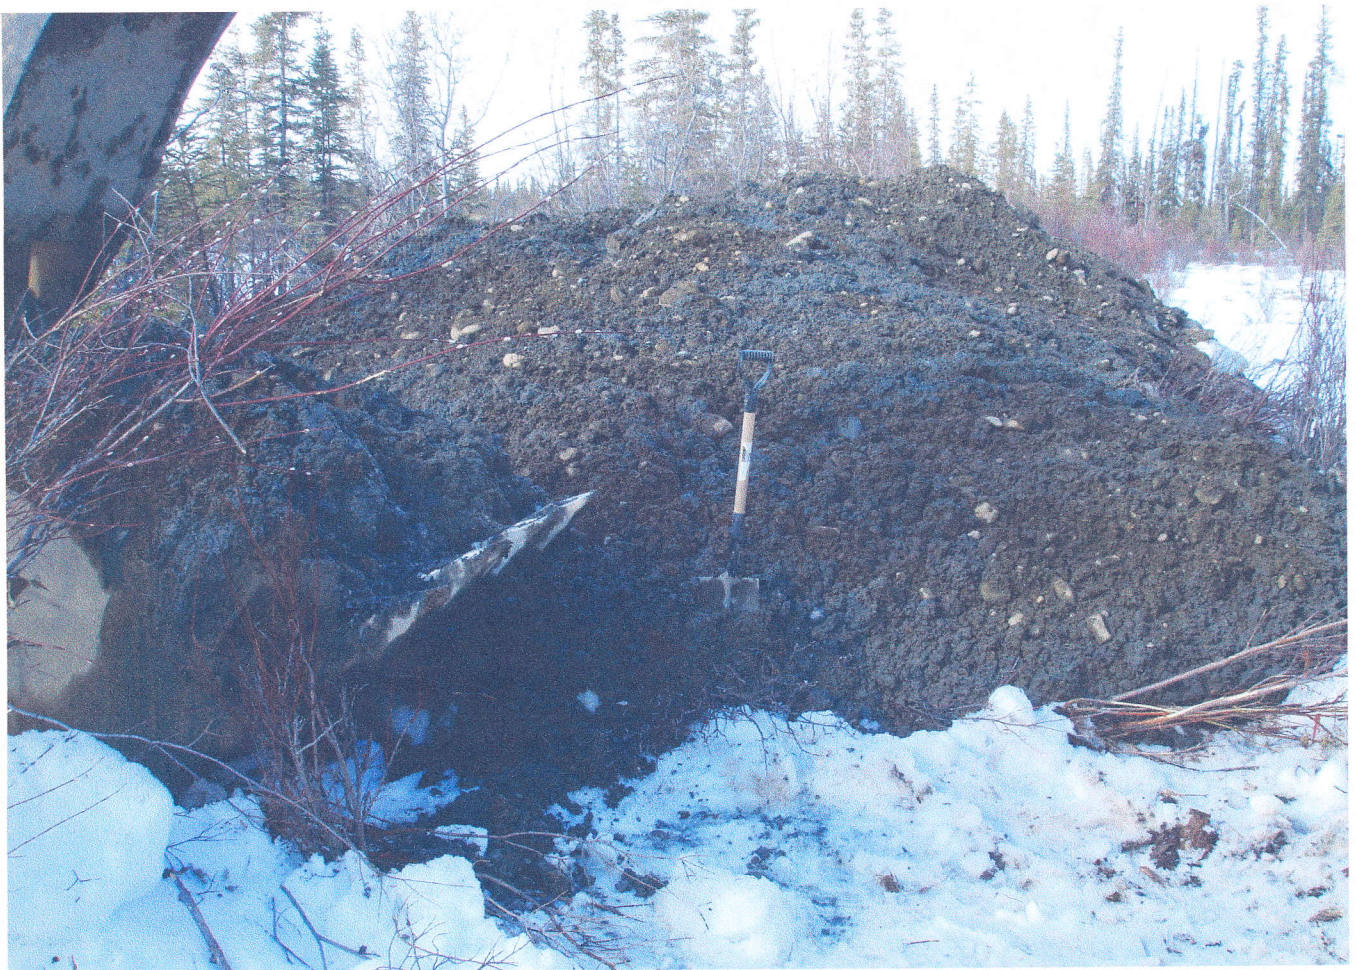
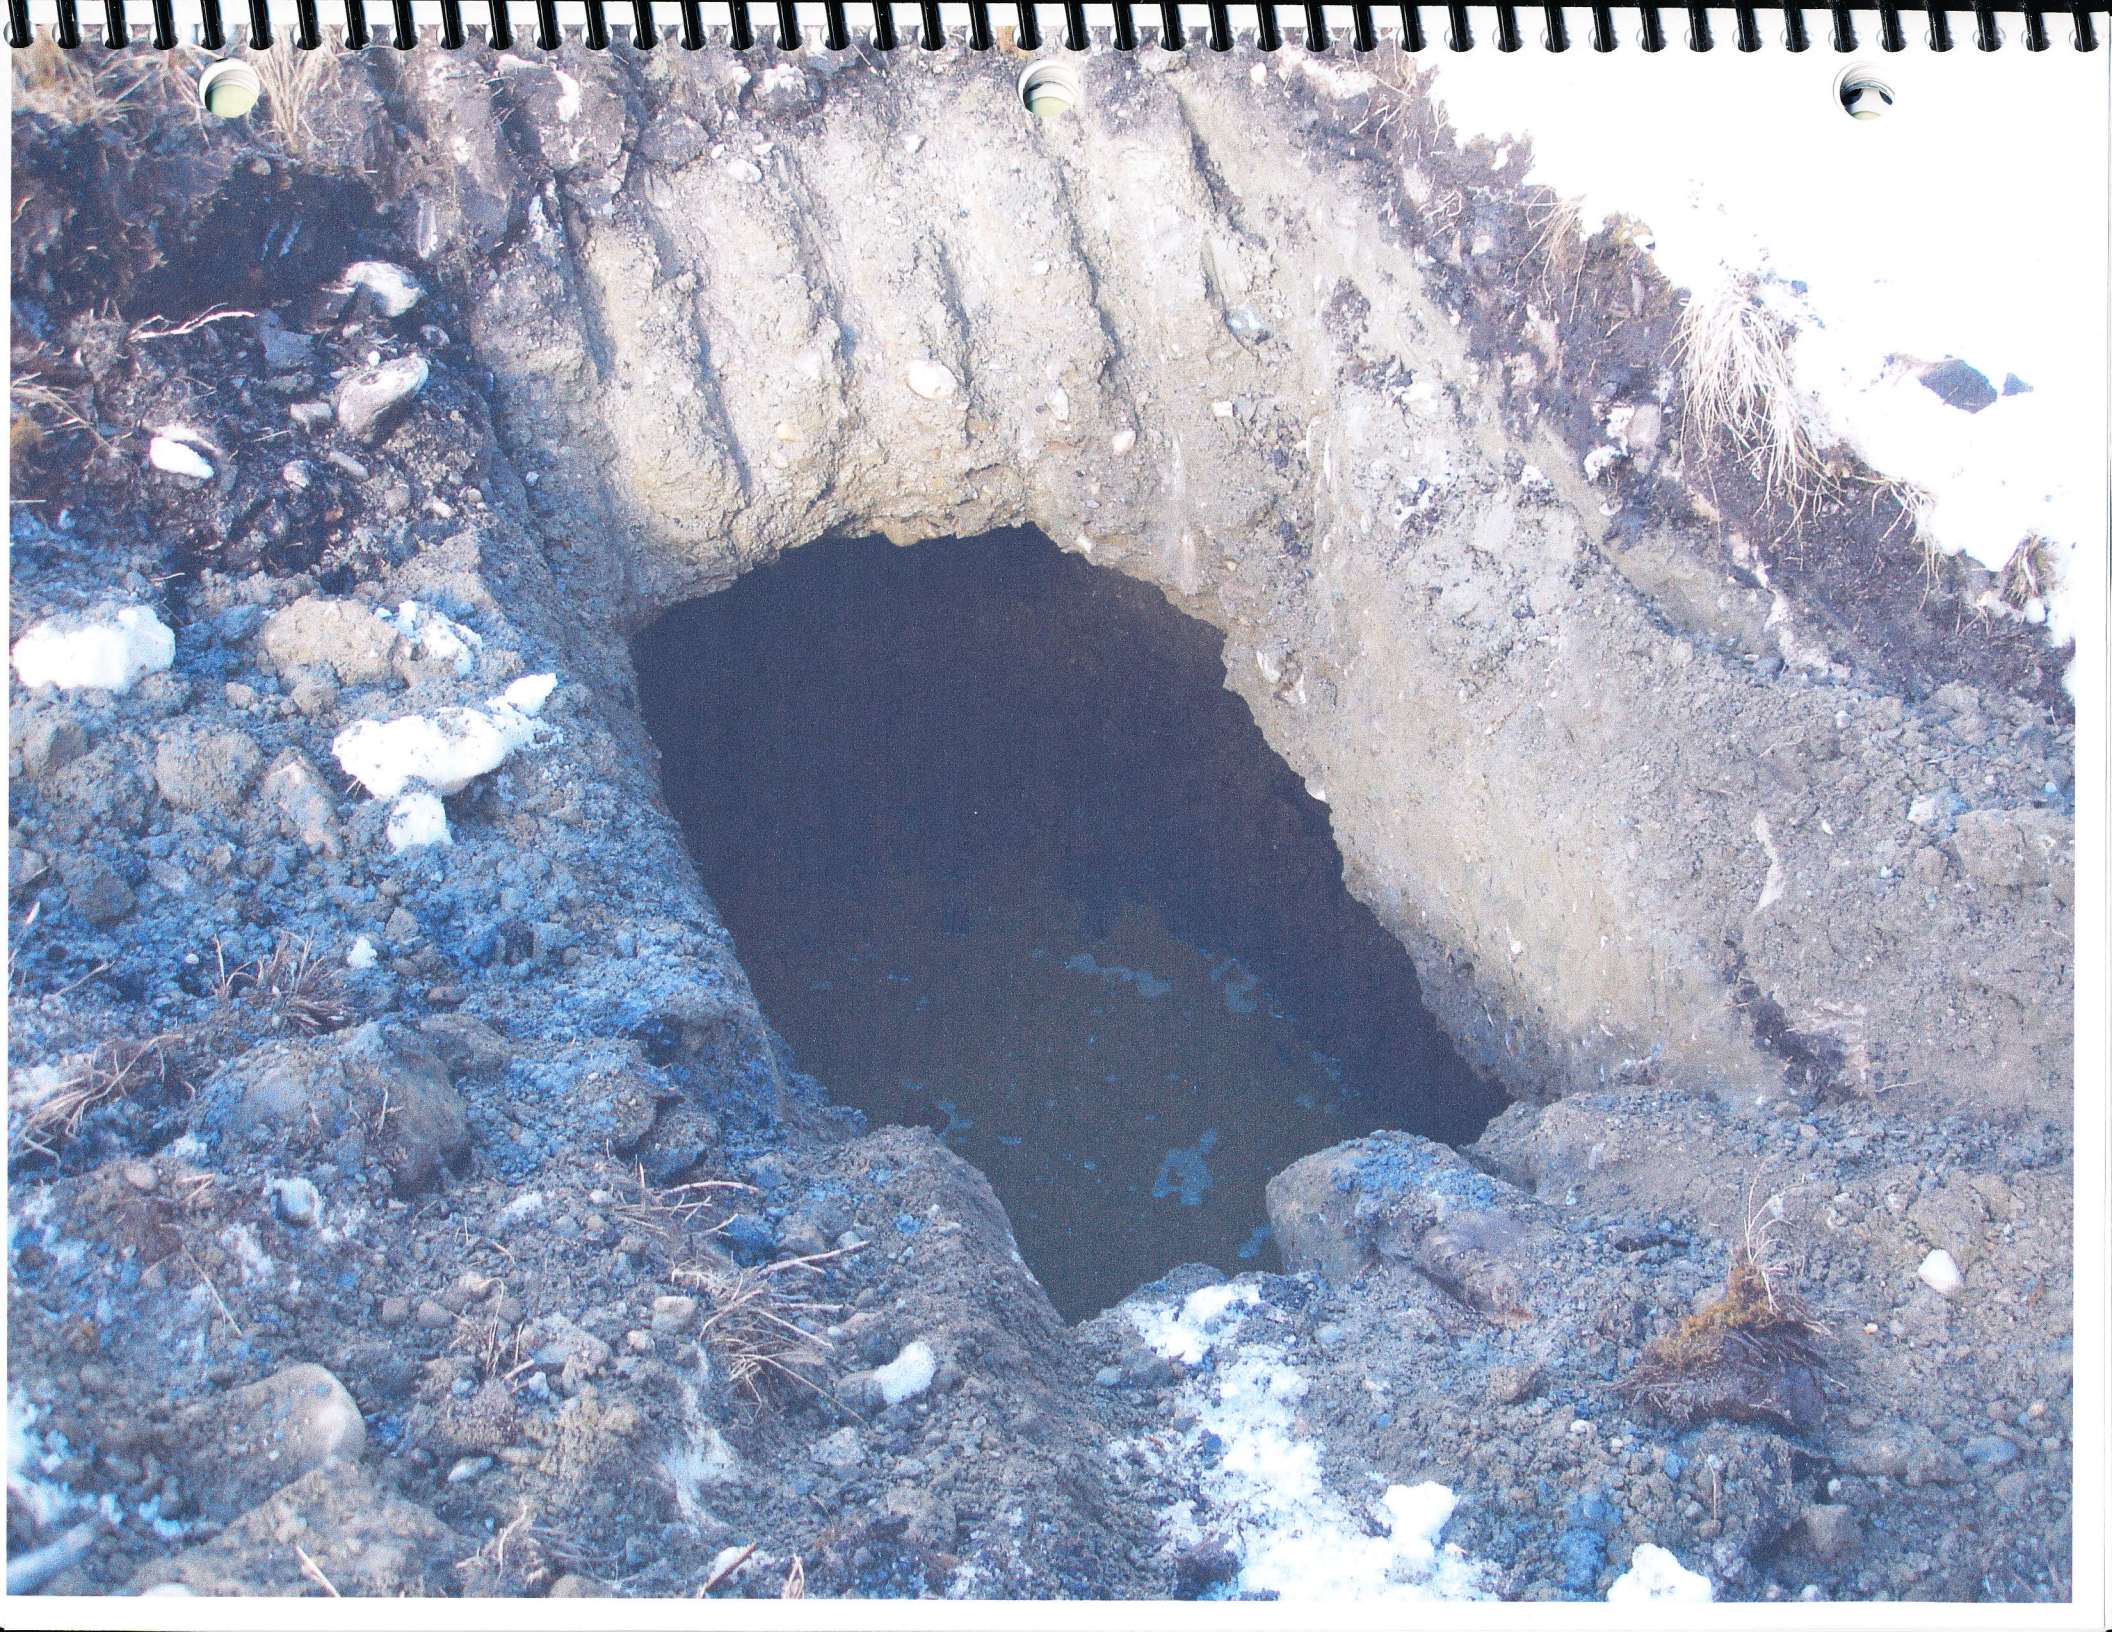
Test Site Location

Pyrite Hole

The second pit excavated encountered water at 10 feet. At this site there was a brown gravel layer to the 10 foot level where it changed to blue grey gravel. No colours were panned. This blue grey gravel was loaded with silver pyrite. No bedrock was reached. A third test pit was excavated on the bottom of the drainage 3 mile lease where it comes into contact with the Pelly River bench gravels. No water or bedrock was reached. One to three colours occurred in the pans.

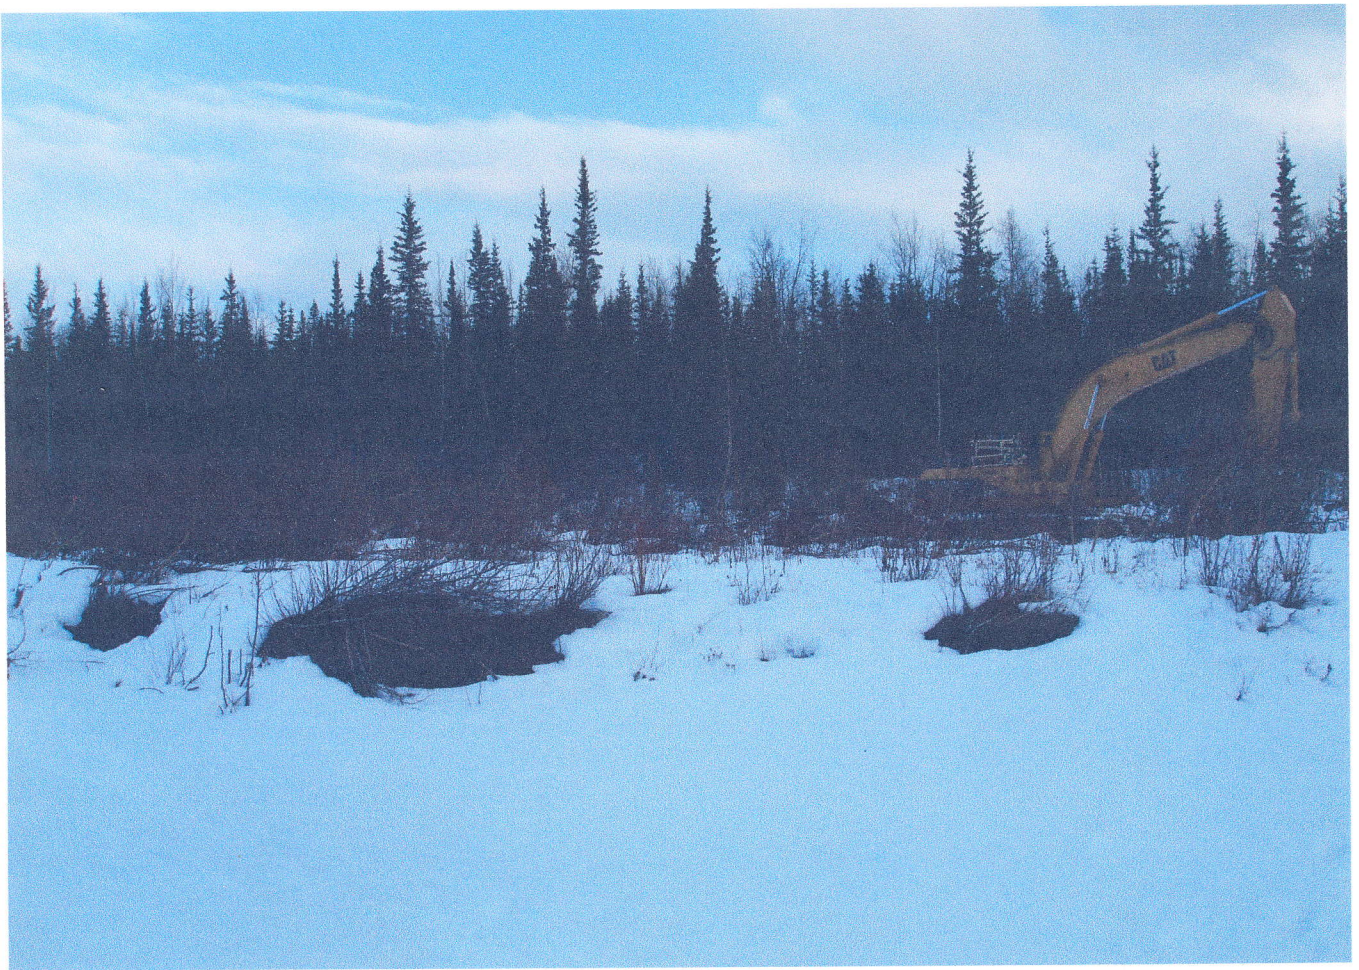
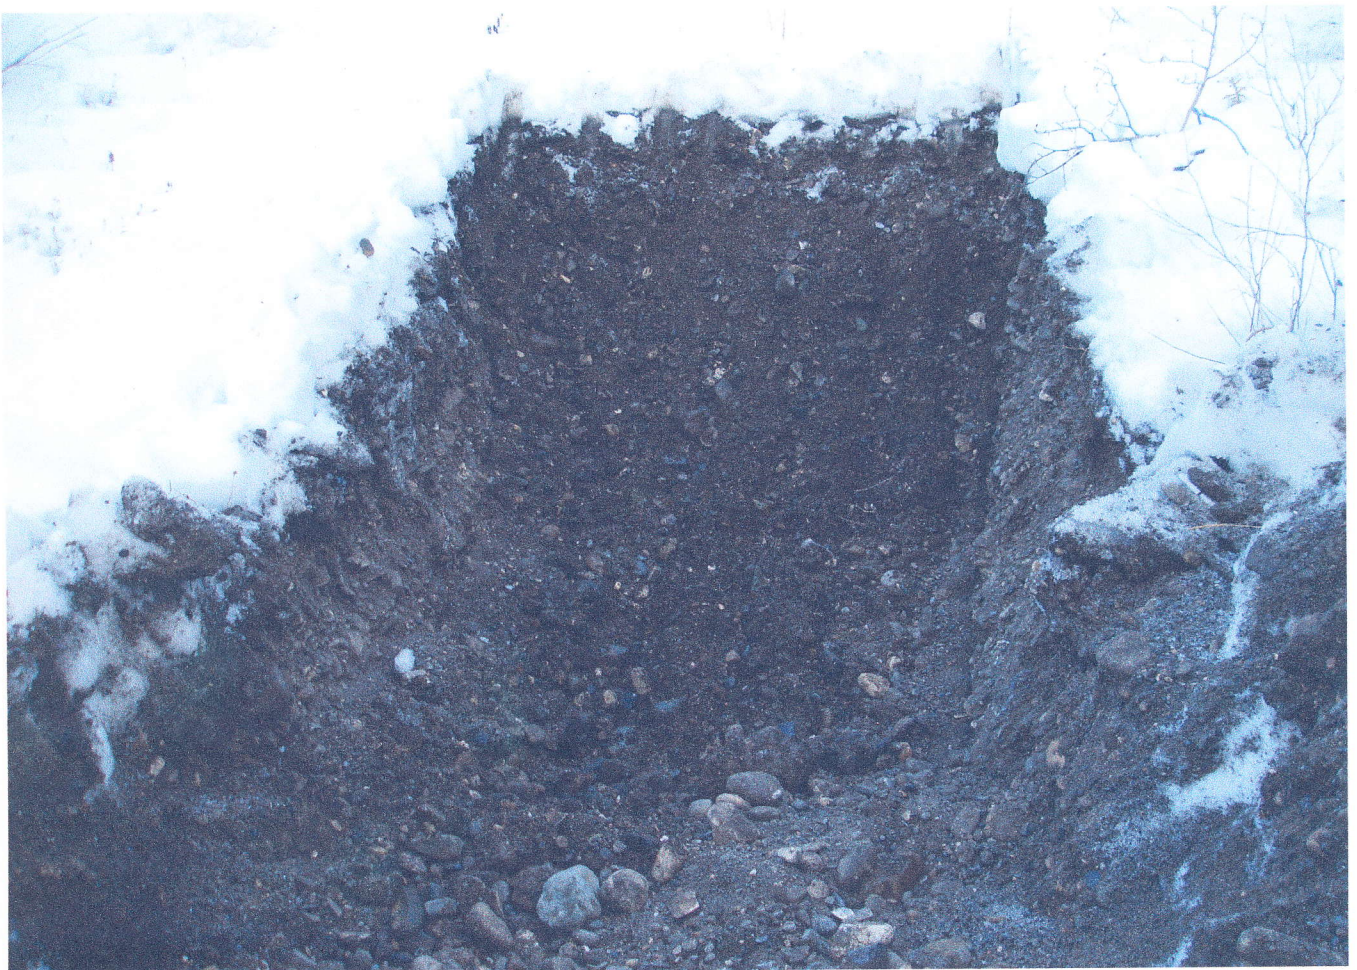
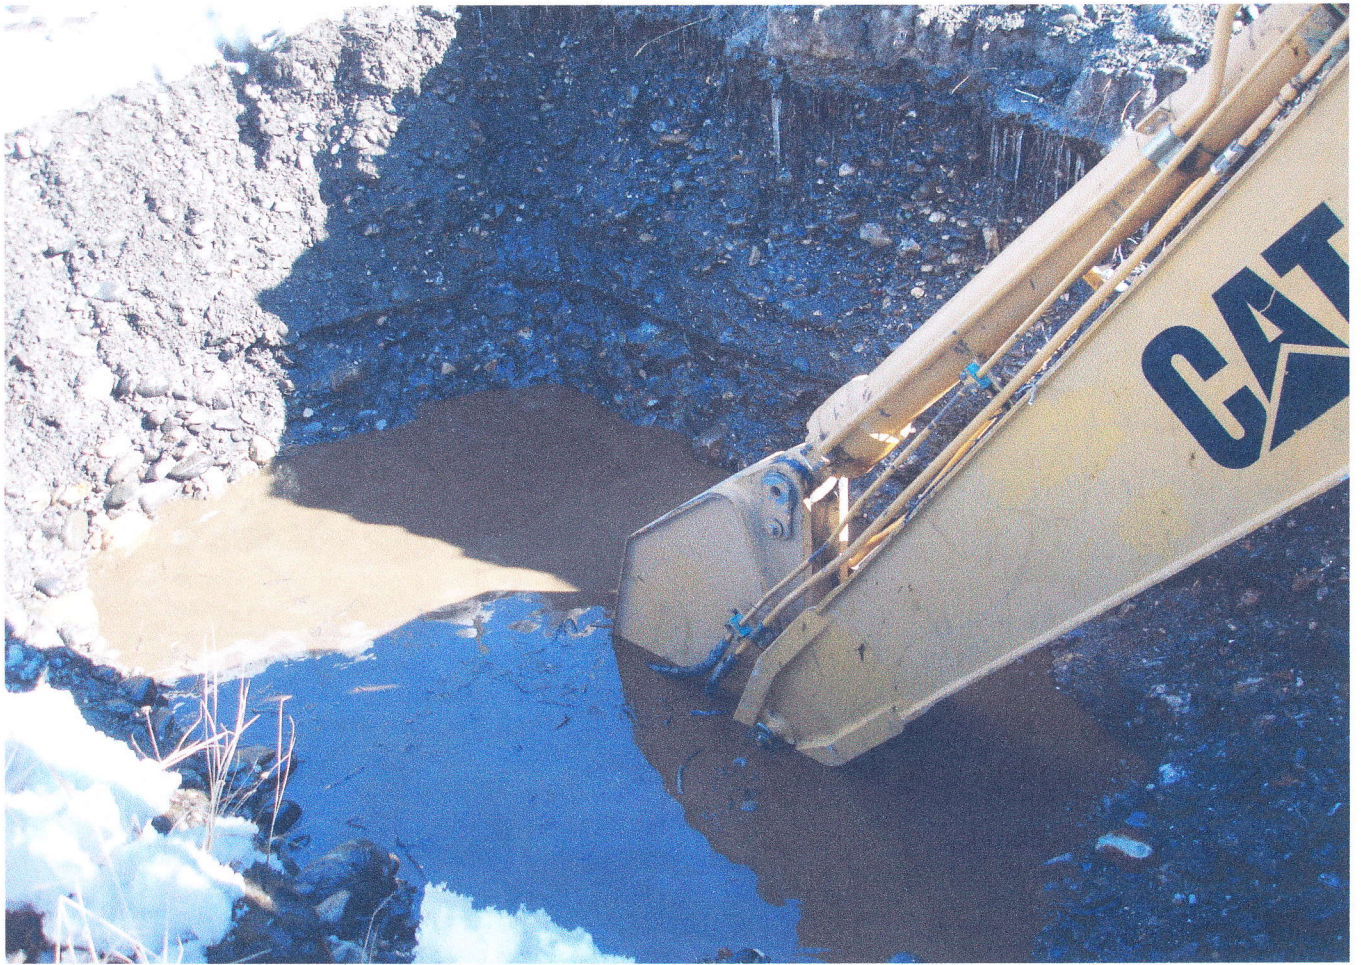
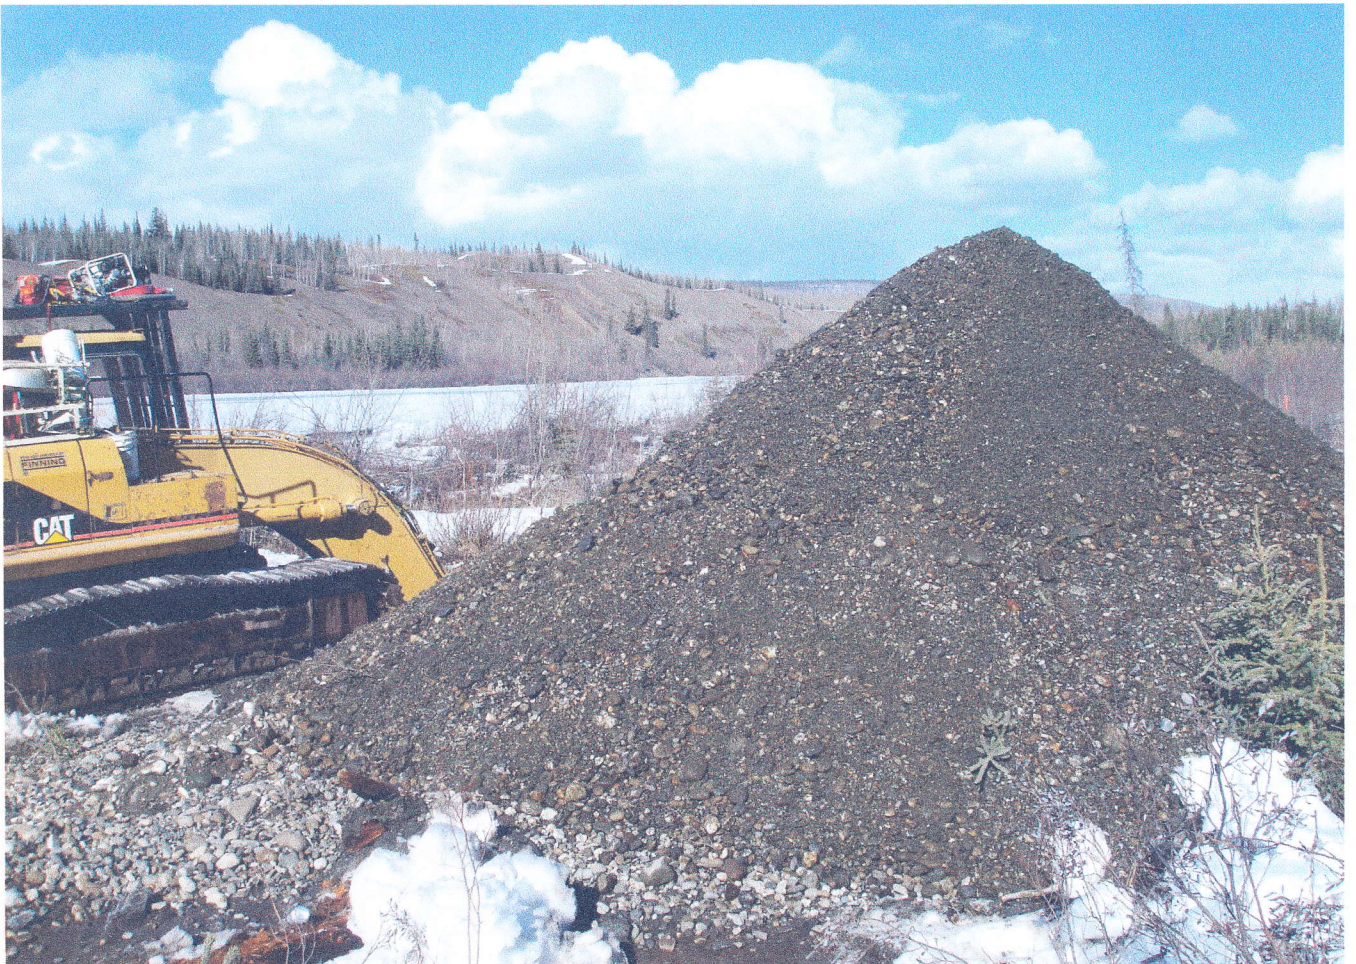
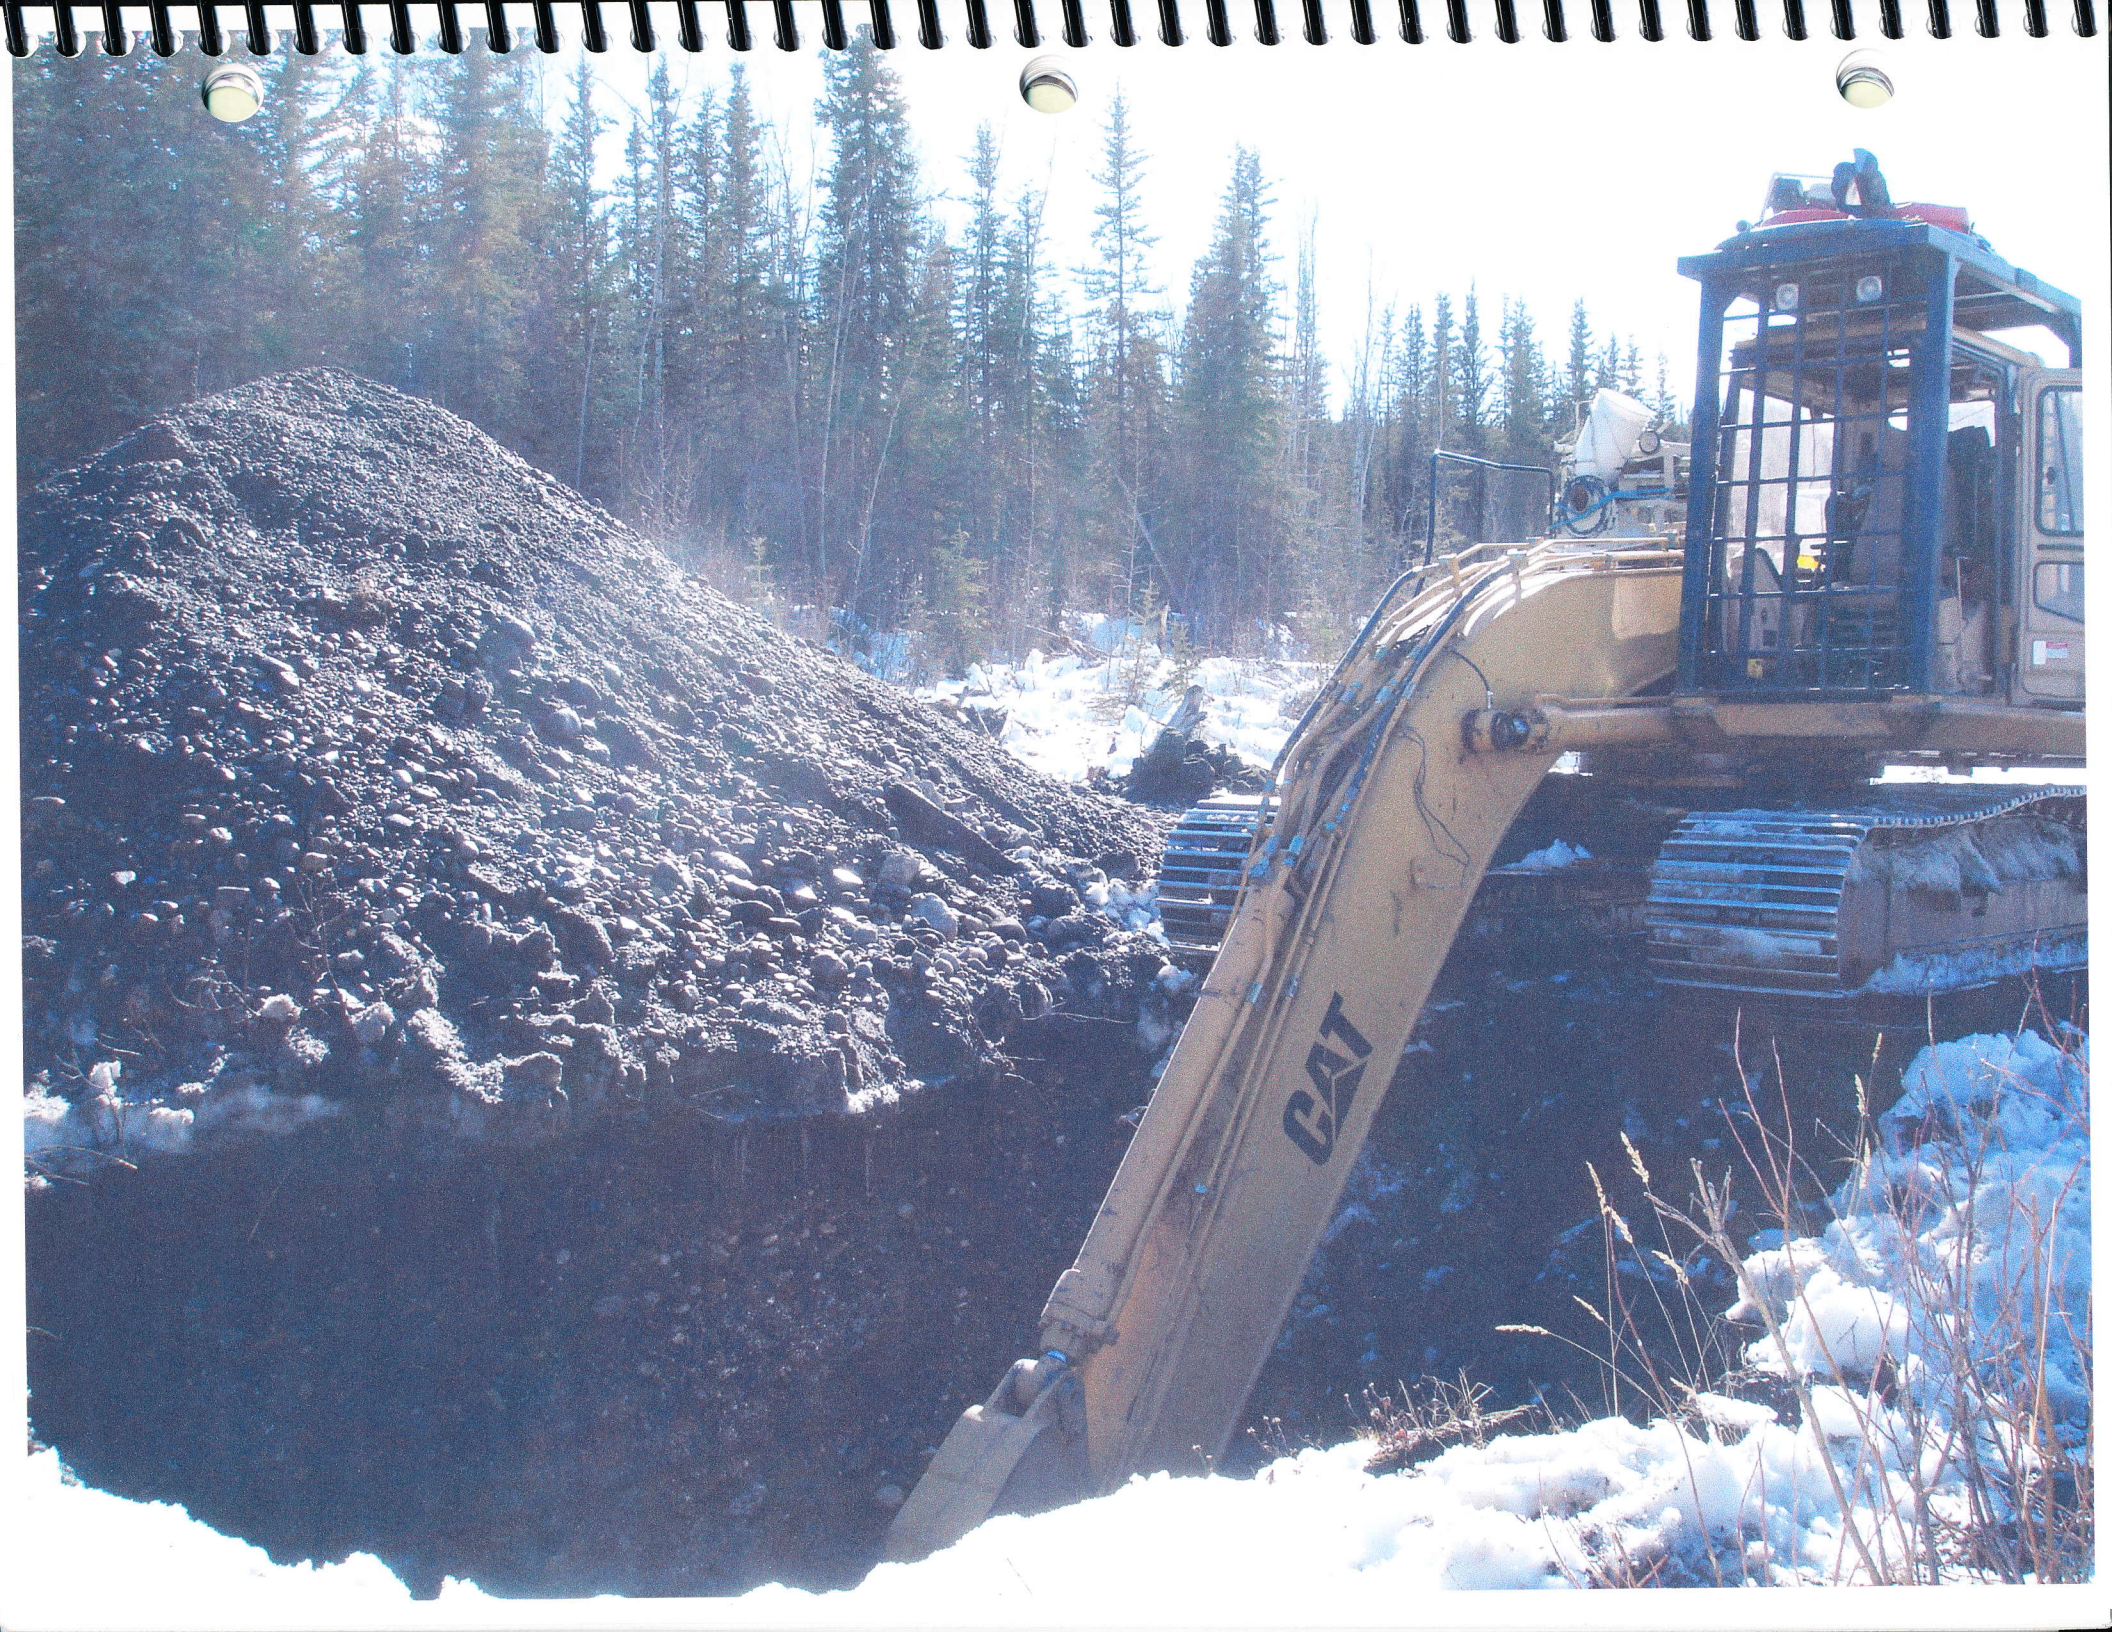
Test Site Location

Test hole on River

On the Pelly River flood plain a pit dug to 25 feet never reached bedrock. Water was encountered at 7 feet. Panned one to three colours below the 7 foot mark. Two more pits were excavated to 25 feet on the river bench. Both showed trace gold with one to three colours per pan in gravels from test sites. No bedrock or water was reached from these 2 sites. Only one test pit reached bedrock. At the 8 foot level where a one yard bulk sample was processed. .1 gram of gold was recovered. The four test areas all contained trace placer gold. See pictures for material types.
