**YEIP
2007
-042**

**Report of 2007 Field Activities
Funded under YMIP Grant #07-042**

NAME OF PROJECTS AREAS

**ALAN DENDYS
PROSPECTOR / PLACER MINER
BOX 31450
WHITEHORSE, YUKON
Y1A 3T5**

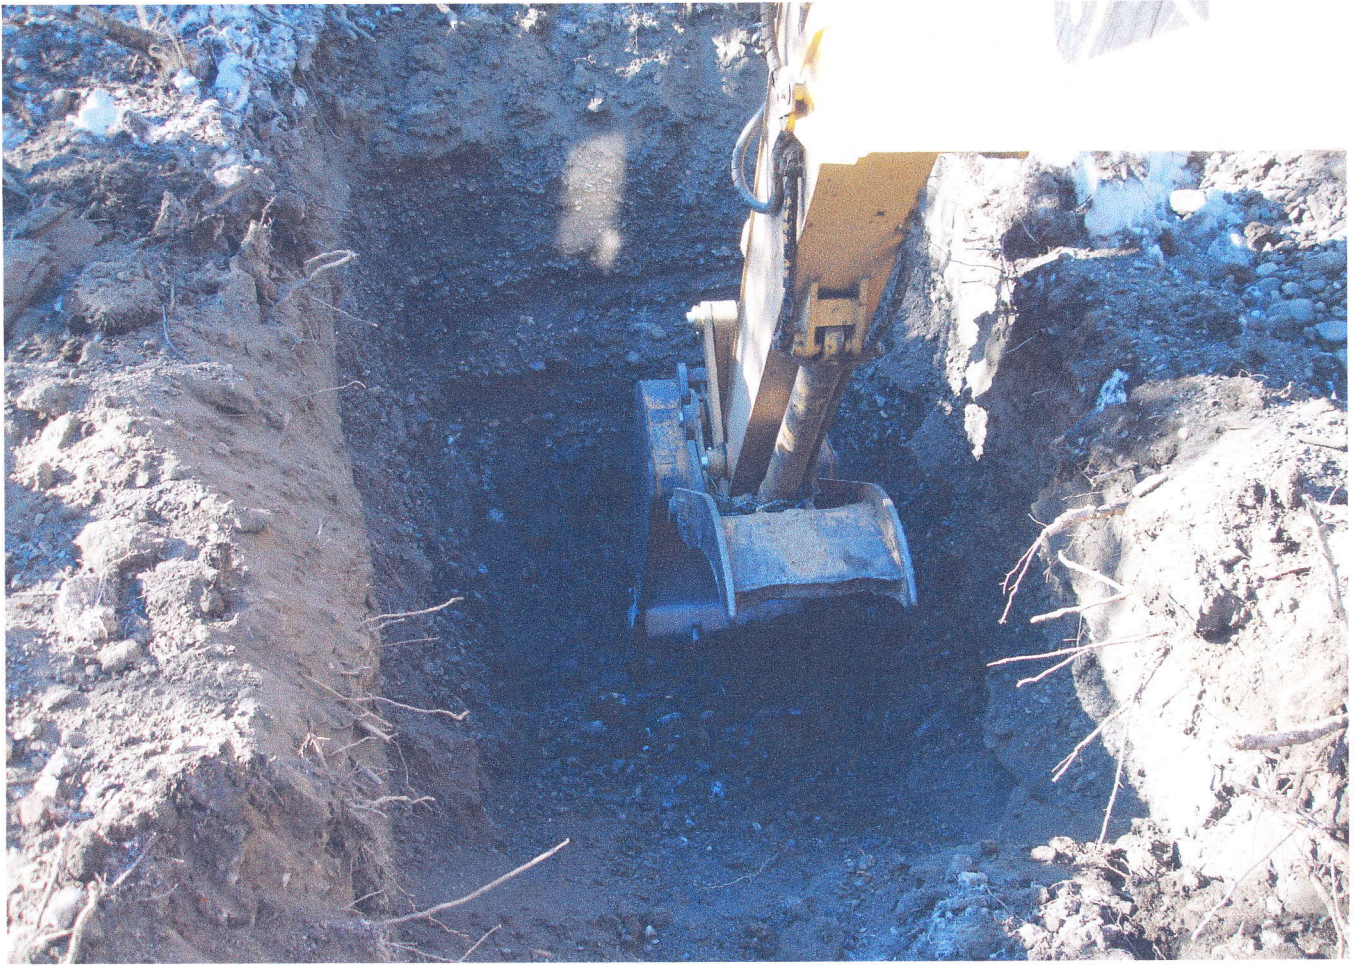
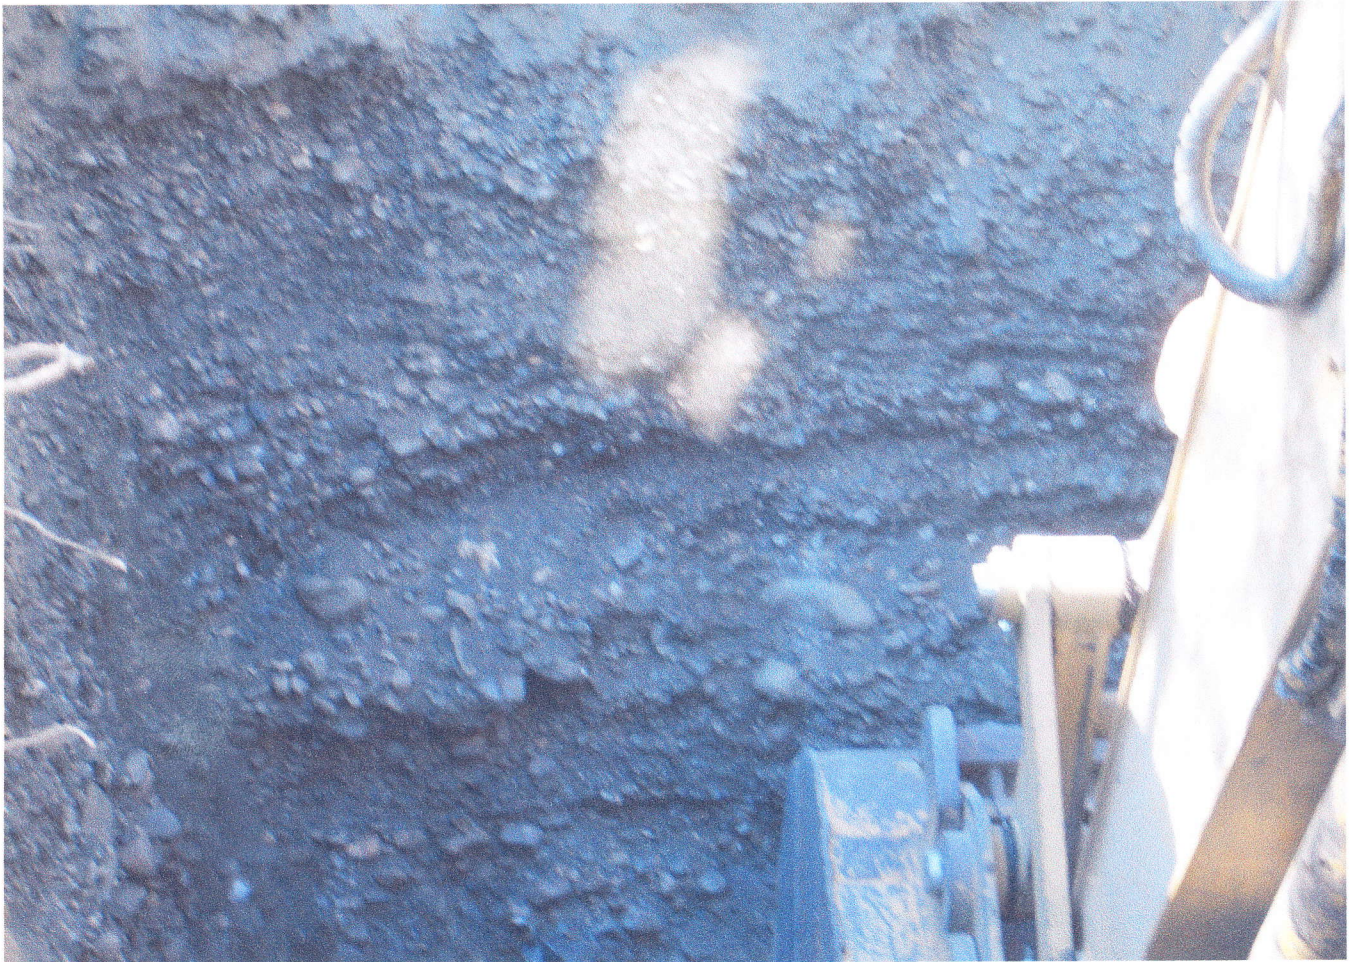
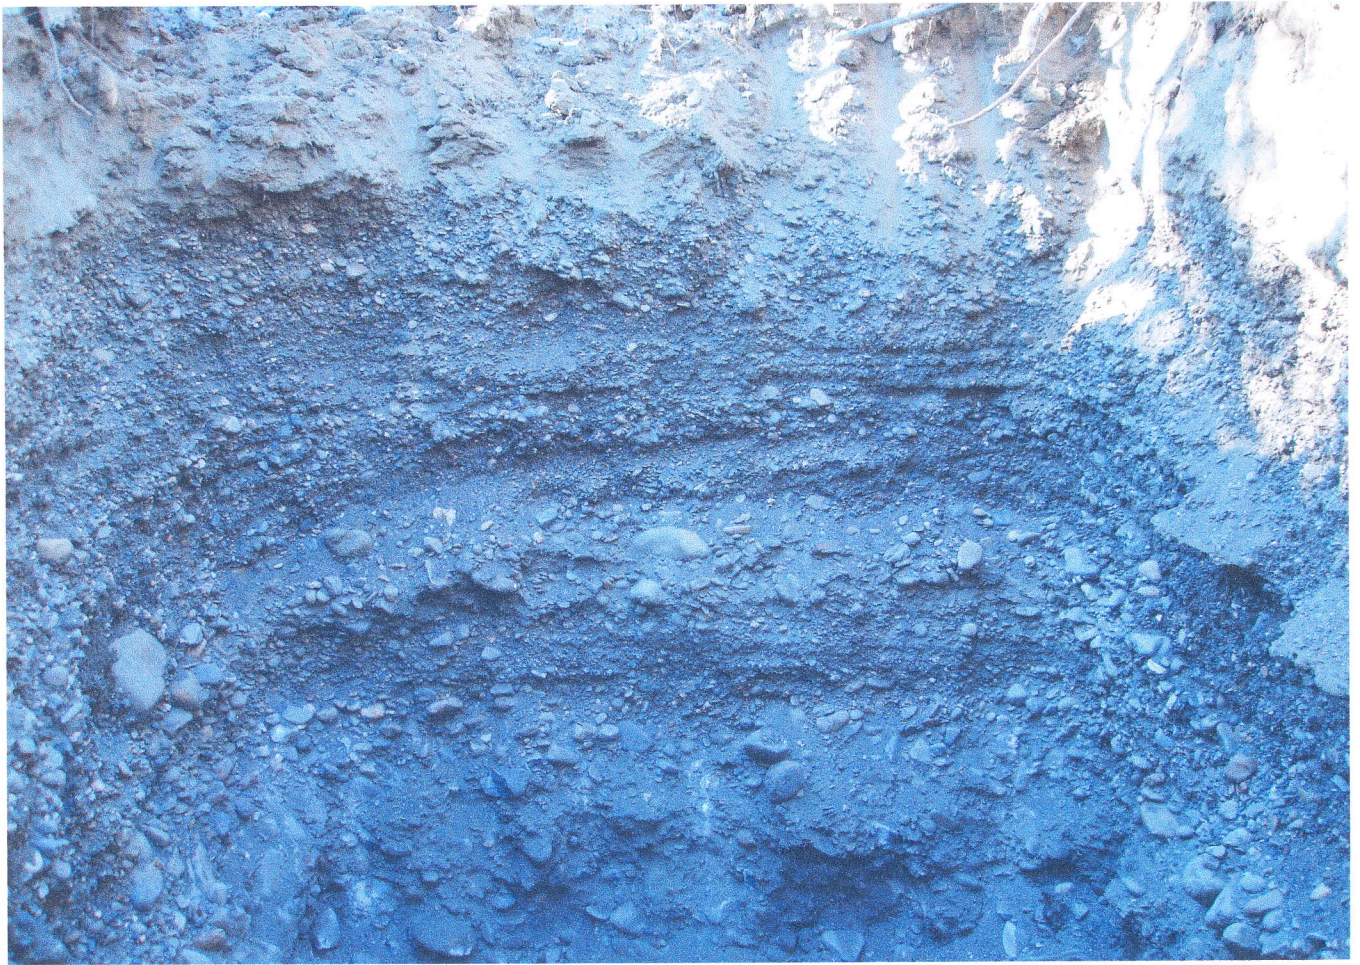
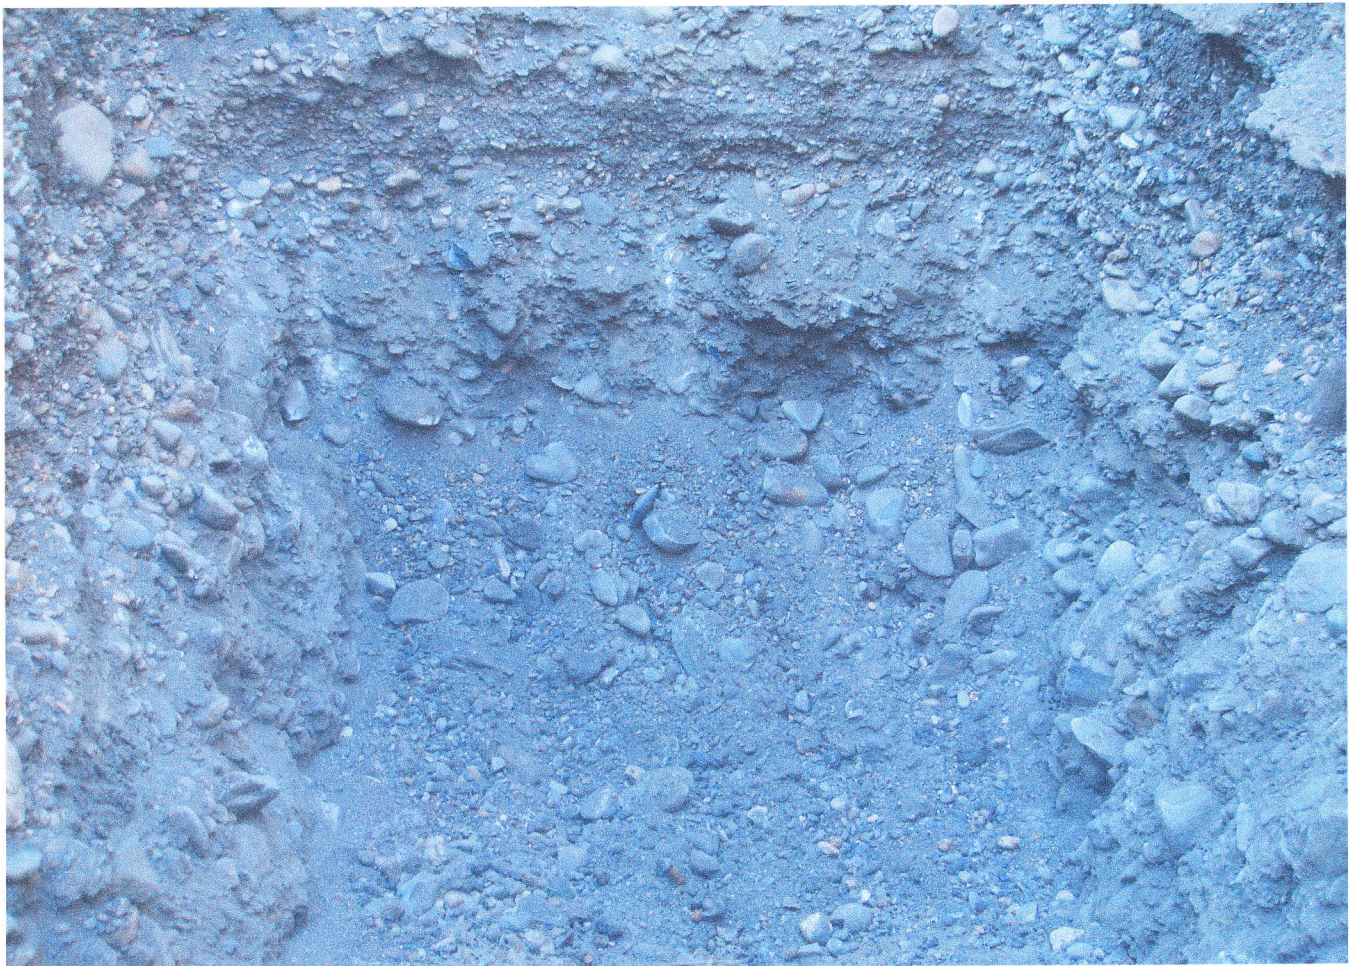
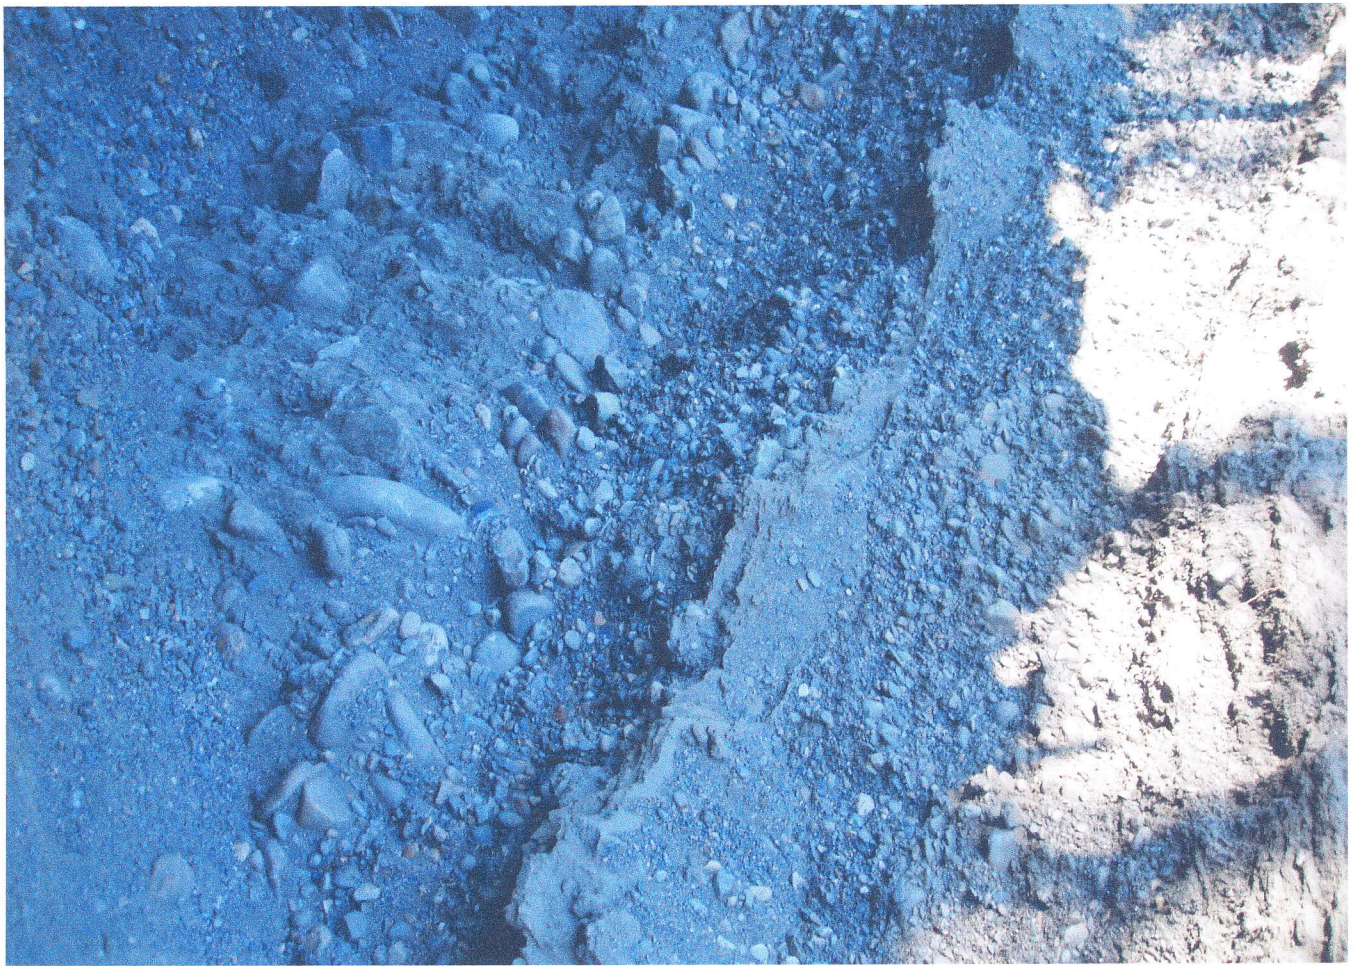
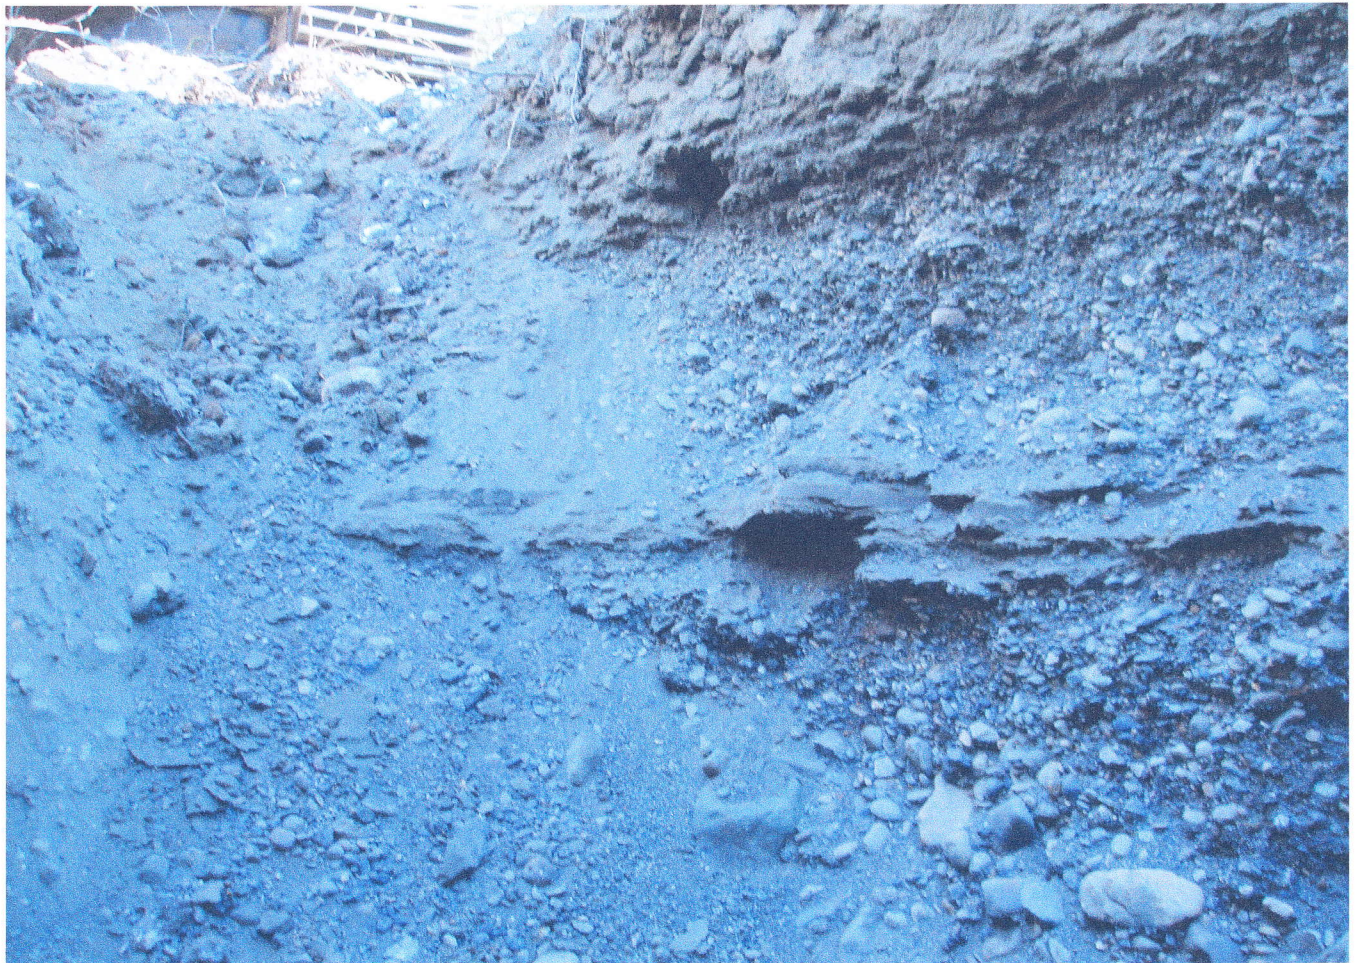
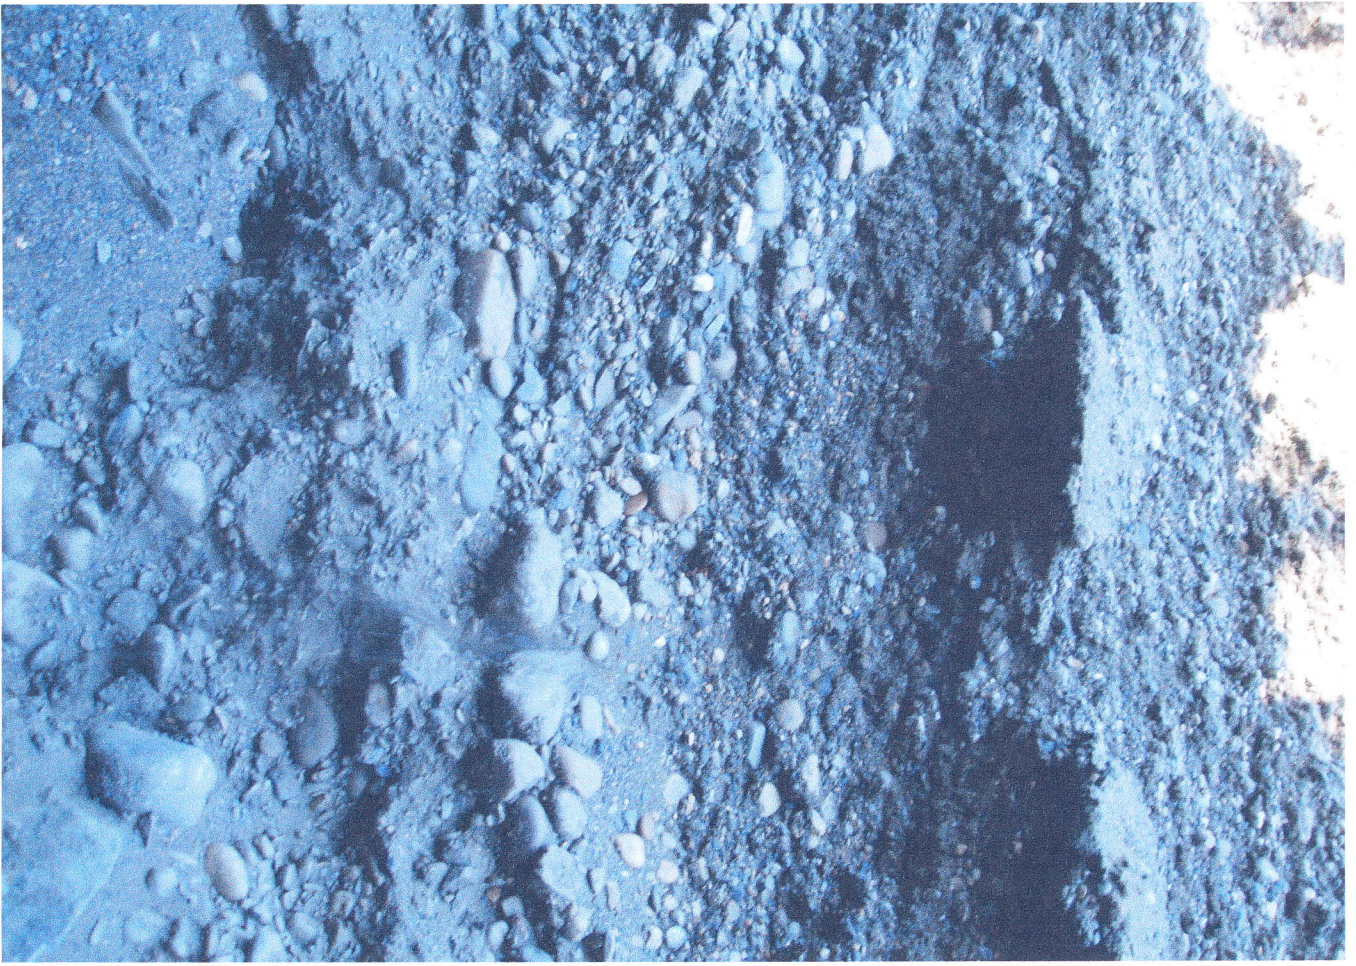
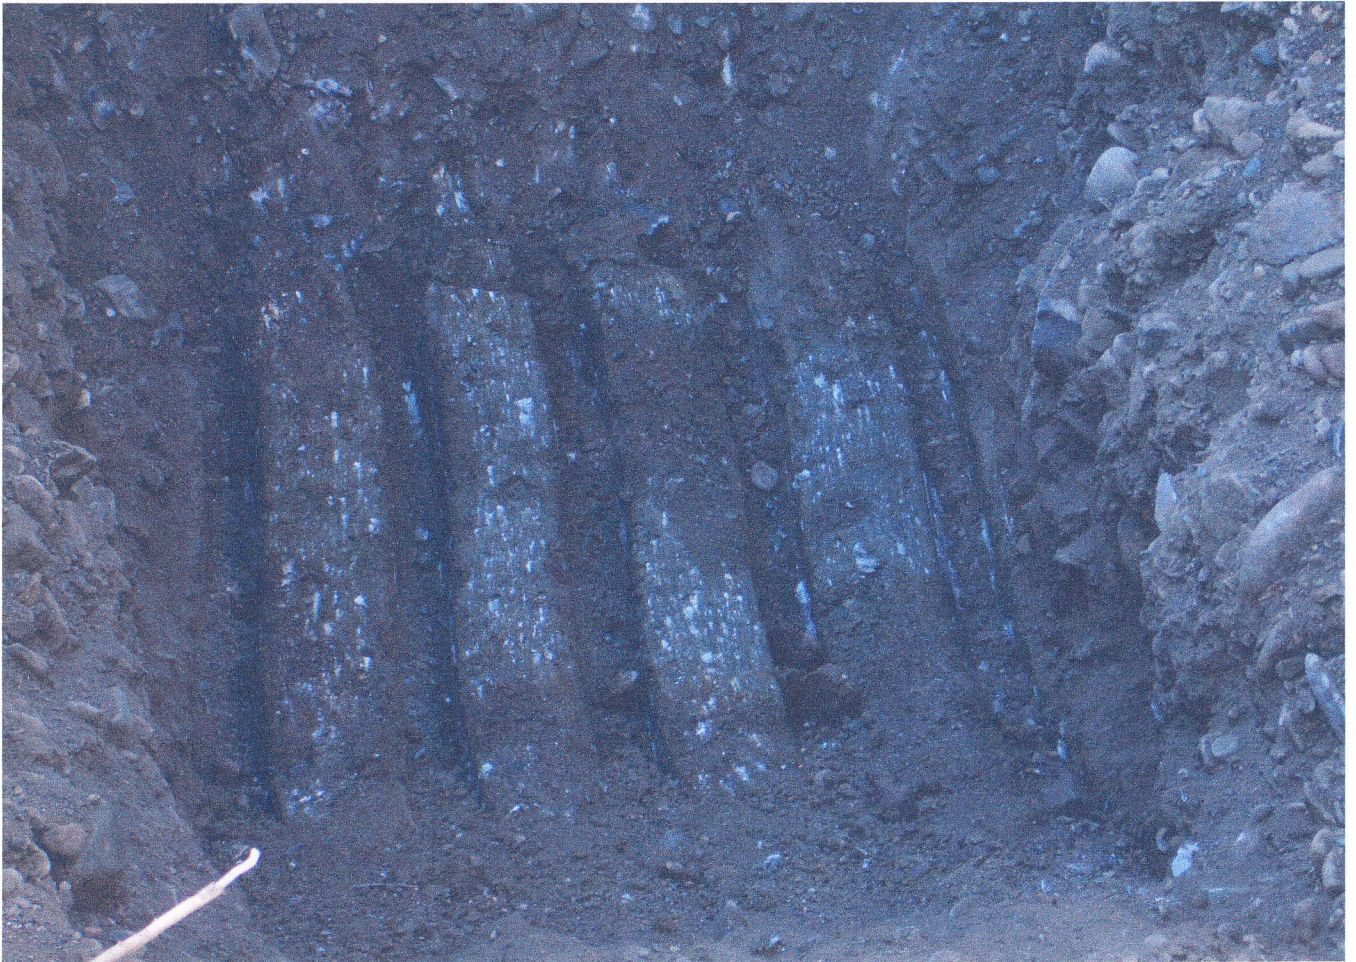
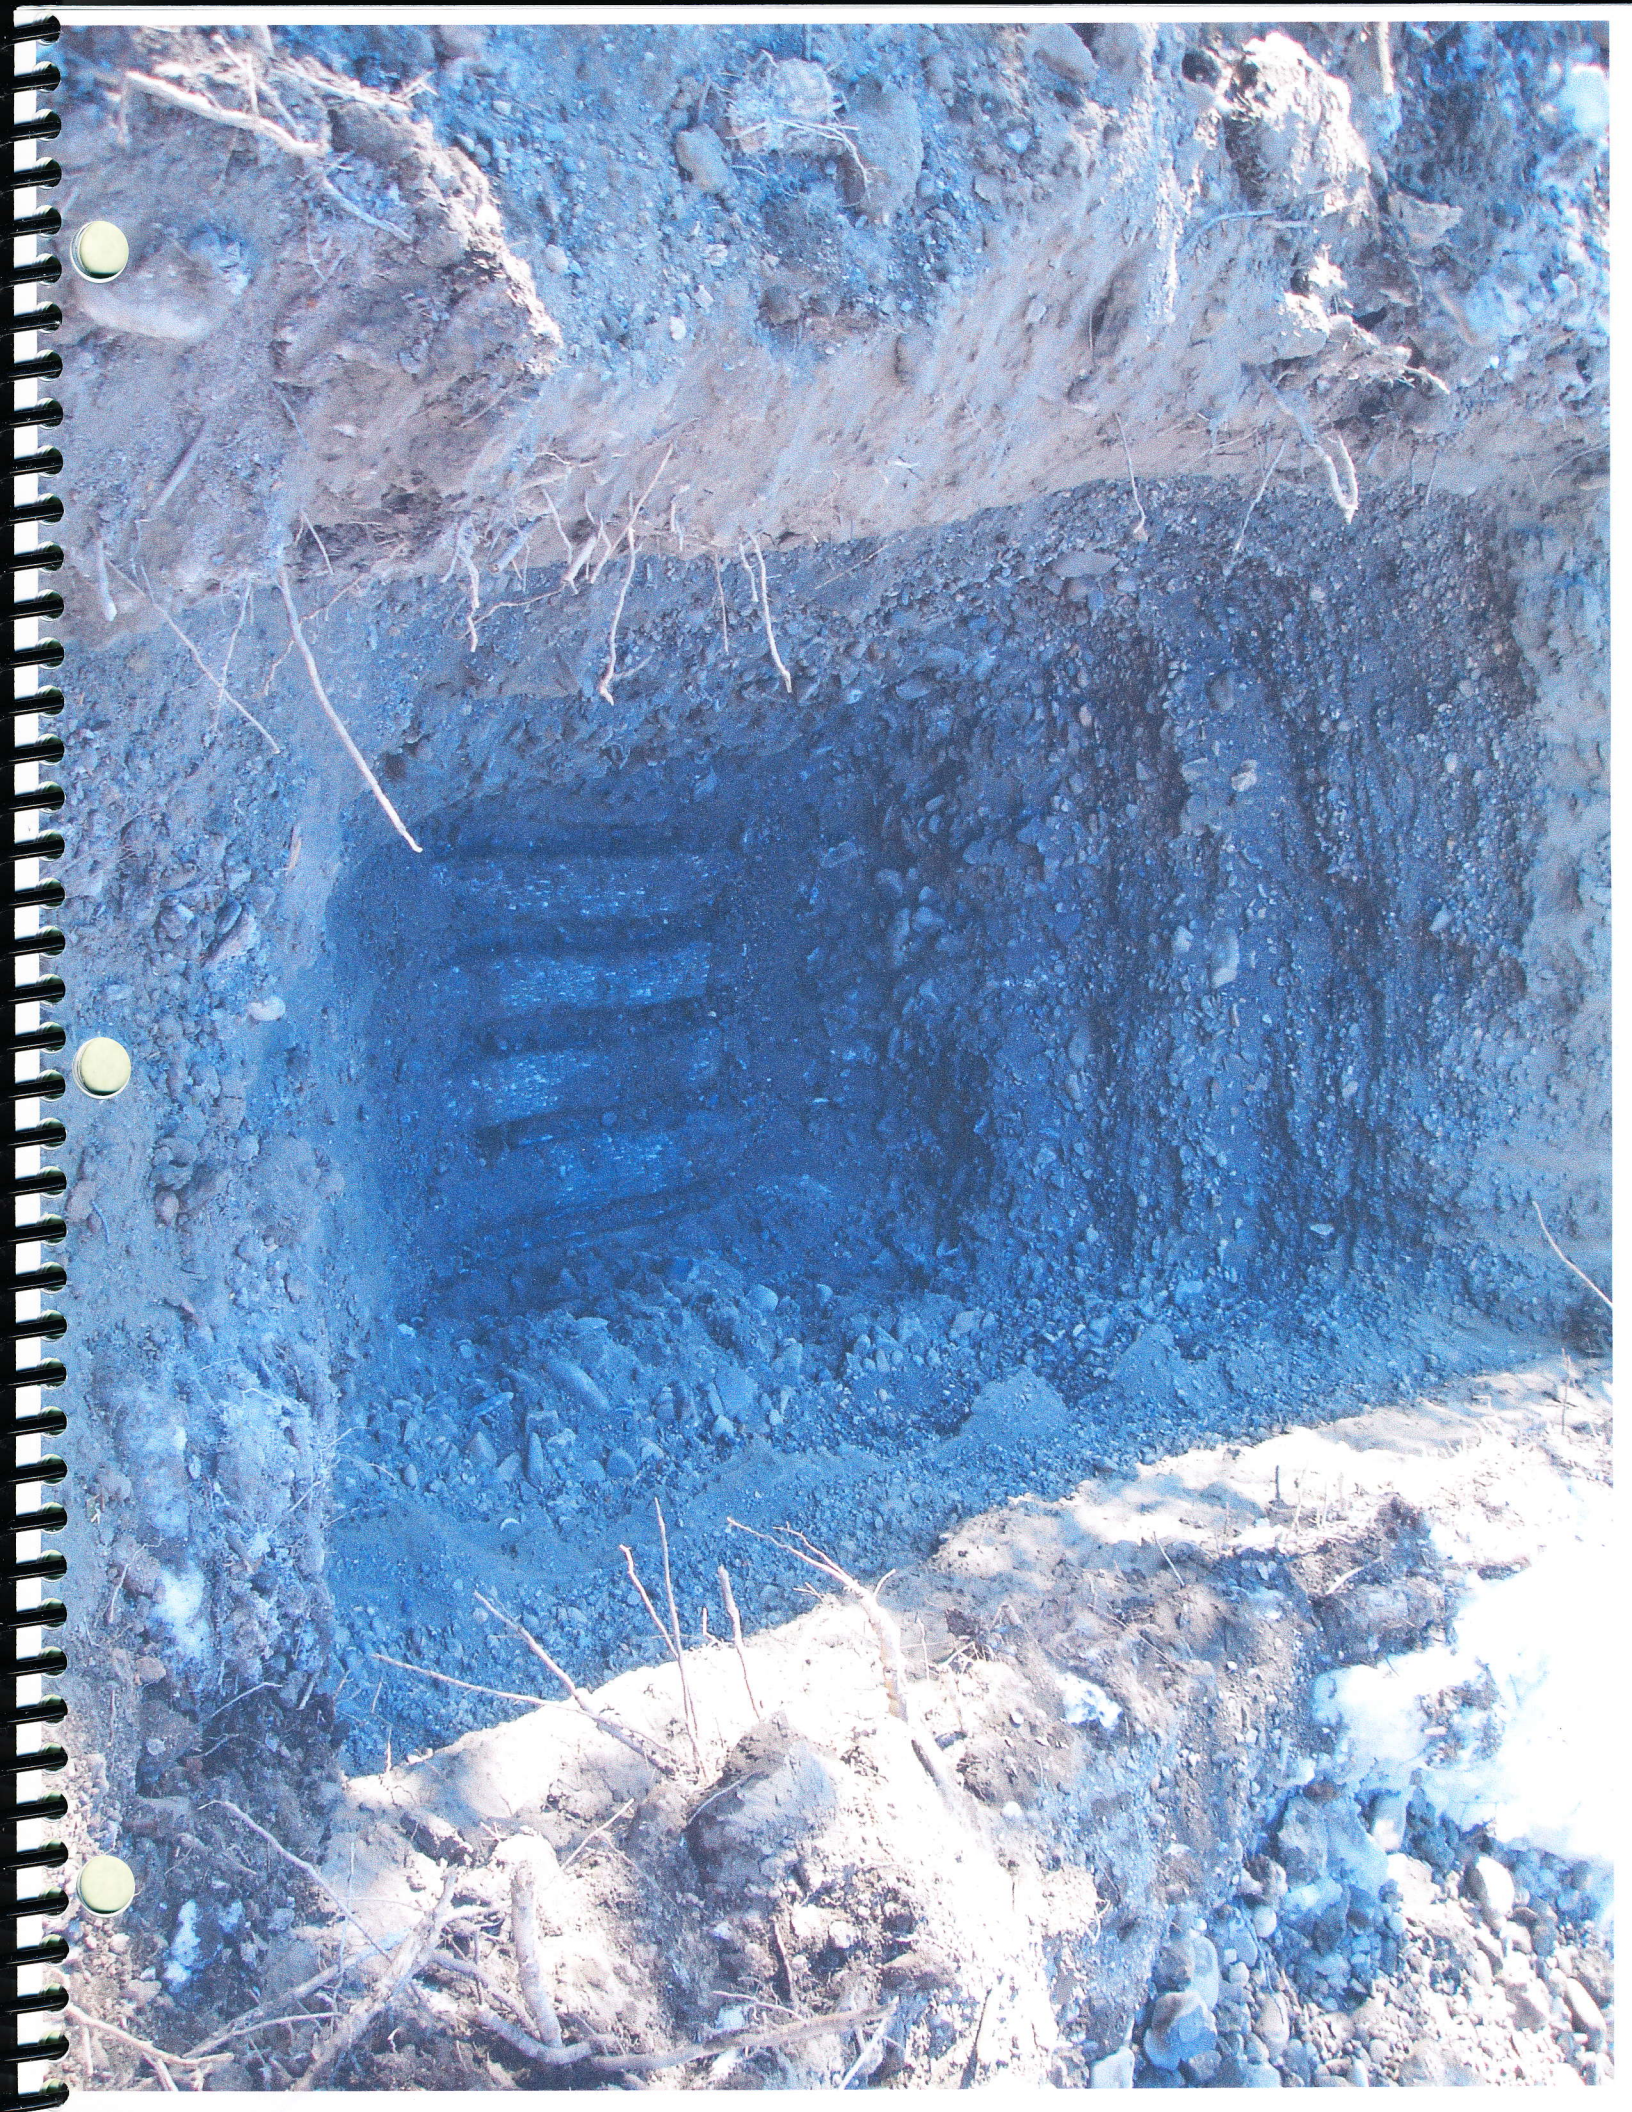
Test Site Location

Pelly River 5 Mile Pit # 2

Frozen layer 12 feet

Two gravel deposits above frozen layer
