**YEIP
2007
-042**

**Report of 2007 Field Activities
Funded under YMIP Grant #07-042**

NAME OF PROJECTS AREAS

**ALAN DENDYS
PROSPECTOR / PLACER MINER
BOX 31450
WHITEHORSE, YUKON
Y1A 3T5**

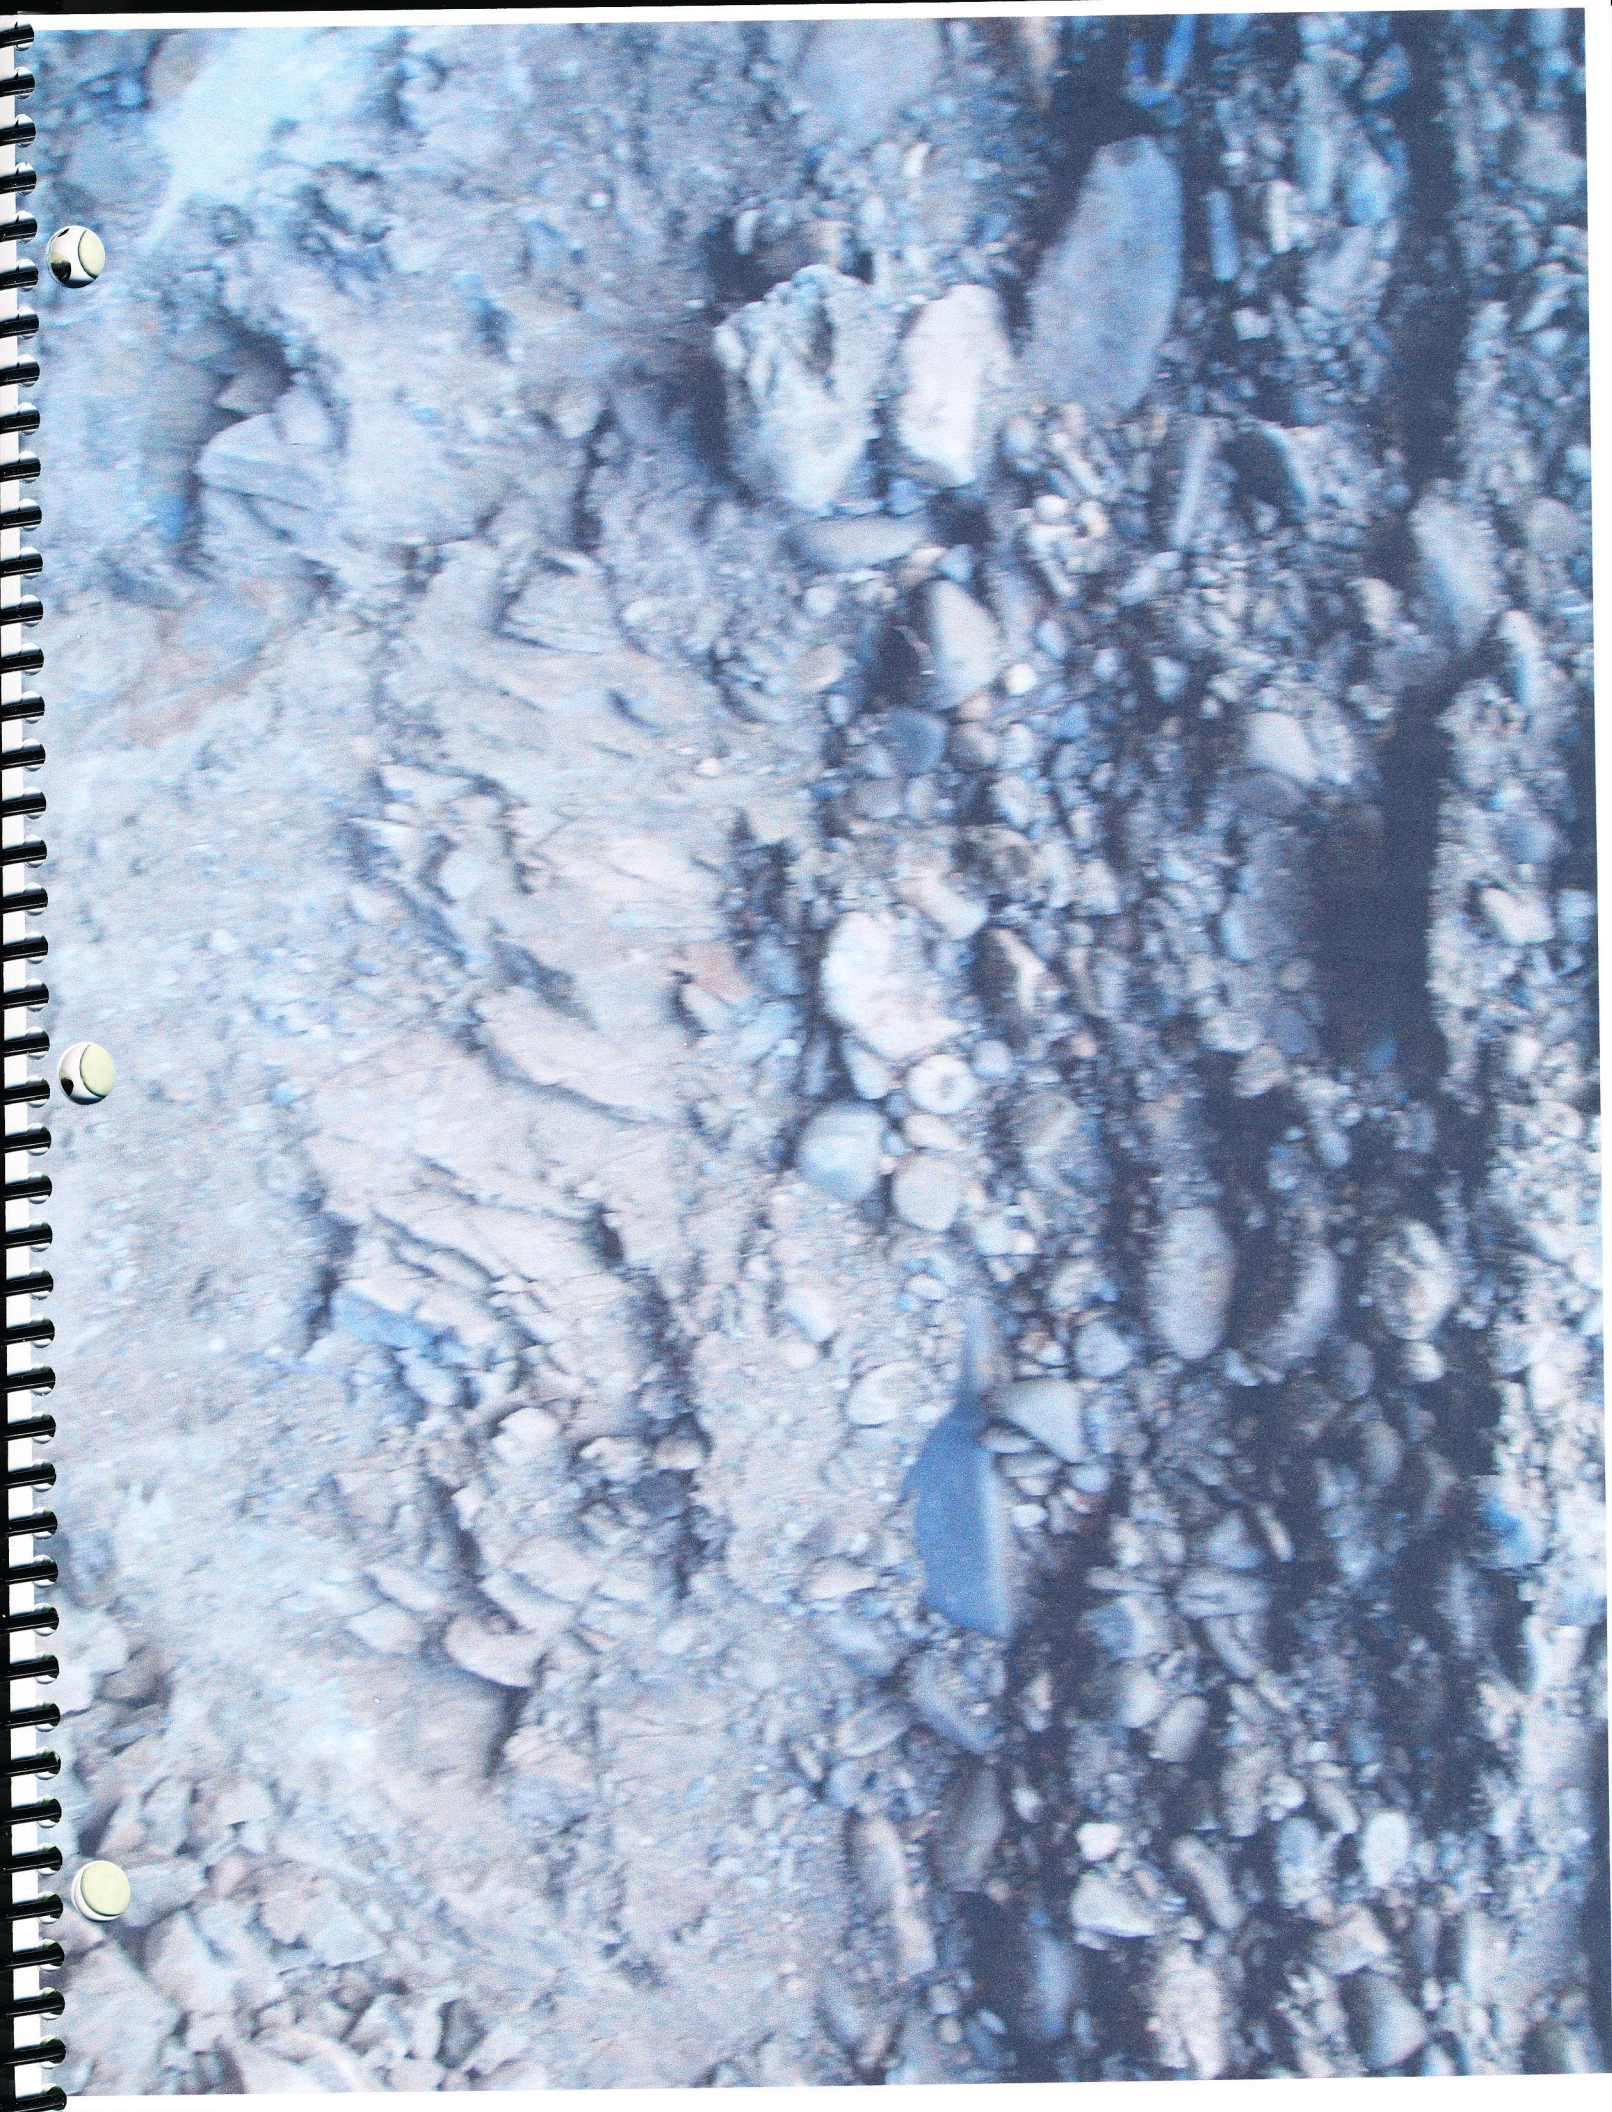
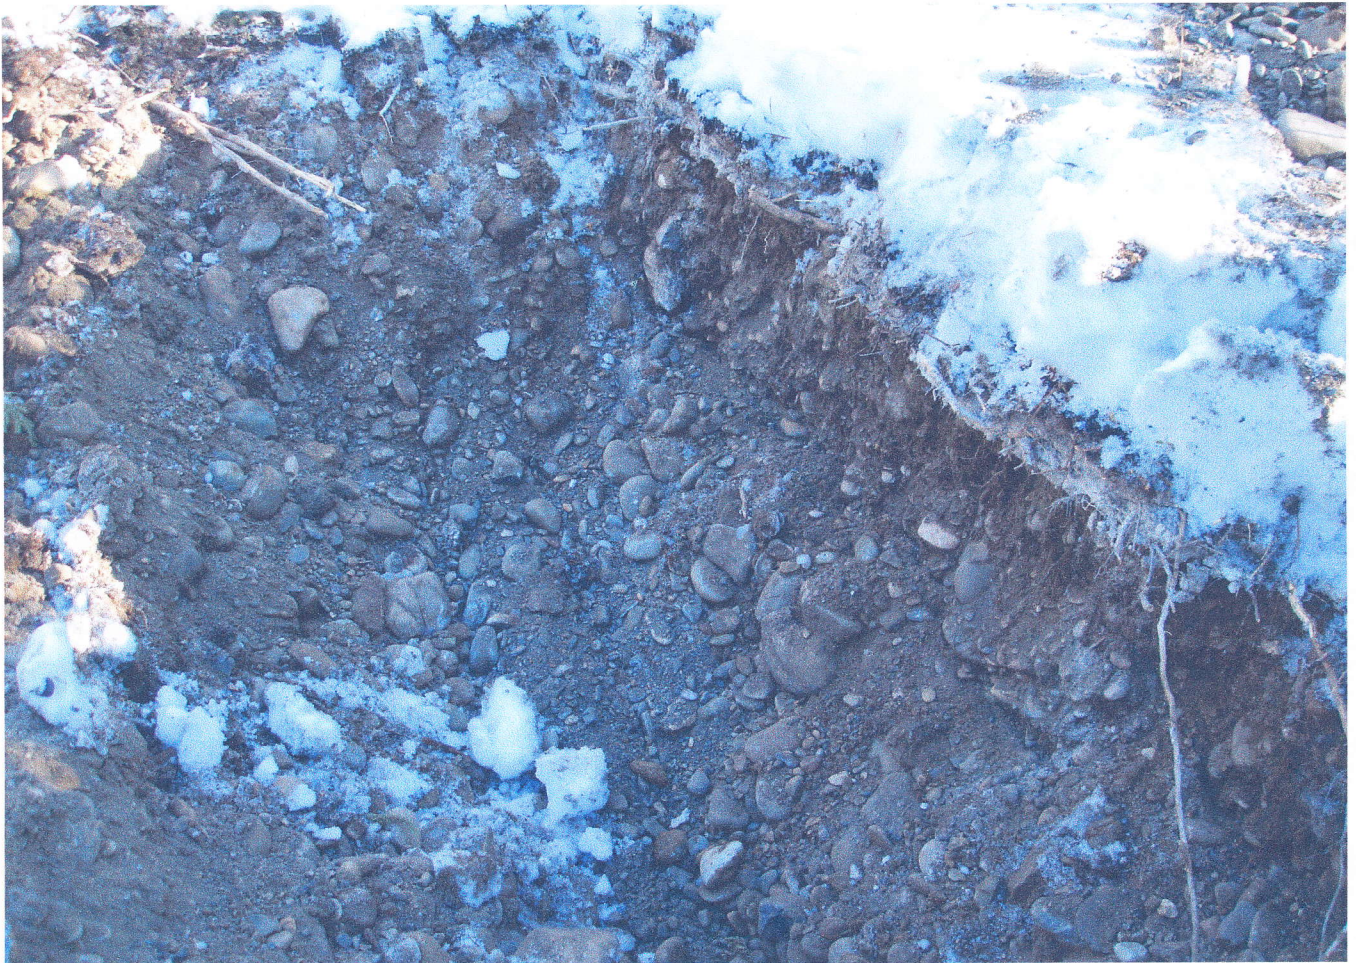
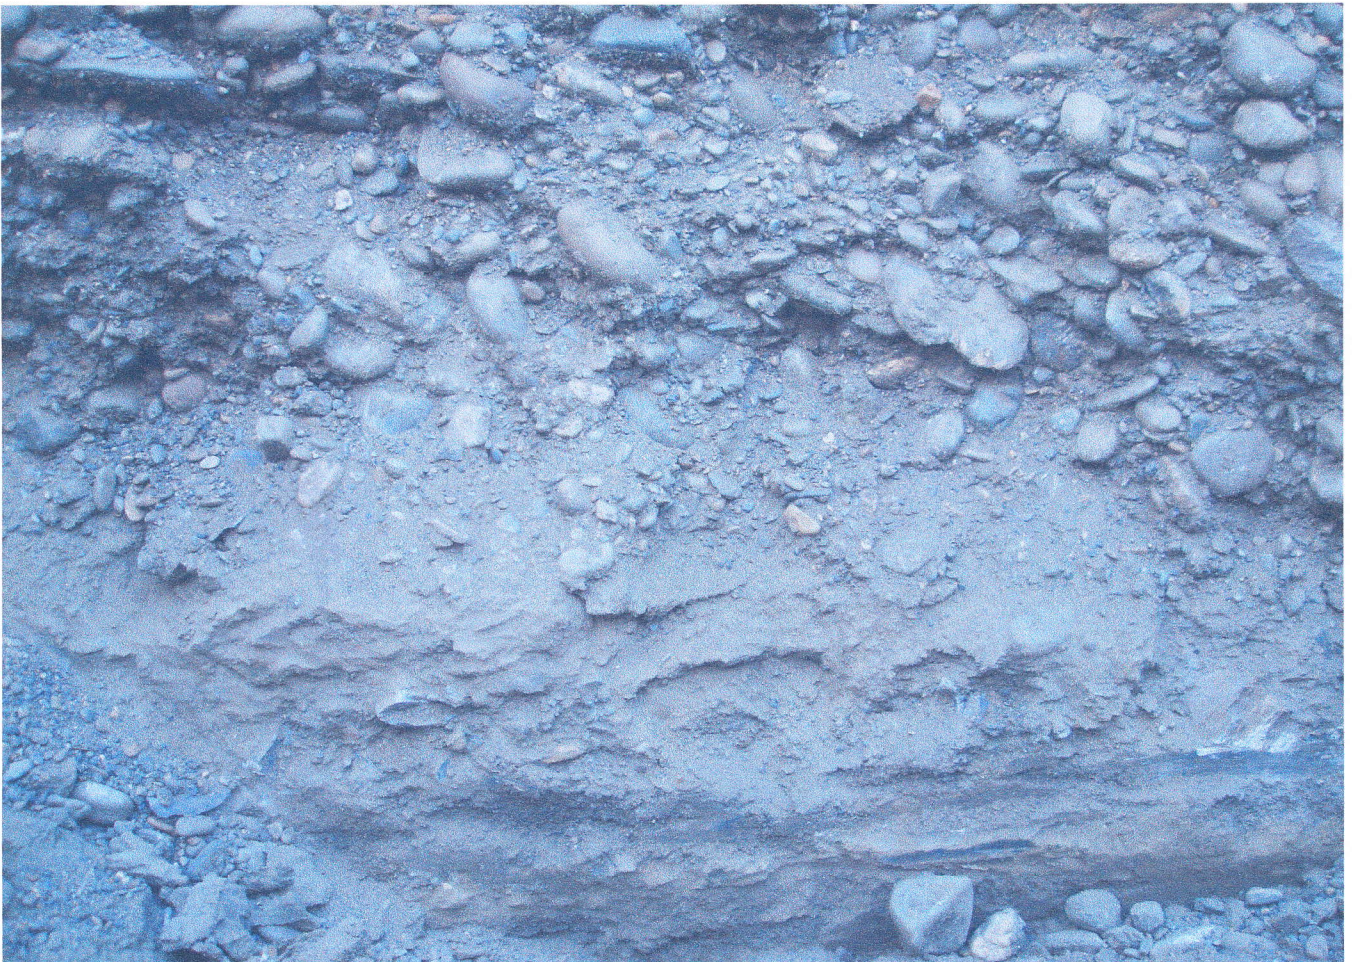
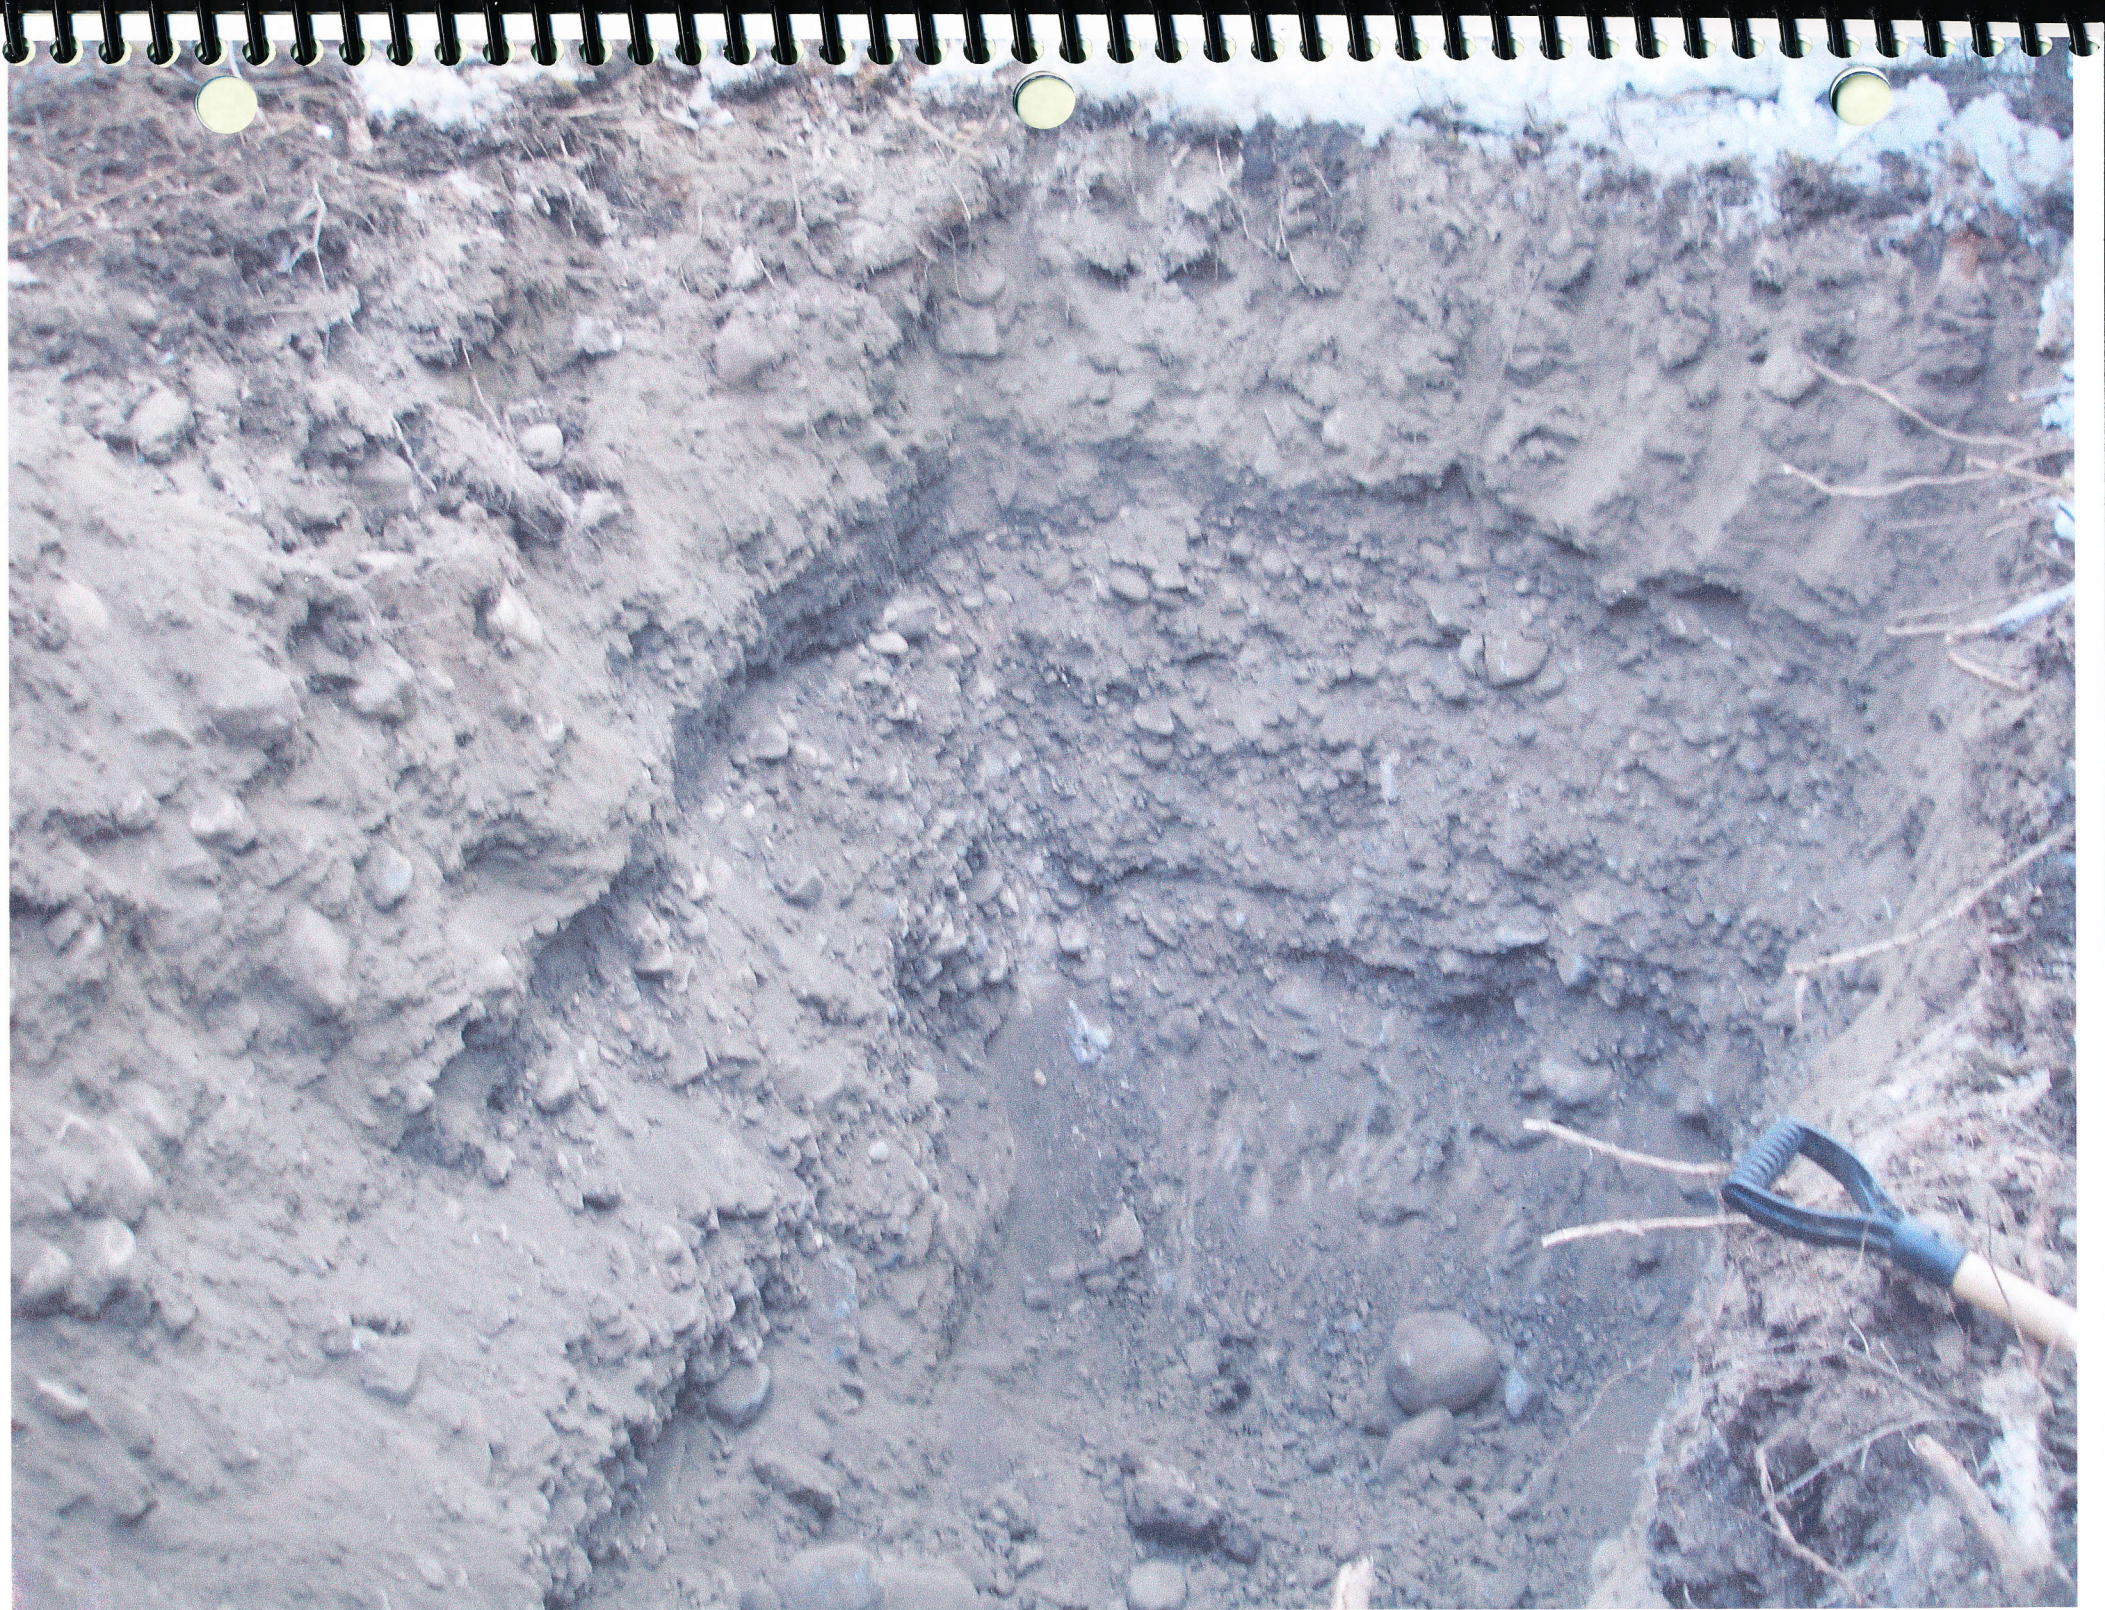
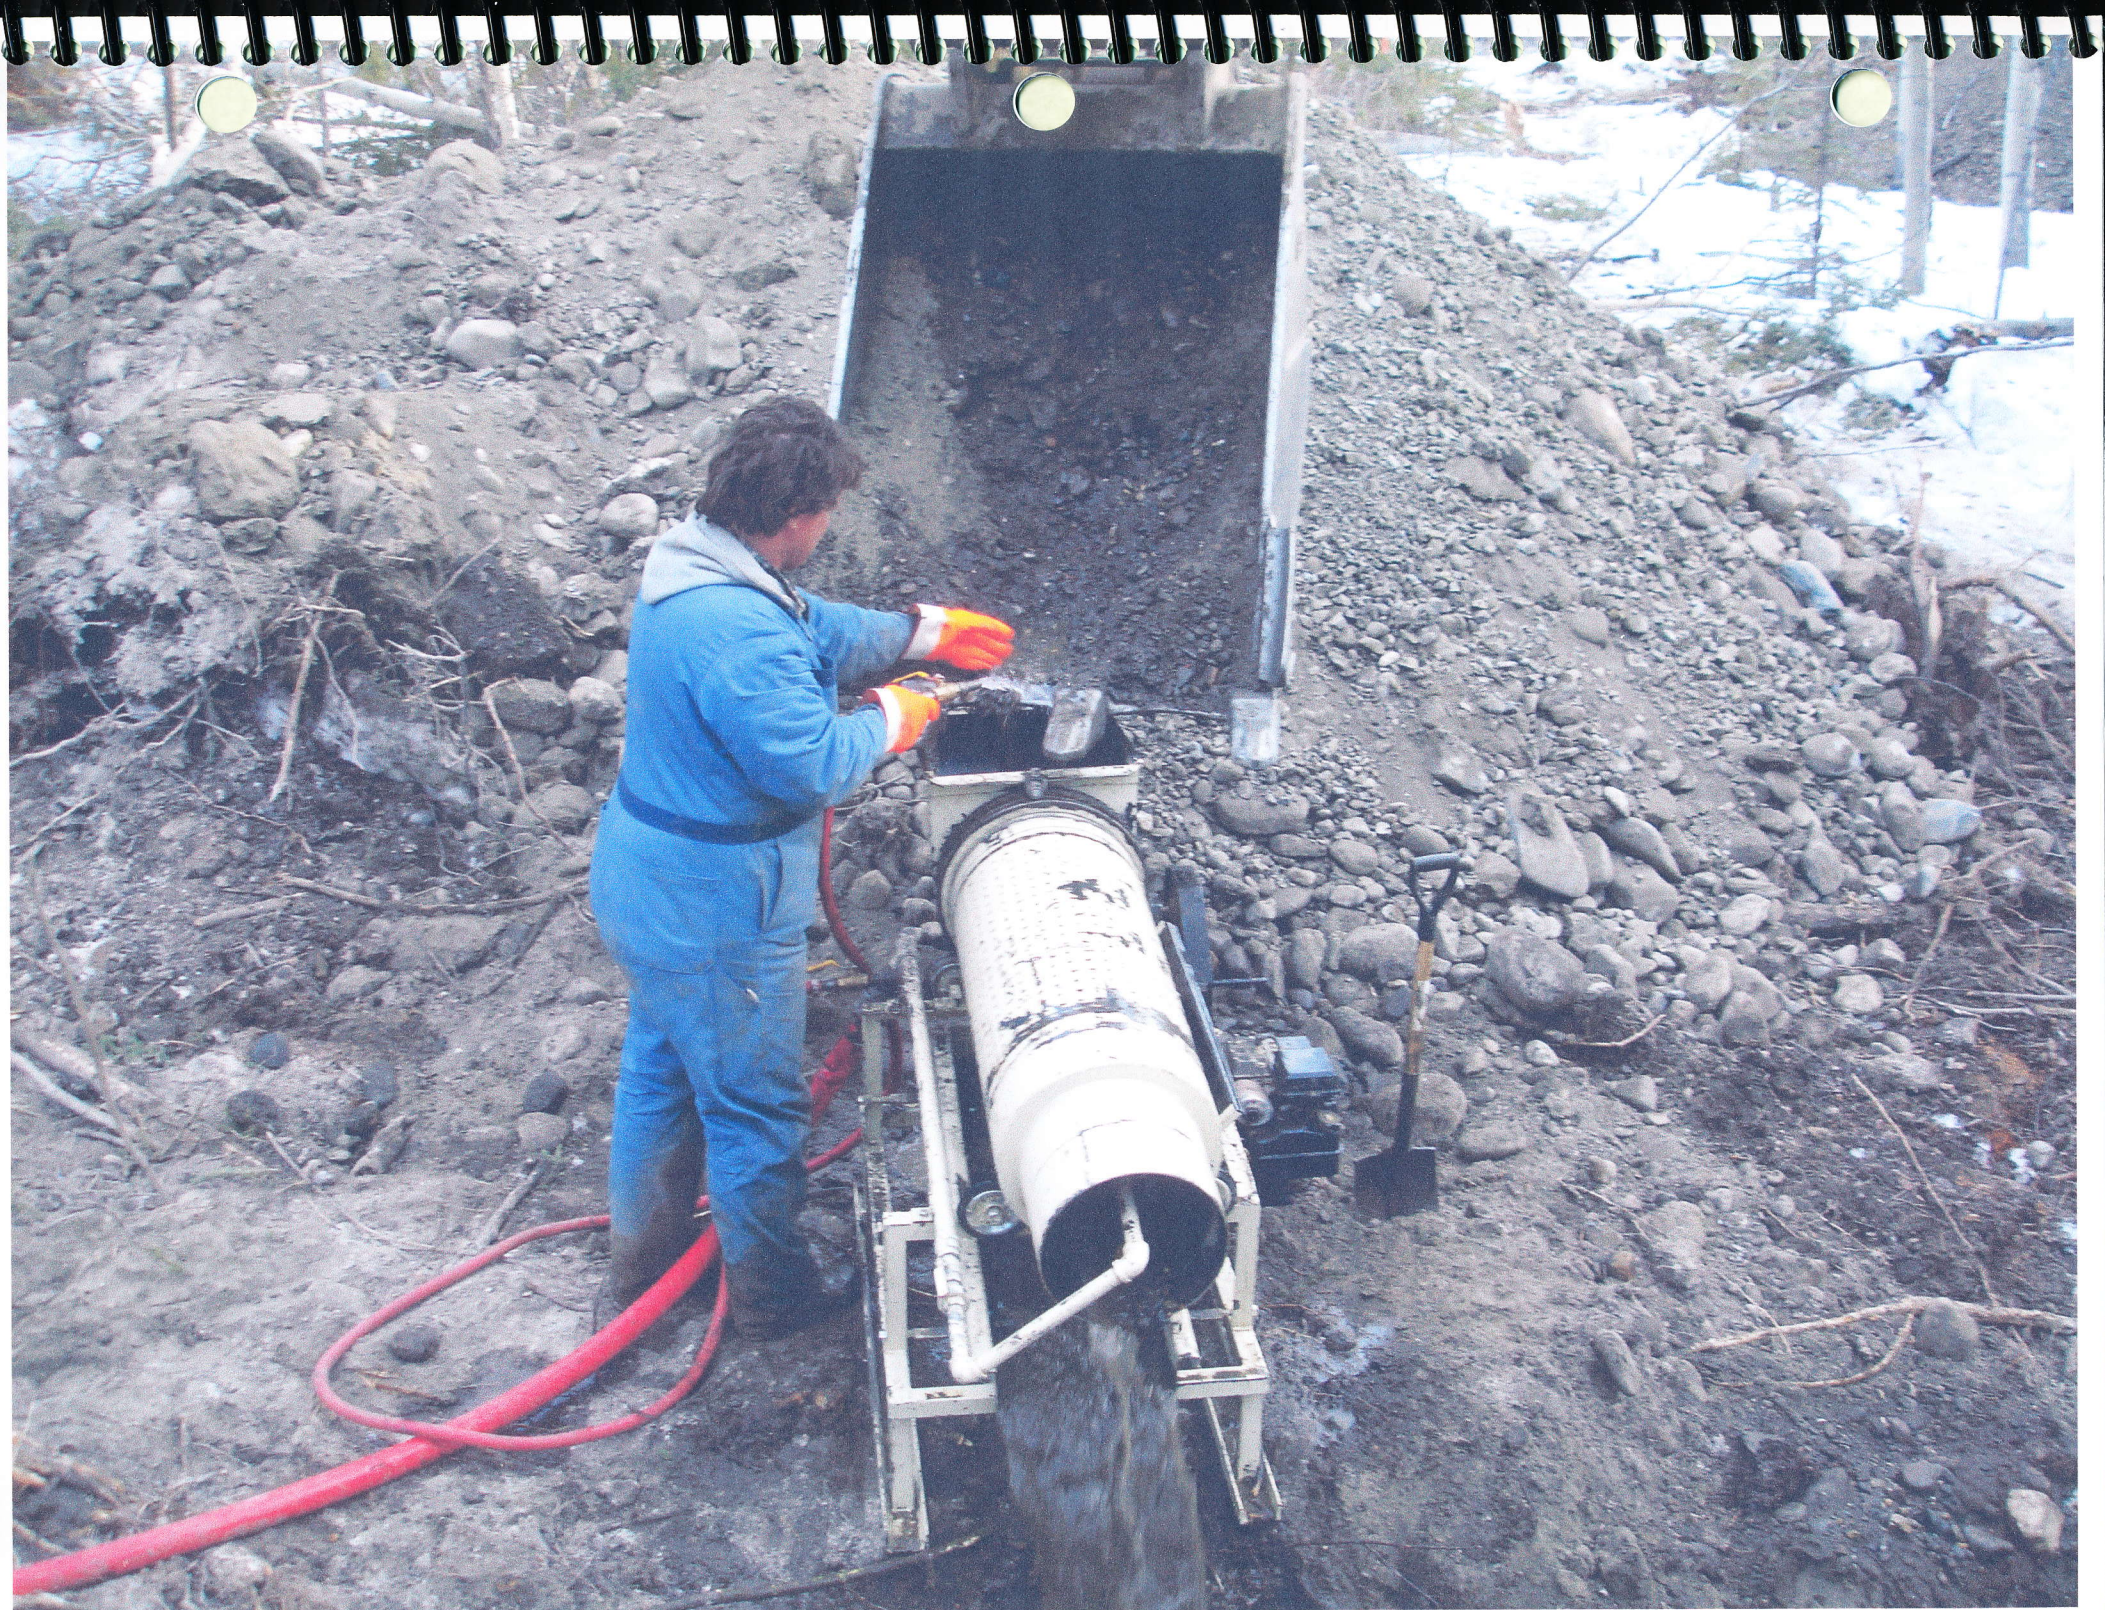
Test Site Location

Bedrock test pit

Test pits were excavated on 3 mile drainage lease to the Pelly and 5 miles River Bench Lease. Due to time restraints of permit no test pits were dug on Hoole canyon 3 mile lease. Only one bulk one yard sample was processed on 5 mile lease. This was the only site we were able to contact bedrock. Hand panning along the river bank only 30 meters from this bedrock test produced values of 19 grams plus a yard.

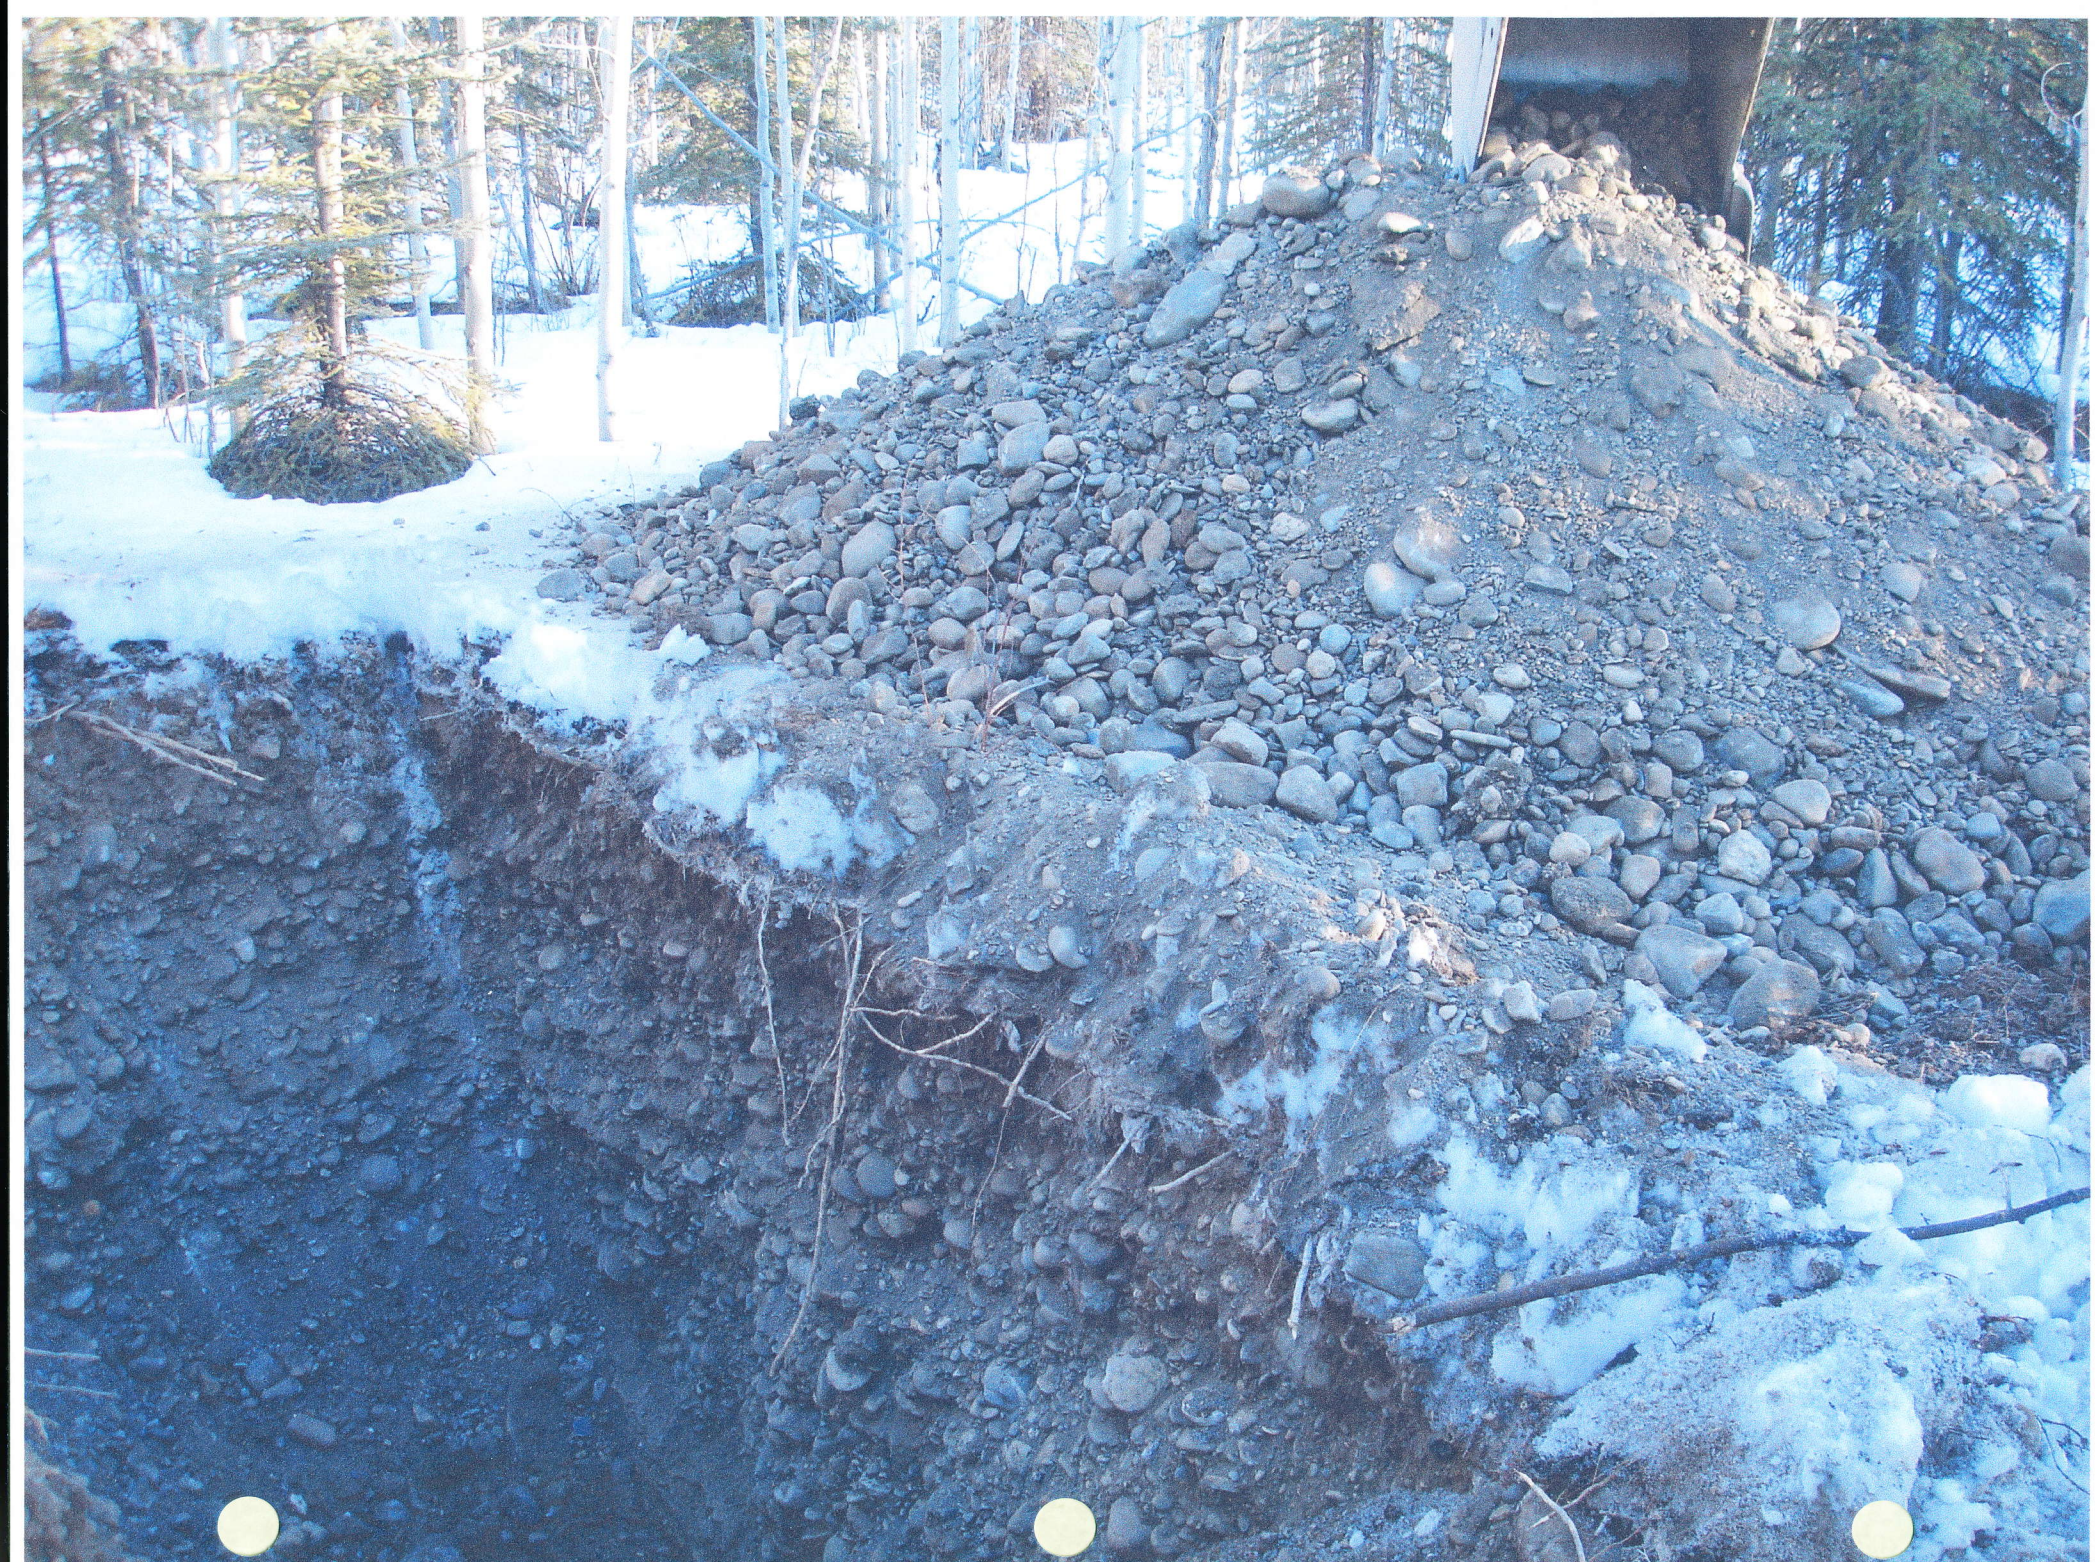
Test site location

5 Mile back from river

Test hole on river flat
