# Surficial geology investigations in Wellesley basin and Nisling Range, southwest Yukon

Bond, J.D., Lipovsky, P.S. and von Gaza, P., 2008. Surficial geology investigations in Wellesley basin and Nisling Range, southwest Yukon. *In: Yukon Exploration and Geology 2007*, D.S. Emond, L.R. Blackburn, R.P. Hill and L.H. Weston (eds.), Yukon Geological Survey, p. 125-138.

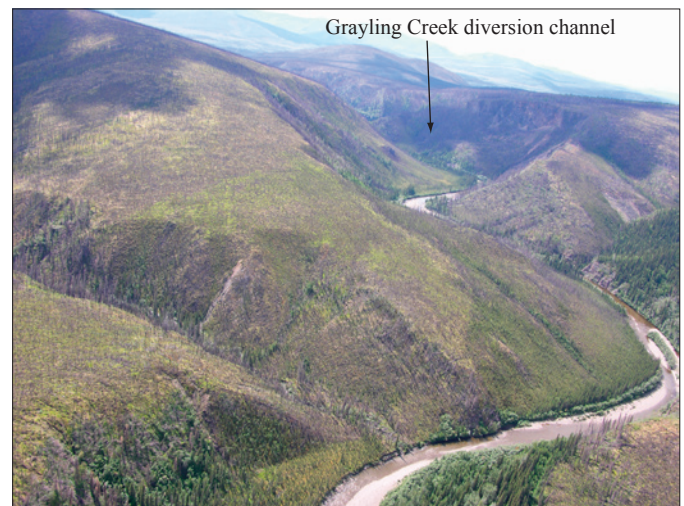
**Figure 3.** A view to the southwest over the Nisling Range and the Grayling Creek diversion channel. The local drop in base level triggered by the diversion is noticeable in the tributary valley located in the bottom left-hand corner of the photograph. The v-shaped morphology of the tributary valley provides an ideal setting for concentrating fluvial deposits.

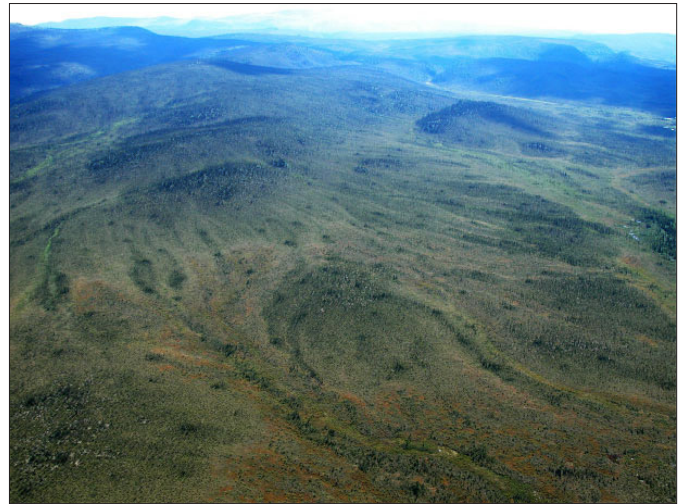
**Figure 4.** The flowing surface appearance on many slopes throughout the study area is inferred to be a result of a shallow permafrost table and extensive sheetwash and soil-creep processes. Also note the highly regular pattern of clustered black spruce trees that creates the polka-dot pattern on the landscape; this could be related to the underlying permafrost structure.

the land surface appears to be flowing; this feature is visible from the air on saturated slopes (Fig. 4).

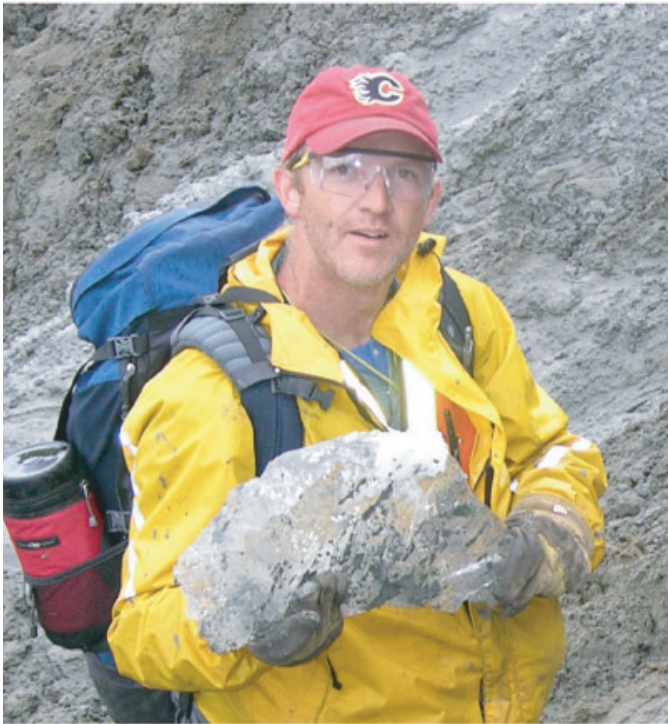
**Figure 5.** Jeff Bond with a large piece of clear ice removed from a 50-cm-thick vein within glaciolacustrine silty clay in a cutbank beside Mackinnon Creek. The ice content within the exposure indicates that permafrost is at least 11 m thick in this valley.

visible ice with massive ice lenses up to 50 cm thick (Fig. 5).

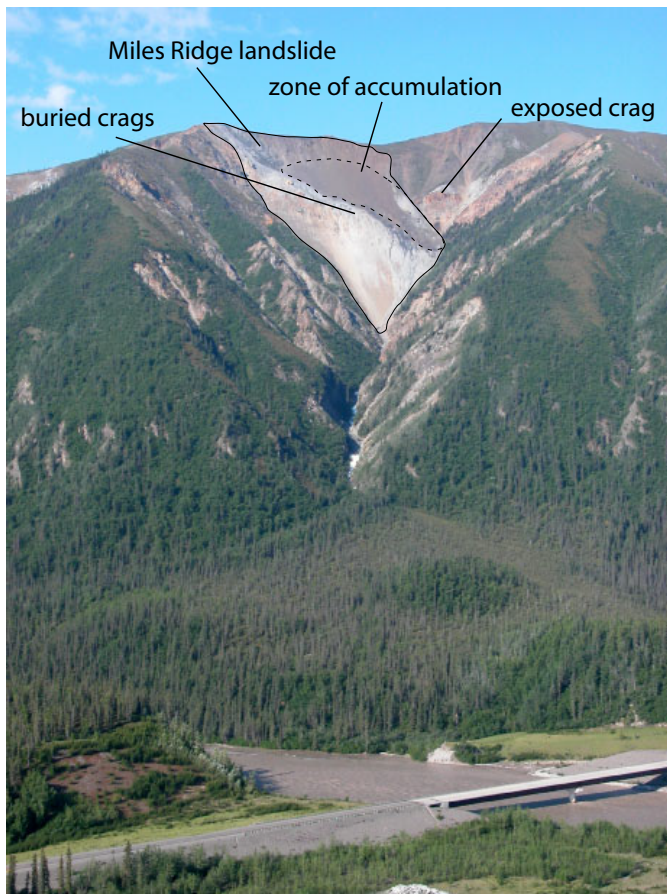
**Figure 6.** The Miles Ridge landslide in relation to the Alaska Highway and White River bridge. View is to the southwest.

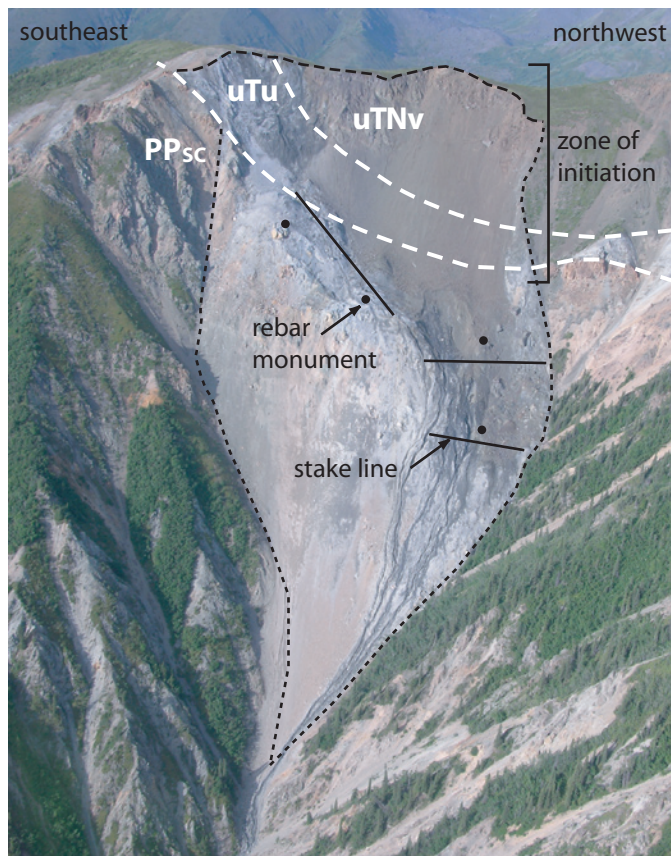
**Figure 8.** An oblique aerial photograph view looking southwest at the Miles Ridge landslide. The locations of stake lines and monuments for deformation monitoring, as well as geological contacts are shown schematically (after Israel *et al.*, 2007). Bedrock unit labels are defined as follows: PPsc = Pennsylvanian-Permian Station Creek Formation; uTu = Late Triassic Kluane mafic-ultramafic complex; uTNv = Late Triassic Nikolai formation.

Vesicular basalt of the Nikolai formation is in fault contact adjacent to the ultramafic rock and extends to the top of Miles Ridge (Fig. 8; Israel *et al.*, 2007). Localized foliation within the Nikolai formation is parallel to movement along the strike-slip fault and is sub-parallel to the crest of Miles Ridge.

1. 17 wooden stakes at approximately 30-m spacing were placed 1 m behind the headscarp in order to provide a reference for ongoing erosion of the initiation zone.
2. 49 stakes with 5-pace spacing were installed along the crest of the southeast debris accumulation zone (Figs. 8 and 9).
3. 26 stakes with 10-pace spacing were installed in two lines across the northwest active debris flow zone (Figs. 8 and 9).

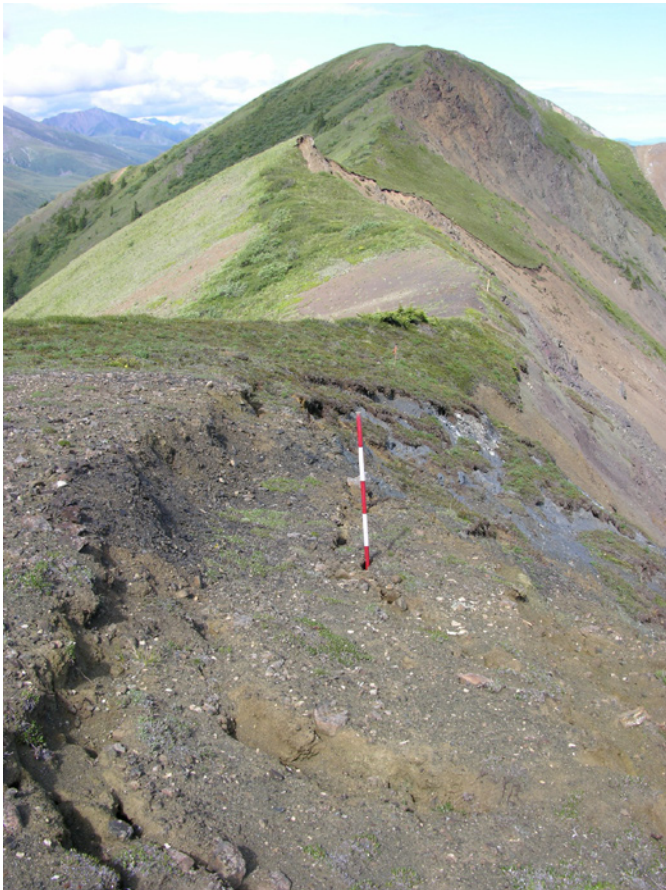
**Figure 10.** A view to the northwest along the headscarp of the Miles Ridge landslide. Active slumping is visible in the foreground. A pogo stick with 25-cm intervals is shown for scale.

Initial field observations in 2007 suggest that the Miles Ridge landslide is largely controlled by the character of the local bedrock. The Station Creek Formation appears to be buttressing the extremely incompetent overlying units of altered ultramafic rock and foliated basalt. Partial collapse of the Station Creek Formation has likely triggered failure of the overlying rocks. Active slumping along the headscarp in the Nikolai formation and debris-flow activity in the highly altered ultramafic rock indicates that the landslide is still actively responding to unstable slope conditions (Fig. 10).
