Assessing Miles Ridge landslide activity using an integrated ground-RPAS-satellite approach

Stix, J., Roman, J., Kalacska, M., Lucanus, O., Lipovsky, P.S. and Arroyo-Mora, P., 2026. Assessing Miles Ridge landslide activity using an integrated ground-RPAS-satellite approach. In: Yukon Exploration and Geology 2025, A. Stuart, L.H. Weston and S.K. Schultz (eds.), Yukon Geological Survey, Government of Yukon, p. 221–237.

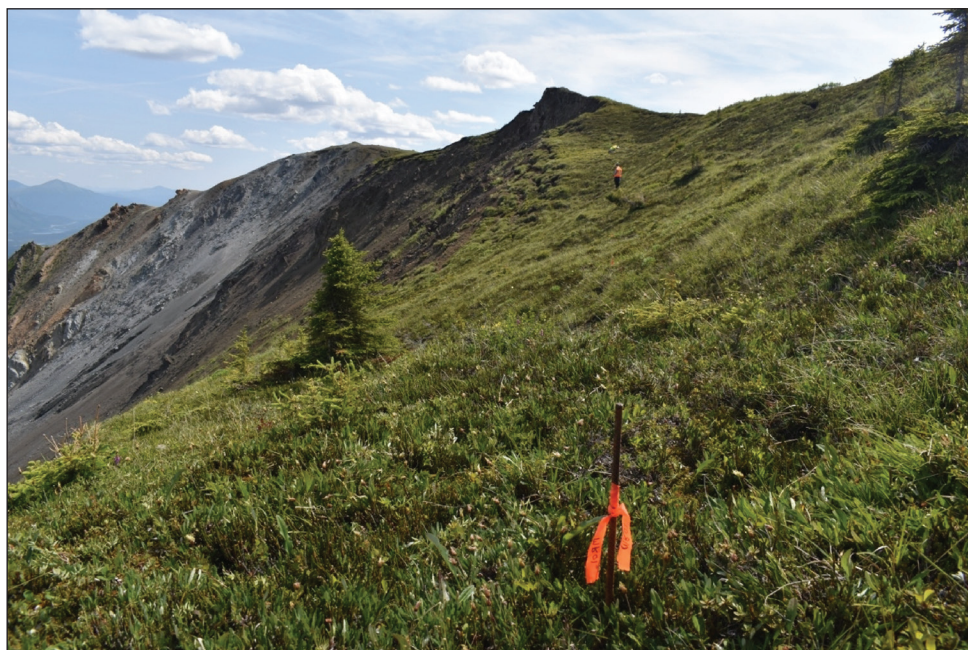
Figure 2. Photograph facing southeast illustrating the new MR line of wood and rebar markers installed on July 9, 2025. The markers are spaced approximately 12 m apart. Note person for scale in upper part of image.

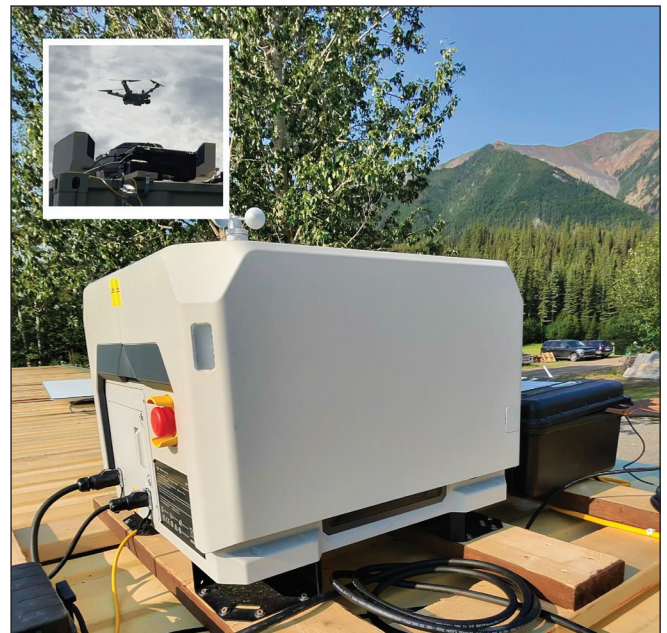
Figure 3. Installation of the DJI Dock 2 on the top of the shipping container; Miles Ridge is in the distance. The inset illustrates the M3TD during take-off. The Dock 2 weighs 34 kg and is 57 × 58.3 × 46.5 cm (L×W×H) with the doors closed.

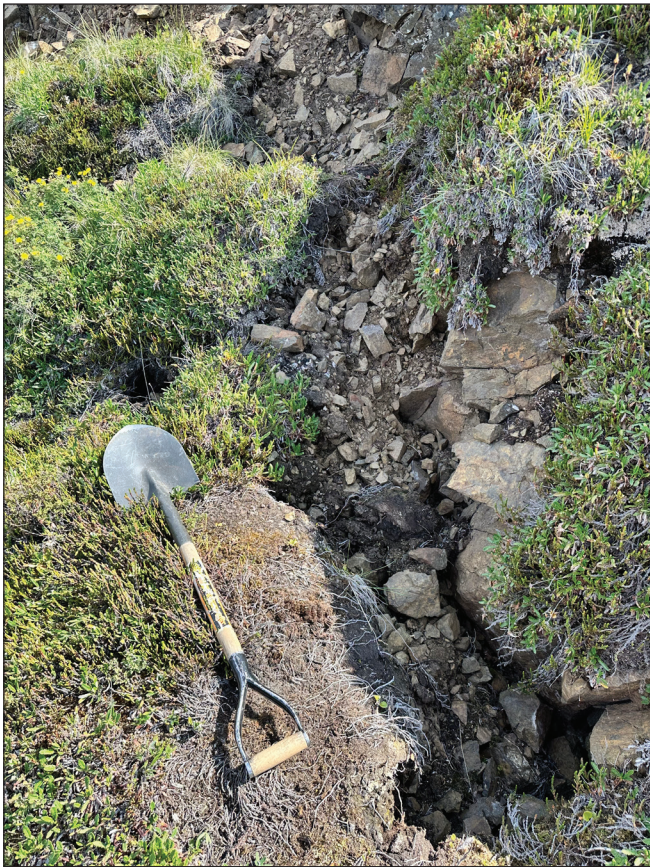
During the MR-series survey, fresh tension cracks were noted on a vegetated slope near the top of the ridge. Uneven ground surfaces and local subsidence were also visible along the ridge. These features provide evidence of active mass movement and support the interpretation of ongoing instability at the site. Figure 4 illustrates large tension cracks up to approximately 50 cm wide and between 20 and 30 cm deep with relatively fresh roots stretched across the cracks. These observations highlight the importance of integrating GNSS measurements with visual observations to characterize the slope activity at Miles Ridge.

Figure 4. Large tension crack observed just below Miles Ridge. Note the fresh-appearing nature of the debris and the angular rock fragments. Shovel for scale is 100 cm long x 20 cm wide (blade).

Both our ground survey and our RPAS data revealed a zone of active tension cracks in this upper sector (Figs. 4 and 6). Fresh, vegetation-free soil within the depressions and the presence of fresh roots and angular clasts indicate that these cracks are actively deforming. Future surveys could include repeated measurements of crack width and length, with high-resolution RPAS imagery supporting change detection and aiding in identifying new or expanding fractures.

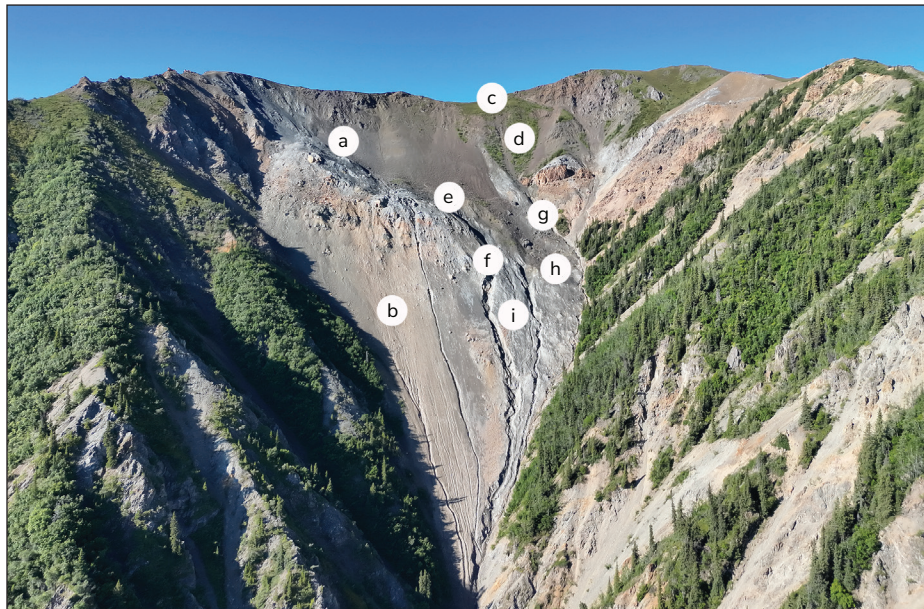
Figure 7. An RPAS photograph of the landslide. (a) apron of brown talus, (b) smooth lobe, (c) tension cracks, (d) vegetated zones, (e) erosional amphitheatre, (f) highly incised channel, (g) large boulder, (h) dark-coloured lobe, (i) topographically rough lobe.

The lower reaches of the landslide comprise two main lobes, one relatively smooth on its surface and one relatively rough (Fig. 7). The lobes are incised by several large erosional gullies which originate from

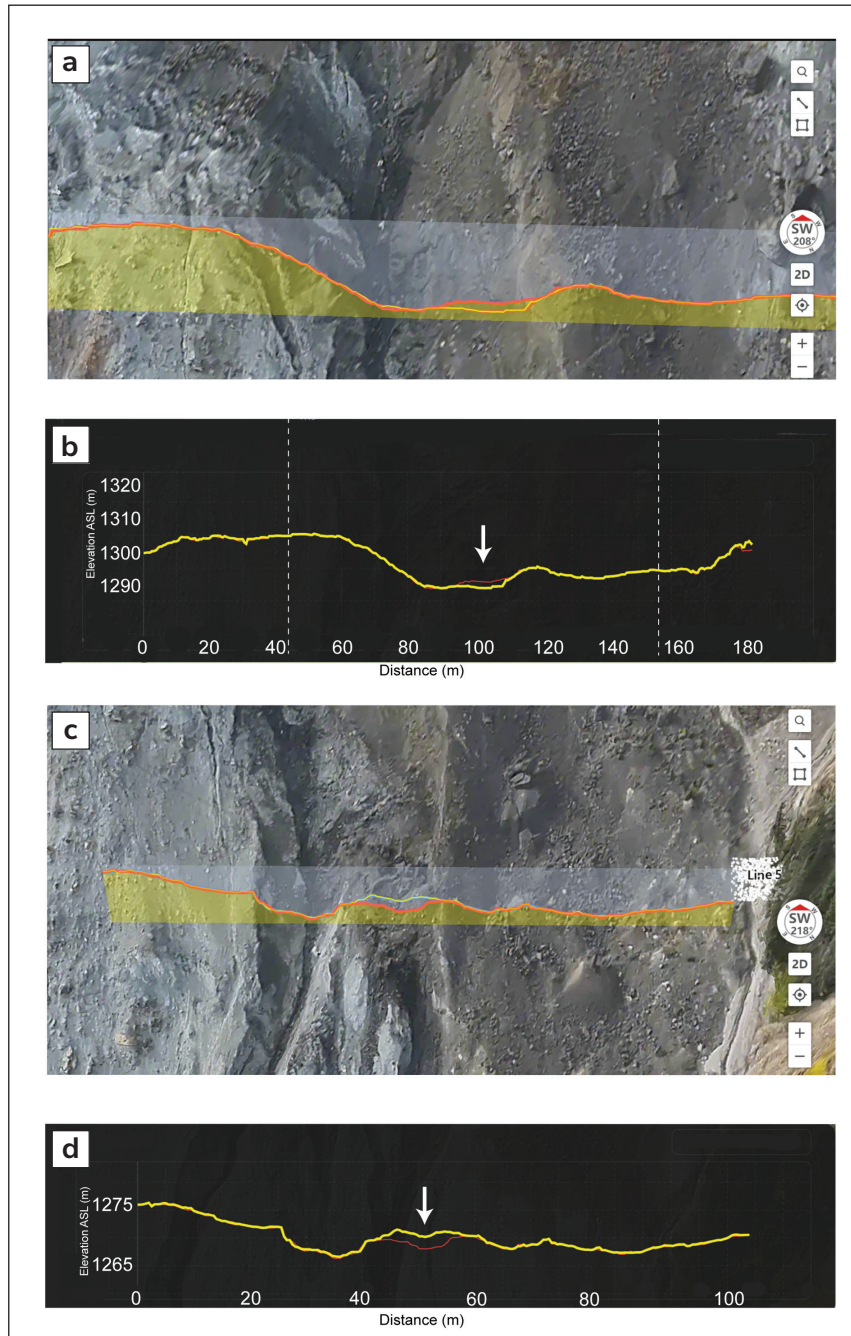
Figures 10 and 11 illustrate a temporal comparison of the 3D RPAS-derived models collected on July 14 and September 7. The cross-sections in Figure 10a and 10b show approximately 2 m of erosion along a ~13 m section of the eastern margin of the amphitheatre. In contrast, the lower cross-sections in Figure 10c and 10d reveal material deposition within the channel immediately downslope of the amphitheatre, with gains of roughly 2.3 m in depth across the ~11 m wide channel. Additional transects, extracted in both vertical and horizontal orientations across the broader landslide, showed no measurable change over this interval. Figure 11 provides a relative spatial map of the detected surface change at both the slope and amphitheatre scales, highlighting the localized distribution of erosion and deposition. Overall, the amphitheatre exhibits a net gain of 174.4 m³, derived from an estimated 2076.7 m³ of material lost upslope and 2251.2 m³ deposited downslope within the channel.

Figure 10. Comparison of cross-sections across the amphitheatre illustrating areas of material erosion and deposition. **(a)** Cross-section extracted from the FlightHub 2 3D models showing a zone of erosion between July 14 (red line) and August 12 (yellow line). **(b)** Elevation-change profile for the same cross-section; the segment between the vertical dashed lines corresponds to the close-up area shown in (a). Arrow indicates area of erosion. **(c)** Cross-section from the 3D models illustrating a zone of deposition immediately downslope of the amphitheatre over the same time interval. **(d)** Elevation-change profile for the cross-section shown in (c). Arrow indicates area of deposition.
