Riverview Hotel

Whitehorse, Yukon

Energy + Building Systems Analysis Energy Upgrading Options 2001

April 2002

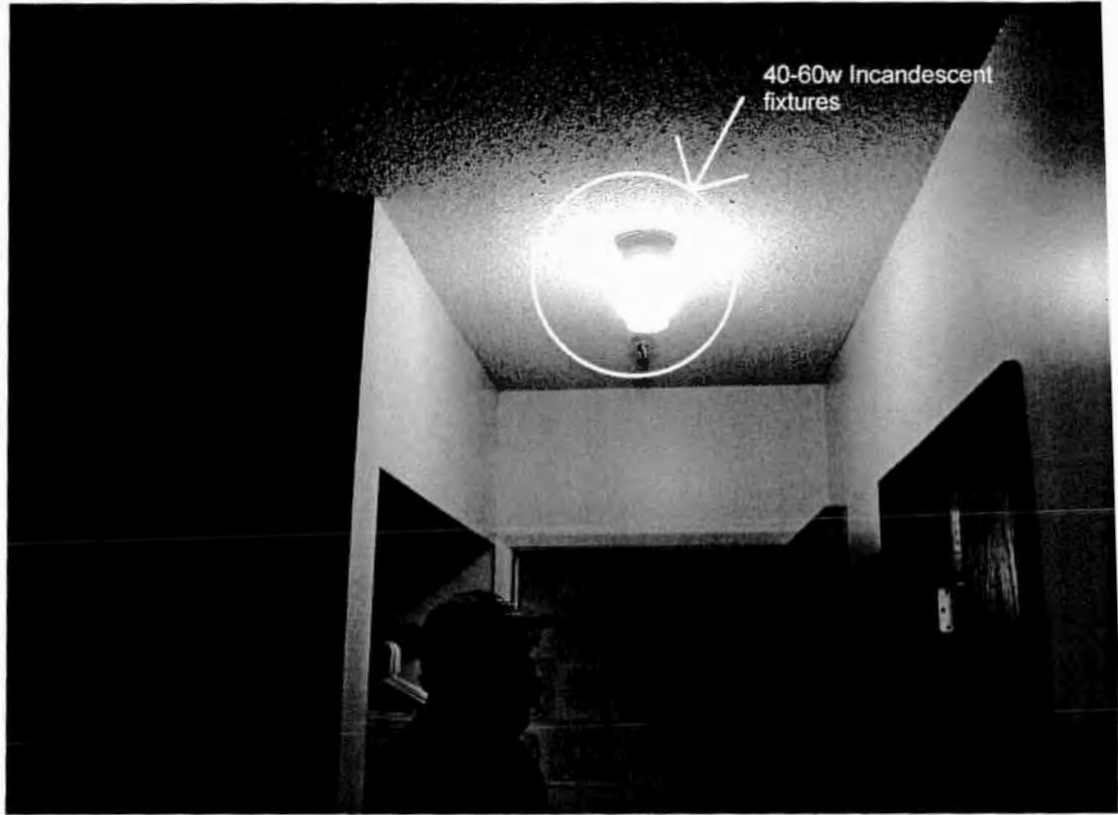
Photograph One

Typical guest room 40-60W incandescent bulb to be replaced with 7W compact fluorescent.

The existing incandescent lamps should be replaced with more energy efficient compact fluorescent lamps. Compact fluorescent lamps consume less energy and output approximately the same level of light, when the correct replacement is used. Care should be given in choosing replacement lamps for existing incandescent fixtures. Common sense is required of the installer to determine

The cost and saving below assumes the replacement of all 293 lamps, with an average saving of 70 percent of the current incandescent lamp consumption. The number of lamps actually installed will affect the capital cost but not the payback period. It should also be noted that compact fluorescent lamps have a longer lamp life than incandescent lamps, savings due to the longer lamp life was not taken into consideration for this report. We have used an installation cost of \$15 per lamp. A lower installation cost will significantly reduce the payback period.

<i>Estimated Cost:</i>	\$10, 841
<i>Calculated Saving:</i>	\$3,336
<i>Simple Payback Period:</i>	3.25 years

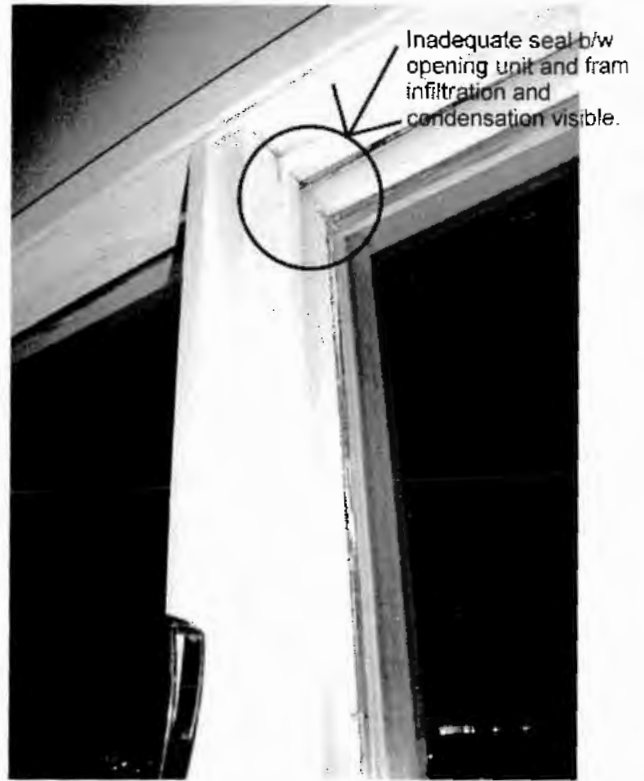
Photograph Three

Existing double glazed wood casement window unit in guest suite.

Measure	Estimated Cost of Measure	Calculated Savings	Simple Payback Period
Insulate Concrete Block Walls	\$1000.00	\$150.00 / year	6.7 years
Replace Windows with Double Glazed Low-e (or equal)	\$500.00 / window	\$31.25 /window/year	16 years

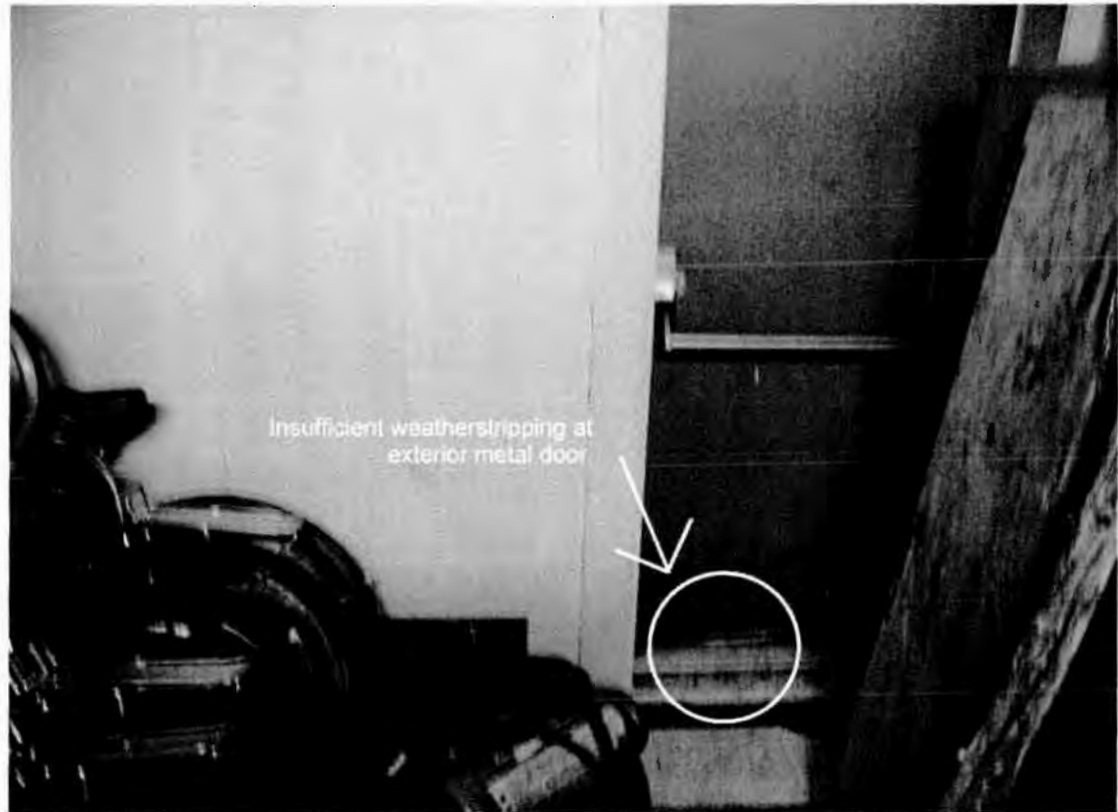
Photograph Seven

Interior view of service area at exterior door
