ROSS RIVER CONTAMINANTS STUDY

A Contaminants Evaluation for the Ross River Dene First Nation

**Patrick Roach
Contaminants Division
DIAND
345 -300 Main Street
Whitehorse, YT.
Report # 99-001**

March 1999

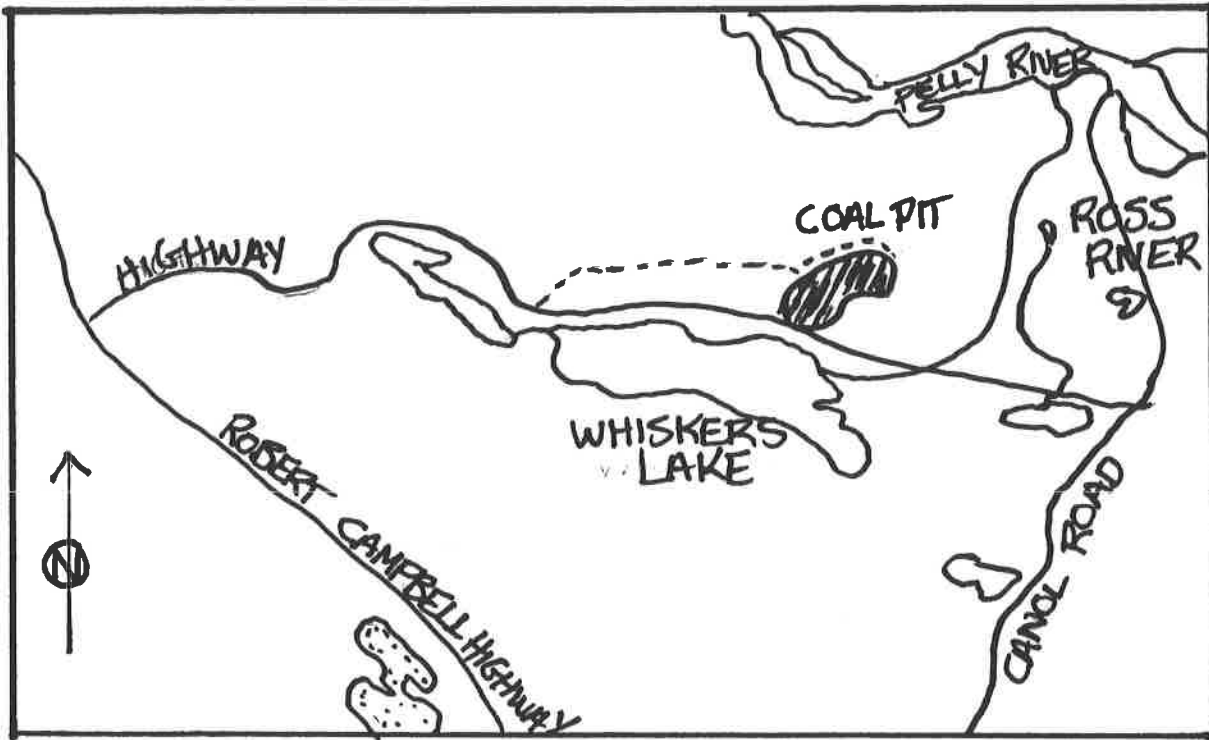
MAP 1: LOCATION MAP OF THE WHISKERS LAKE COAL PROPERTY

The Whiskers Lake Coal Property is located approximately 2.0 kilometers west of the Town of Ross River (Map 1). It is situated within the traditional territory of the Ross River Dene. The mined area terminates to the southwest at the highway running along the shore of Whiskers Lake.

Water has pooled in the bottom of the northeastern portion of the open pit, within an open coal seam. It appears that the water will not fill the pit and overflow. The sides of the mine are steep but appear stable and groundwater movement likely occurs along bedding planes. The coal is of good quality, low sulphur bituminous (Langdon, 1998). An analysis of the coal and waste rock is provided in Appendix I. The waste rock is chemically stable not acid generating so the metals present will not easily transport. The analysis of the pit water supports this with a low conductivity, low metal levels, and a pH of 7.5. The cadmium level is within accepted effluent guidelines, and while zinc and copper are higher than most guidelines, there is no discharge directly from the site to the Lake. Sulphates are high in the sample and reflect the magnesium and iron sulphates present in the rock. (Table 1&2).

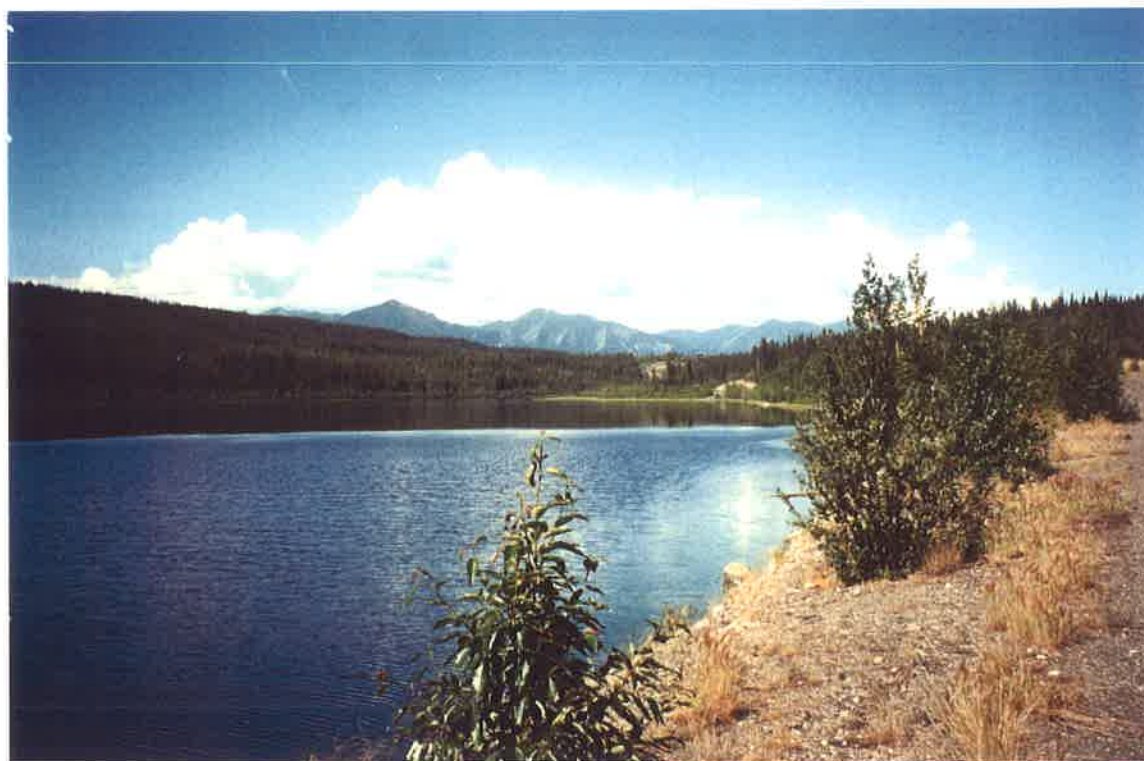
PHOTO A: WHISKERS LAKE

Whiskers Lake is an important fishing lake and attracts many avid fishers to the Ross River area (Photo A). In 1977, 20,000 coho salmon were released. In 1982, 17,000 rainbow trout were released. Since 1982, the lake has been stocked six more times with the most recent being in 1994 (Renewable Resources, 1996). The lake is large and deep with the fish showing a good growth rate and high survival. A concern that runoff from the mine might effect water quality and subsequently affect the fish quality was expressed. There is no direct discharge to the lake from the pit (Table 1&2).

Cadmium and zinc were not detected in Whiskers Lake and the copper level is within acceptable levels in the lake. Sulphate levels remain high and are related to the country rock.

The results of the study indicate no contamination of Whiskers Lake is occurring from the mine site. The open pit water chemistry is a result of the water sitting on the coal seam, capturing drainage from the waste rock. Continued site reclamation of the mine site would help to insure that the mobilization of metals from the site does not increase.

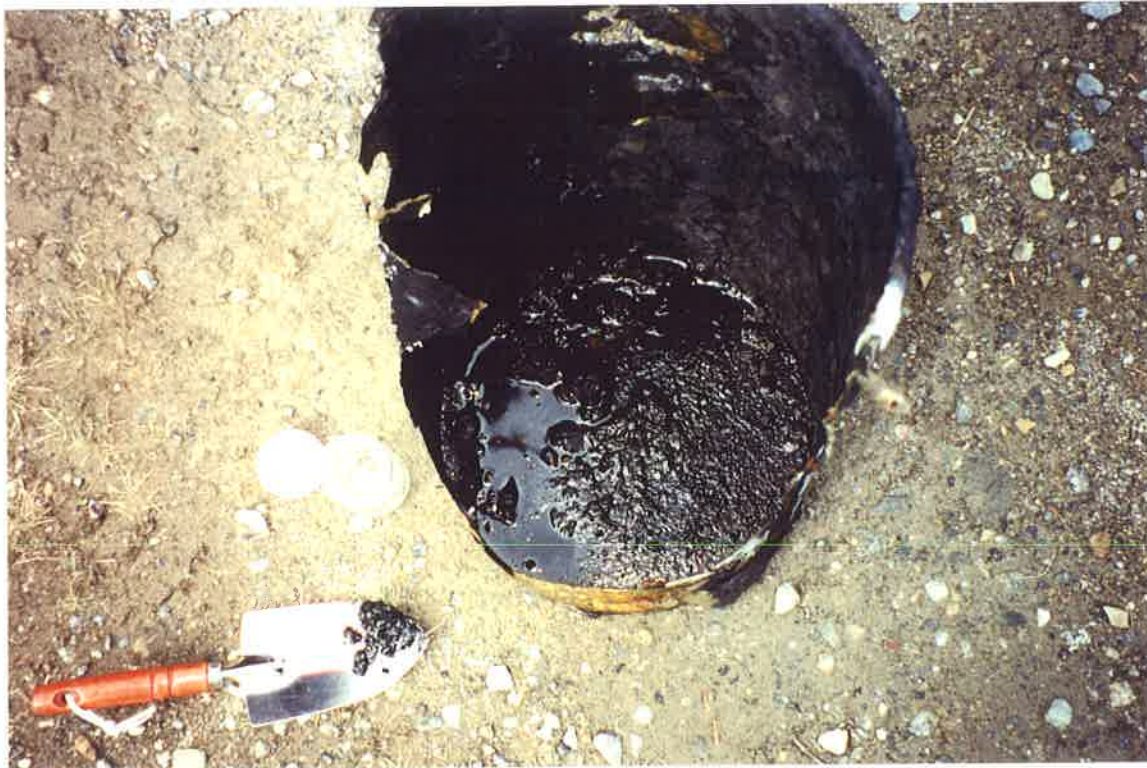
PHOTO A: RETRIEVED TAR BUCKET FROM JACKFISH LAKE

A total of 18 barrels and one bucket were found at the East End of the lake where road access and the float plane docks are located (Map 1). Most of the barrels and the bucket were visible and near the shore. Some of the barrels have the ends missing and the rest are filled with water. A 5-gallon bucket was the only container with visible contents other than water. It was retrieved and the contents analyzed (Photo A&B).

The pail contents were analyzed for organochlorines including DDT, PCP's and pesticides. No organochlorines were found in the sample. A hydrocarbon analysis indicates that it is a heavy oil, possibly a tar compound used on docks (Appendix I).

The barrels remaining in Jackfish Lake are probably left from past dock construction and pose no hazard to water quality. The bucket containing heavy hydrocarbons was removed and the analysis of the contents suggests it may have been used to "tar" a dock. Jackfish Lake should be included in the study of long range contaminant transport.

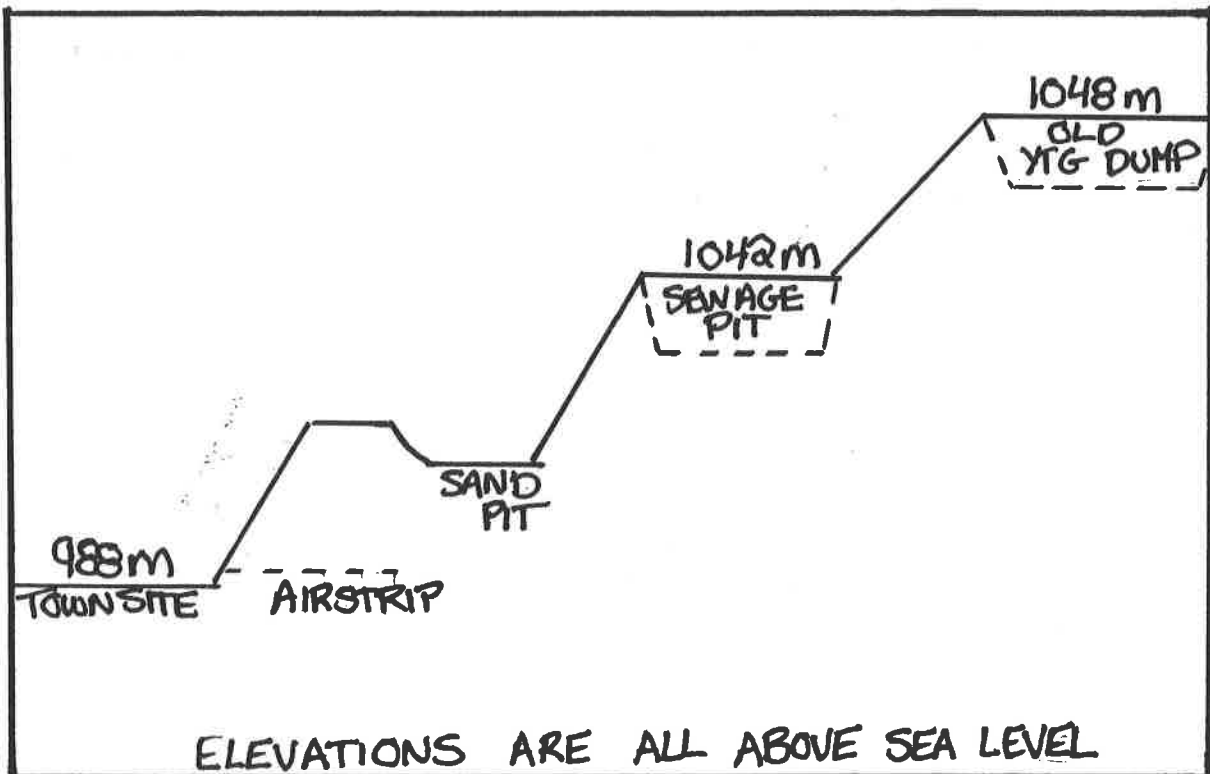
MAP 2: ELEVATION MAP OF CLOSED YTG DUMP SITE AND SEWAGE PIT

Physical description of the wells follows with an elevation map (Map 2)(Burns, 1998):

Well #1 -- Located on an up slope from Well #2 in a sandy, open area. The well depth was 2.4m. Approximately 1 cm of water was produced but due to low volume could not be extracted.

Well #2 – Located on an up slope from Well #3 in a sandy depression. Well depth was 2.29m with 0.35m of standing water contained in the pipe. The water was removed using a Waterra foot valve and tubing. The water was very turbid and contained a fine dark gray suspended sediment with an odour of petroleum products.

Well #3 – Located in a ravine up from Well #4. Permafrost existed approximately 30 cm below the surface and drilling was not completed.

Well #4 – Located in a ravine near the highway to Ross River. This is where the spring pools and the water is collected for drinking. There was no water on top of the permafrost, which existed several centimeters below the surface. The sleeve of the well could not be sunk.

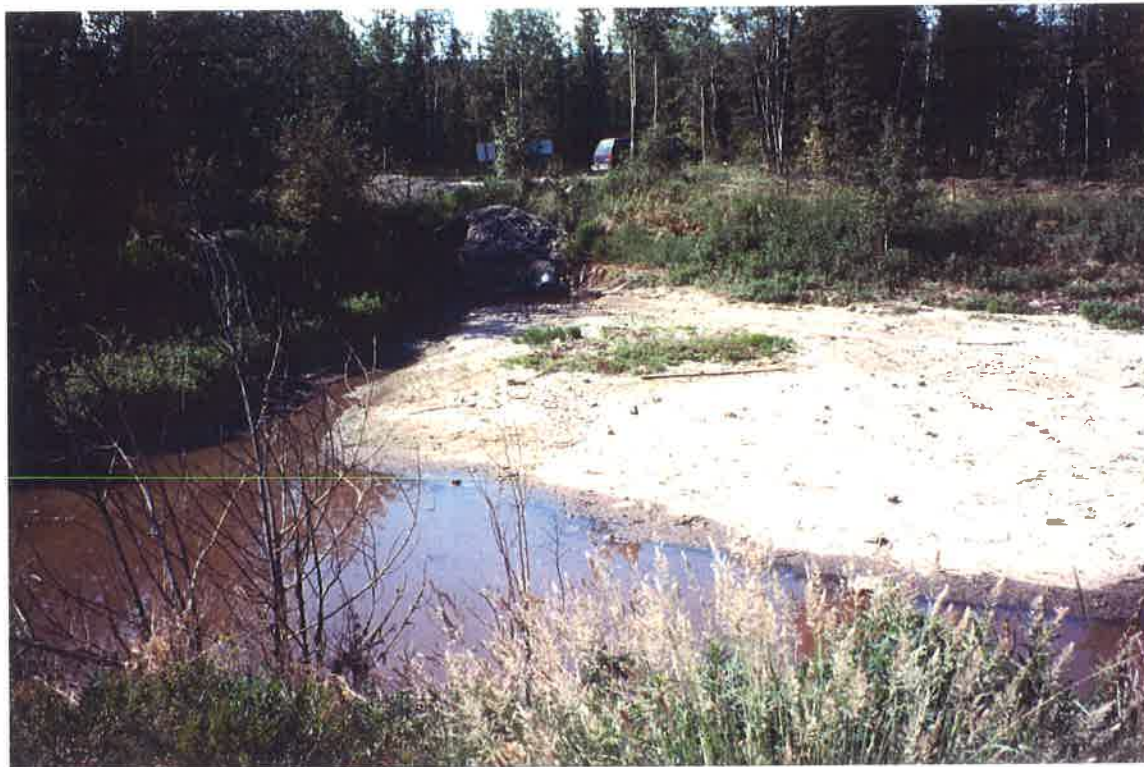
PHOTO C: BACK VIEW OF THE ACTIVE SEWAGE PIT

An old municipal dump is located approximately 2.5 km from the Ross River town site (Map 1) (Photos A, B&C). It operated from 1968 to approximately 1974.

No DDT, PCB or other organochlorine compounds were detected in the sample. Hydrocarbons were detected in significant concentration. The hydrocarbon analysis and the associated chromatogram indicates that this contamination is most likely from lubricating oils such as waste motor oil (Appendix I). These may have been deposited in either the dump or the sewage pit, owing to the location of the well.

The small sample size, from only one well, limits the range of interpretation. There are no organochlorines in the sample, while there is definitely hydrocarbon contamination. The type of hydrocarbon and the exact source are not known. There may be waste oil in the old dumpsite or it may have come from the sewage pit. More sampling will be undertaken in the Spring of 1999 during spring thaw and additional wells may be required to locate the source. The Ross River First Nation should not drink water from the spring until this sampling has occurred.

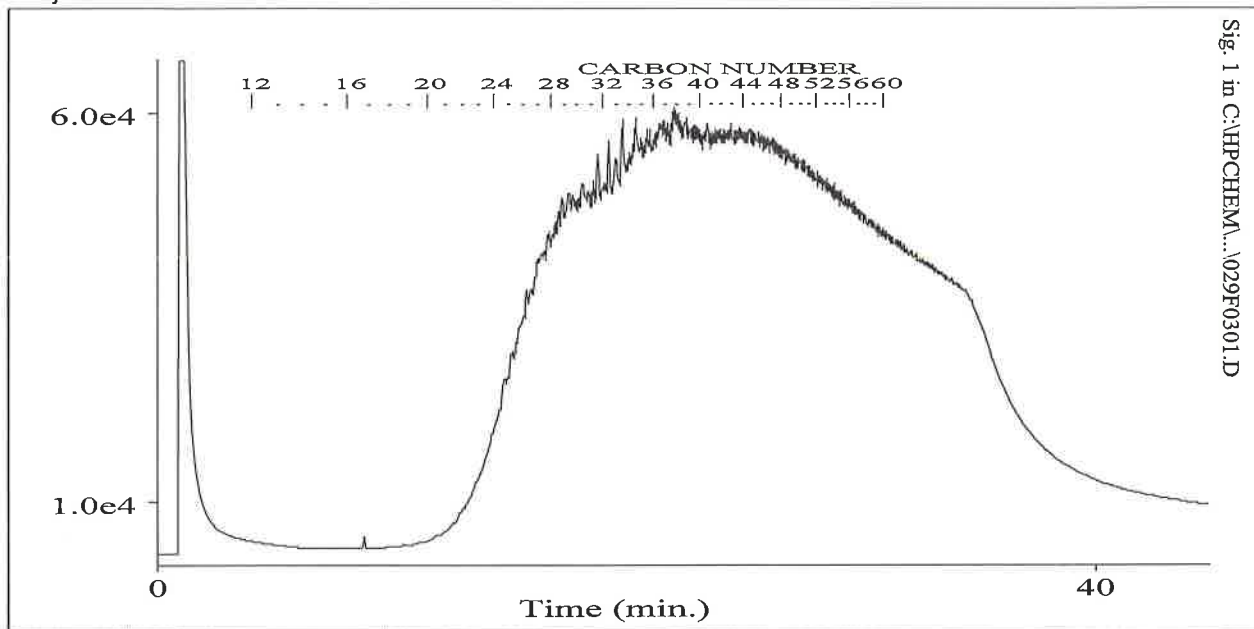
HYDROCARBON CHARACTERIZATION - C60 SCAN

Client: Northern Affairs Program
 Sample ID: Jackfish Lake Sediment/Petroleum
 Lab No.: 38645-1
 Project No:

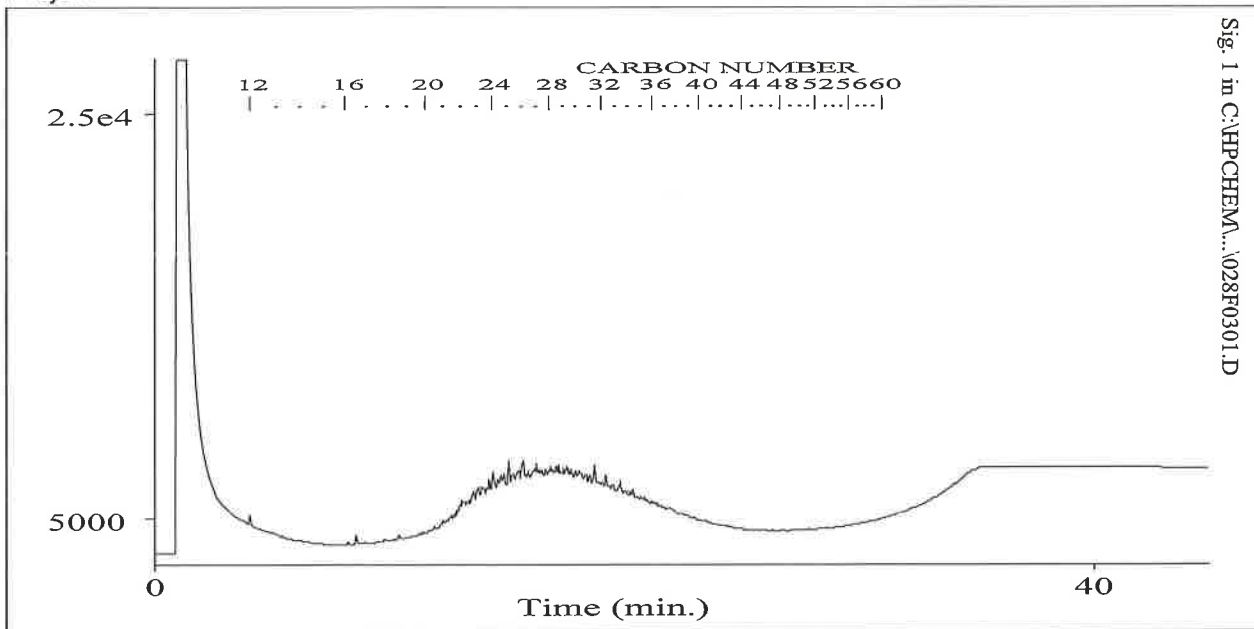
HYDROCARBON CHARACTERIZATION - C60 SCAN

Client: Northern Affairs Program
 Sample ID: Water Sample
 Lab No.: 38645-2
 Project No:
